SUBJECT: Final Case Closure with Continuing Obligations
Leo Tucker Auto Salvage (Former), N6817 Left Foot Lake Road, Crivitz, WI
DNR BRRTS Activity #: 02-38-169979
FID #: 438109540

RESIDUAL SOIL CONTAMINATION

FORMER LEO TUCKER PROPERTY
 N6817 LEFT FOOT ROAD
 CRIVITZ, WISCONSIN

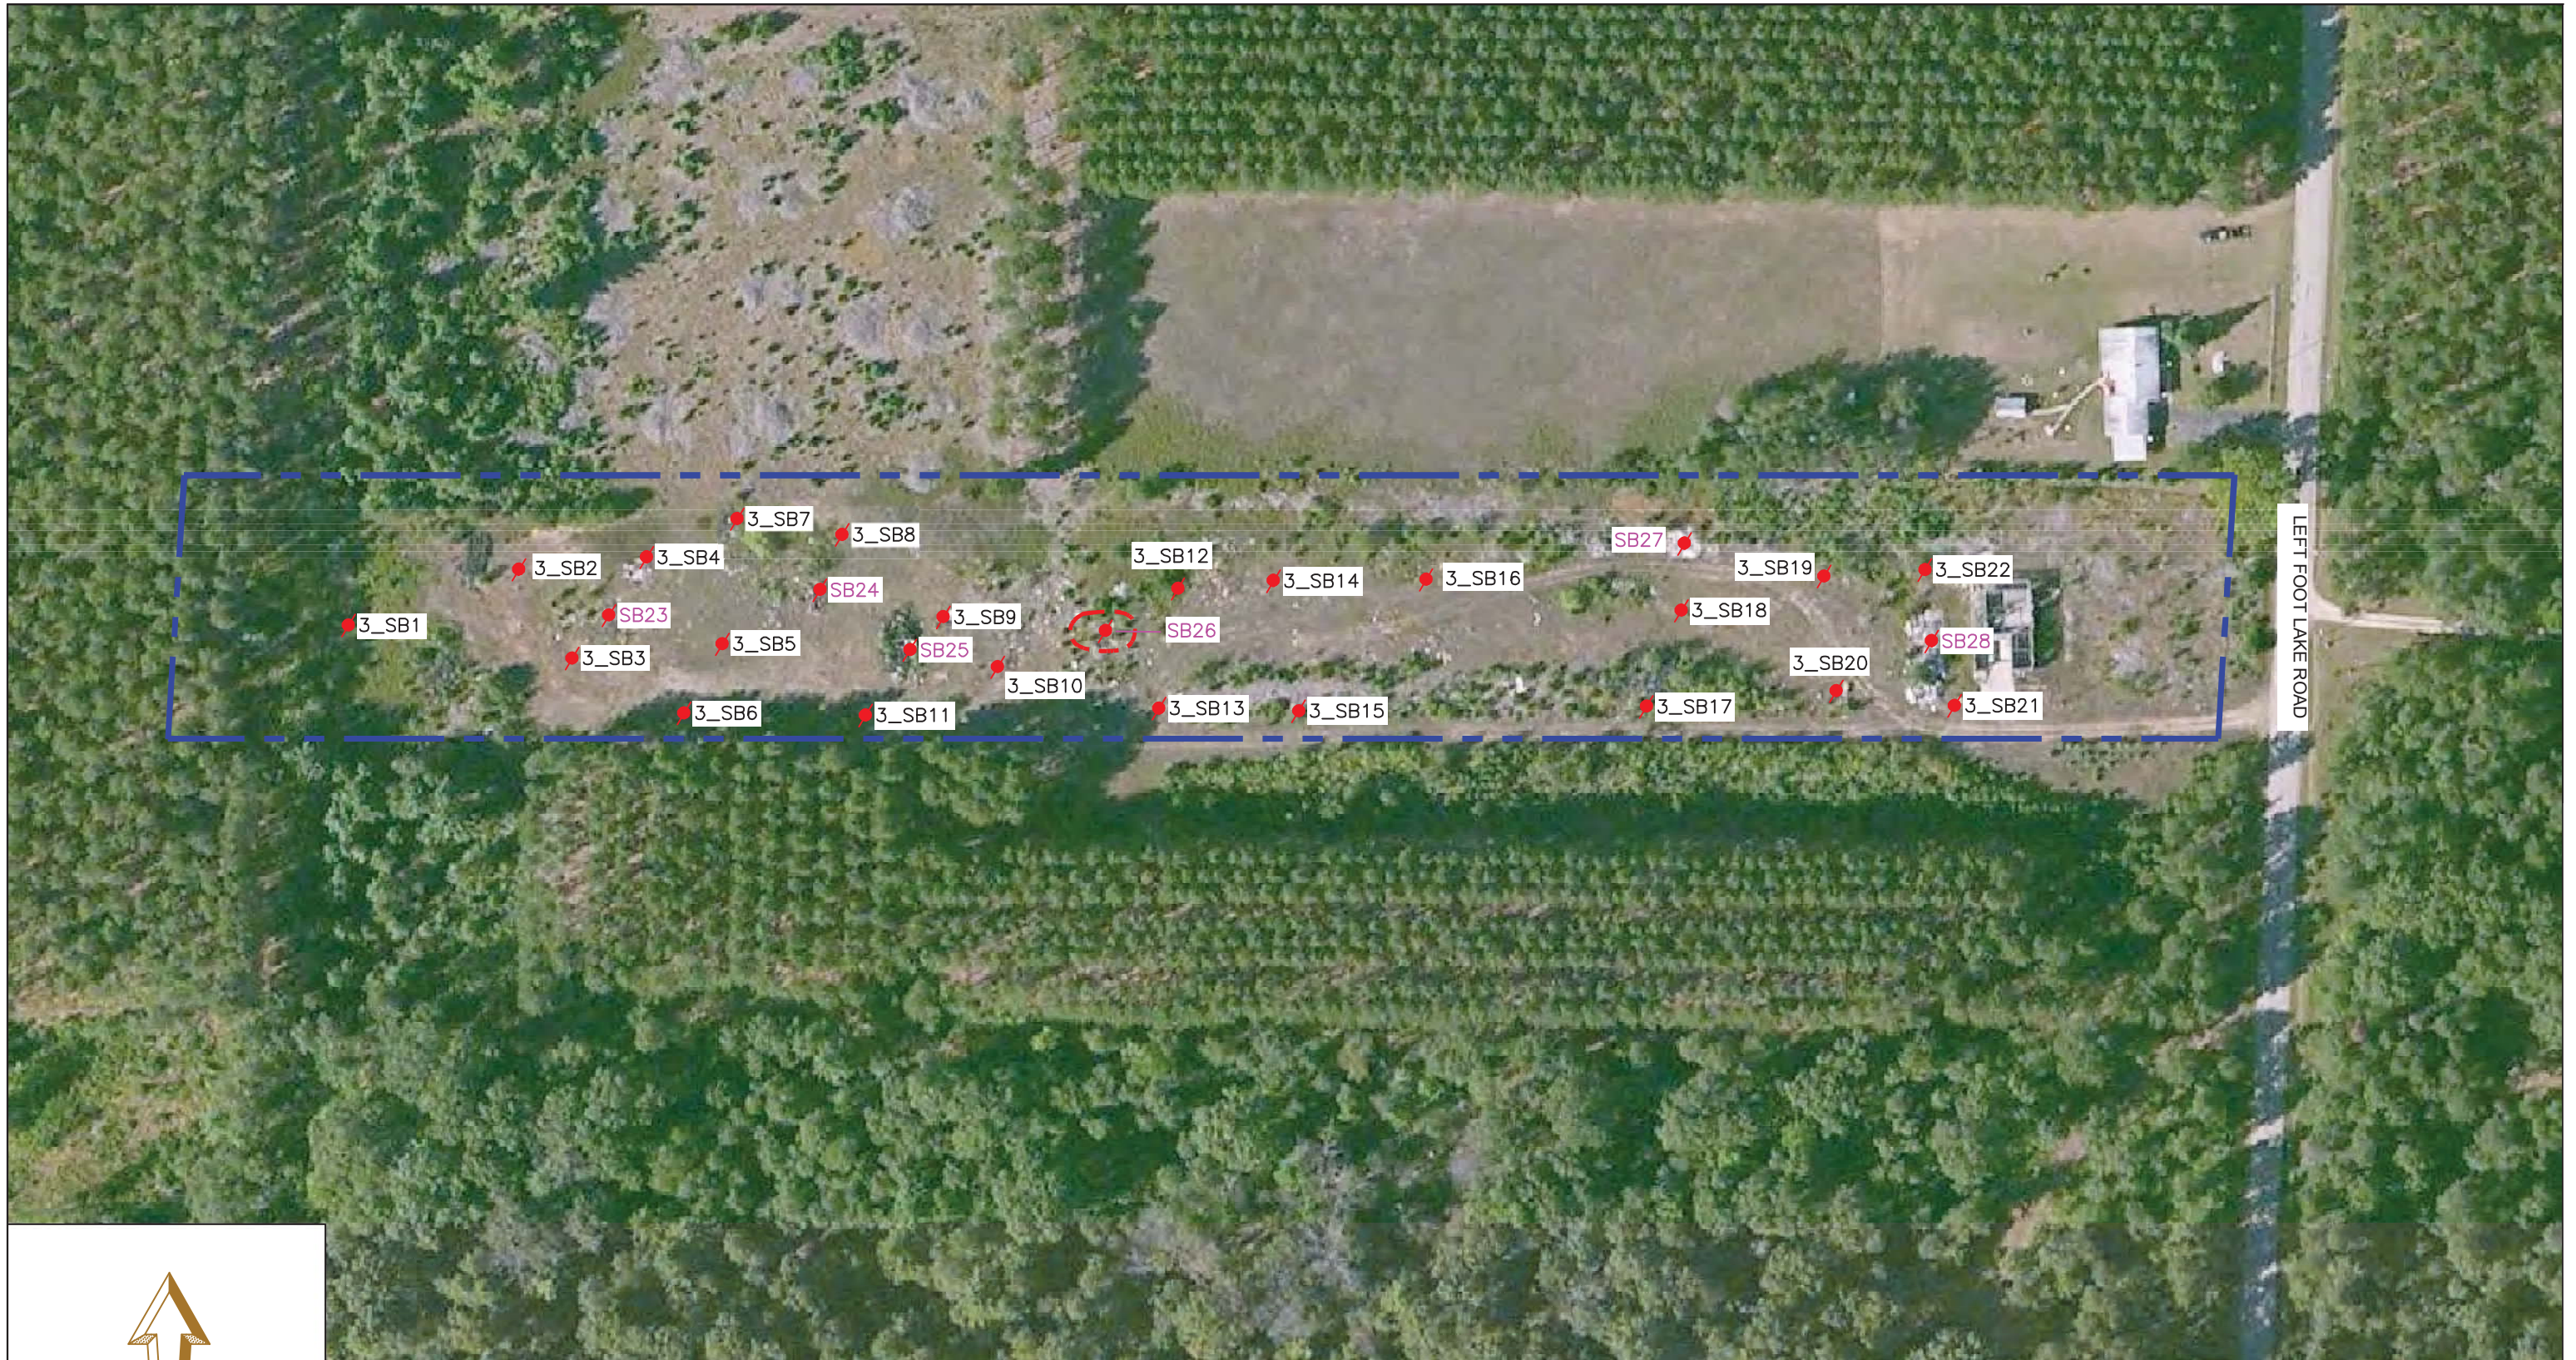
PROJECT NUMBER: 193705745 FIGURE B.2.b

Soil contamination remains in the central portion of the site as indicated on the attached map Figure B.2.b – Residual Soil Contamination, July 12, 2018. If soil in the specific locations described above is excavated in the future, the property owner or right-of-way holder at the time of excavation must sample and analyze the excavated soil to determine if contamination remains. If sampling confirms that contamination is present, the property owner or right-of-way holder at the time of excavation will need to determine whether the material is considered solid or hazardous waste and ensure that any storage, treatment or disposal is in compliance with applicable standards and rules. Contaminated soil may be managed in accordance with ch. NR 718, Wis. Adm. Code, with prior DNR approval.

- ii. Describe the concentration(s) and types of soil contaminants found in the upper four feet of the soil column.
Lead in soil exceeds the NR720 RCL for groundwater protection at a depth of 0-2 fbg in boring B26.

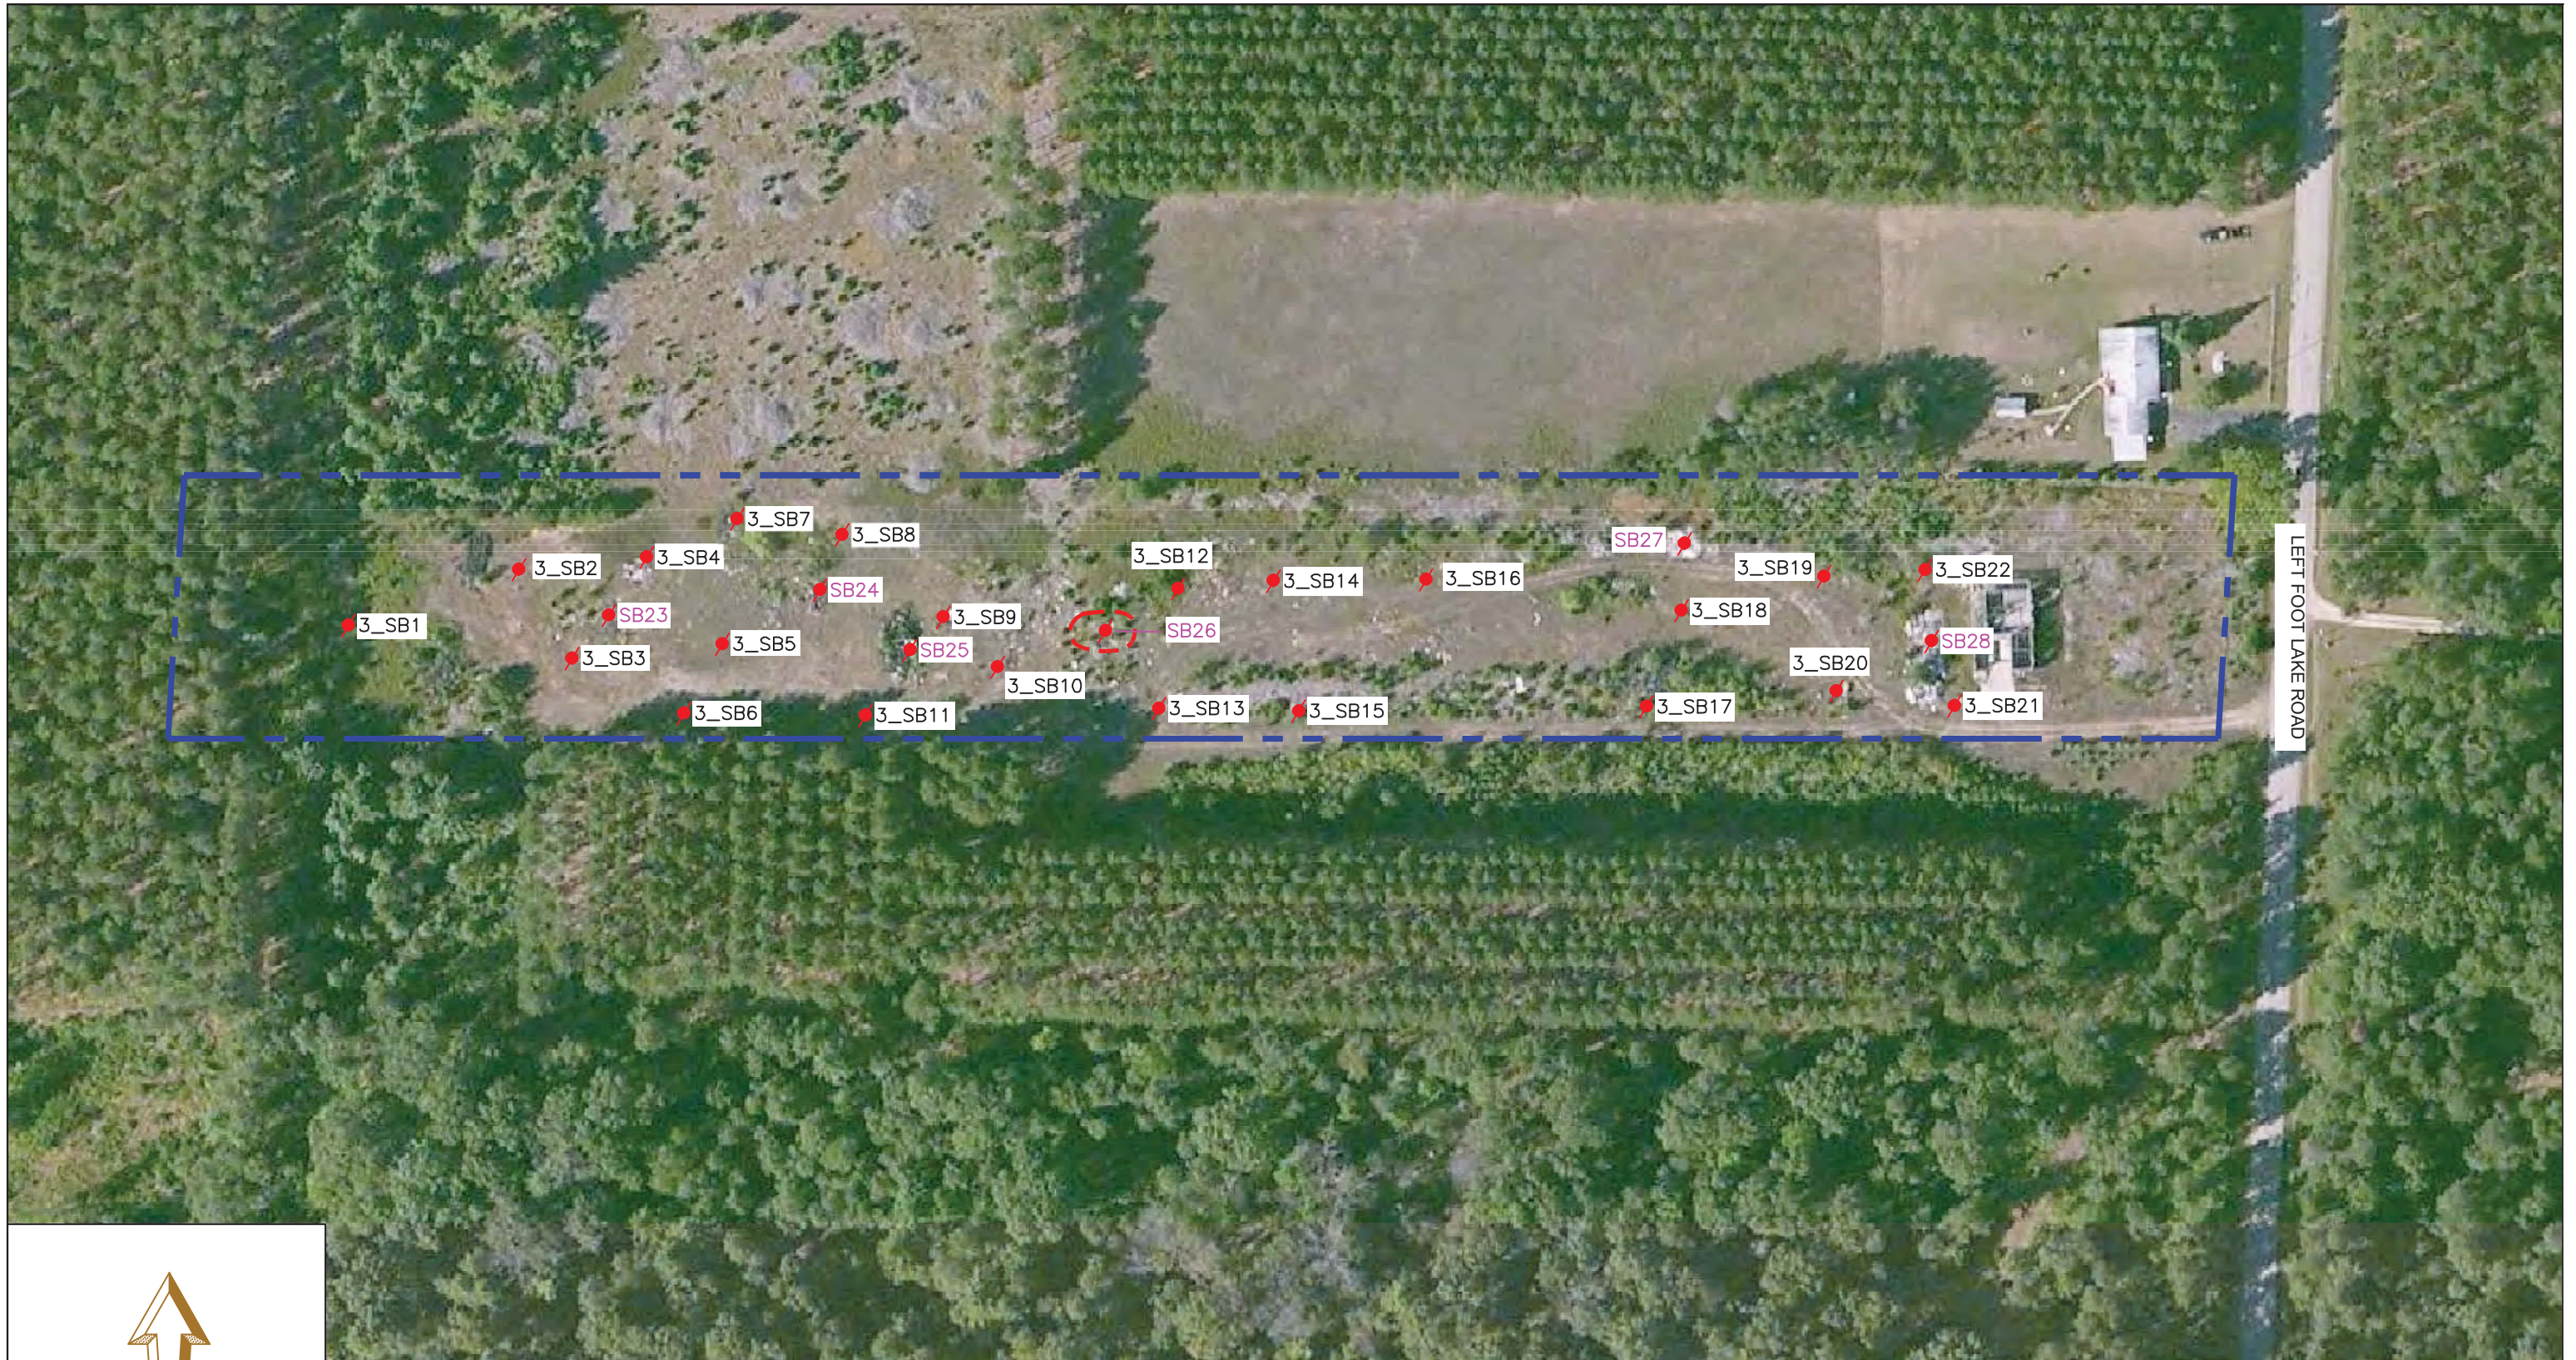
SOIL CONTAMINATION
