SUBJECT: Final Case Closure with Continuing Obligations  
City Wide Insulation, 2159 S. 116<sup>th</sup> St., West Allis, WI  
BRRTS #: 03-41-182126, FID #: 241898910, PECFA #: 53227-1093-59

**Phase II Environmental Site Assessment  
City Wide Insulation Company, Inc.  
2159 S. 116th Street  
West Allis, WI 53227**

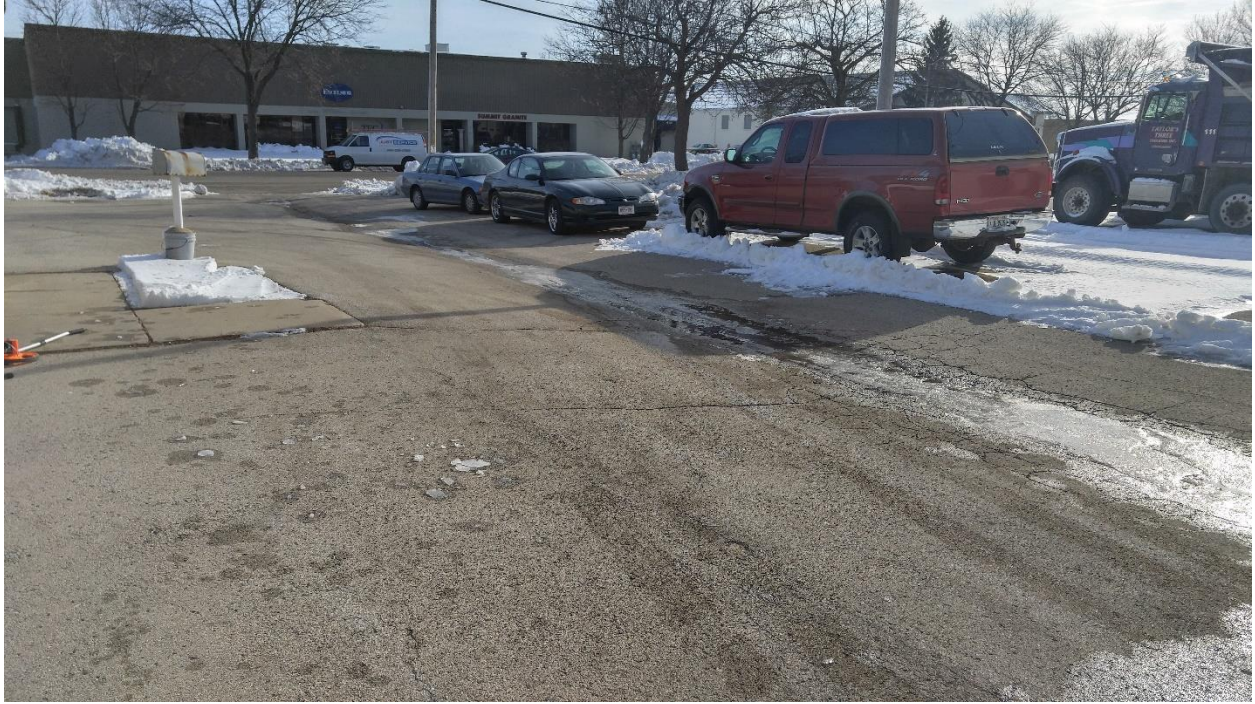
**WESTERN PORTION OF THE IMPERMEABLE CAP LOOKING SOUTHEAST**

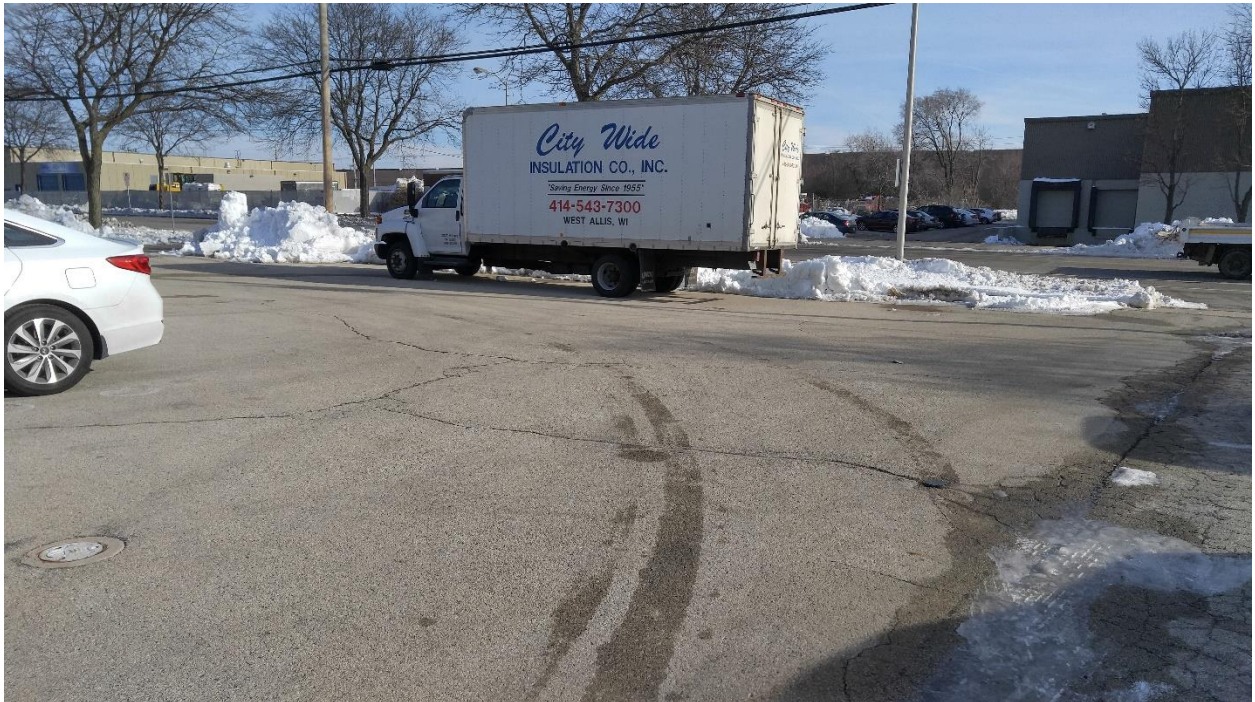
**EASTERN PORTION OF THE IMPERMEABLE CAP LOOKING NORTHEAST**

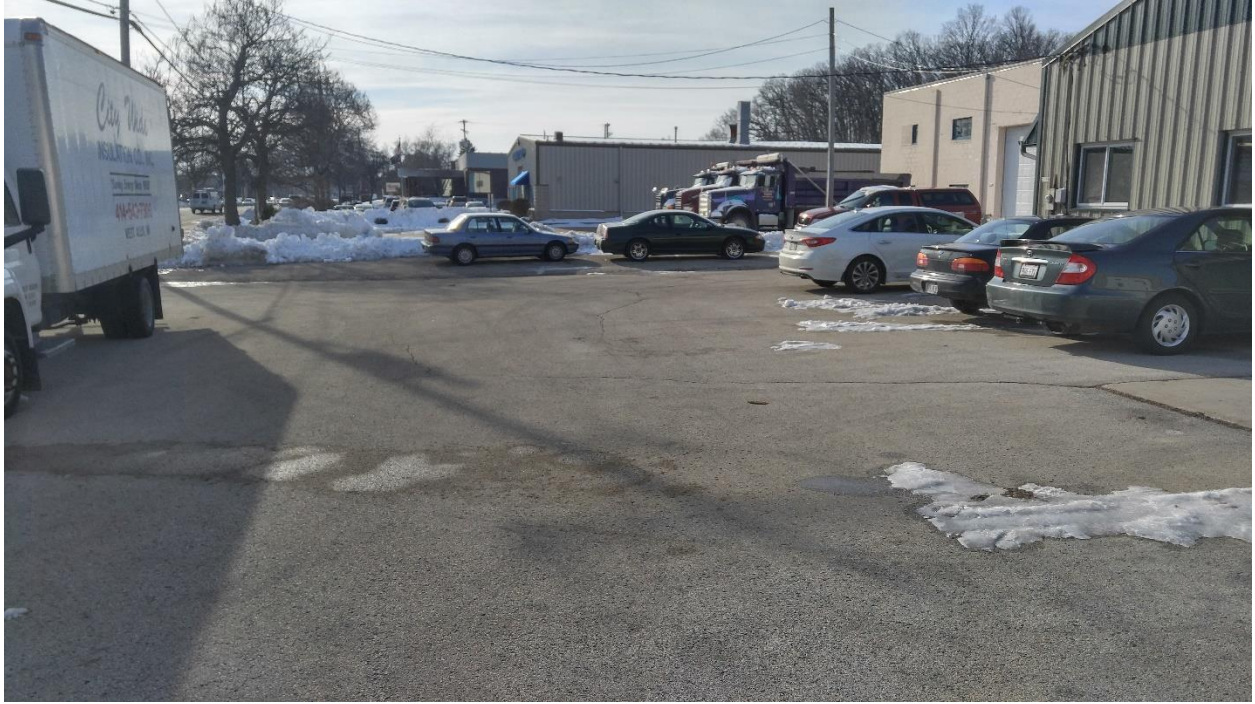
**NORTHERN PORTION OF THE IMPERMEABLE CAP LOOKING SOUTH**
