Subject: **Change Order**
 ▪ **Vapor Intrusion**
 ▪ **Remedial Excavation**

Site: Odau Station (also known as: Bud's Service Station)
 Westboro, Wisconsin
 DNR BRRTS No. 03-61-000014
 PECFA No. 54490-0127-83
 Meridian No. 05F754

This Change Order is for a Vapor Intrusion Investigation and additional source control excavation.

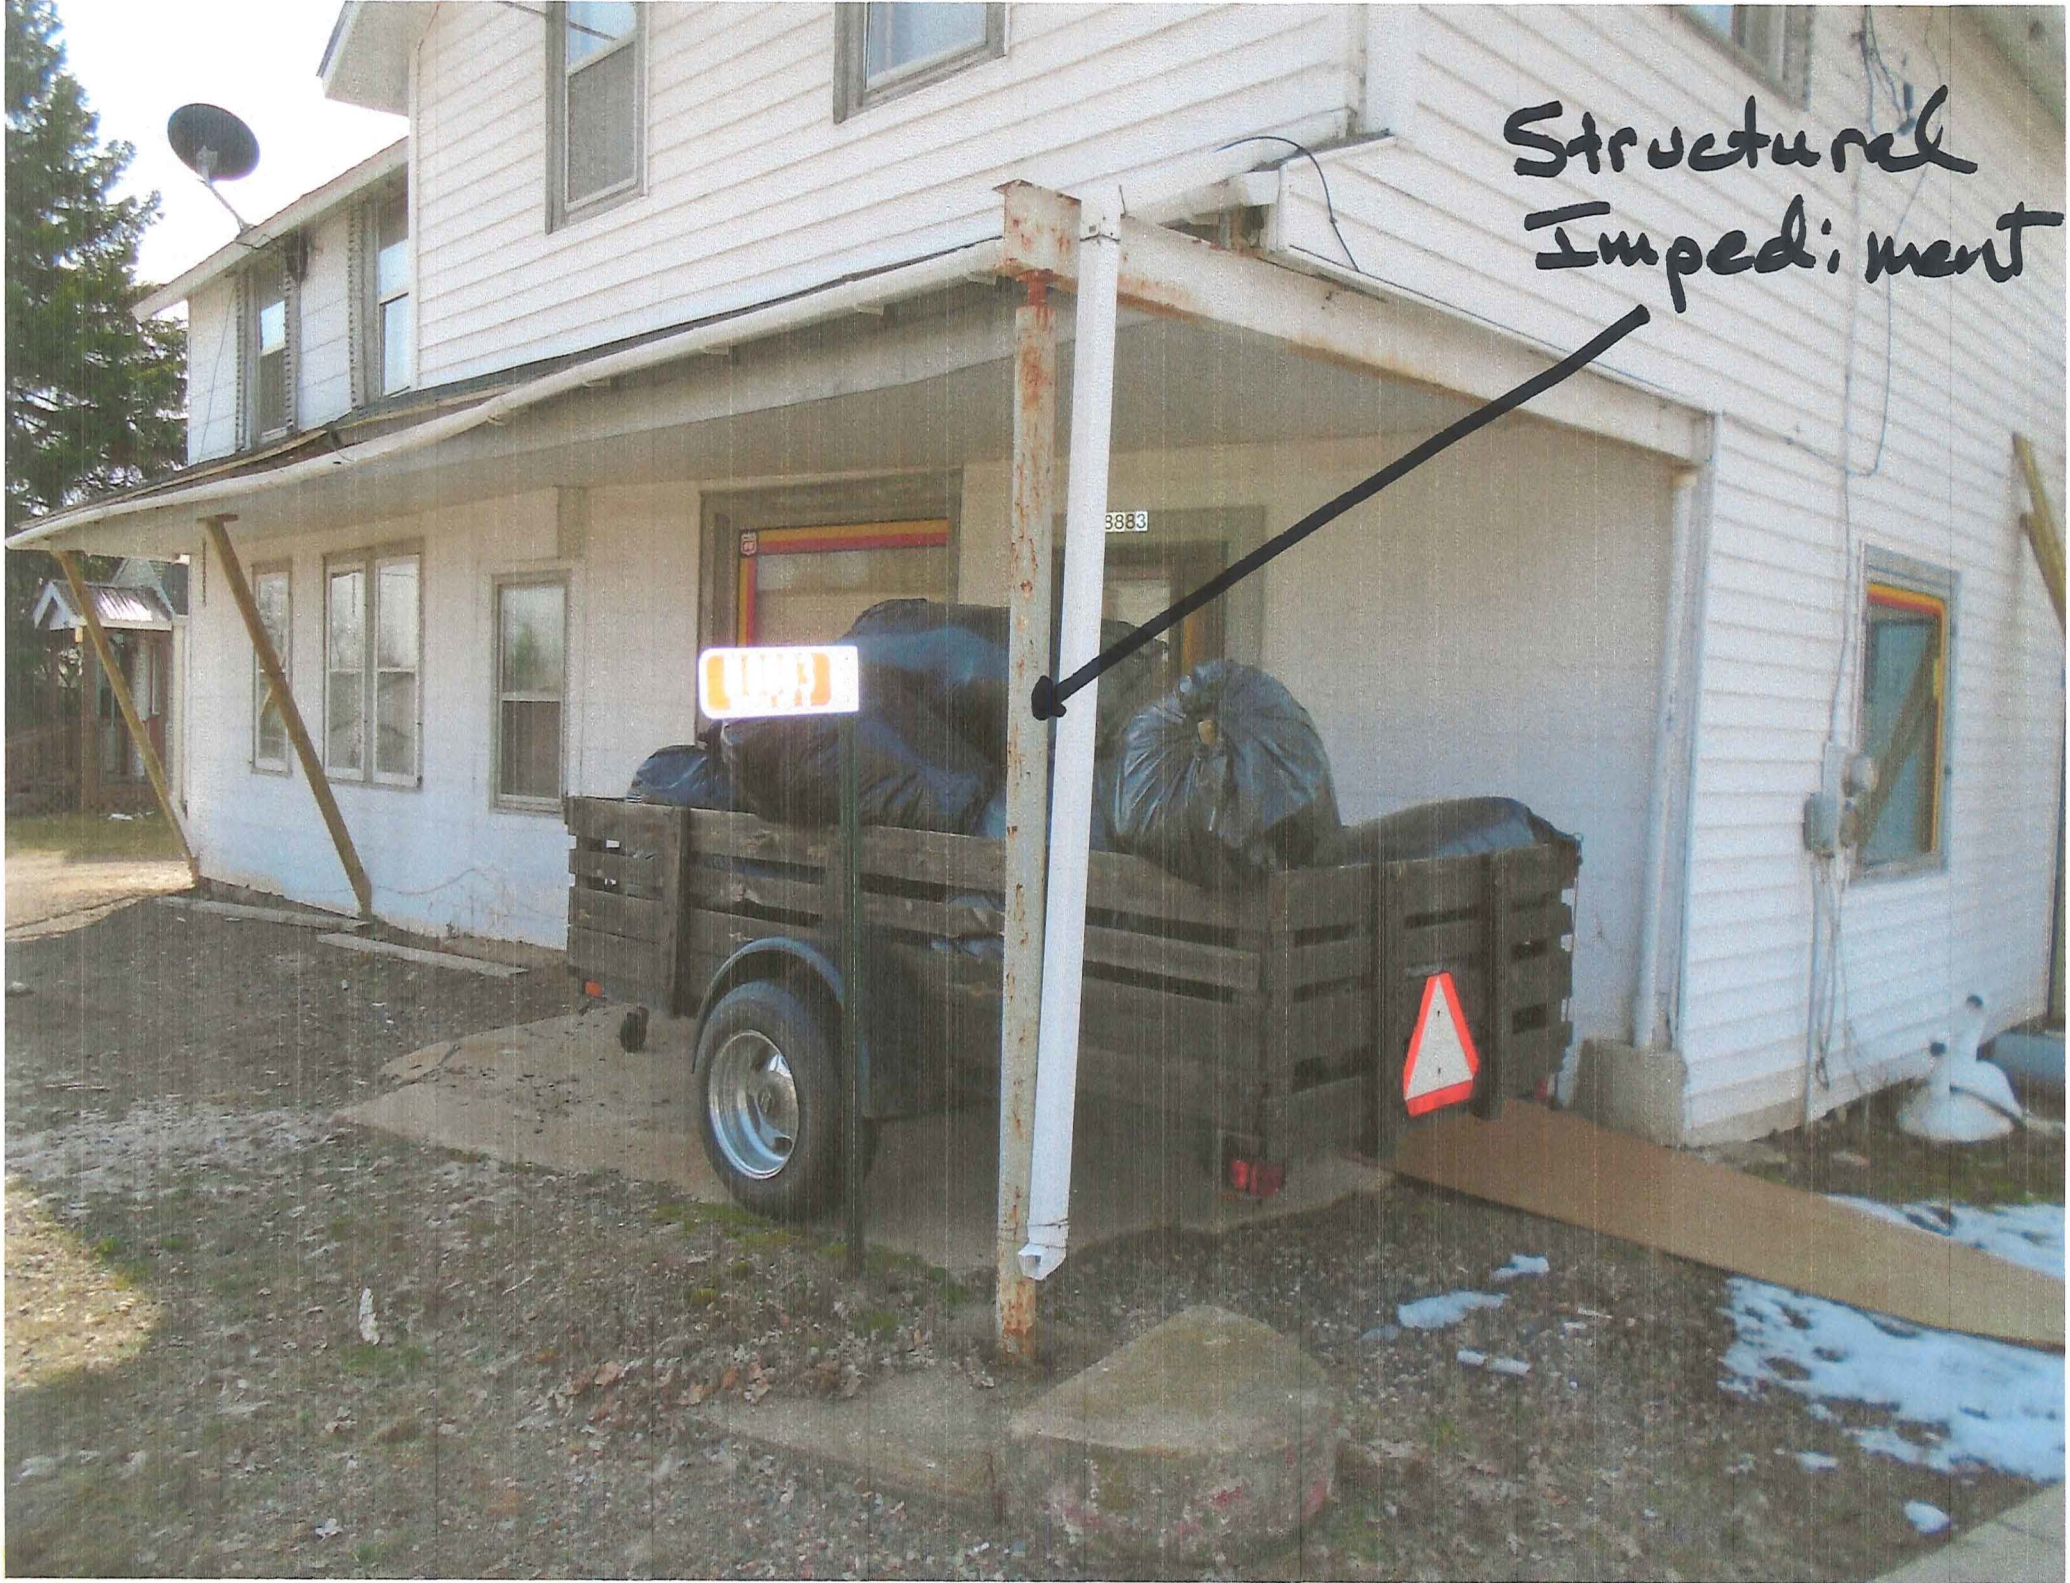
Structural Impediment

Please recall the original excavation (2009) removed as much source soil as technically practicable (Figure 1). Due to a structural impediment (see photographs in Appendix A), DNR and PECFA staff approved leaving the soils beneath and near the former pump island. These soils contained petroleum impacts (Table 1).

A house support (see enclosed photograph) will have to be temporarily removed, temporary support installed, and then a permanent support installed. This task will be completed by Meridian before the work begins. However, work will be conducted around this temporary support requiring special care to not disturb the temporary support.
