ACTIVITY NAME: Westby Dry Cleaners

PROPERTY ADDRESS: 213 Melby Street

SUBJECT: Final Case Closure with Continuing Obligations
Westby Drycleaners, 213 Melby Street, Westby WI
DNR BRRTS Activity #: 02-63-183796

GROUNDWATER PCE CONCENTRATION MAP (JULY, 2012)
 REMEDIAL ACTION IMPLEMENTATION
 FORMER WESTBY DRY CLEANERS
 213 MELBY STREET
 WESTBY, WISCONSIN

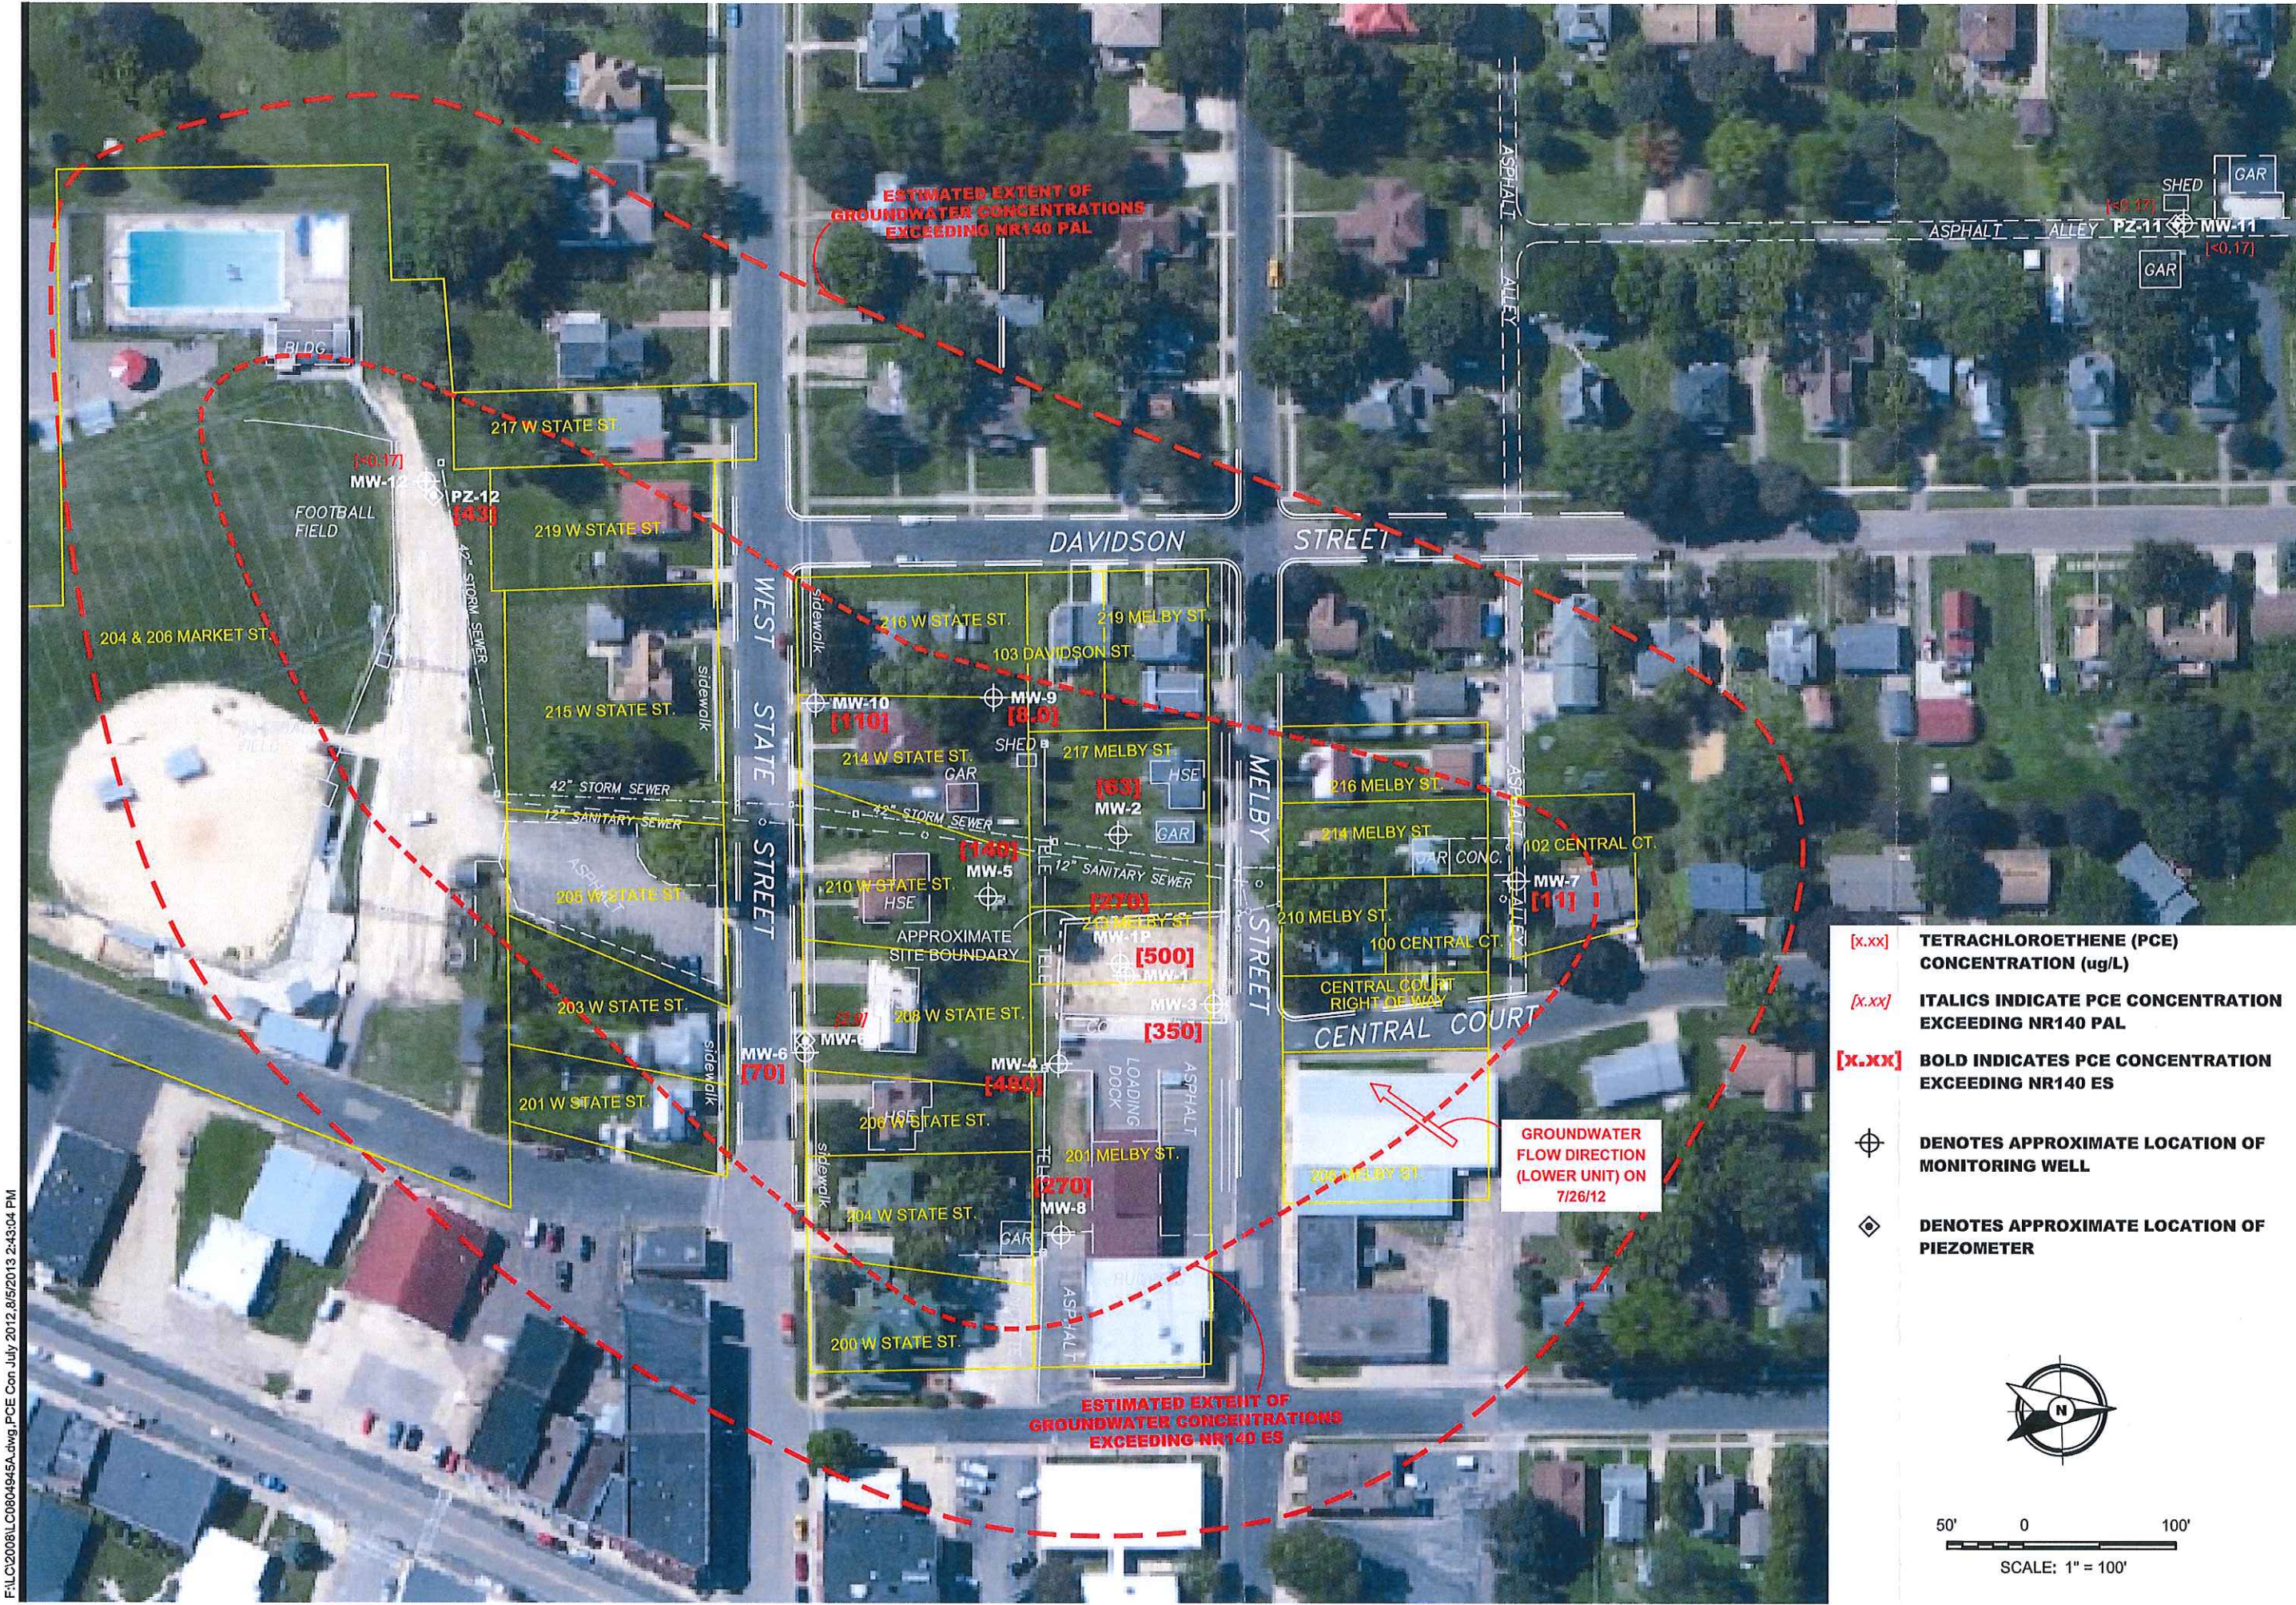
Project No:	LC0804945
Drawn No:	LC0804945A
Scale:	1" = 100'
Drawn By:	BJB
Date Drawn:	1/4/10
Checked By:	KDN
Last Modified:	7/22/13
Sheet:	Fig:
of	B.3.b

Groundwater contamination greater than enforcement standards is present both on this contaminated property and off this contaminated property, as shown on the attached map (Groundwater PCE Concentration Map, B.3.b, 7/22/13). If you intend to construct a new well, or reconstruct an existing well, you'll need prior DNR approval. Affected property owners and right-of-way holders were notified of the presence of groundwater contamination.

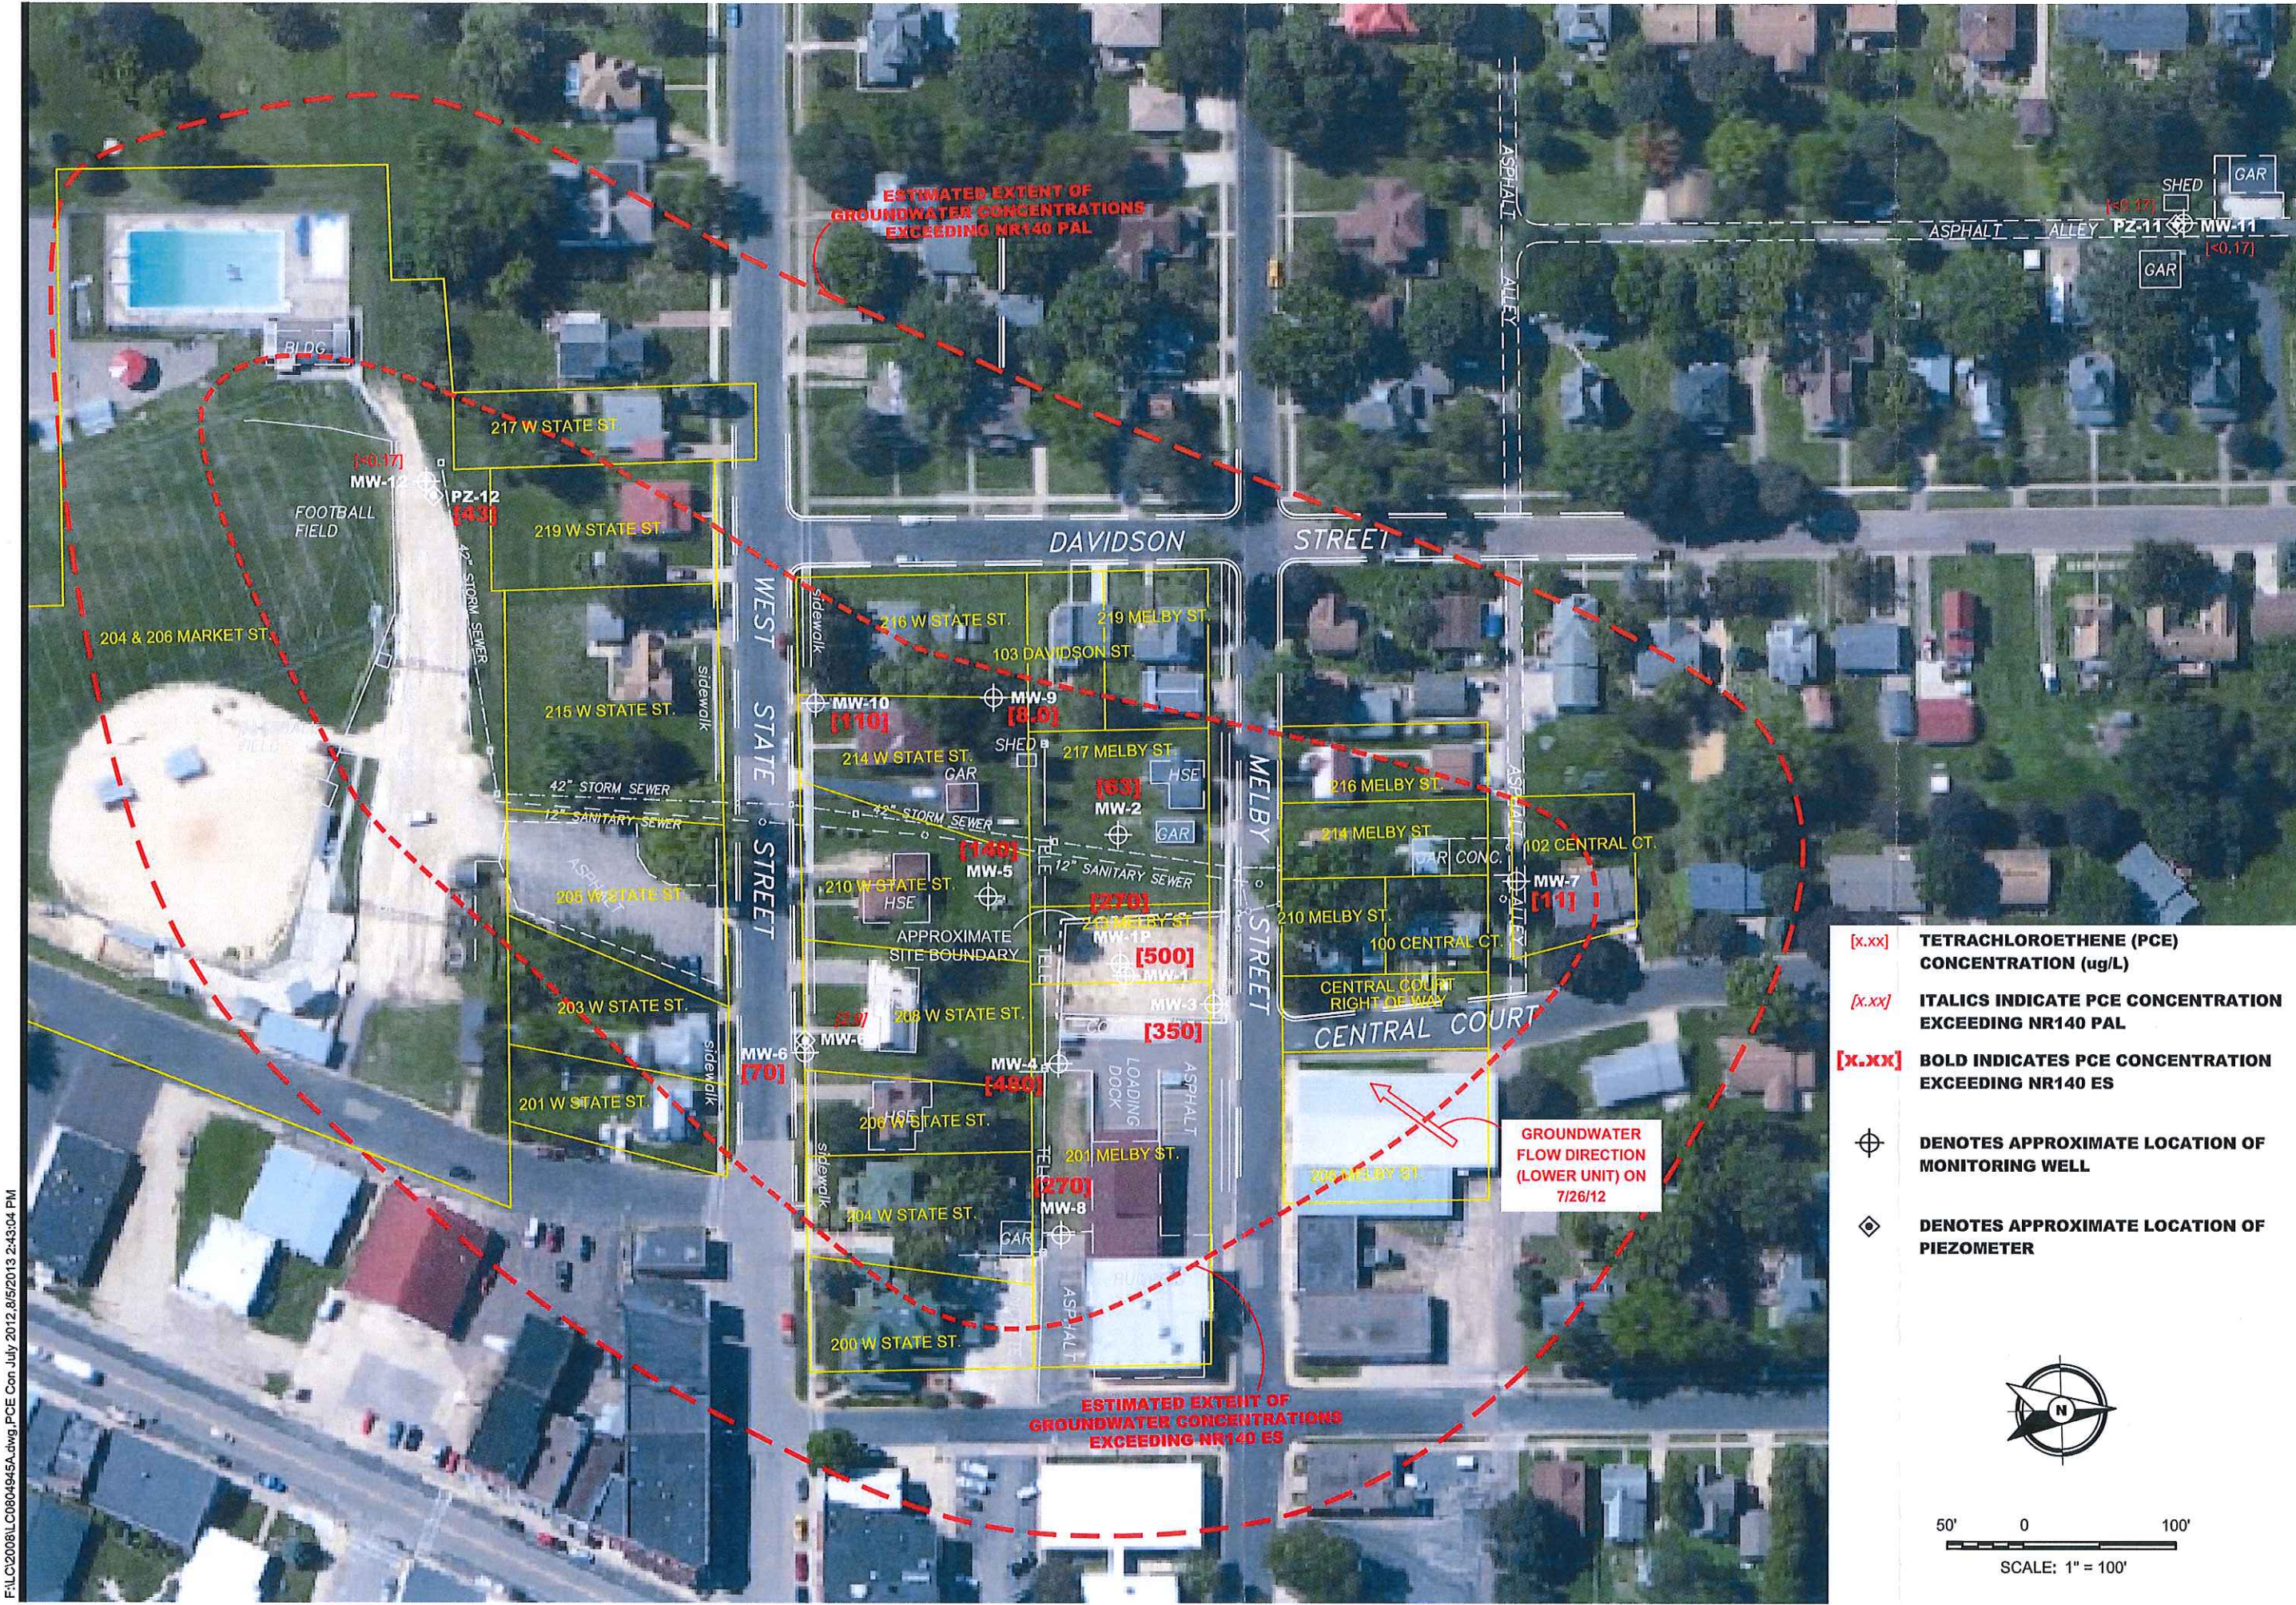
Project No:	LC0804945
Drawn No:	LC0804945A
Scale:	1" = 100'
Drawn By:	BJB
Date Drawn:	1/4/10
Checked By:	KDN
Last Modified:	7/22/13
Sheet:	Fig:
of	B.3.b

GROUNDWATER PCE CONCENTRATION MAP (JULY, 2012)
 REMEDIAL ACTION IMPLEMENTATION
 FORMER WESTBY DRY CLEANERS
 213 MELBY STREET
 WESTBY, WISCONSIN
