SUBJECT: Case Closure with Continuing Obligations
River Bends Bar, N7298 County Highway (CTH) X, Town of Brooklyn, WI
BRRTS #: 03-23-198810, FID: 123040280

B.3.b GROUNDWATER ISOCONCENTRATION (8/14/19)
 RIVER BENDS BAR

B.2.b RESIDUAL SOIL CONTAMINATION RIVER BENDS BAR

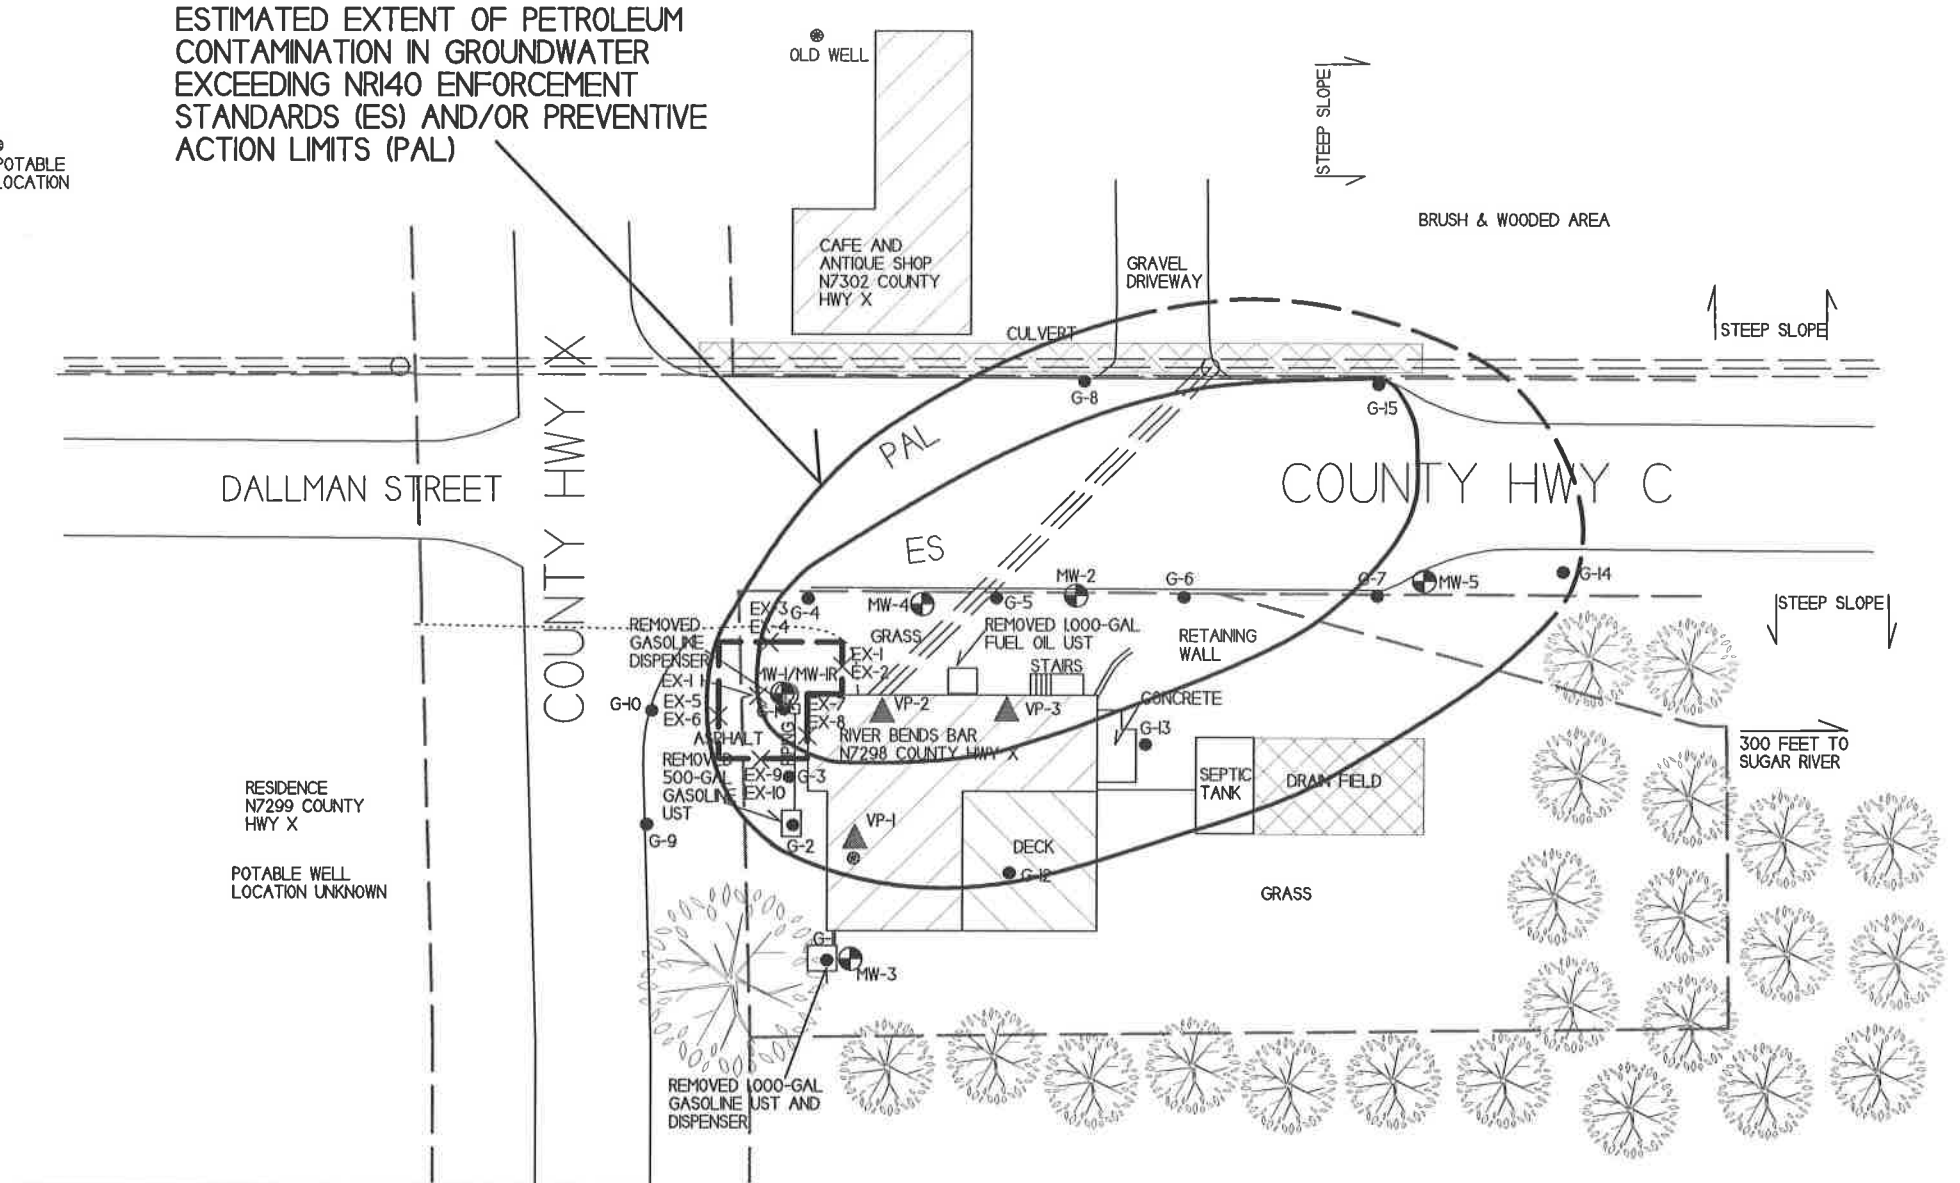
ESTIMATED EXTENT OF PETROLEUM CONTAMINATION IN GROUNDWATER EXCEEDING NRI40 ENFORCEMENT STANDARDS (ES) AND/OR PREVENTIVE ACTION LIMITS (PAL)

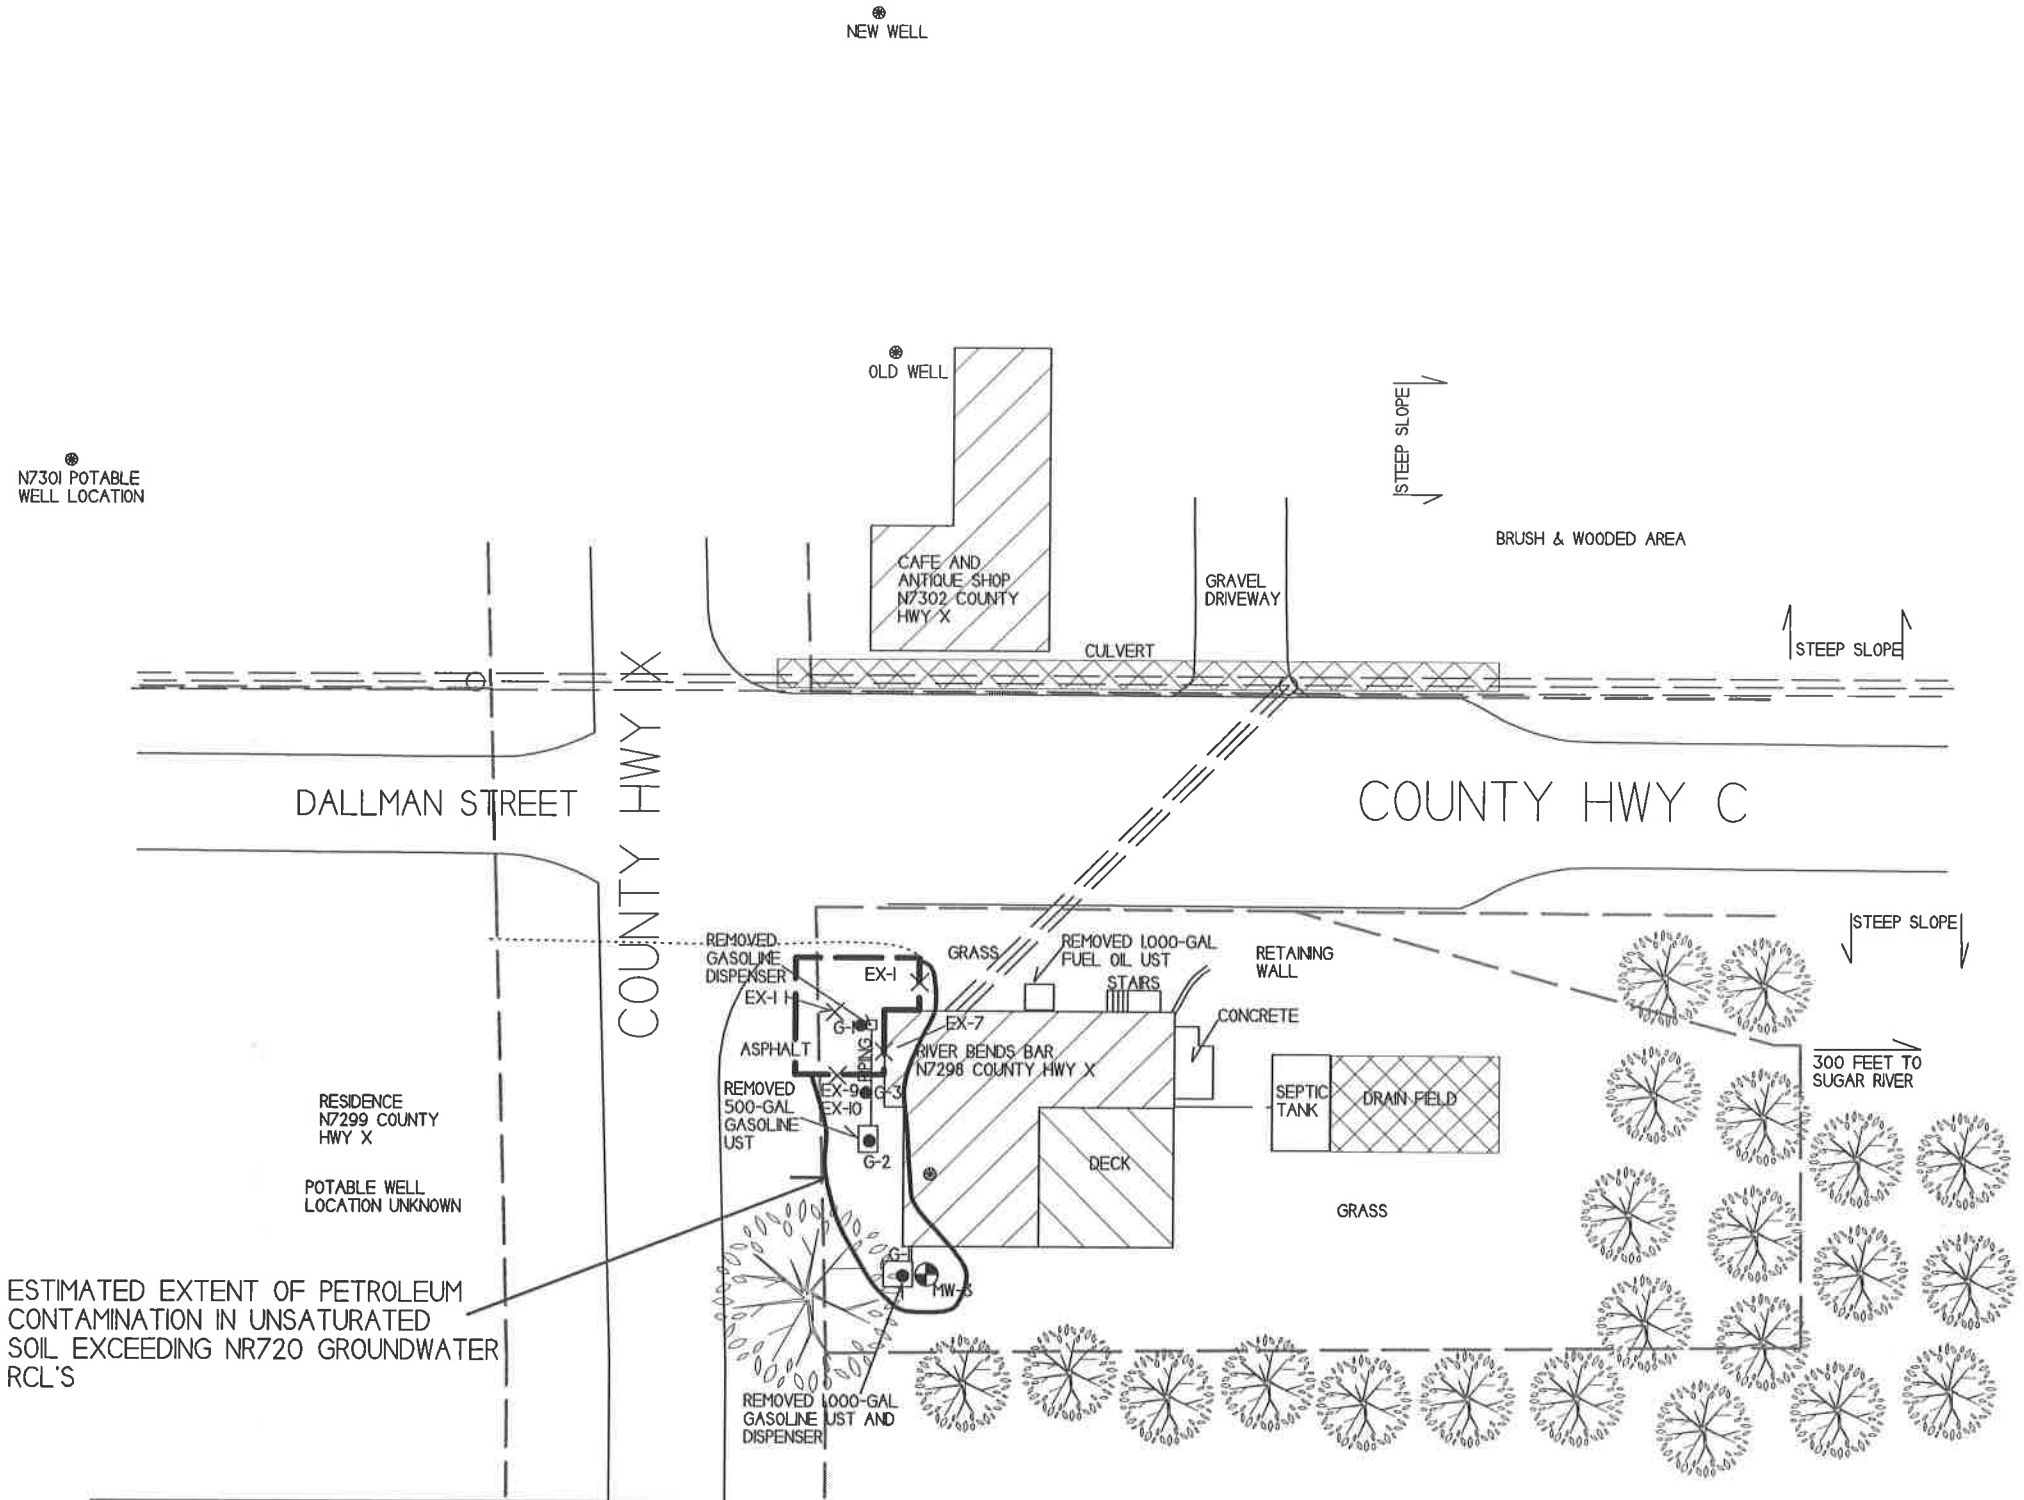
ESTIMATED EXTENT OF PETROLEUM CONTAMINATION IN UNSATURATED SOIL EXCEEDING NR720 GROUNDWATER RCL'S

Soil contamination remains within the ROW of CTH X, as indicated on the attached map, Fig. B.2.b., Residual Soil Contamination, 07/17/2012, if soil in the specific locations described above is excavated in the future, the property owner or right-of-way holder at the time of excavation must sample and analyze the excavated soil to determine if contamination remains. If sampling confirms that contamination is present, the property owner or right-of-way holder at the time of excavation will need to determine whether the material is considered solid or hazardous waste and ensure that any storage, treatment or disposal is in compliance with applicable standards and rules. Contaminated soil may be managed in accordance with ch. NR 718, Wis. Adm. Code, with prior DNR approval.

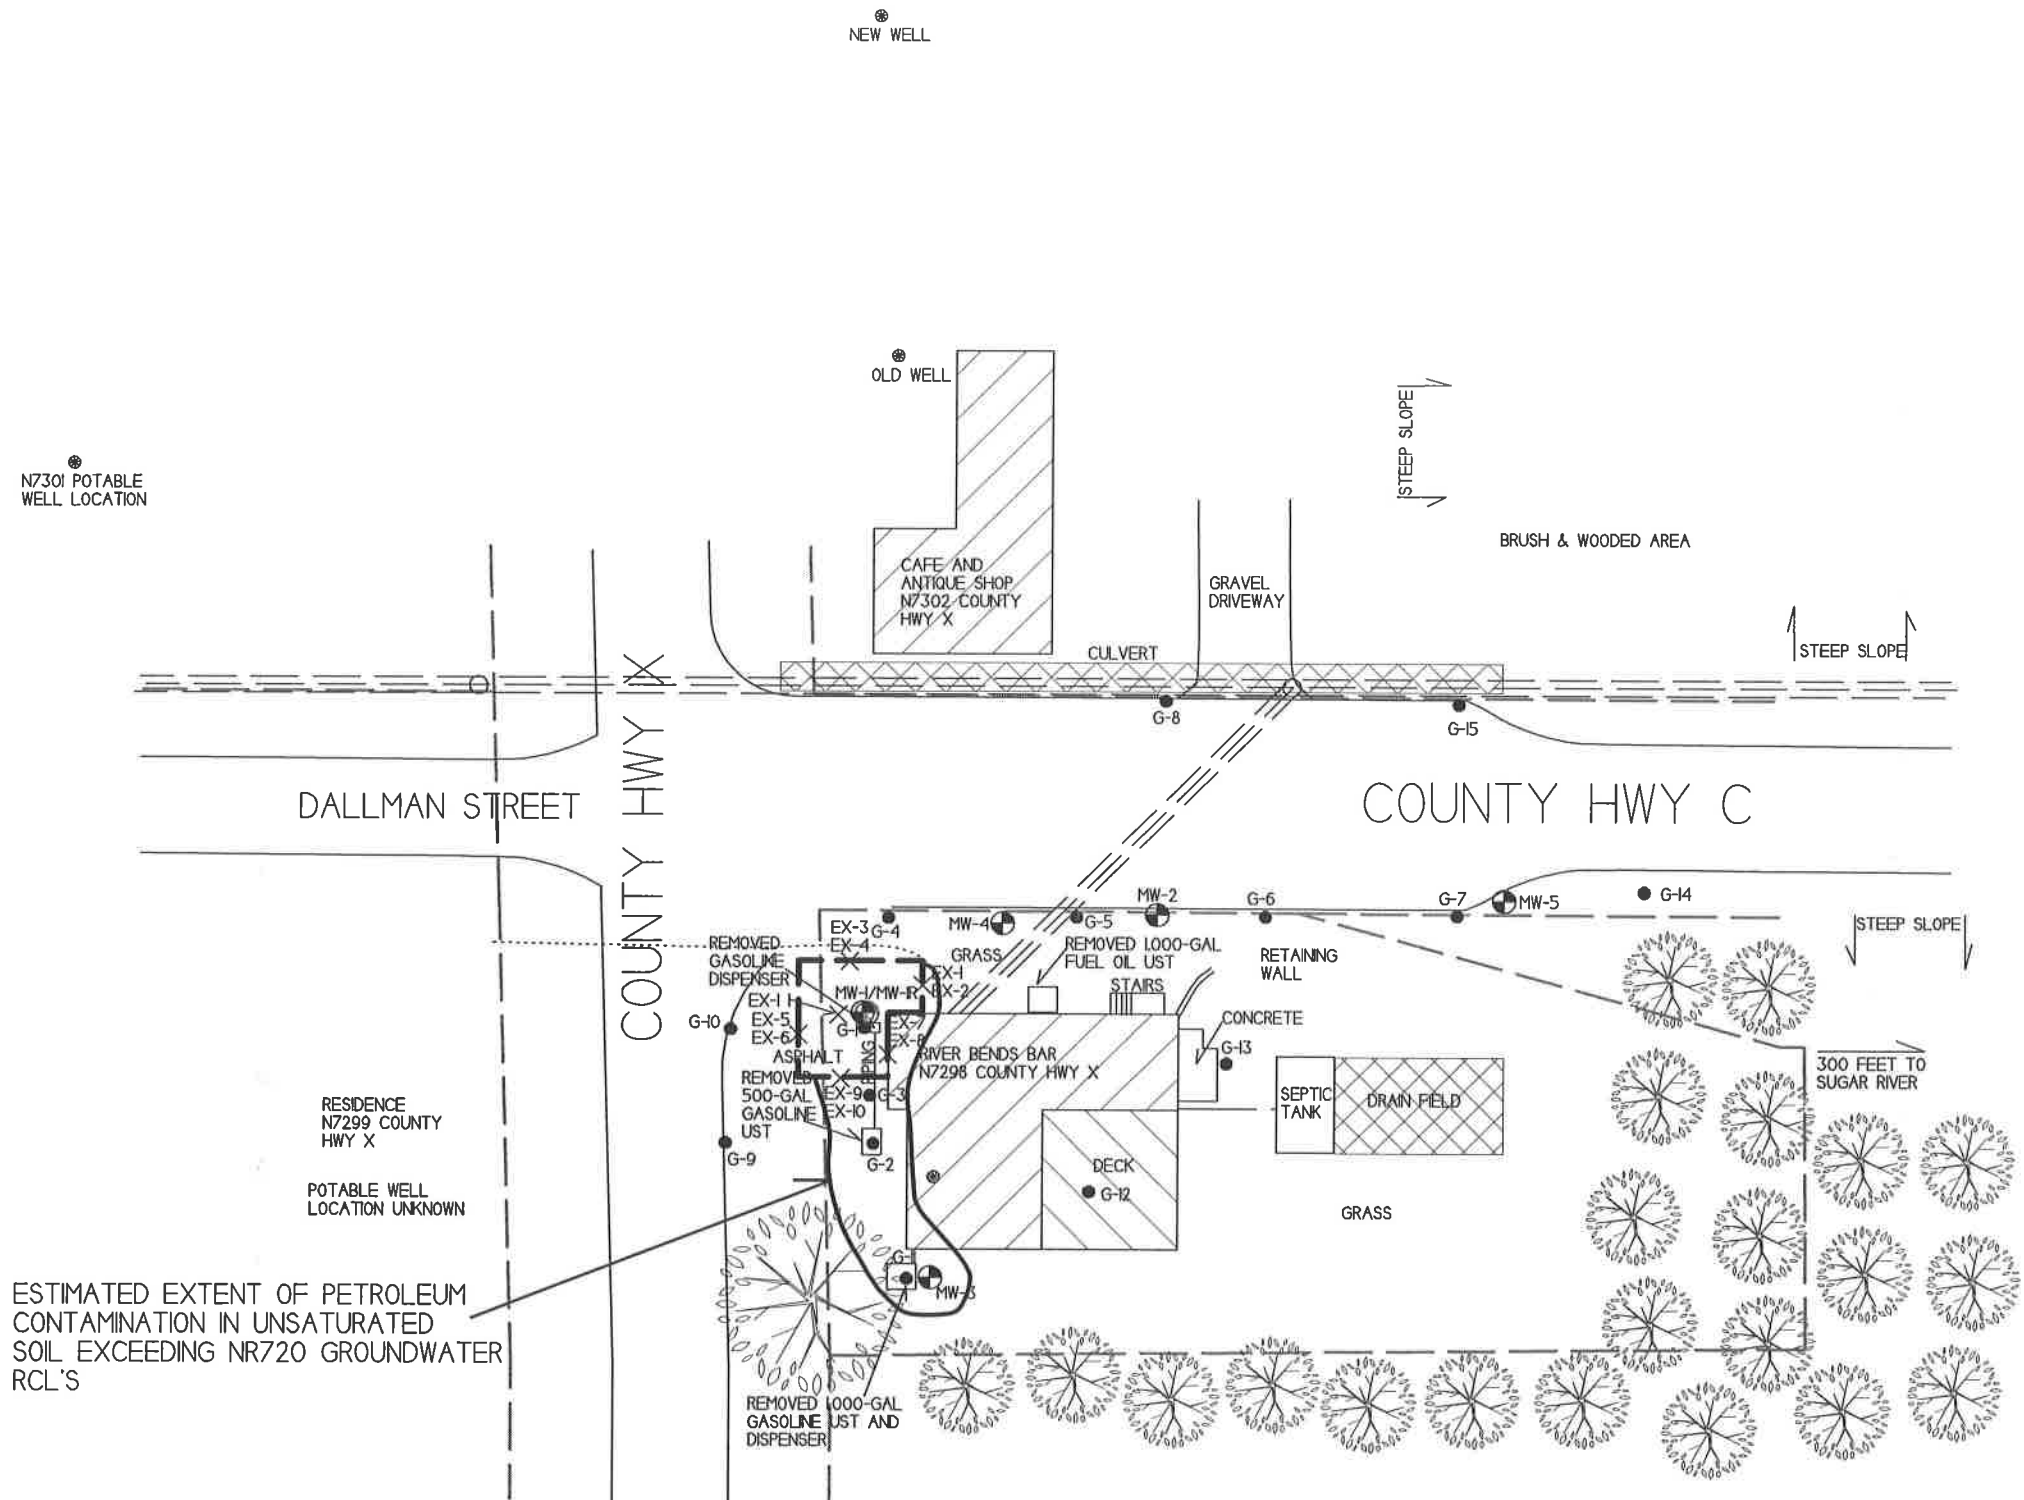
B.2.a
SOIL CONTAMINATION
RIVER BENDS BAR

ESTIMATED EXTENT OF PETROLEUM CONTAMINATION IN UNSATURATED SOIL EXCEEDING NR720 GROUNDWATER RCL'S

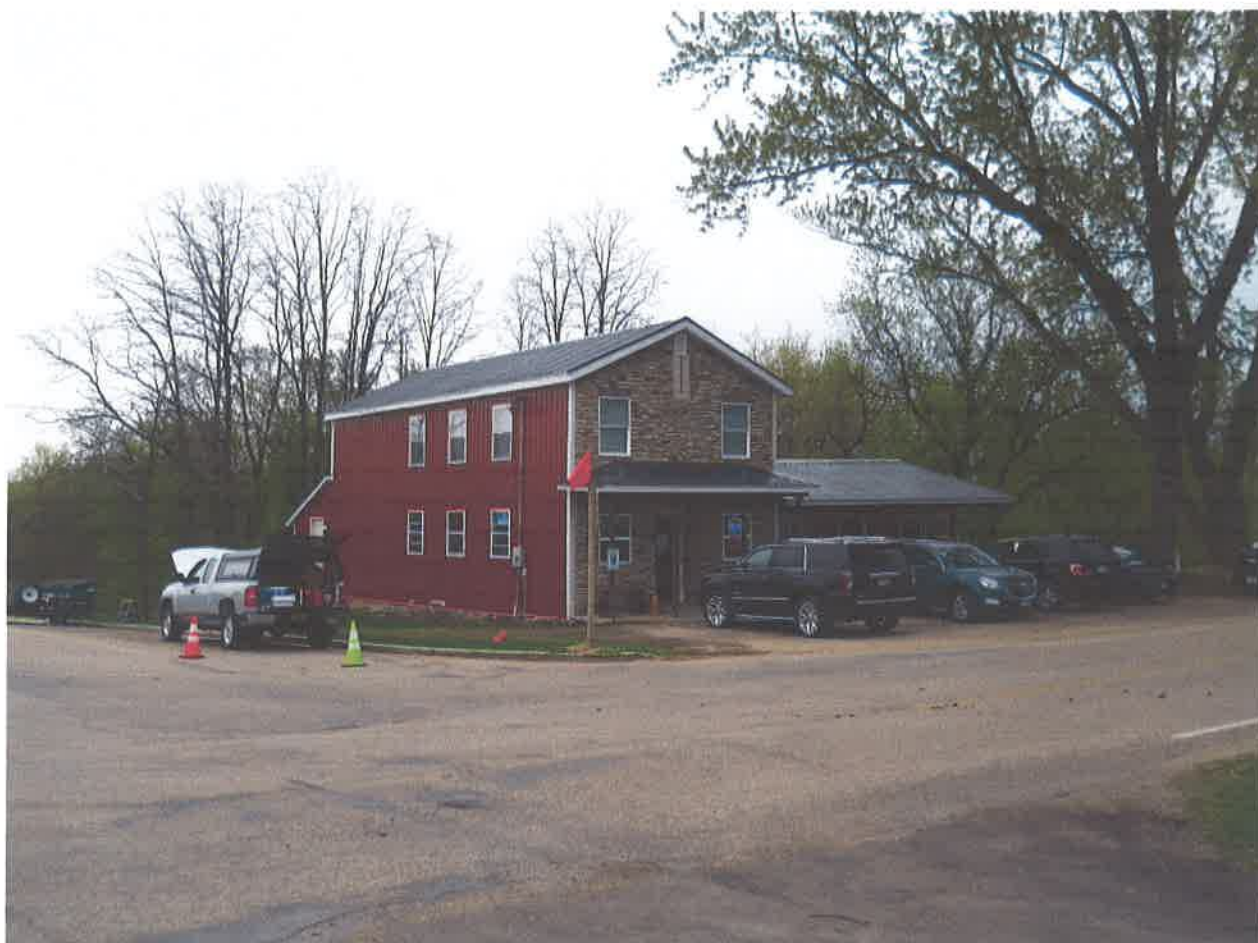
B.5. Structural Impediment Photos

Photo #1: On site building looking southeast (picture taken: 4/25/2017).

the structural impediment, the property owner shall investigate the degree and extent of petroleum contamination obstructed by the structural impediment. If contamination is found at that time, the property owner shall remediate the contamination in accordance with Wis. Admin. Code chs. NR 700 - 799.

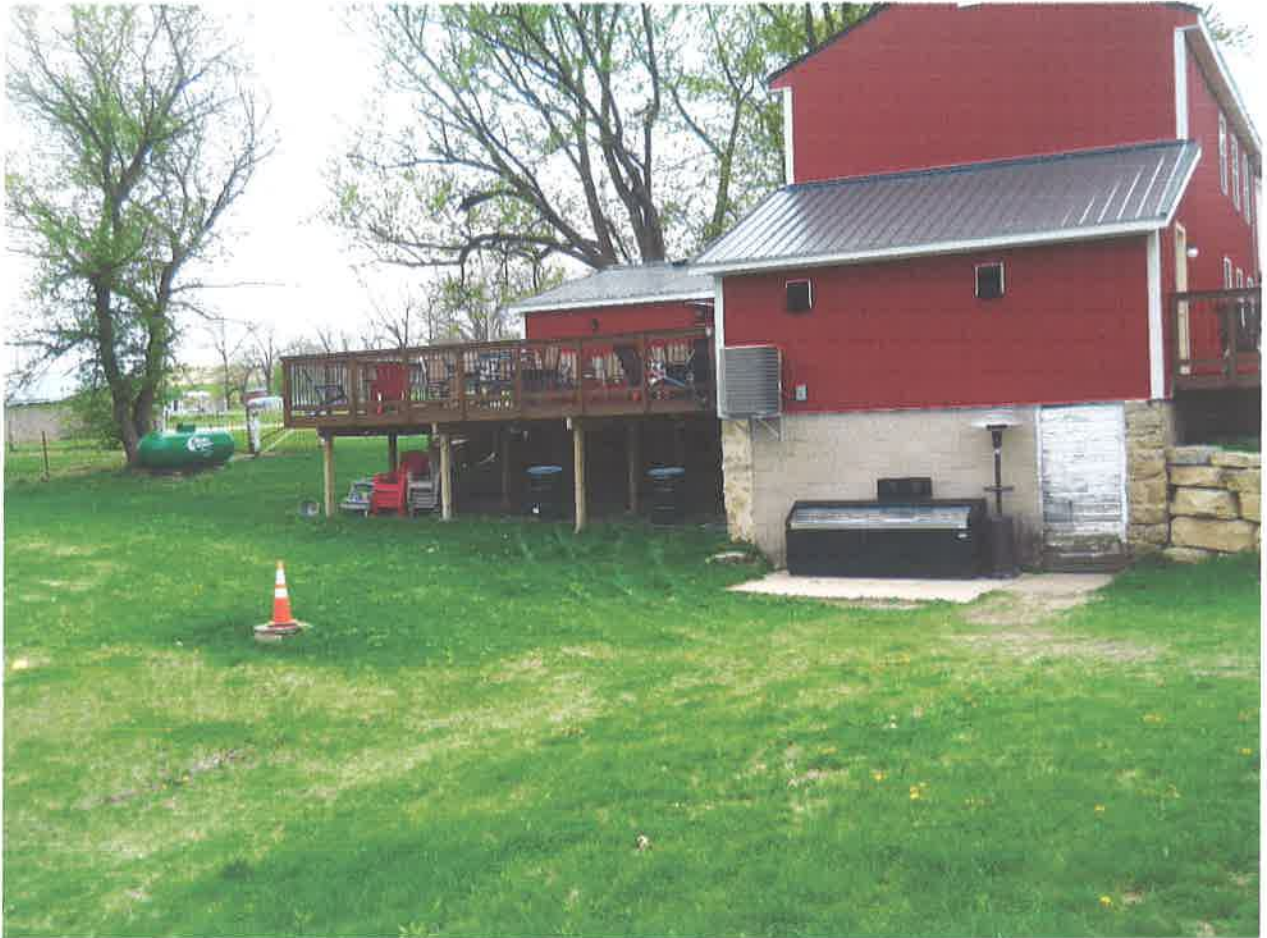
B.5. Structural Impediment Photos

Photo #2: On site building looking southwest (picture taken: 4/25/2017).
