Subject: Final Case Closure
Dunbar Service Center, W11475 USH 8, Dunbar, WI
DNR BRRTS Activity # 03-38-000043

August 4, 2015
Dunbar Community Bible Church
Final Case Closure
Dunbar Service Center, BRRTS #03-38-000043

Subject: Conditional Closure Decision, With Requirements to Achieve Final Closure
Dunbar Service Center, Dunbar, Wisconsin DNR BRRTS Activity # 03-38-000043

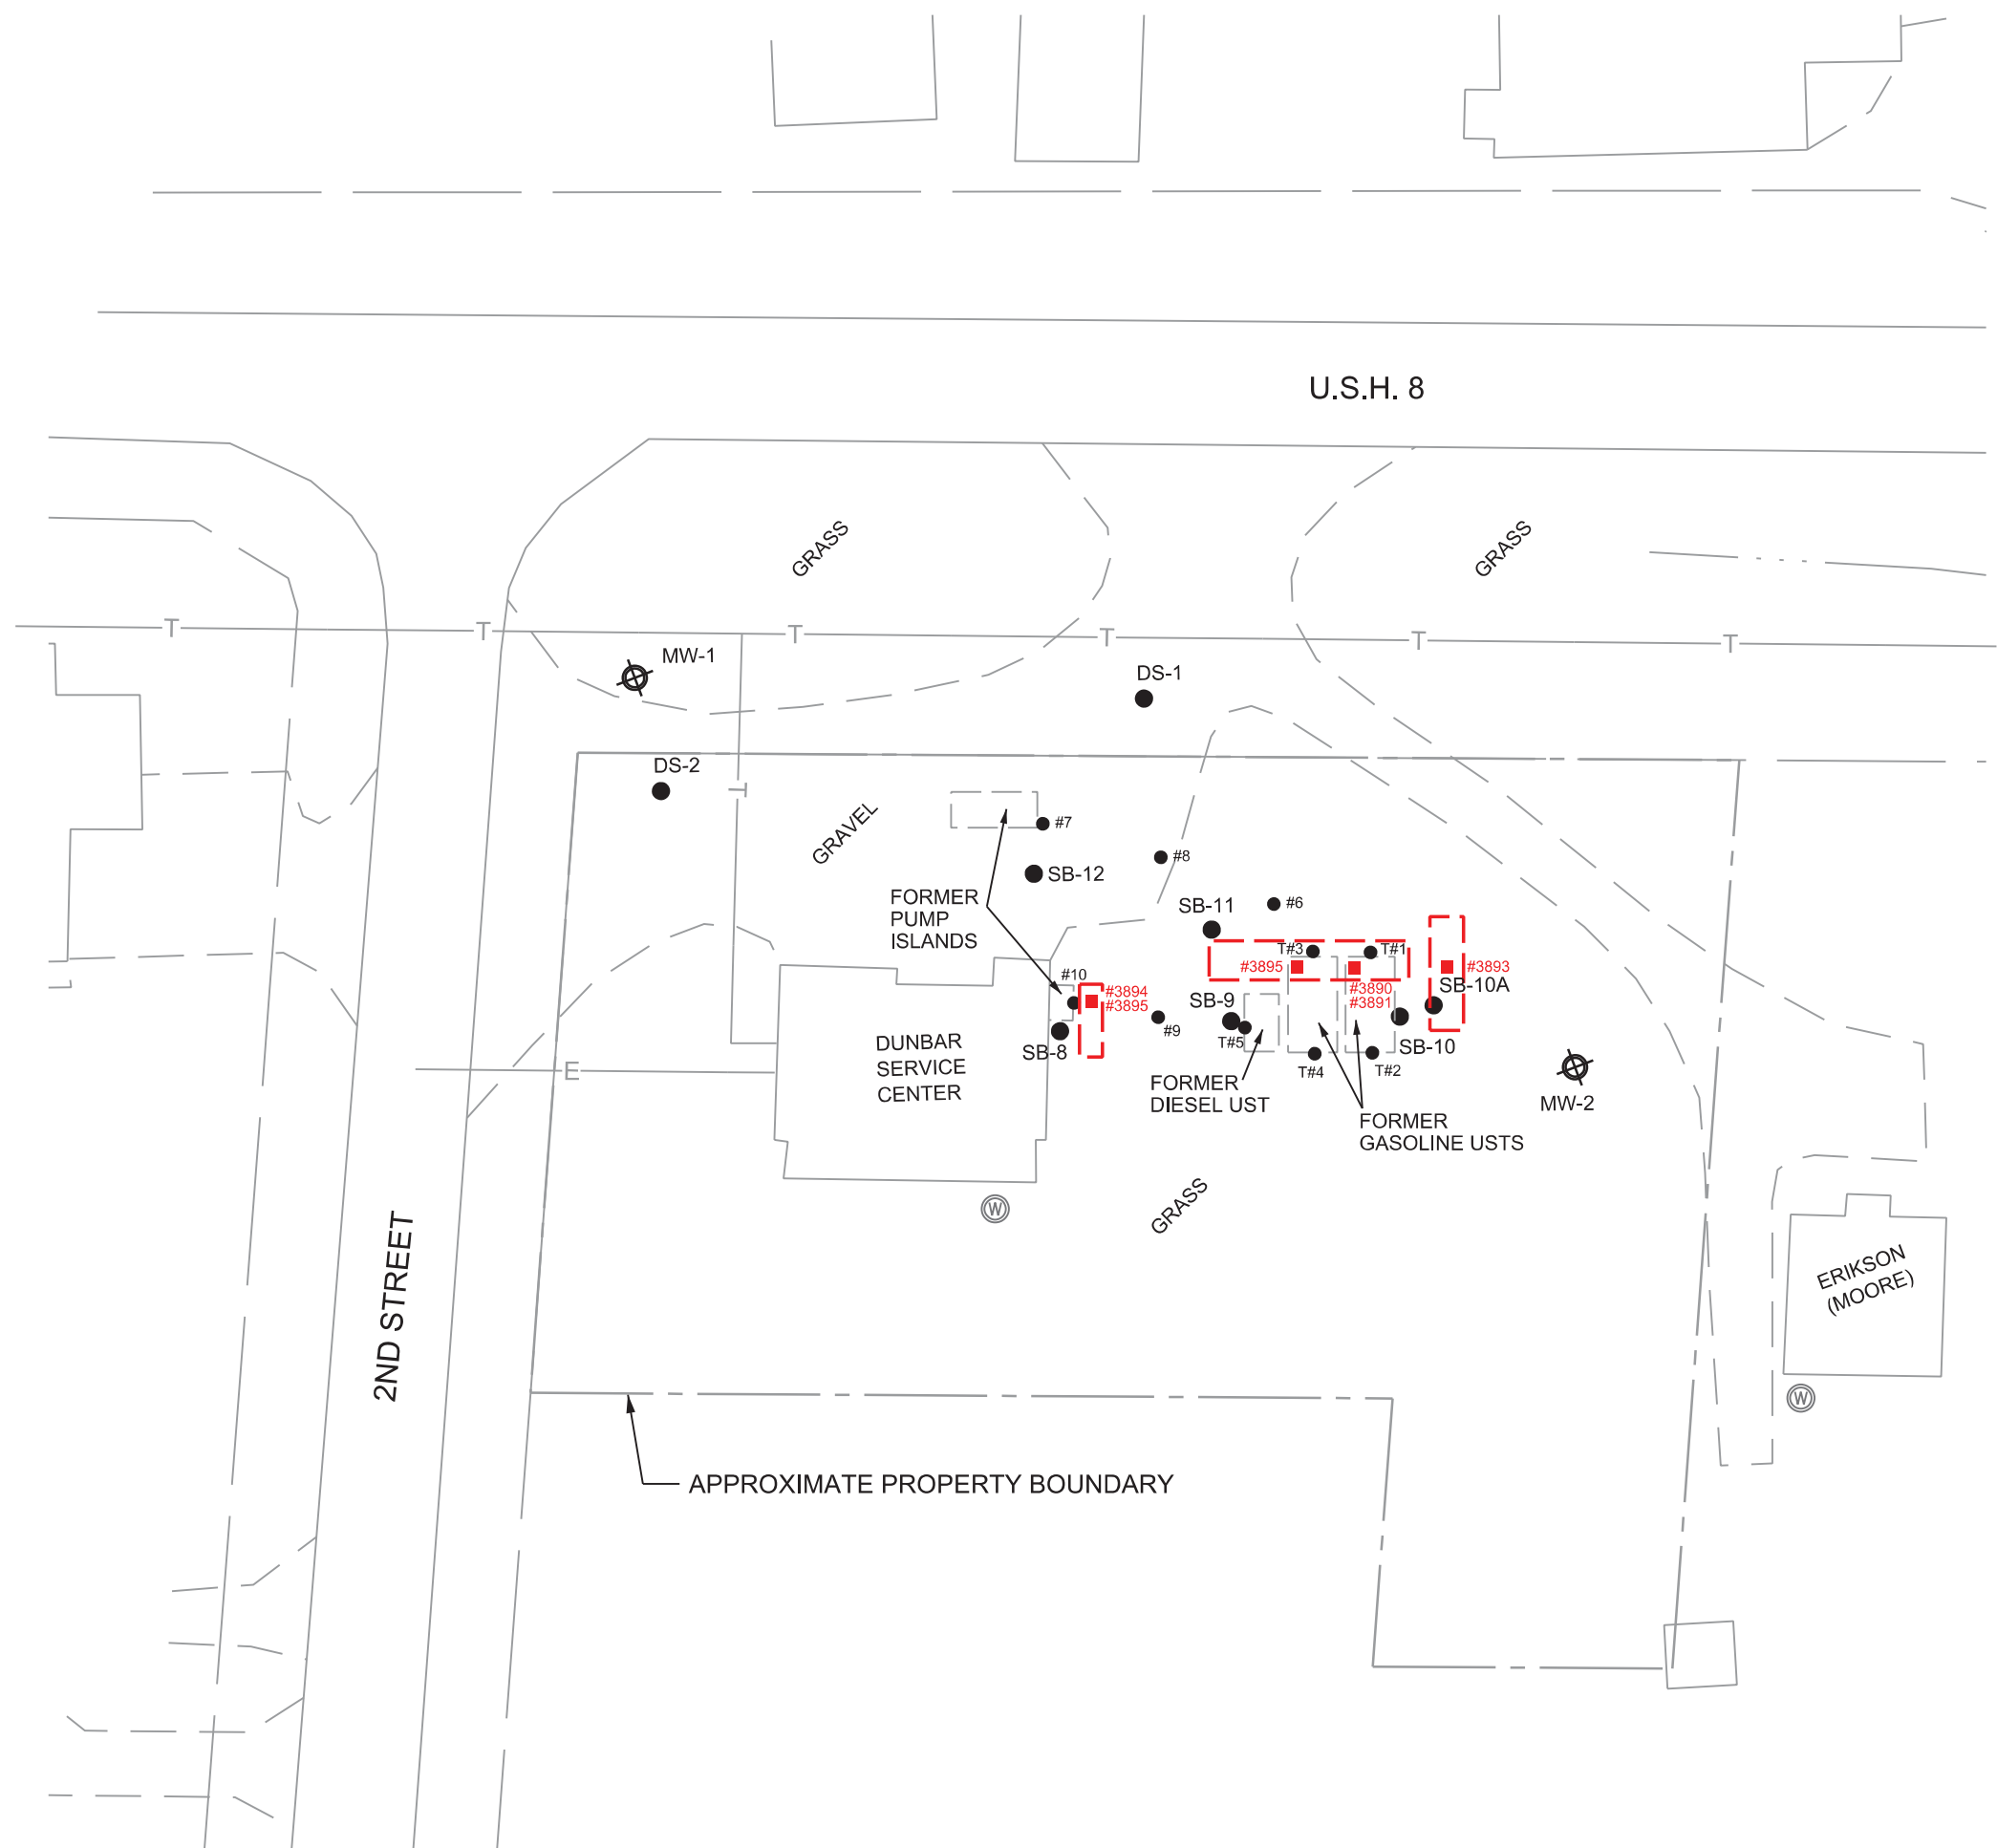
- RIGHT OF WAY
- WATER FEATURE
- x—x— FENCE
- SB-9 SOIL BORING NUMBER AND LOCATION
- ⊕ MW-2 MONITORING WELL NUMBER AND LOCATION
- #6 SOIL SAMPLE
- ⊕ WELL POINT
- ▭ TEST PIT
- #3895 TEST PIT SAMPLE

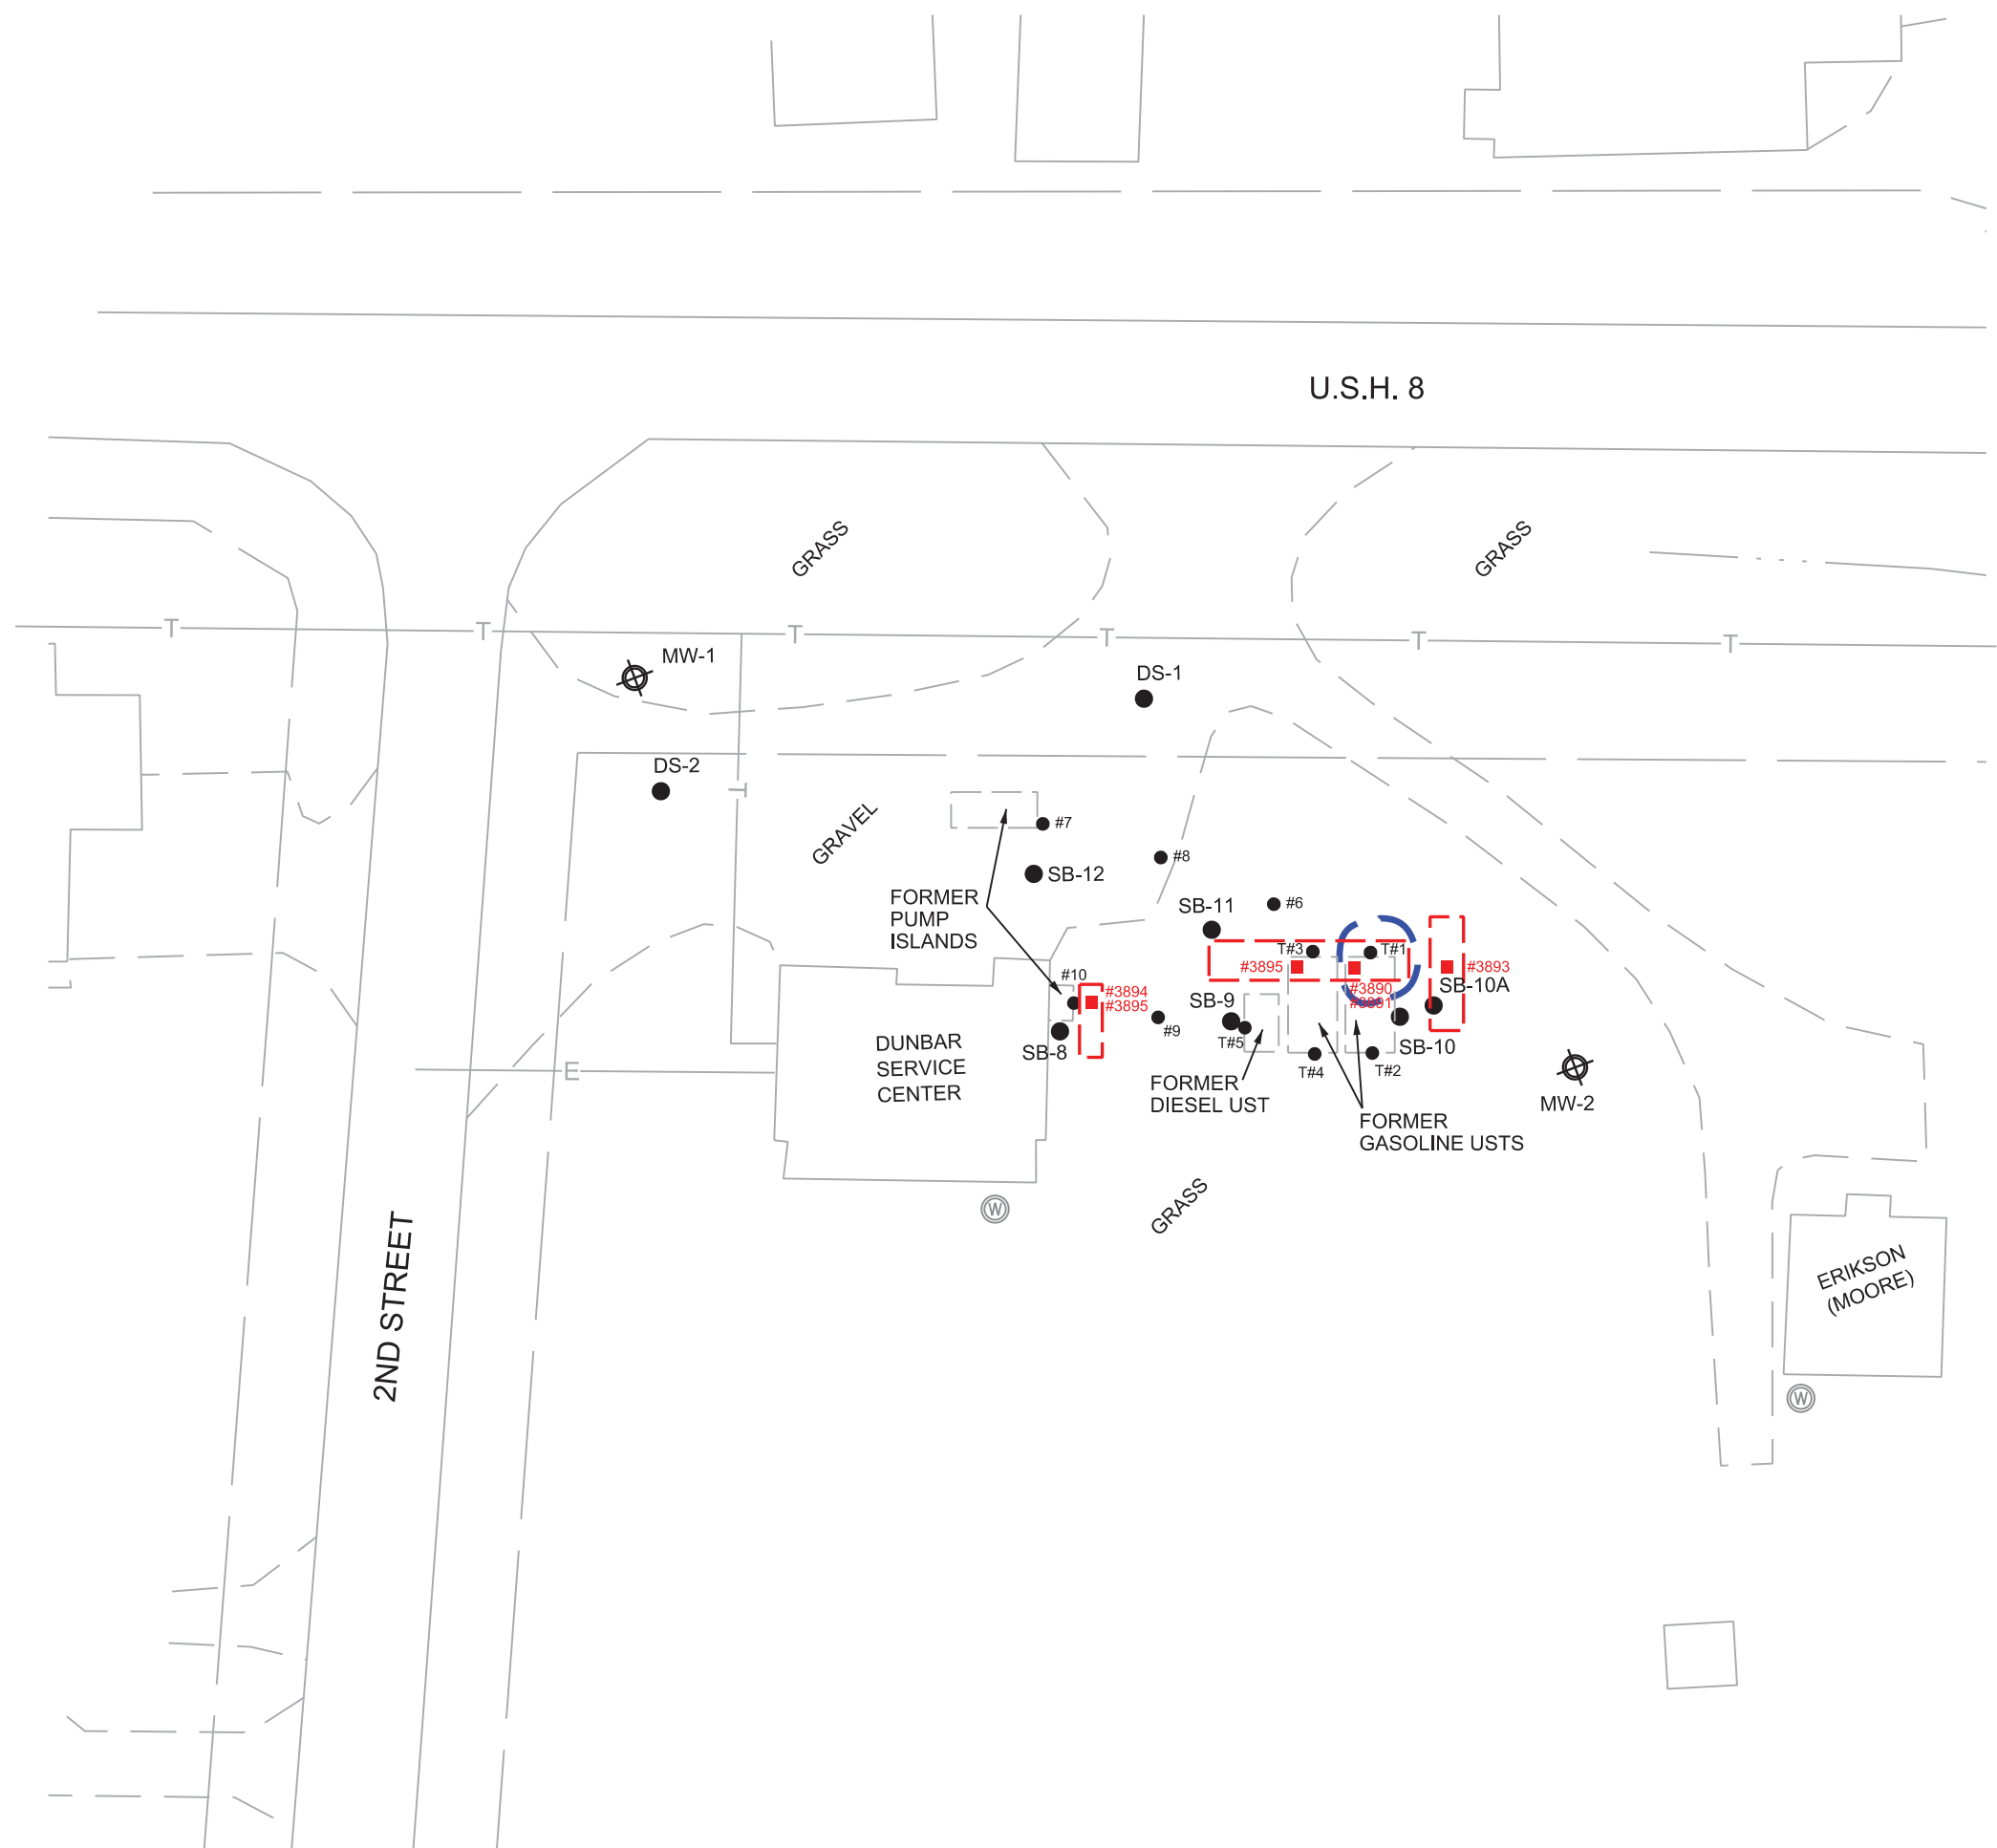
- LEGEND**
- RIGHT OF WAY
 - WATER FEATURE
 - x—x— FENCE
 - SB-9 SOIL BORING NUMBER AND LOCATION
 - ⊕ MW-2 MONITORING WELL NUMBER AND LOCATION
 - #6 SOIL SAMPLE
 - ⊙ WELL POINT
 - ▭ TEST PIT
 - #3895 TEST PIT SAMPLE
 - EXTENT OF SOIL CONTAMINATION EXCEEDING NR720 RCL

- i. **Describe degree and extent of soil contamination** at and from this site. Relate this to known or suspected sources and known or potential receptors/migration pathways.
Very little soil contamination was detected at this property. Soil contamination was detected during the tank closure sampling in April 1989 at the north end of the easternmost gasoline tank, and at low levels in a pipeline sample. Low levels of soil contamination were detected in samples collected from test pits performed in 1991 in the vicinity of the former tank system. No soil contamination exceeding standards was detected in the monitoring well or soil boring samples performed by Foth and Van Dyke during the site investigation at this property.

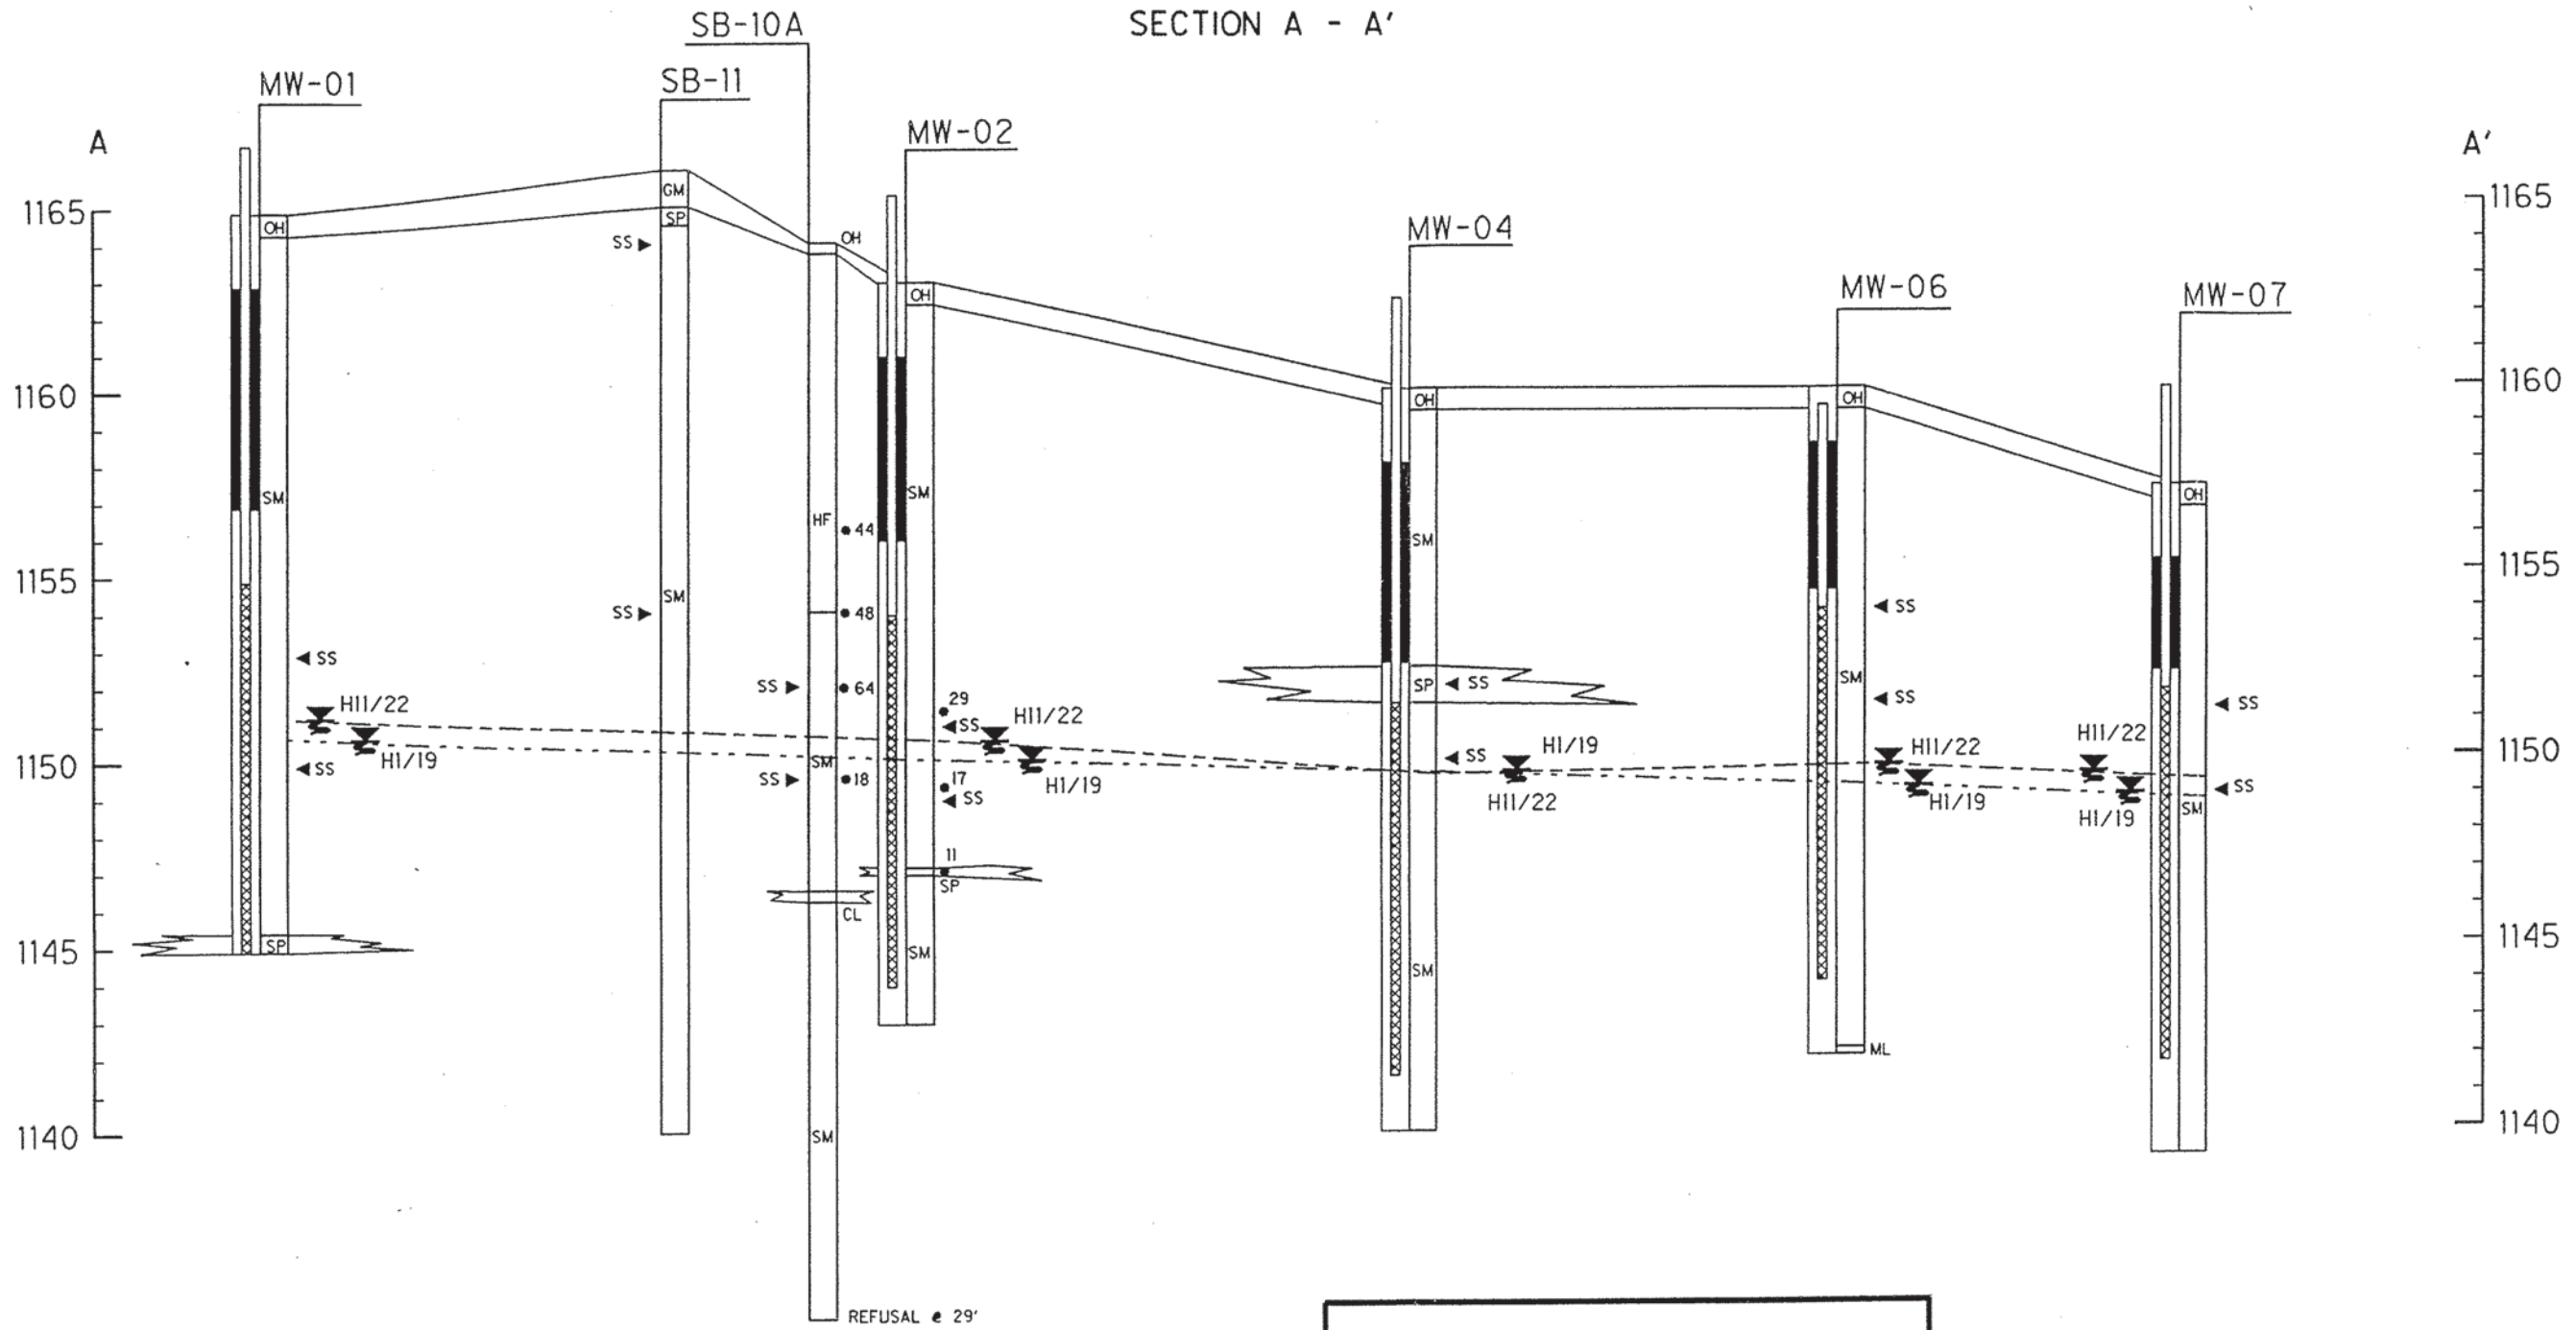
SECTION A - A'

- SM SILTY SAND
- SP POORLY GRADED SAND
- HF FILL MATERIAL
- GM SILTY GRAVEL
- ML LEAN SILT
- CL LEAN CLAY
- WATER LEVEL
- H11/22 WATER ELEVATION 11/22/94
- H1/19 WATER ELEVATION 1/19/95
- GRADIENT CONTACT
- 45 • PID READING
- SS ◀ SOIL SAMPLE AT APPROX. DEPTH

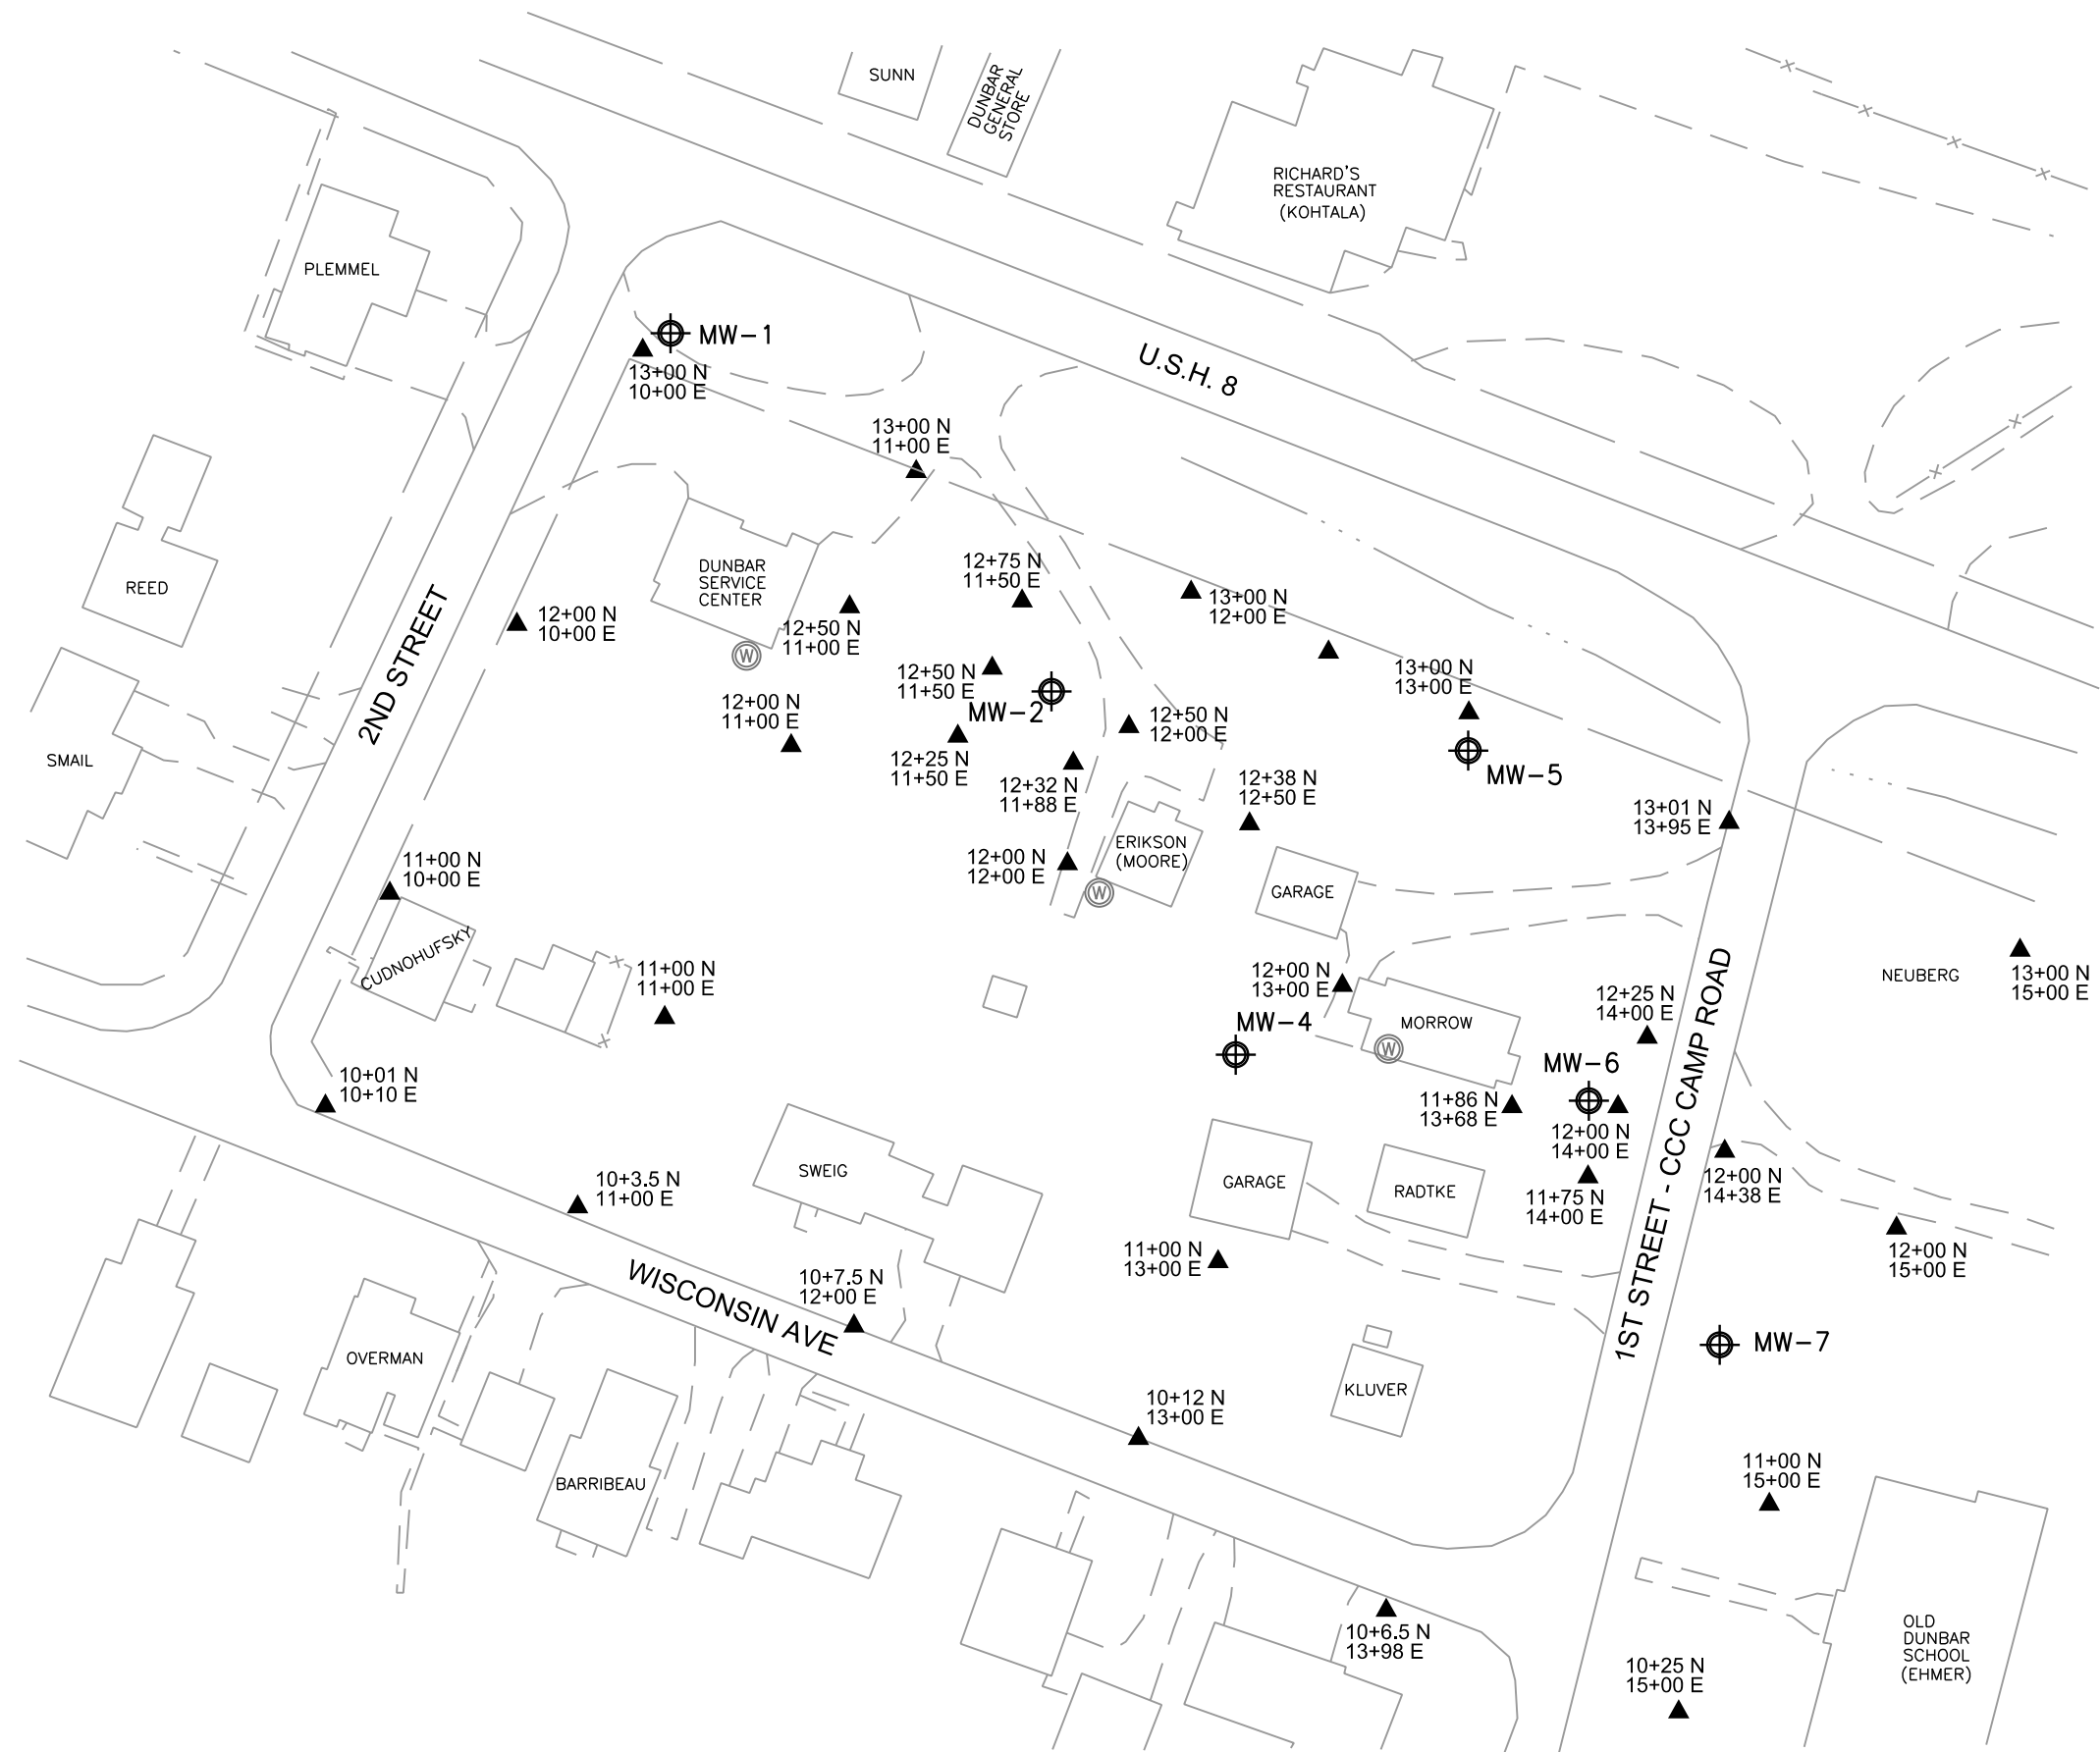
B.3.d.

**MONITORING WELLS
DUNBAR SERVICE CENTER
DUNBAR, WI**

All monitoring wells installed for this investigation have been located and will be properly abandoned upon the DNR granting conditional closure to the site. Therefore, the information required for this attachment is not applicable to this site.
