**SUBJECT:** Final Case Closure with Continuing Obligations  
Macks Service Corner, 1711 W. Center Street, Milwaukee, WI  
— DNR BRRTS Activity #: 03-41-208431  
FID #: 241143760

## B.2.b. Residual Soil Contamination

Mack's Service Corner  
1711 W. Center Street, Milwaukee, WI

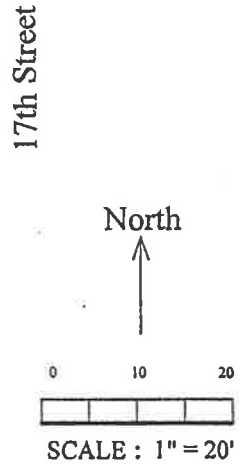
## B.3.c Groundwater Flow Direction (3/3/2016)

- ii. Discuss groundwater flow direction(s), shallow and deep. Describe and explain flow variations, including fracture flow if present.  
Groundwater elevations measured in the monitoring wells indicate a local groundwater flow direction that radiates to the north, west, and south from the center of the property.

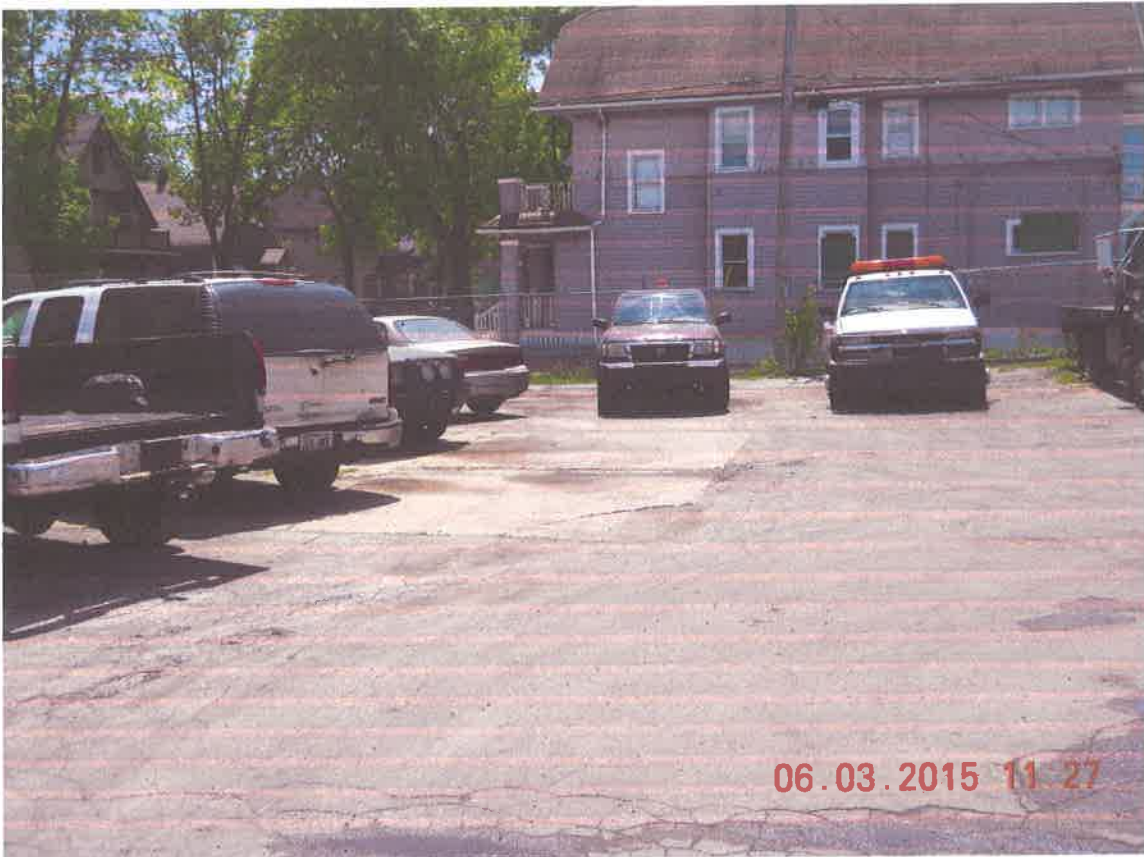
Looking south at the asphalt parking lot.

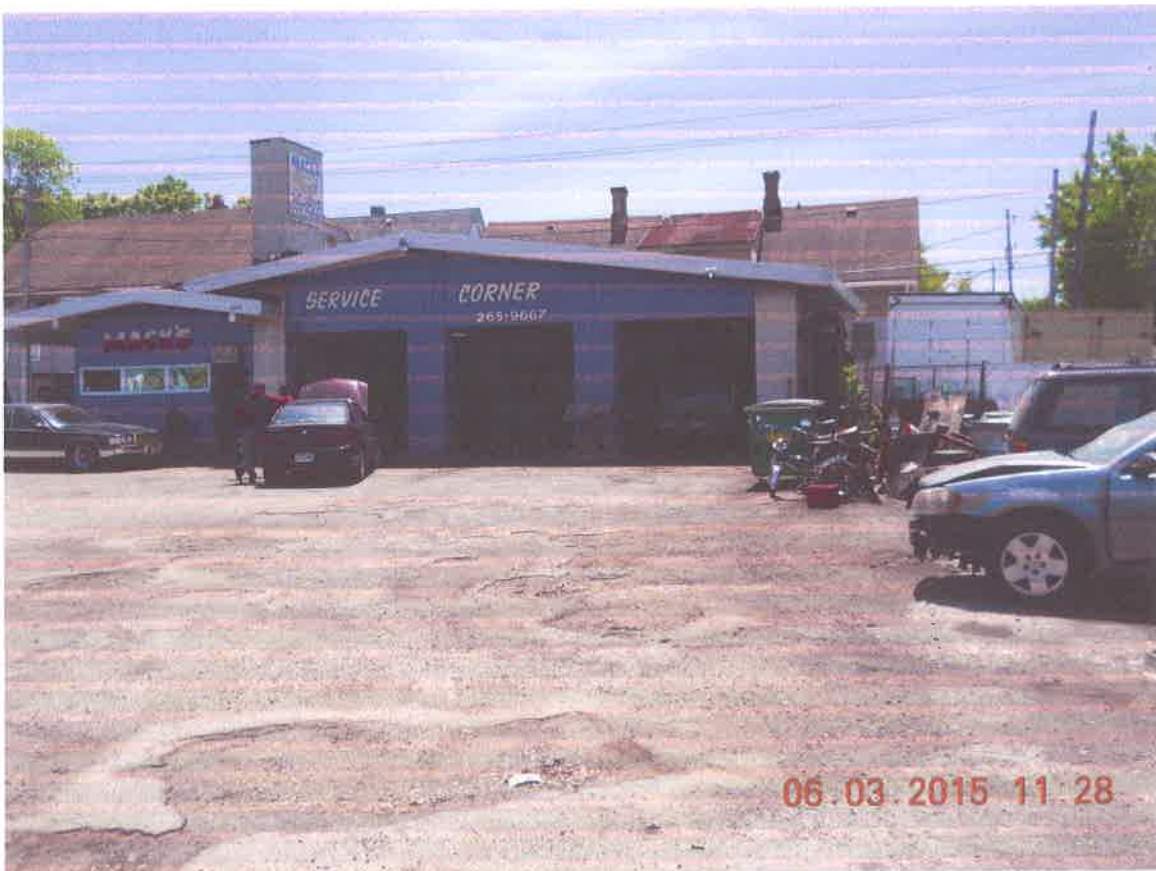
Looking south at the Mack's Service Corner Building.

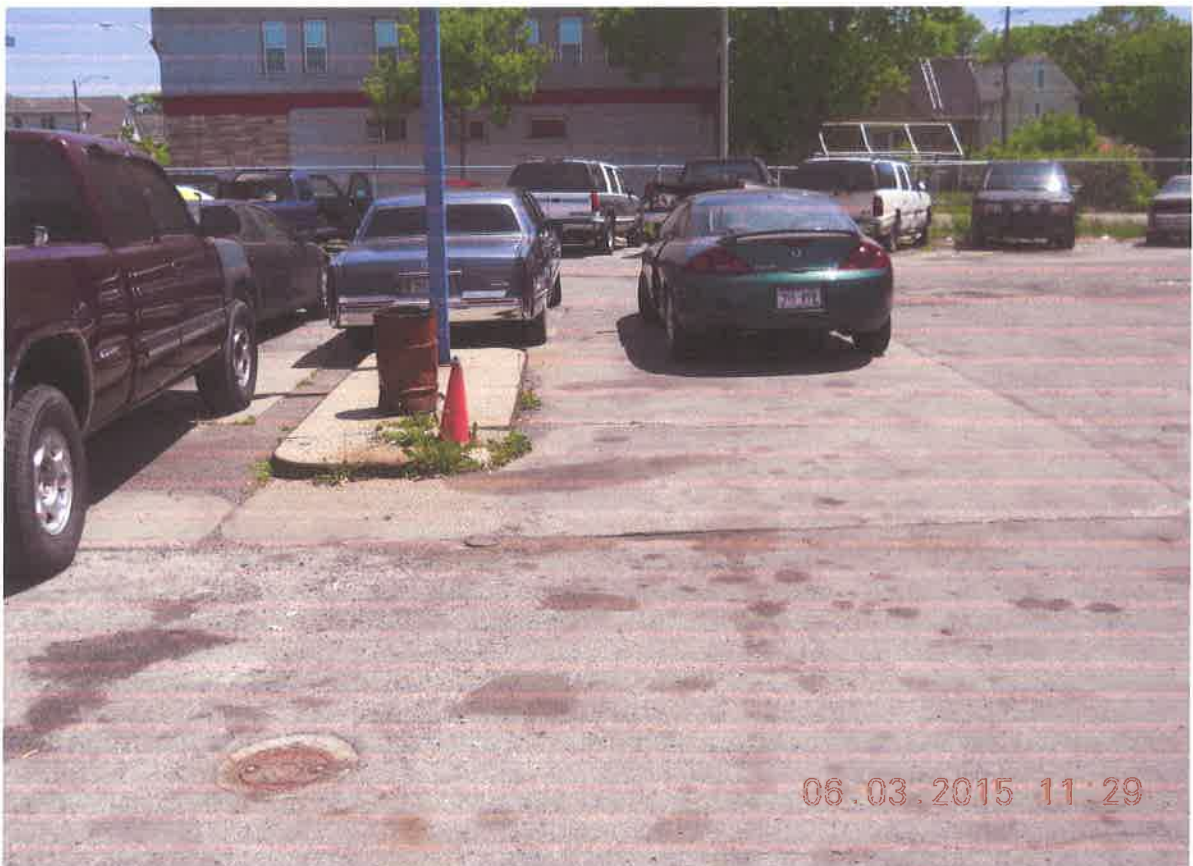
Looking east at the asphalt parking lot.
