January 3, 2024

SUBJECT: Case Closure with Continuing Obligations
Badgerland Co-op-Bob's Citgo (also known as the former Bob's Citgo)
602 W. Madison Ave., Milton, WI 53563
DNR BRRTS Activity # 03-54-000193

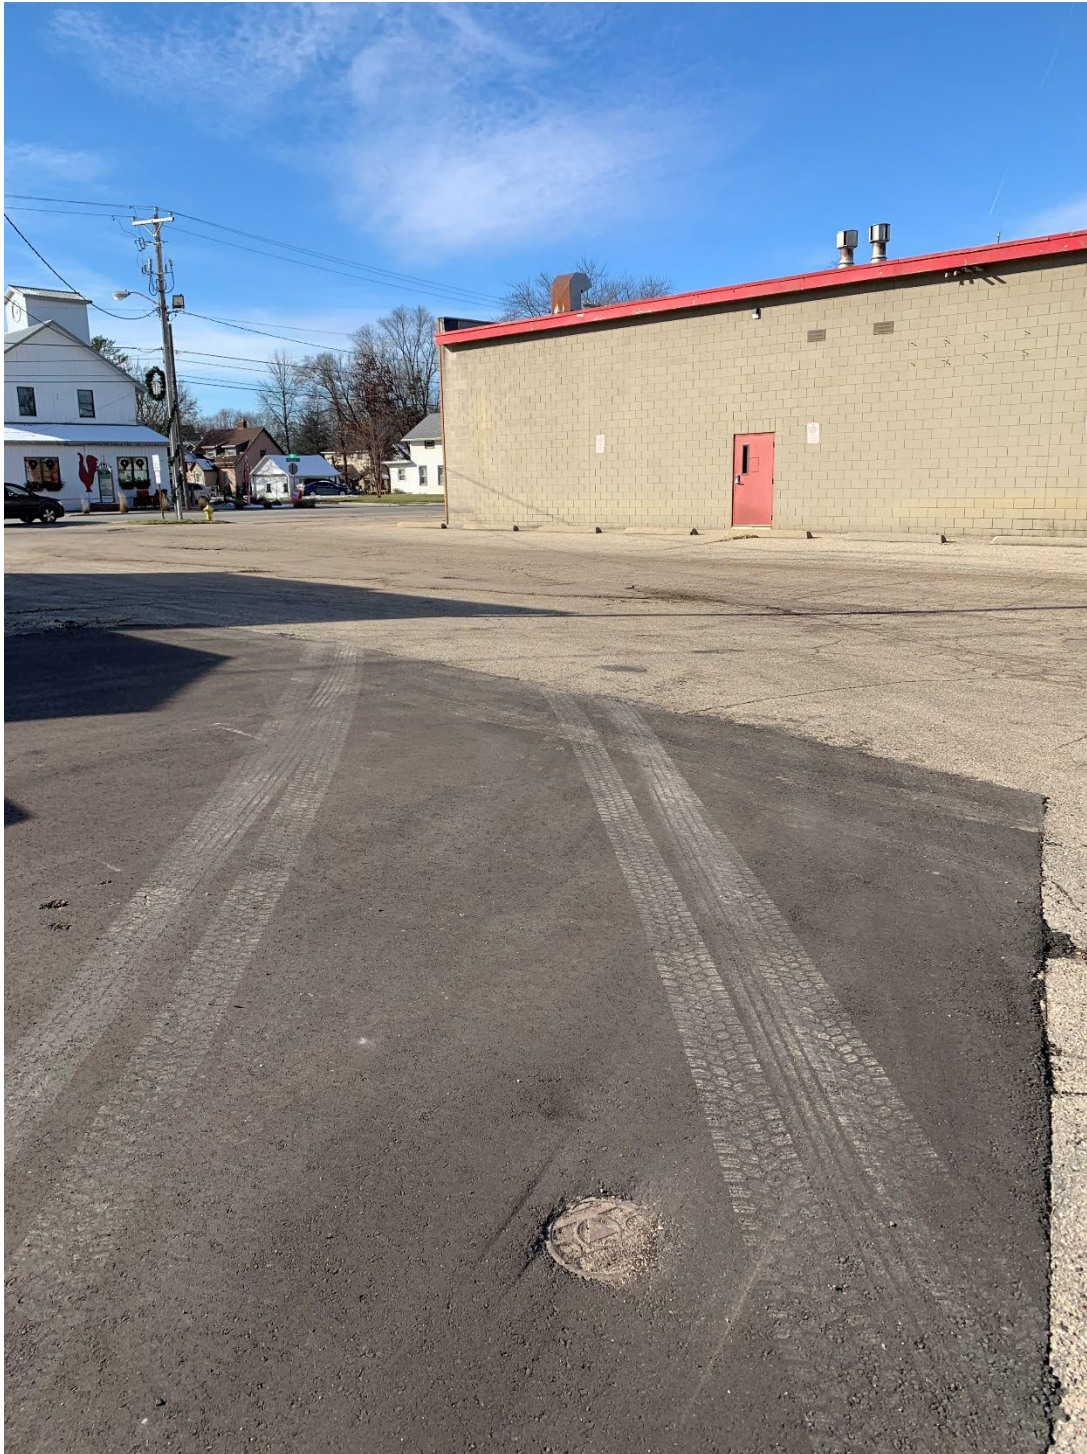
D.3 MAINTENANCE PLAN PHOTOGRAPHS

Asphalt cap to be maintained. MW1 in foreground, former Fire Dept. building and W. Madison Ave. in background. Photo taken November 22, 2022.

The attached photographs document the condition and extent of the cover/barrier at the time of the closure request.

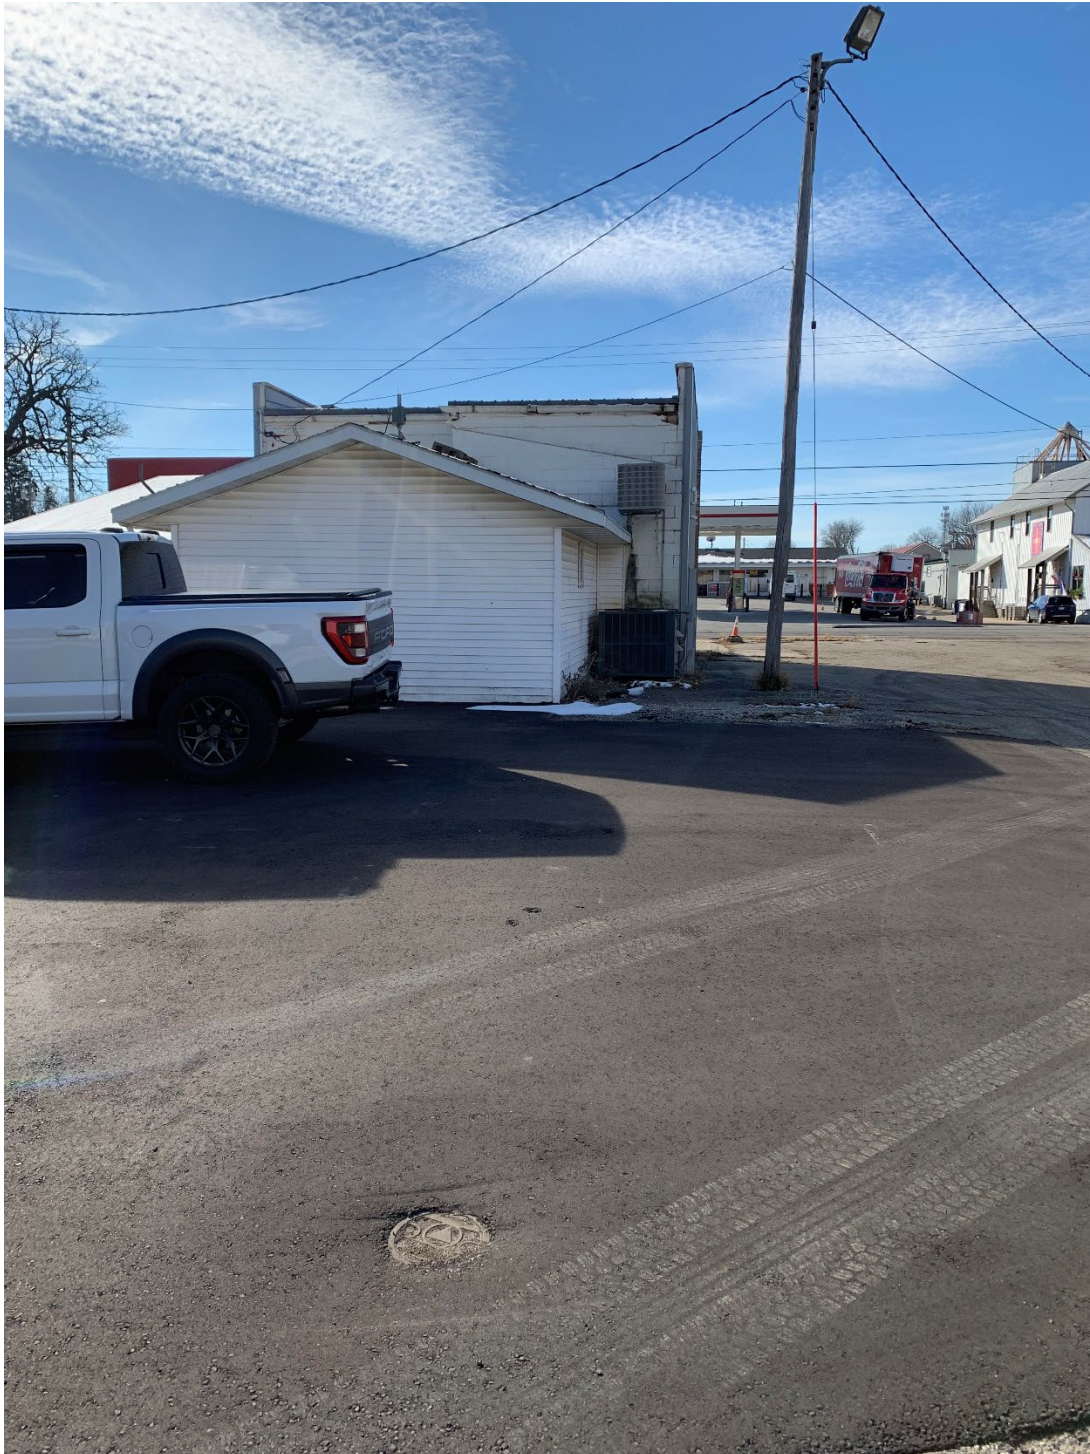
D.3 MAINTENANCE PLAN PHOTOGRAPHS

Asphalt cap to be maintained. MW1 in foreground, former Bob's Citgo building and W. Madison Ave. in background. Photo taken November 22, 2022.

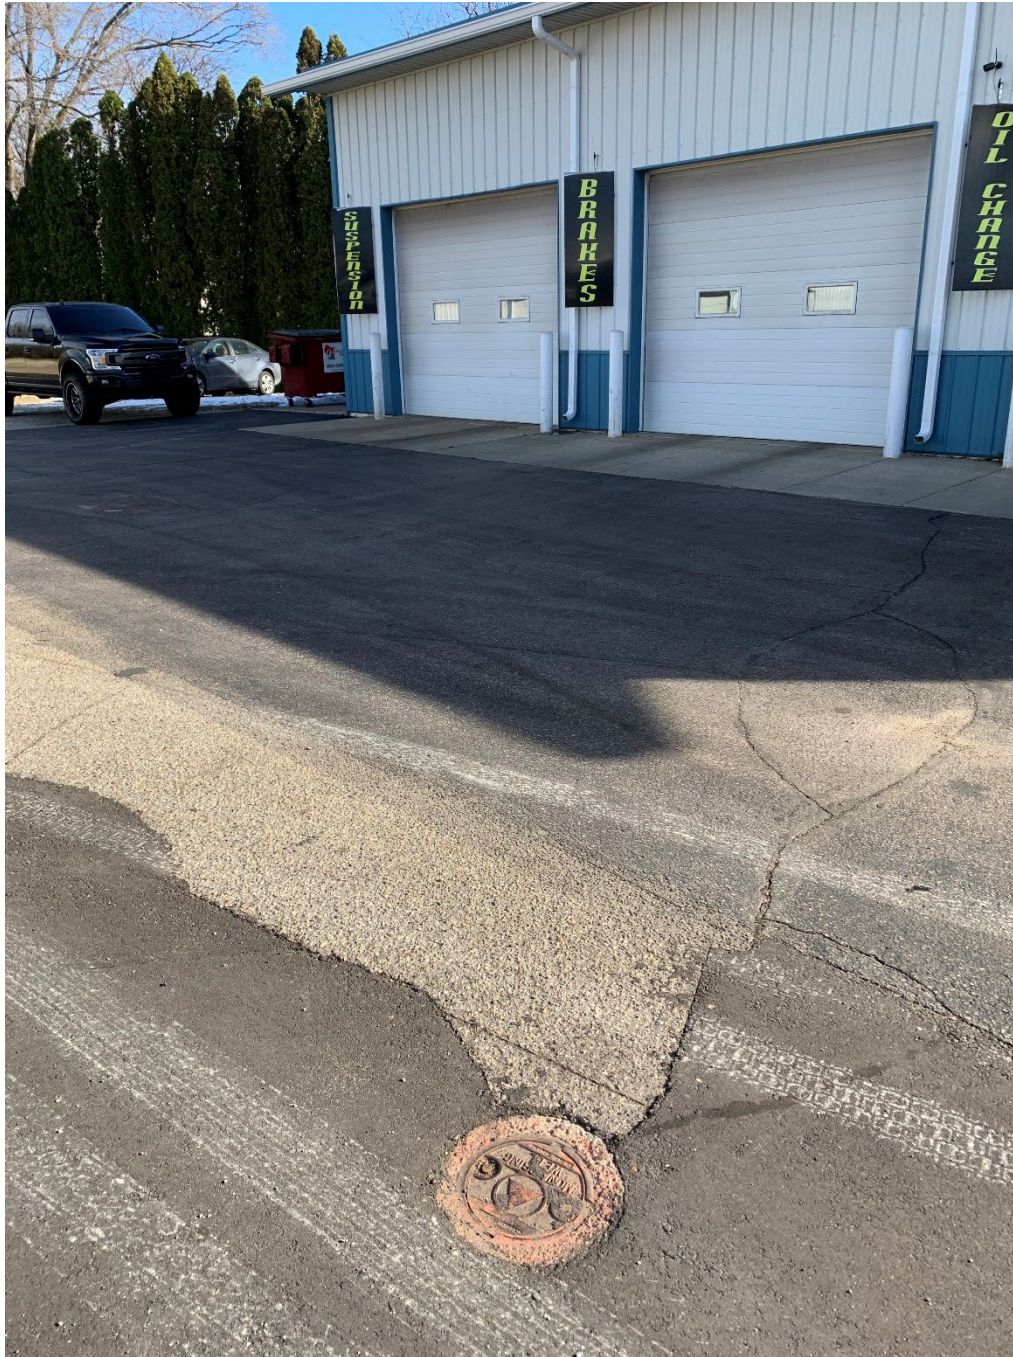
D.3 MAINTENANCE PLAN PHOTOGRAPHS

Asphalt cap to be maintained. MW2 in foreground, Jim's Service building in background. Photo taken November 22, 2022.

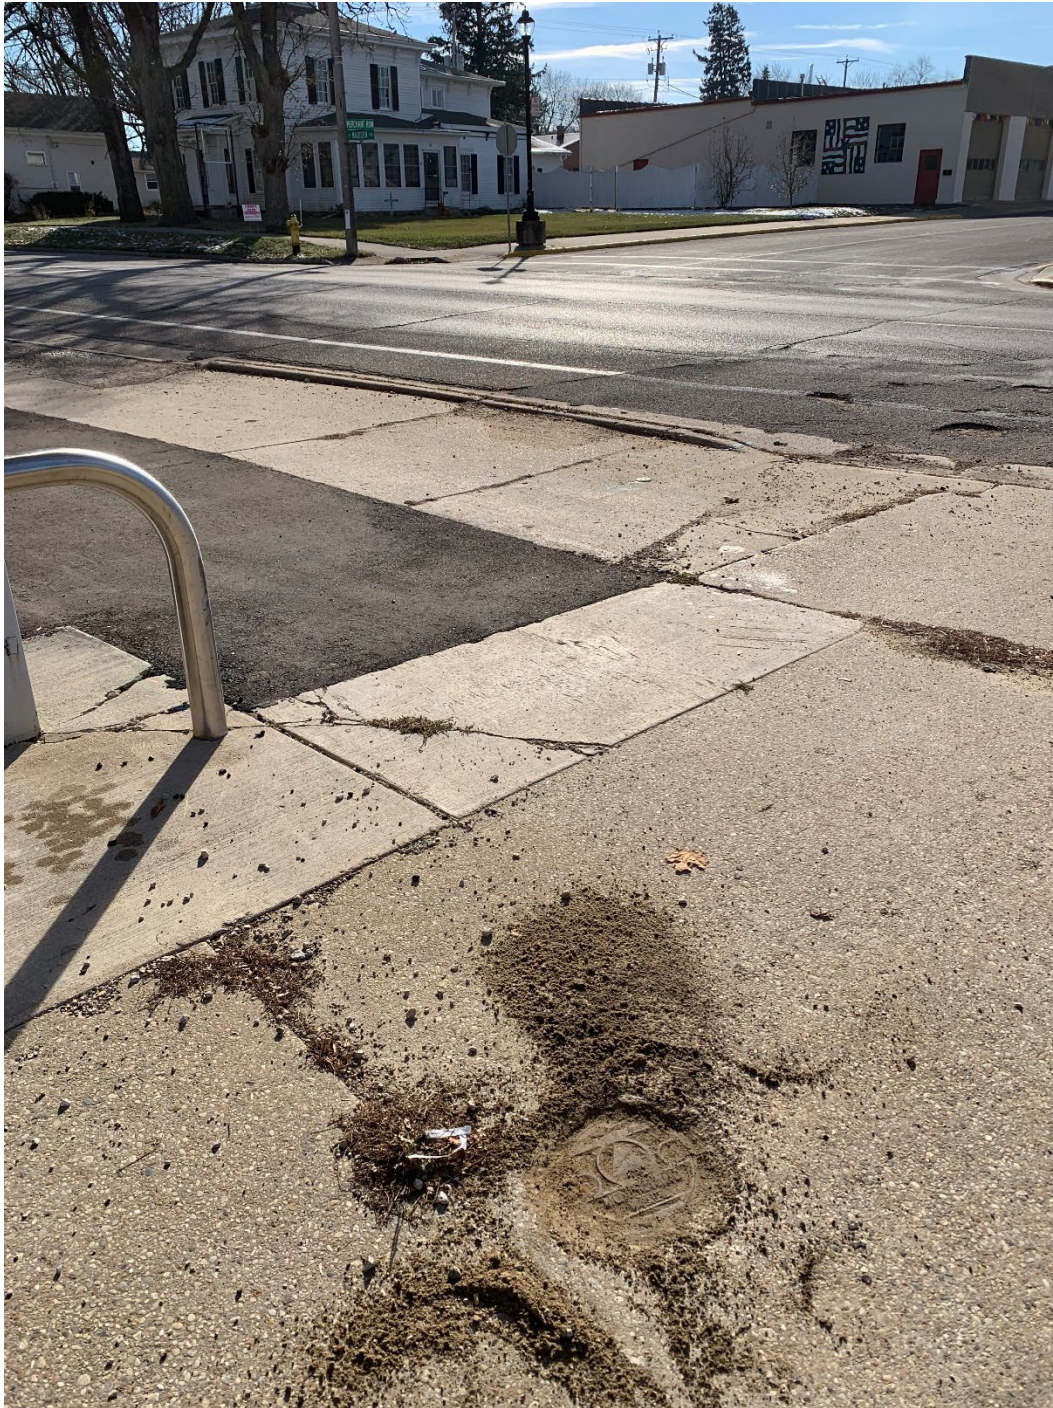
D.3 MAINTENANCE PLAN PHOTOGRAPHS

Asphalt and concrete cap to be maintained. MW3 in foreground, former gasoline pump island area, sidewalk, and W. Madison Ave. in background. Photo taken November 22, 2022.

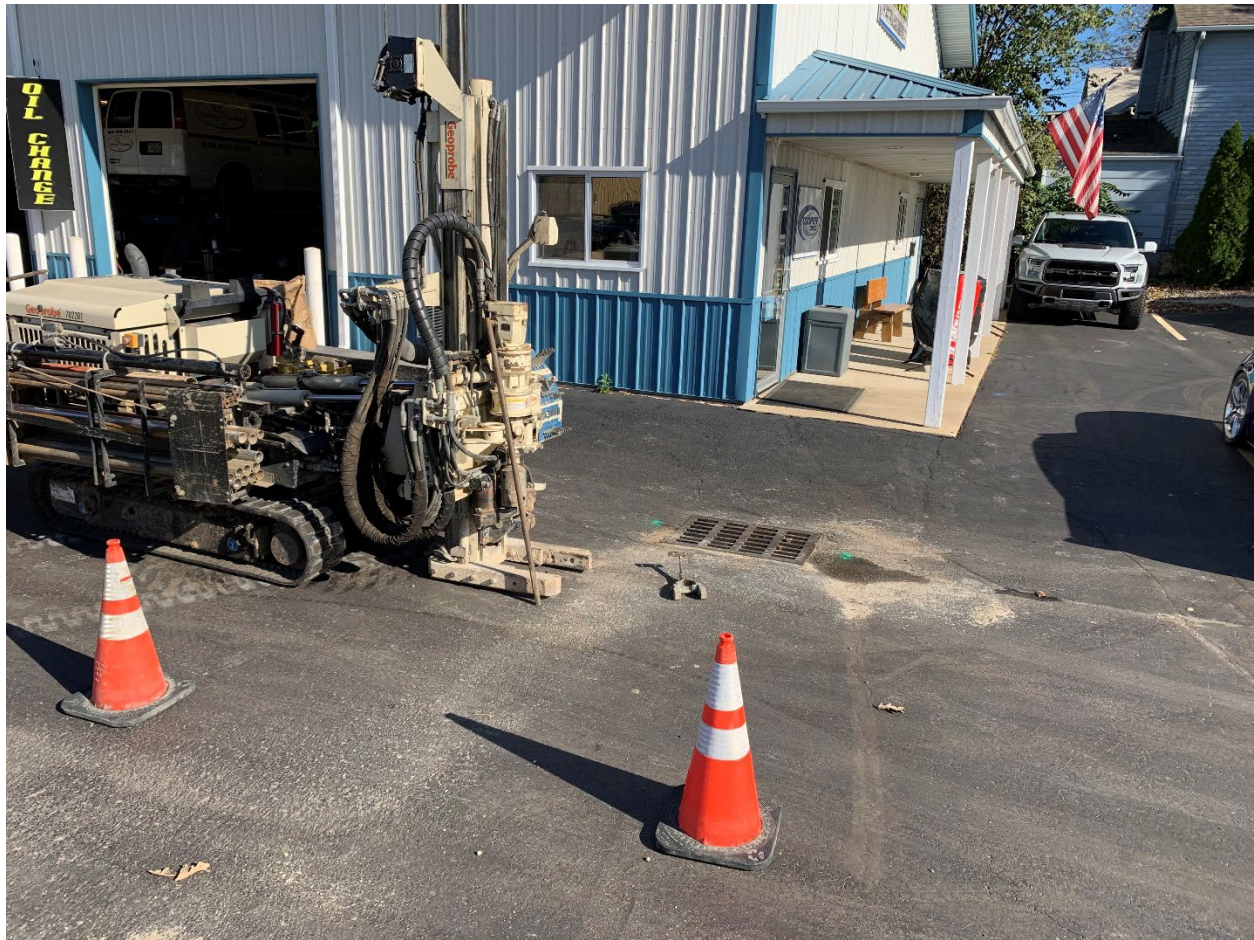
D.3 MAINTENANCE PLAN PHOTOGRAPHS

Cap in area of boring B-25.

Photographs documenting the condition and extent of the pavement cap are attached.

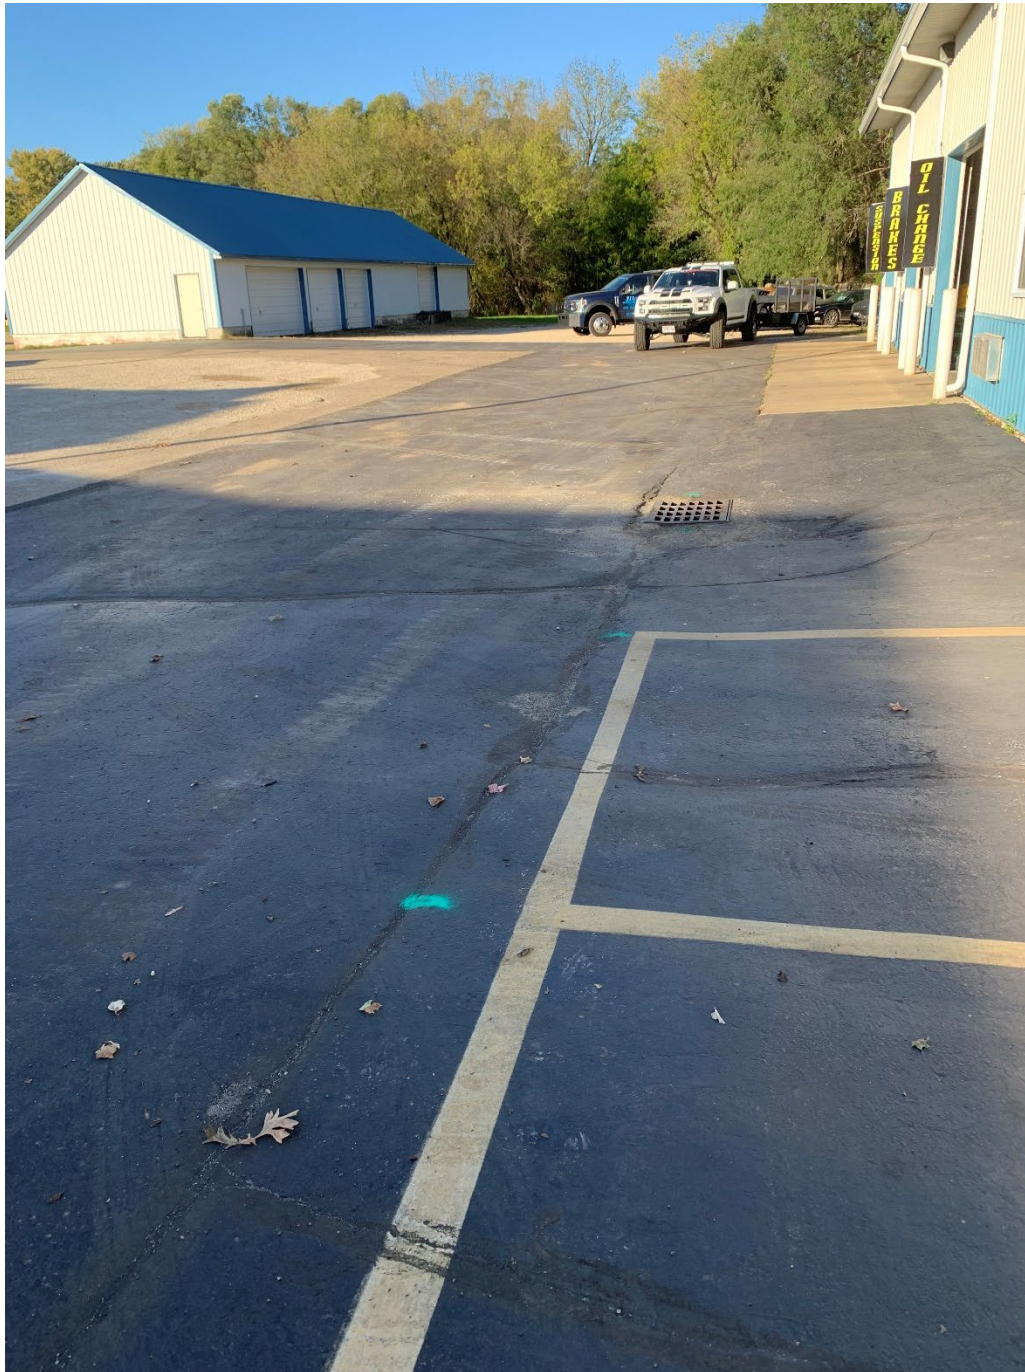
D.3 MAINTENANCE PLAN PHOTOGRAPHS

Asphalt cap in area to be maintained.

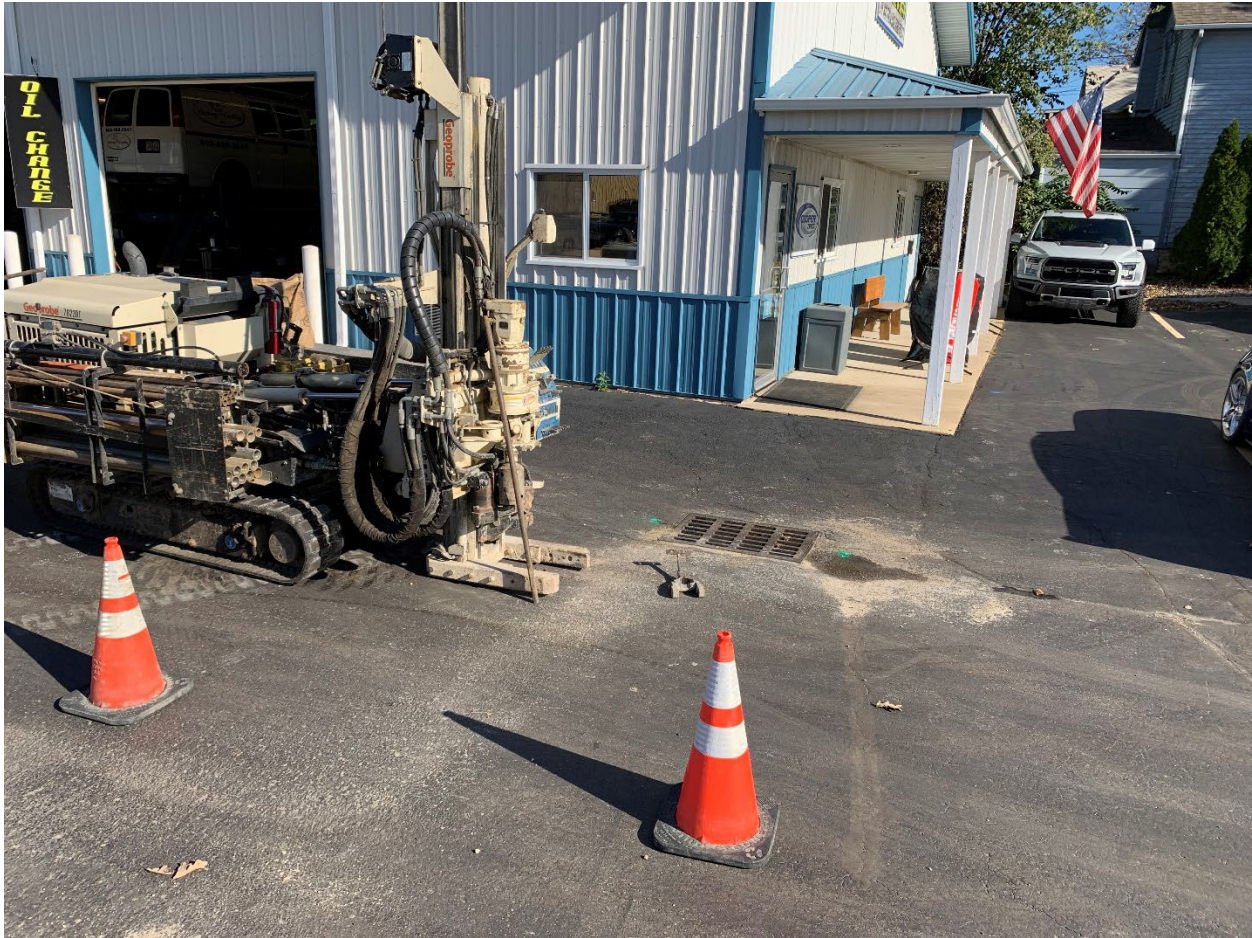
520 W. Madison Ave., Milton, WI

Cap in area of boring B-25.

Photo taken October 18, 2021.

Photographs documenting the condition and extent of the pavement cap are attached.

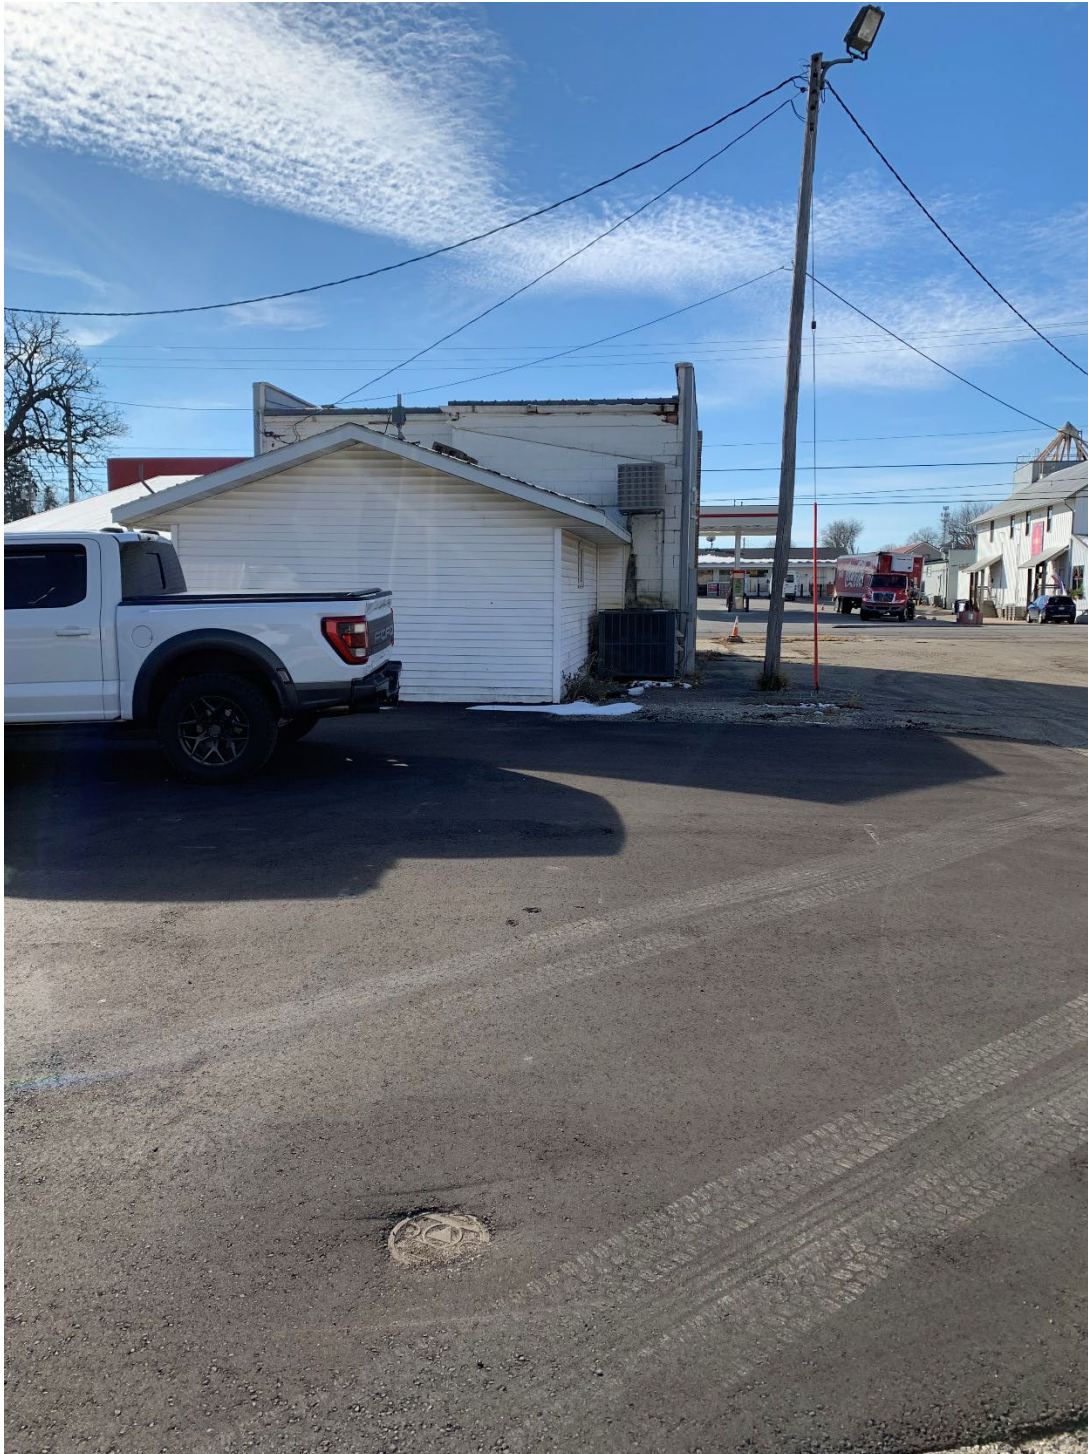
602 W. Madison Ave., Milton, WI

Asphalt cap to be maintained. MW1 in foreground, former Bob's Citgo building and W. Madison Ave. in background. Photo taken November 22, 2022.

The asphalt covers, shown on the enclosed maps (Figure D.2, Area Where Cap is to be Maintained, 7/13/2022;) shall be maintained in compliance with the enclosed maintenance plans, dated October 16, 2023. The purpose of the cover is to minimize the infiltration of water through contaminated soil and prevent direct contact with residual soil contamination that might otherwise pose a threat to human health.
