ACTIVITY NAME: SPIC & SPAN INC DBA DRYCLEAN USA

PROPERTY ADDRESS: 17525 W NORTH AVE

Subject: Conditional Closure Decision, With Requirements to Achieve Final Closure
Spic & Span, Inc. DBA Dry Clean USA Facility #84
17525 W. North Ave., Brookfield, Wisconsin
BRRTS Activity #: 02-68-219337, FID #: 268486570

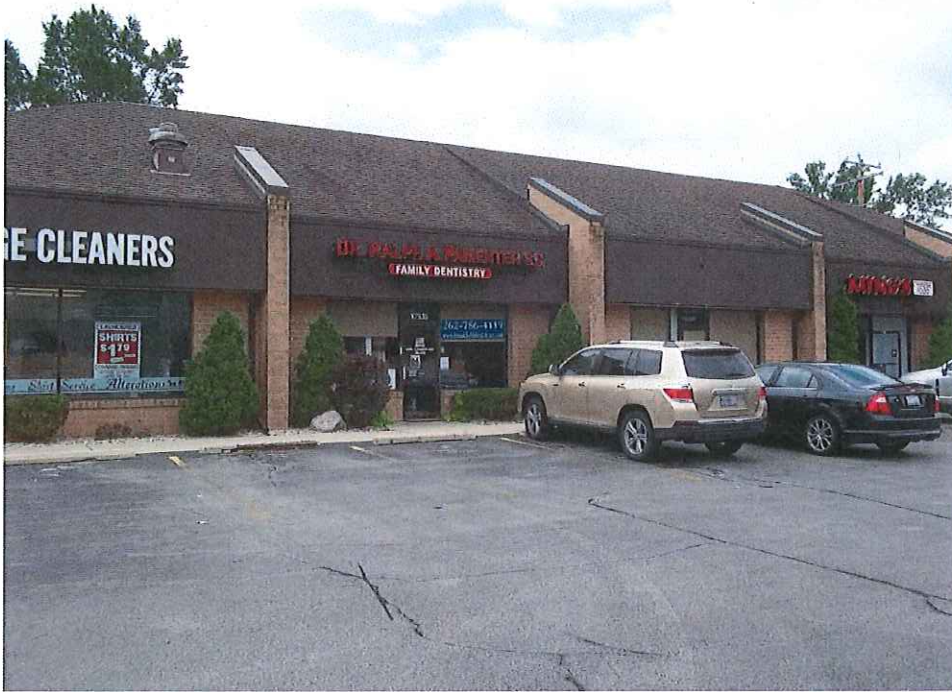
Looking south at the northwest portion of the asphalt cap

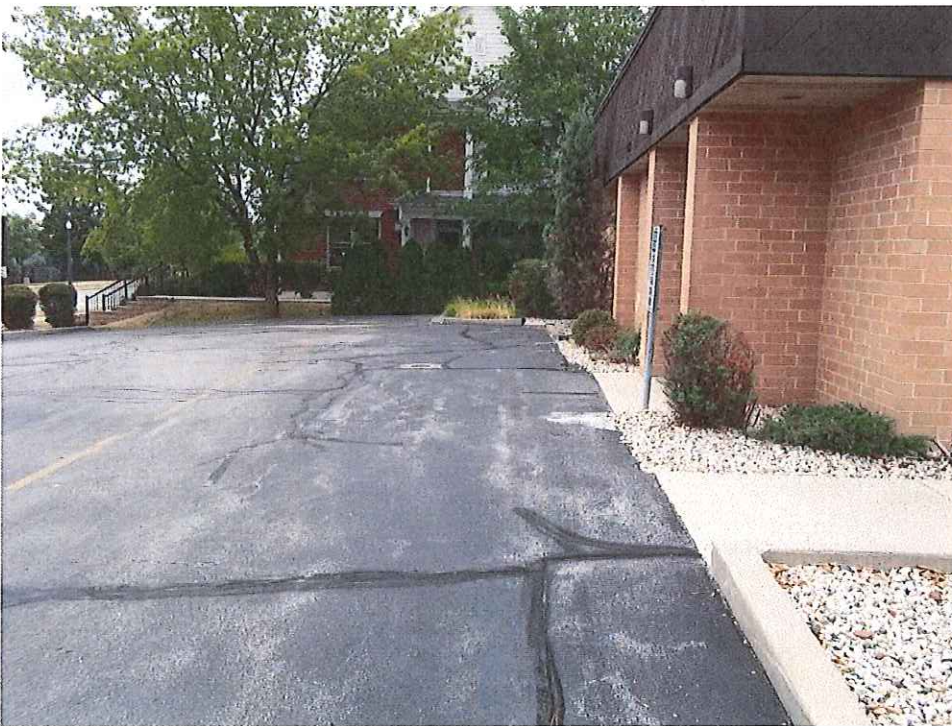
Looking south at the asphalt cap east of the dry clean facility

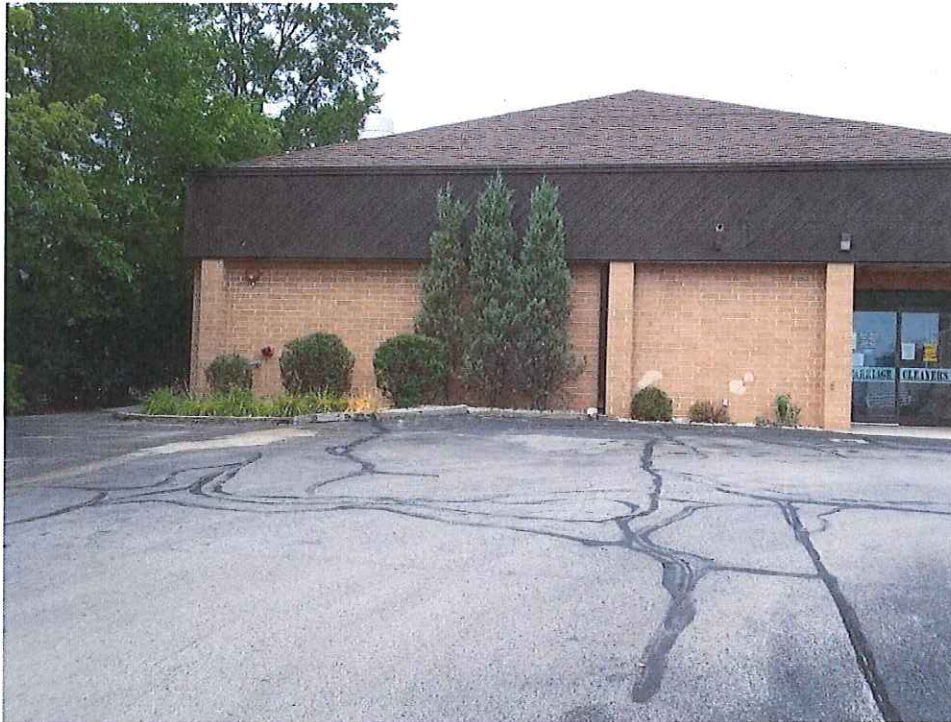
Looking west at the asphalt cap (MW-5 is located in the center right of the photo)

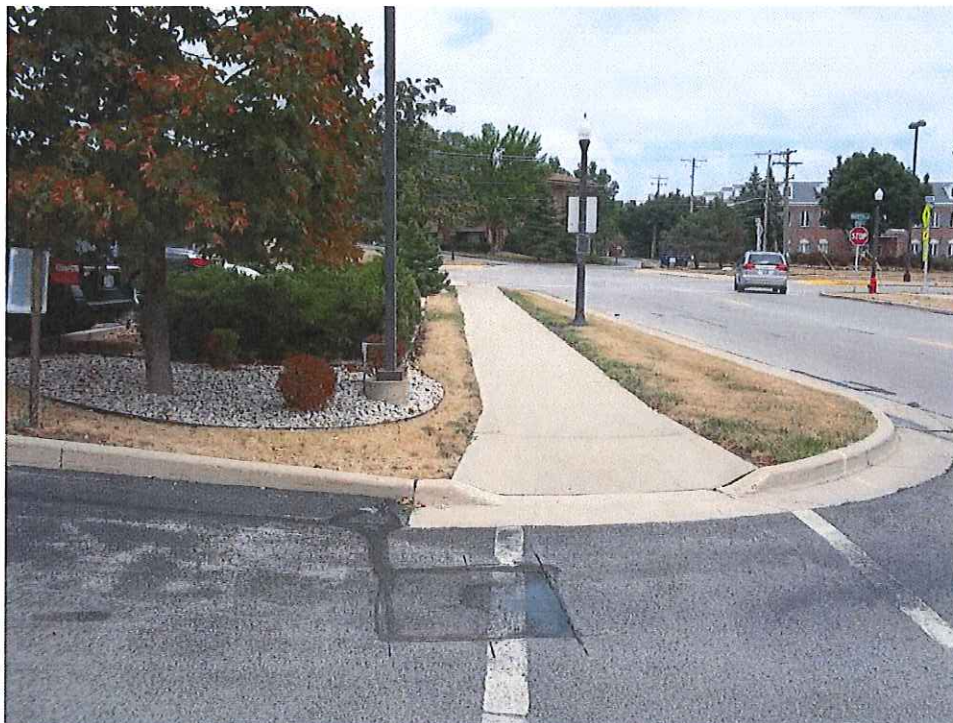
Looking north along the eastern edge of the photo

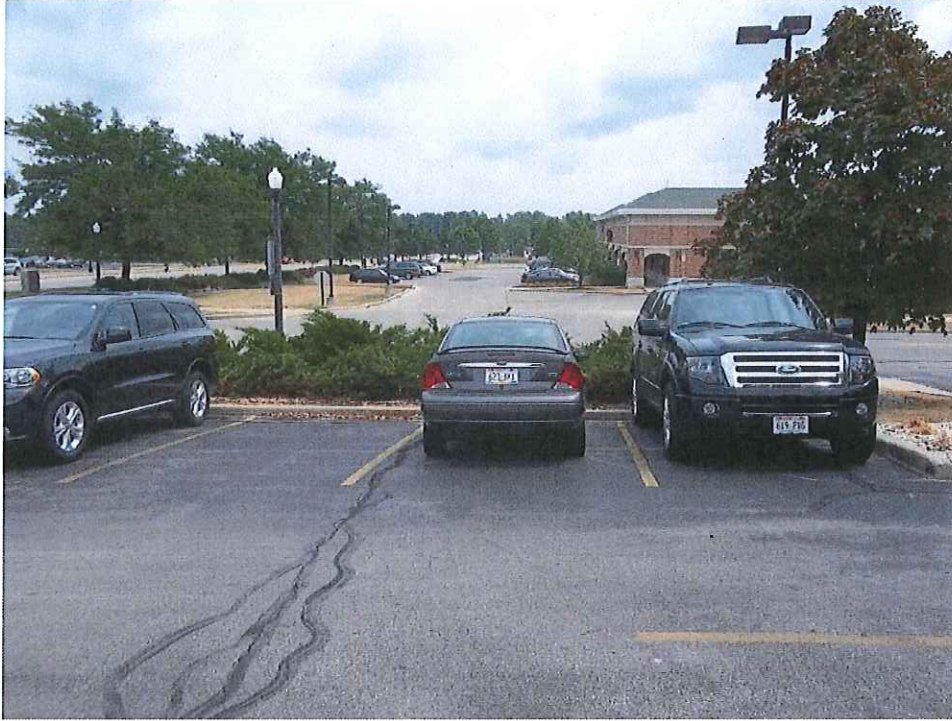
Looking east at the east portion of the asphalt cap
