SUBJECT: Final Case Closure with Continuing Obligations
Y GO BY, N3215 CTH Y, Shawano WI 54166
DNR BRRTS Activity #: 03-59-220671

The Department of Natural Resources (DNR) considers Y GO BY closed, with continuing obligations. No further investigation or remediation is required at this time. However, you, future property owners, and occupants of the property must comply with the continuing obligations as explained in the conditions of closure in this letter. Please read over this letter closely to ensure that you comply with all conditions and other on-going requirements. Provide this letter and any attachments listed at the end of this letter to anyone who purchases, rents or leases this property from you.

Y Go BY Tavern was previously used for retail fuel sales from approximately the 1950's to 1976. In 1976 a 300-gallon gasoline underground storage tank (UST) was removed from the property. The Y GO BY tavern operated until a fire in 1998 destroyed a portion of the building, the building is currently being used for storage. Petroleum impacts are found in both soil and groundwater. Natural attenuation is the approved remedial action. Continuing obligations are required to mitigat

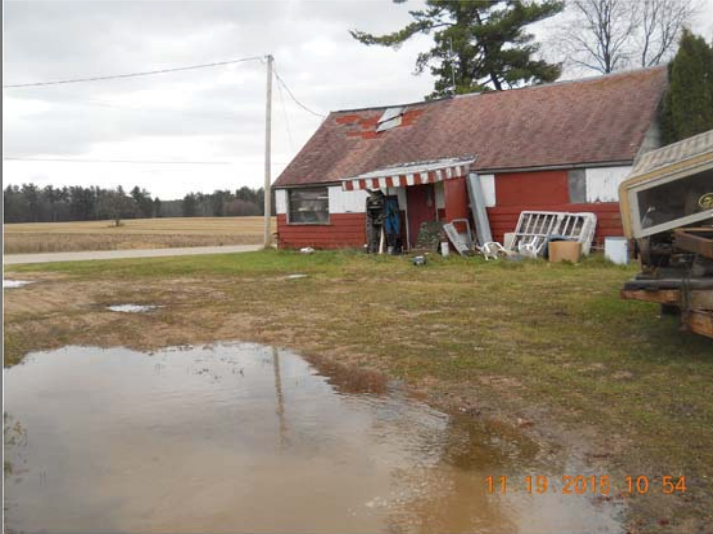
Title: Photo #1: Area of Cap to be Maintained (looking southeast)

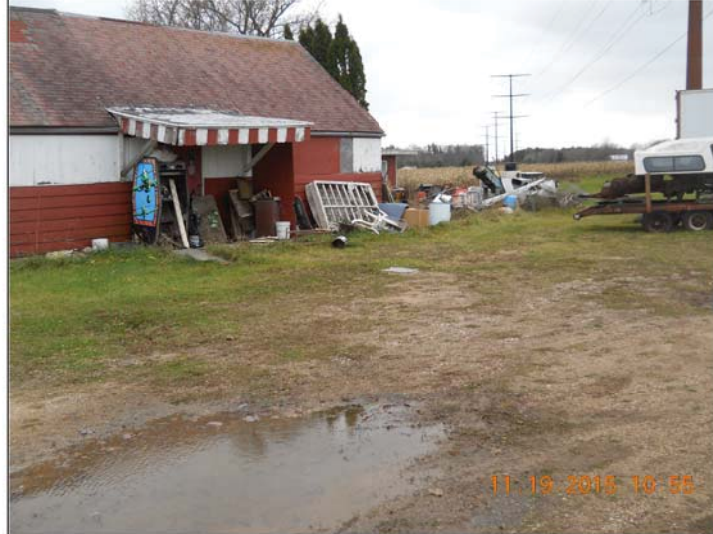
Title: Photo #2: Area of Cap to be Maintained (looking southwest)

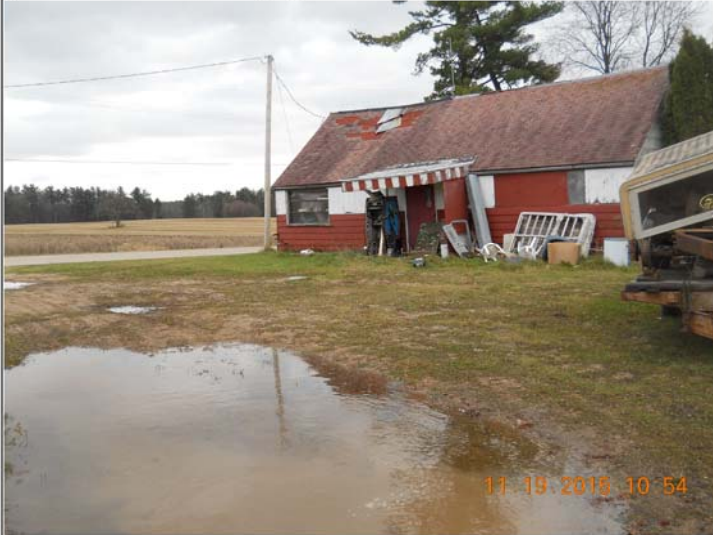
Title: Photo #1: Area of Cap to be Maintained (looking southeast)

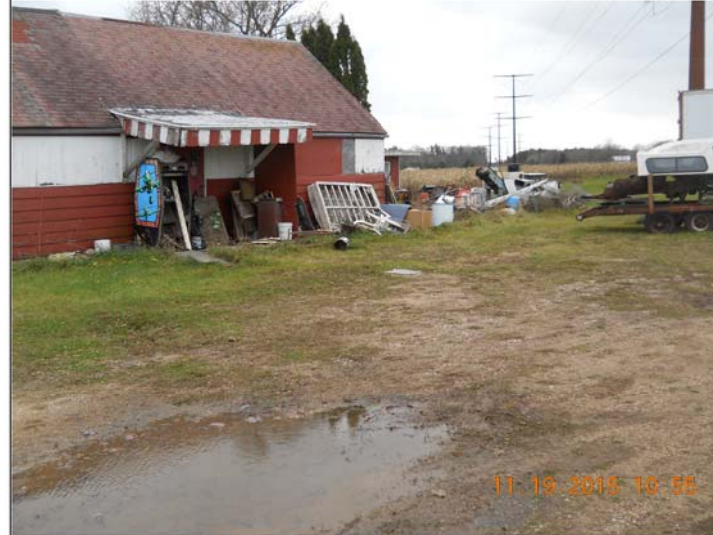
Title: Photo #2: Area of Cap to be Maintained (looking southwest)
