Subject: **Drilling Damage**
Corner Store
102 State Rd 25
Ridgeland, WI
PECFA No. 54763-9623-02
DNR BRRTS No. 03-17-223007
Meridian No. 05F761

**Figure 1
Site Map
Fosters Corner Store
Ridgeland, Wisconsin**

REVISIONS DATE	DAVY ENGINEERING CO LA CROSSE WISCONSIN			
7/17/55 J.E.H.	ASBUILT PLAN			
8-2-55 J.C.	OF			
8-23-55 J.C.	SANITARY SEWERS			
	RIDGELAND, WISCONSIN			
DATE	DRAWN	CHECKED	SCALE	SHEET
JAN. 1959	R.M.H.	P.S.D.	1"=200'	1

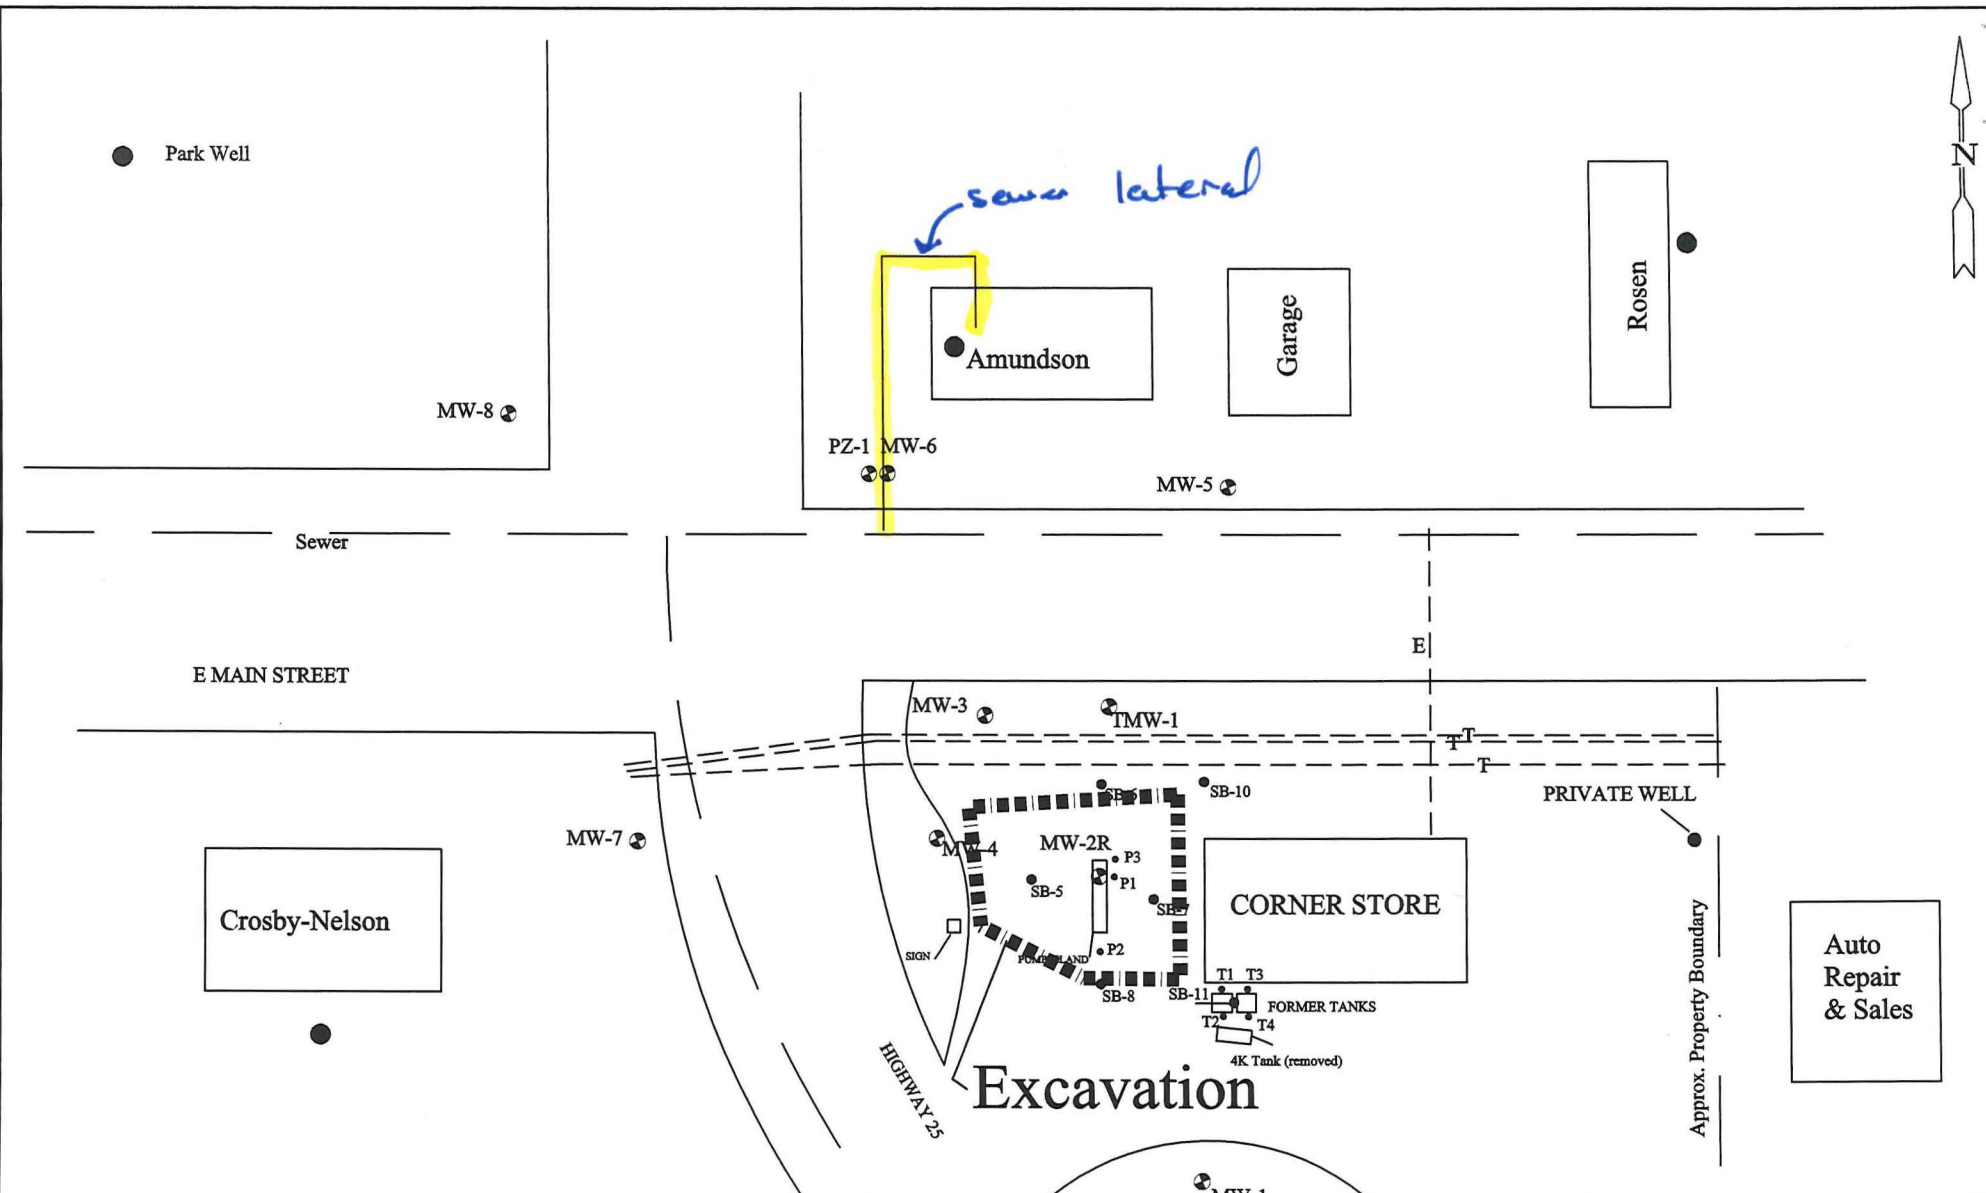
As I mentioned in my email of June 11, 2013, the Village of Ridgeland contacted me last week and informed me our monitoring well MW-6 or PZ-1 (see attached site map) slightly damaged the sewer lateral for the Pat Amundson residence. The Village has paid for the sewer to be flushed out several times. The sewer appears to be intact but must have been cracked. The exact location and depth of the sewer lateral is still unknown.

Last week (June 13), I met with the Village official (Lowell Weber), Mrs. Amundson, and Brian Wirth of Wirth Bros. (local contractor who installs/repairs sewers in Village). They all agreed we could not have known the sewer lateral had been installed in this unusual configuration. Most sewer laterals go from the house straight out to the sewer main. Mrs. Amundson thinks the lateral was installed by hand in the late 1950's or early 1960's.

Brian Wirth (Wirth Bros) estimated the repair cost will be \$500 provided the sewer is readily accessible. We are going to wait until August to allow the water table to drop allowing easier and safer access to the sewer. Costs could be higher if it continues to be a wet summer and if the lateral is buried deep.

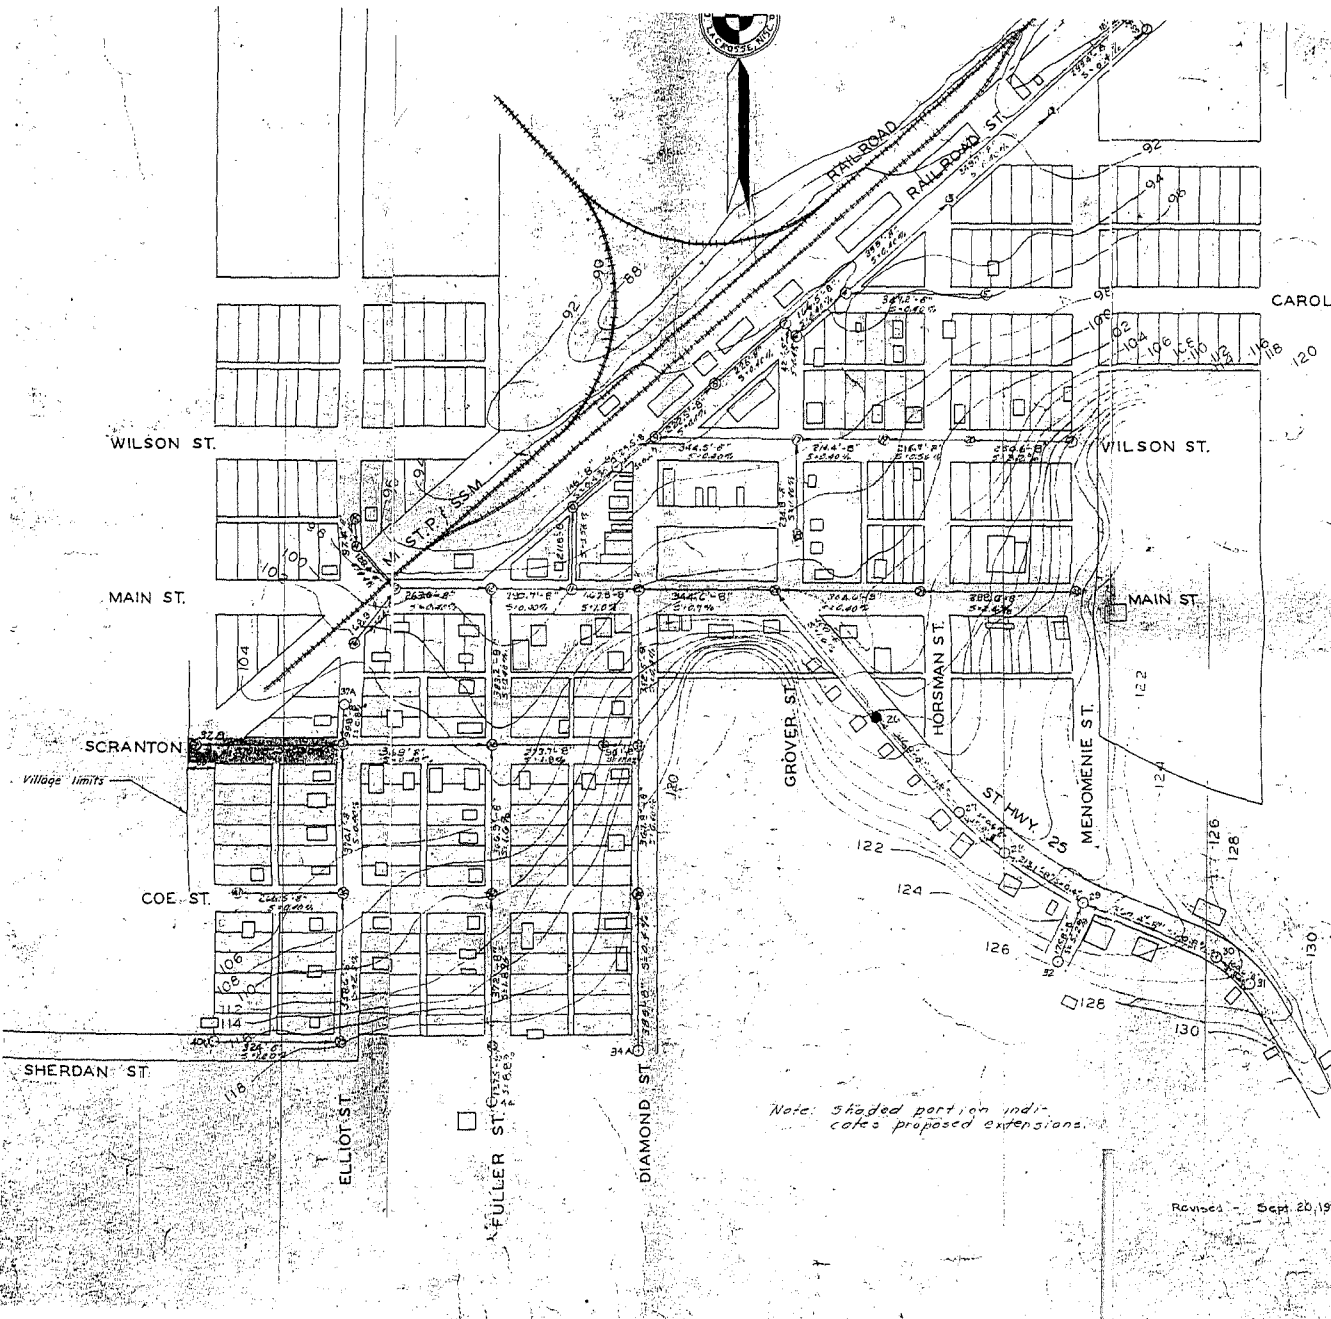
1. Contacted Digger's Hotline (Ticket No.20112209841)
2. Spoke with Village official (Lowell Weber) by phone and sent letter (copy attached).
3. Spoke with property owner (Mrs. Amundson)
4. Met with Village Sewer technician (Mike) who provided copy of sewer plans (attached). Sewer was installed in late 1950's.
