### VAPOR MITIGATION SYSTEM MAINTENANCE PLAN Hub Pub, 15672 State Highway 80, Richland Center, Wisconsin

September 12, 2018

## INTRODUCTION

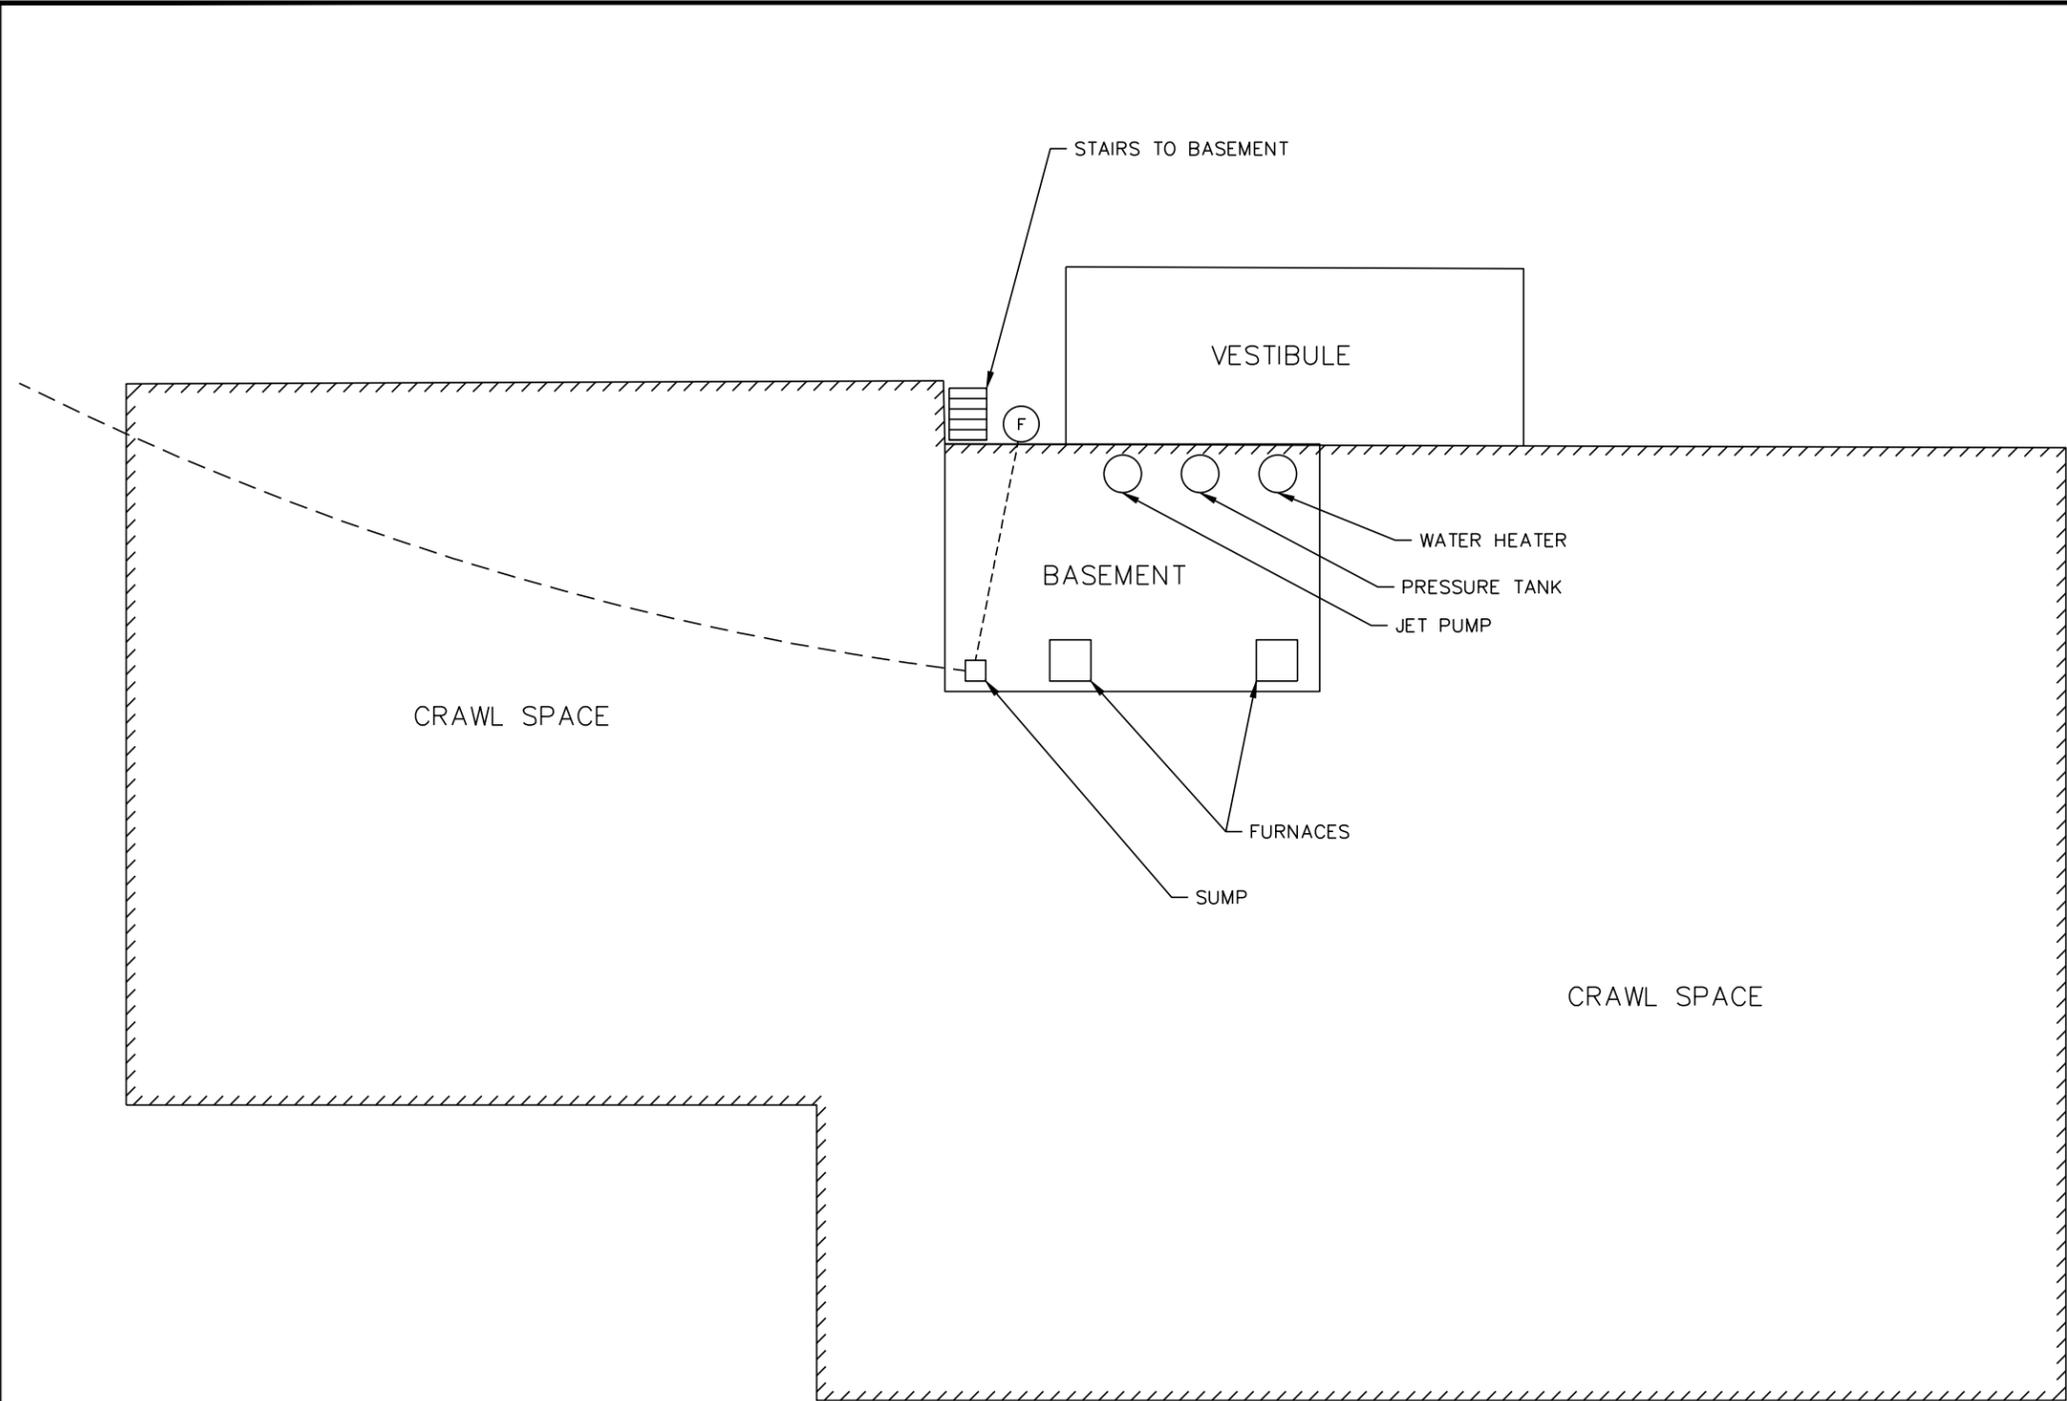
SITE	HUB PUB 15672 STATE HIGHWAY 80 RICHLAND CENTER, WI 53581	SITE PLAN	FIGURE
DRAWN: 08/21/18	CHECKED BY: REL								1
REVISED: 08/21/18	APPROVED BY: REL, 08/27/18

The location of the VMS is shown on **Figure 1** and in photographs included in **Attachment A**. The VMS was constructed by installing an aeration system, sump lid, vacuum pick-up point, and blower to capture and remove vapor from an existing basement sump.

See **Figure 1** for a map of features to maintain.

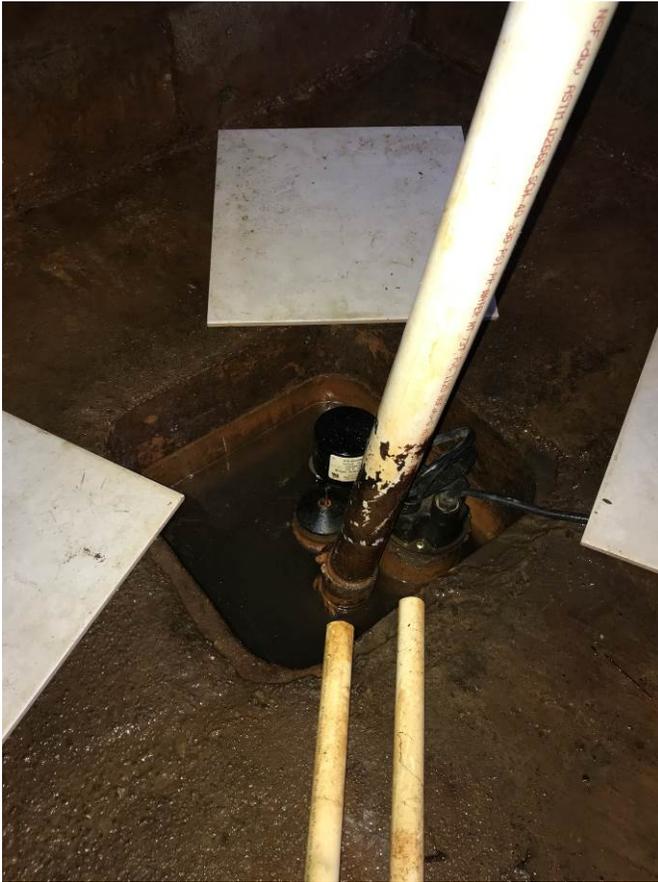
**Photo 1:** Sump pit prior to installing mitigation system  
Date: 7/18/2018

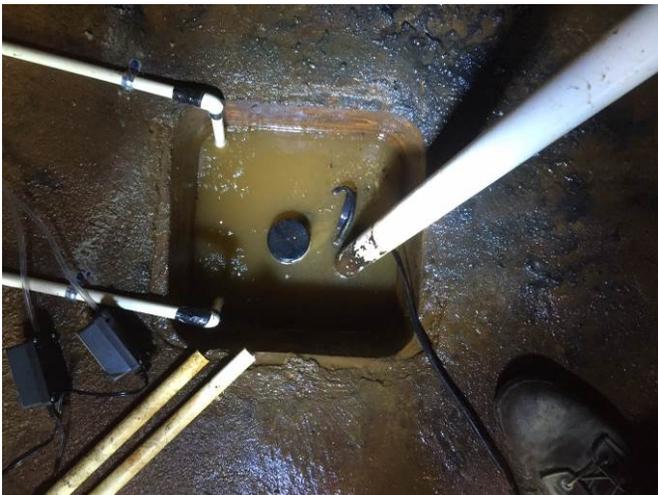
The sump aeration system includes two Marine Metal aerators with aeration lines set inside ½-inch PVC pipes. The pipes were secured to the basement floor and extended to the bottom of the sump. A glass bead air stone was mounted to the end of each airline to diffuse air into the sump water and remove dissolved gases from the water.

**Photo 2:** Sump pit with aeration system installed  
Date: 8/14/2018

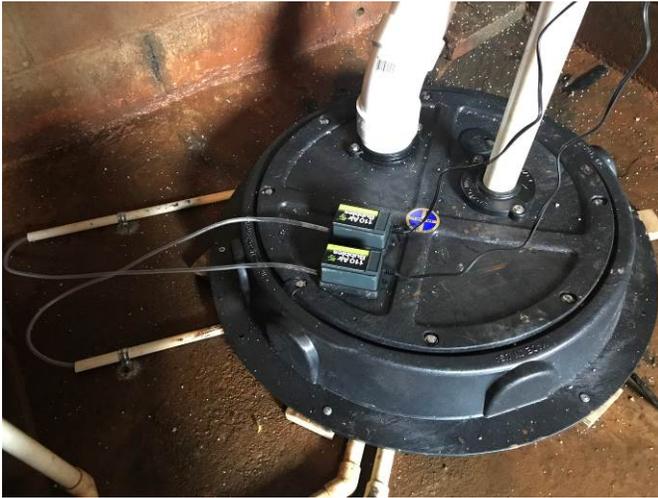
A plastic dome sump lid, manufactured by Jackel, Inc., was placed over the sump and secured to wood blocks to leave an approximate 1-inch gap between the floor and the bottom of the lid. As required by the WDNR, this gap was designed to allow water (if present) to drain from the floor into the sump while capturing vapors over the sump and also ventilating the basement.

**Photo 3:** Sump lid with aeration pumps  
Date: 8/14/2018

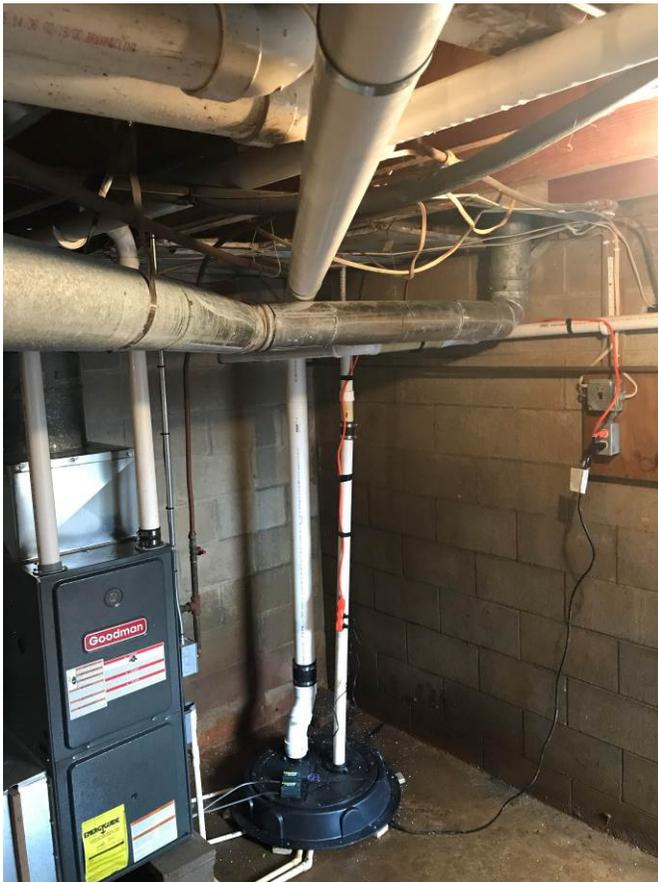
The sump pump discharge and vacuum pick-up point piping were sealed into the sump lid. The 3-inch PVC pick-up point piping was extended to the ceiling and out the side of the building where it was connected to a 120 volt AMG Spirit radon fan. The vent pipe for the fan was extended above the roof line outside the north end of the building. The PVC vent pipe and power line penetrations through the building wall were sealed.

**Photo 4:** Pick-up point and piping  
Date: 8/14/2018

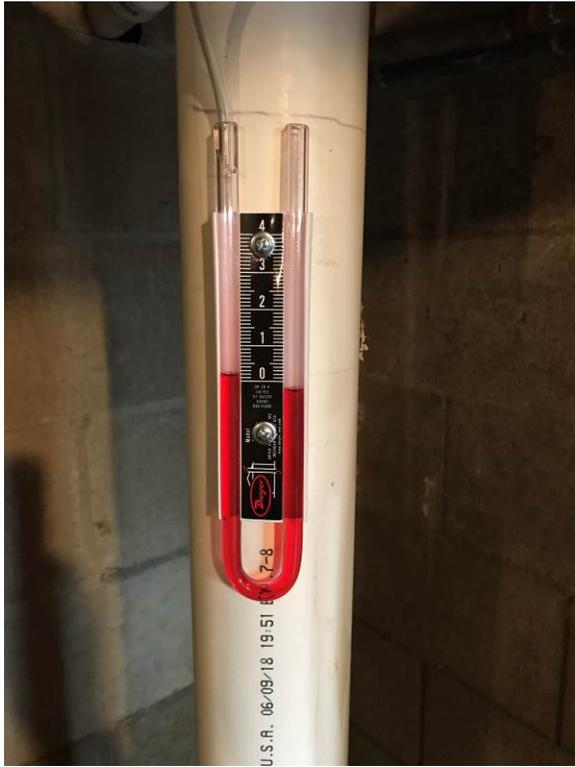
A manometer was installed on the vertical section of the pick-up point over the sump to check for fan operation. The fan is capable of producing up to approximately 1-inch of water column (WC) vacuum. At start-up the fan was pulling approximately 0.3 inches WC, which equates to a flow rate of approximately 80 cubic feet per minute.

**Photo 5:** Pick-up point manometer  
Date: 8/14/2018

Minimal operator control or maintenance is required. There are no service requirements for the venting fan or aeration pumps. The fan status is checked using the manometer. If the manometer displays greater than zero, the fan is functioning. The aeration pumps are checked by inspecting the sump water for bubbles. If there are bubbles emanating from both aeration lines the pumps are functioning.

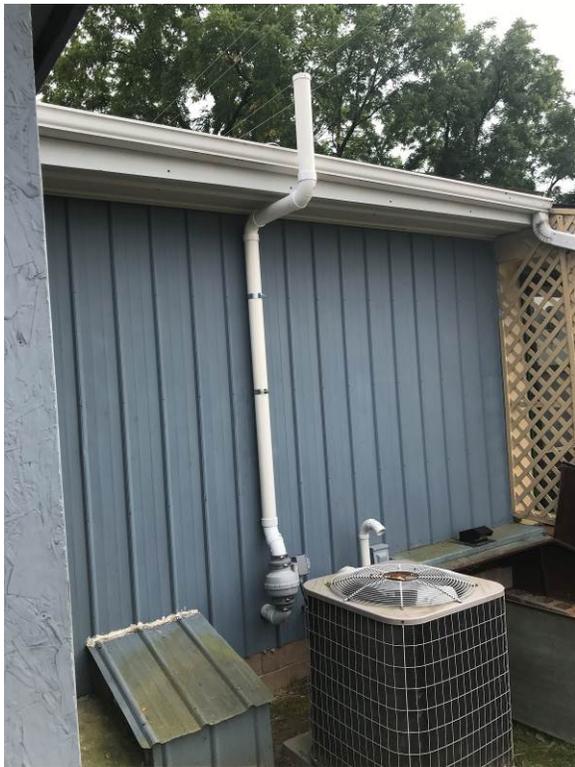
**Photo 6:** Fan and exhaust line  
Date: 8/14/2018
