Subject: Final Case Closure with Continuing Obligations

Shortville Store Former, W4109 STH 73, Neillsville, WI

DNR BRRTS Activity #: 03-10-000581

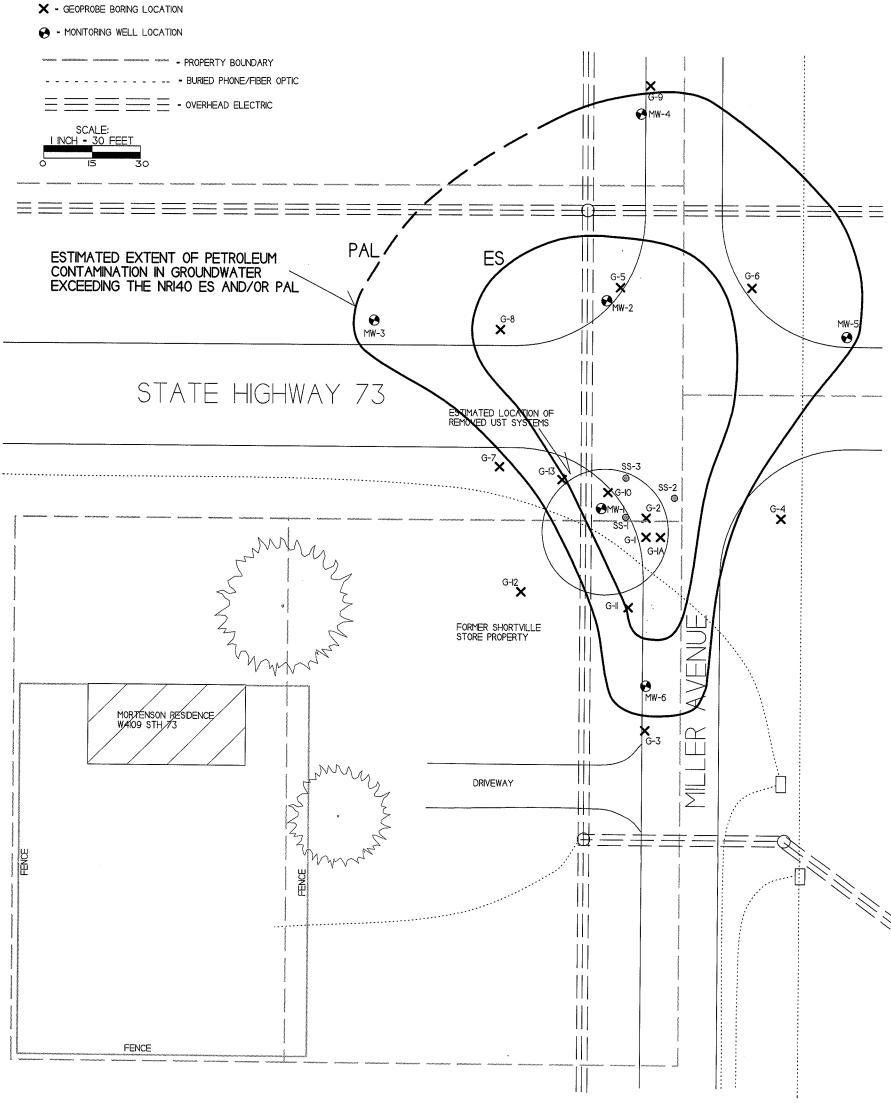
Groundwater contamination greater than enforcement standards is present both on this contaminated property and off this contaminated property, as shown on the attached map; 'B.3.b Groundwater Isoconcentration, 10/19/17'. If you intend to construct a new well, or reconstruct an existing well, you'll need prior DNR approval. Affected property owners and right-of-way holders were notified of the presence of groundwater contamination. This continuing obligation also applies to the owners of N2175 Miller Avenue, N2084 Miller Avenue, and ROW holders for Miller Avenue and State Highway 73.

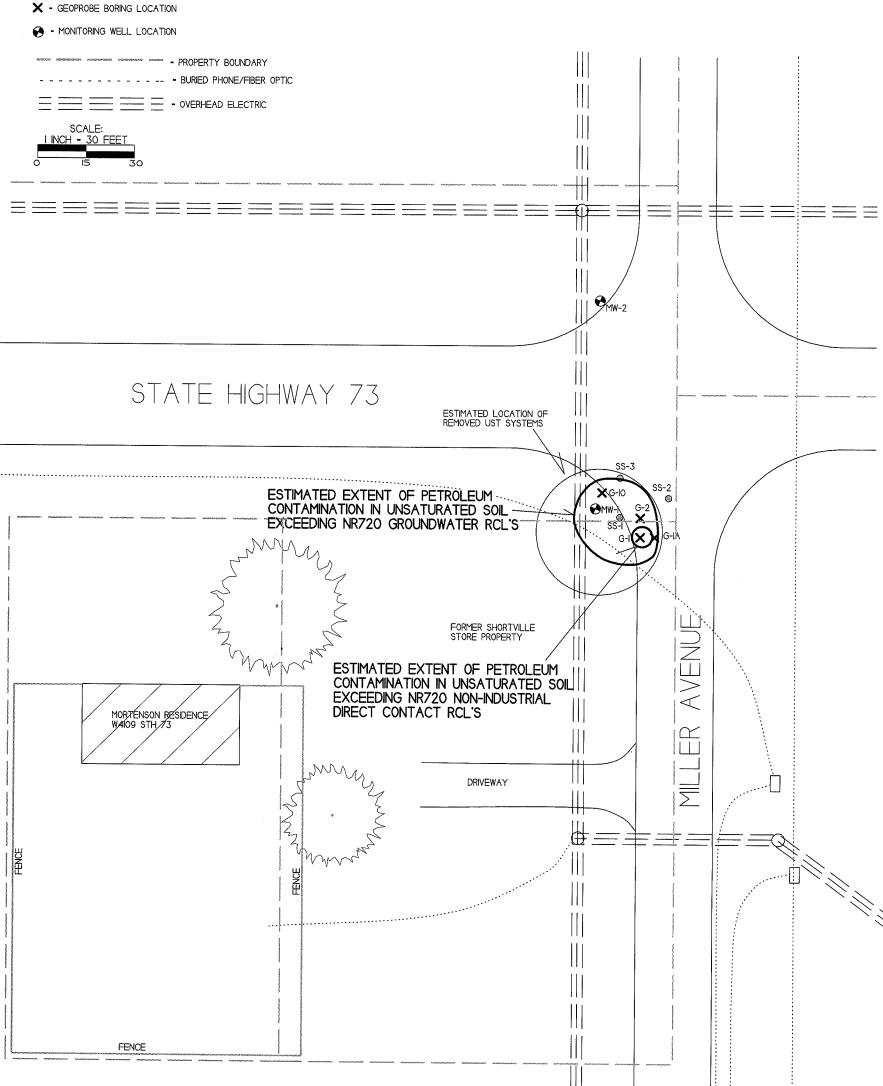
Residual Soil Contamination (ch. NR 718, chs. 500 to 536, Wis. Adm. Code or ch. 289, Wis. Stats.) Soil contamination remains as indicated on the attached map; 'B.2.b Residual Soil Contamination, 04/29/2014'. If soil in the specific locations described above is excavated in the future, the property owner or right-of-way holder at the time of excavation must sample and analyze the excavated soil to determine if contamination remains. If sampling confirms that contamination is present, the property owner or right-of-way holder at the time of excavation will need to determine whether the material is considered solid or hazardous waste and ensure that any storage, treatment or disposal is in compliance with applicable standards and rules. Contaminated soil may be managed in accordance with ch. NR 718, Wis. Adm. Code, with prior DNR approval. This continuing obligation also applies to the ROW holders for Miller Avenue.

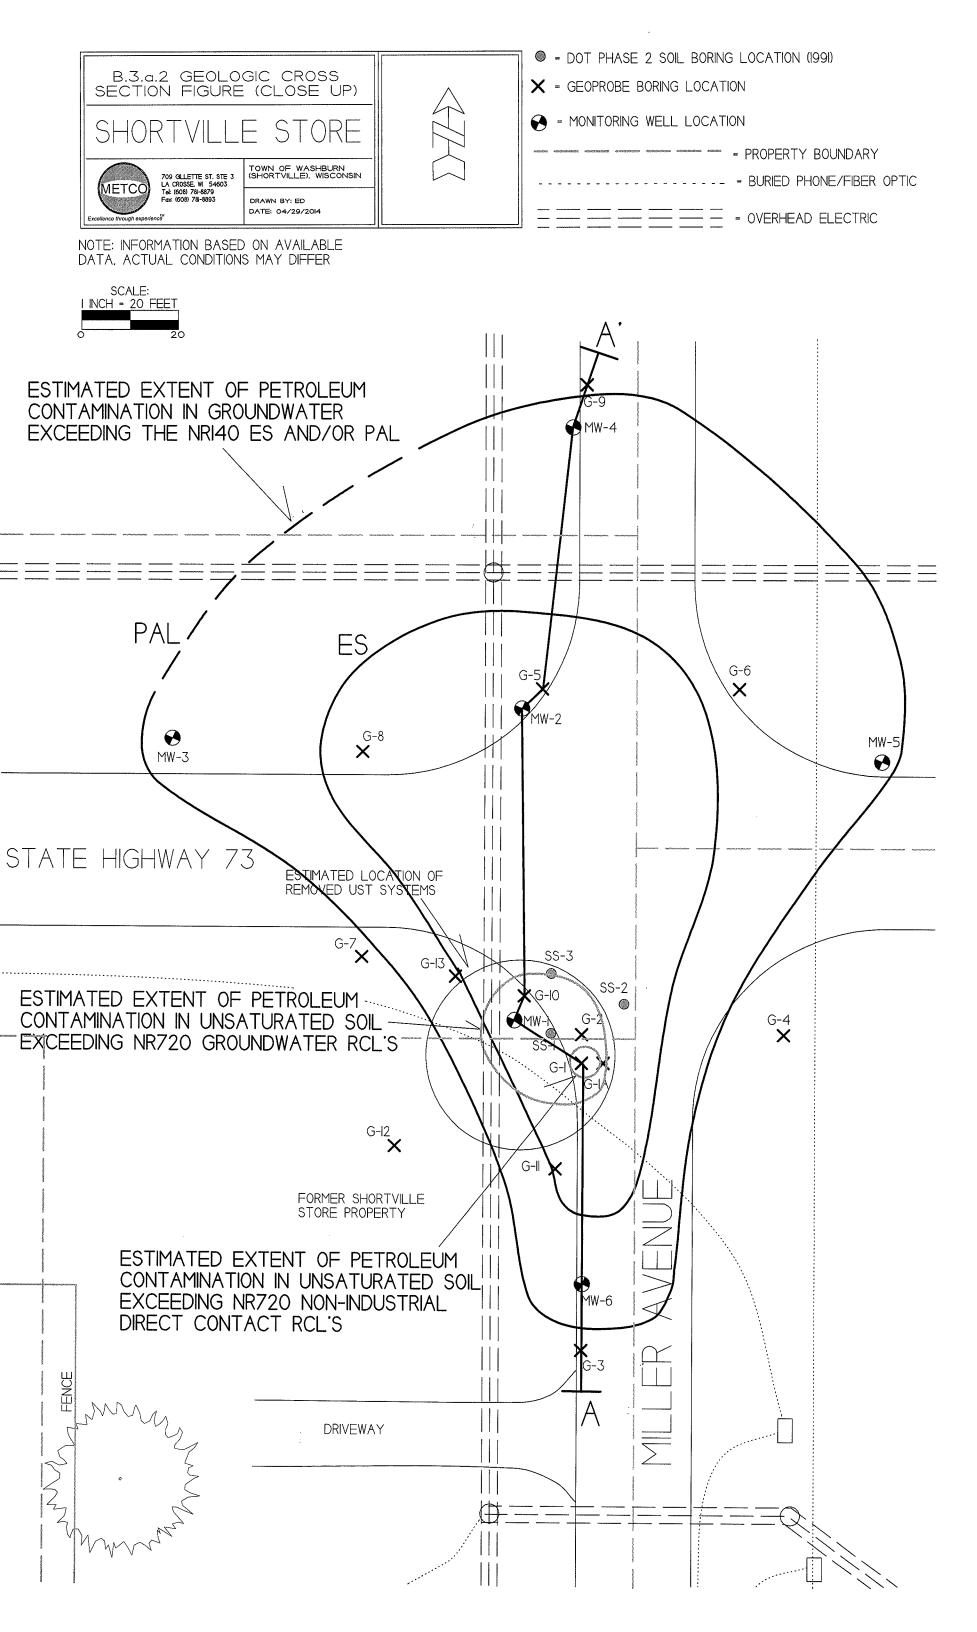
NOTE: SOIL RESULTS SHOW DETECTS AND EXCEEDANCES THAT HAVE BEEN DOCUMENTED ON THE MAP. SEE DATA TABLES AND/OR LABORATORY REPORTS FOR ALL RESULTS
