PHASE II½  
ENVIRONMENTAL ASSESSMENT  
FOR THE  
McGLYNN PROPERTY SITE  
STATE HIGHWAY 80  
UNINCORPORATED VILLAGE OF HUB CITY  
TOWN OF HENRIETTA  
RICHLAND COUNTY, WISCONSIN

MARCH 1992

PREPARED FOR THE  
WISCONSIN DEPARTMENT OF TRANSPORTATION  
PROJECT 5042-02-00

PREPARED BY  
ADVENT ENVIRONMENTAL SERVICES, INC.  
P.O. BOX 246  
PORT WASHINGTON, WISCONSIN 53074  
AESI PROJECT NO. 92500

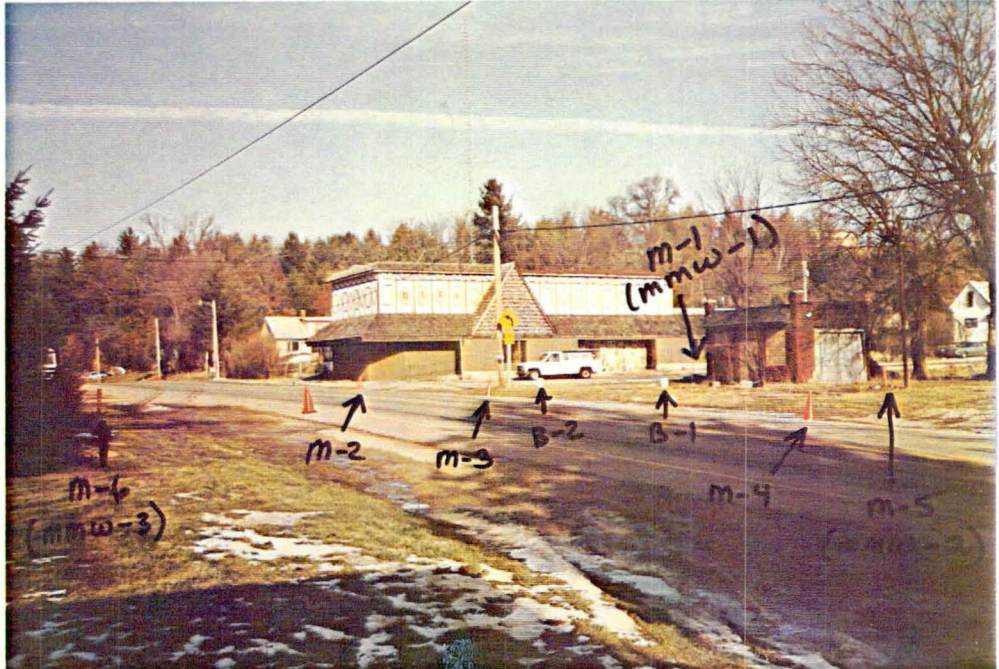
DESCRIPTION: The McGlynn Property showing the previous soil boring locations, the recent soil boring locations, and the monitoring well locations. State Highway 80 runs through the center of the photo and the white truck is parked on Mandt Street.
