SUBJECT: Final Case Closure with Continuing Obligations
Kopatz / Cronic Property, W8317 County Highway P, Town of Beaver, WI
DNR BRRTS Activity #: 03-38-231379
PECFA # 54114-7330-17A

B.1.a SITE LOCATION MAP CONTOUR INTERVAL 10 FEET
KOPATZ/CRONCE PROPERTY – BEAVER, WI
SEAMLESS USGS TOPOGRAPHIC MAPS ON CD-ROM

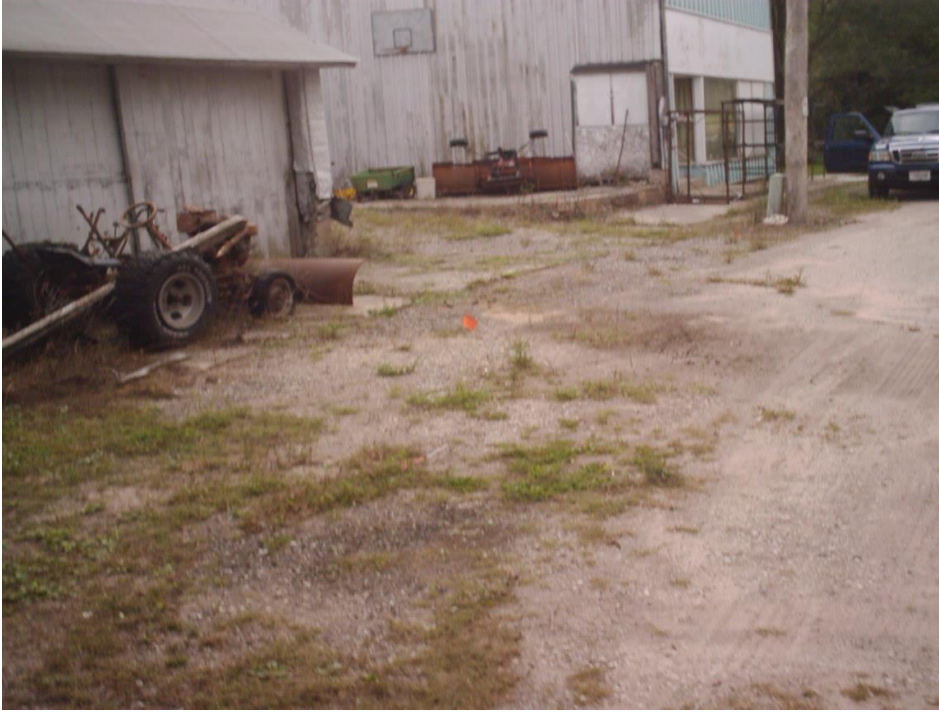
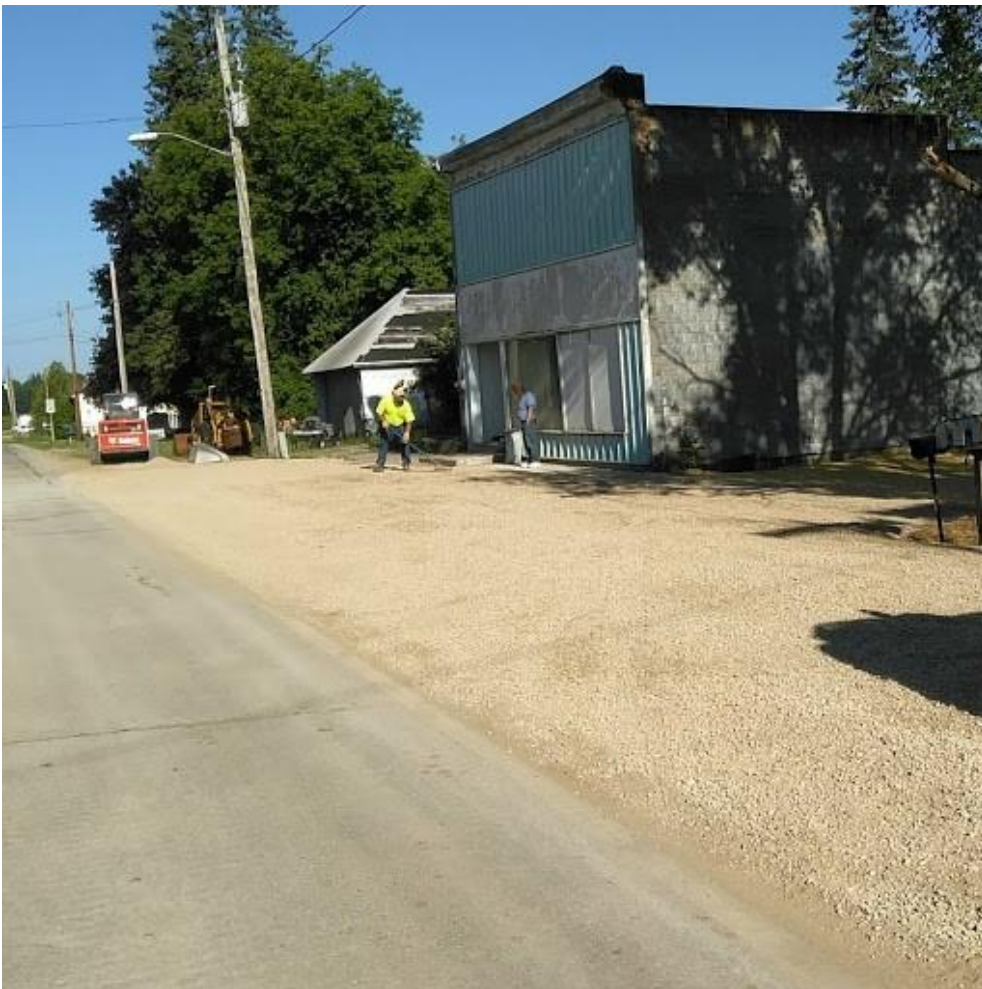
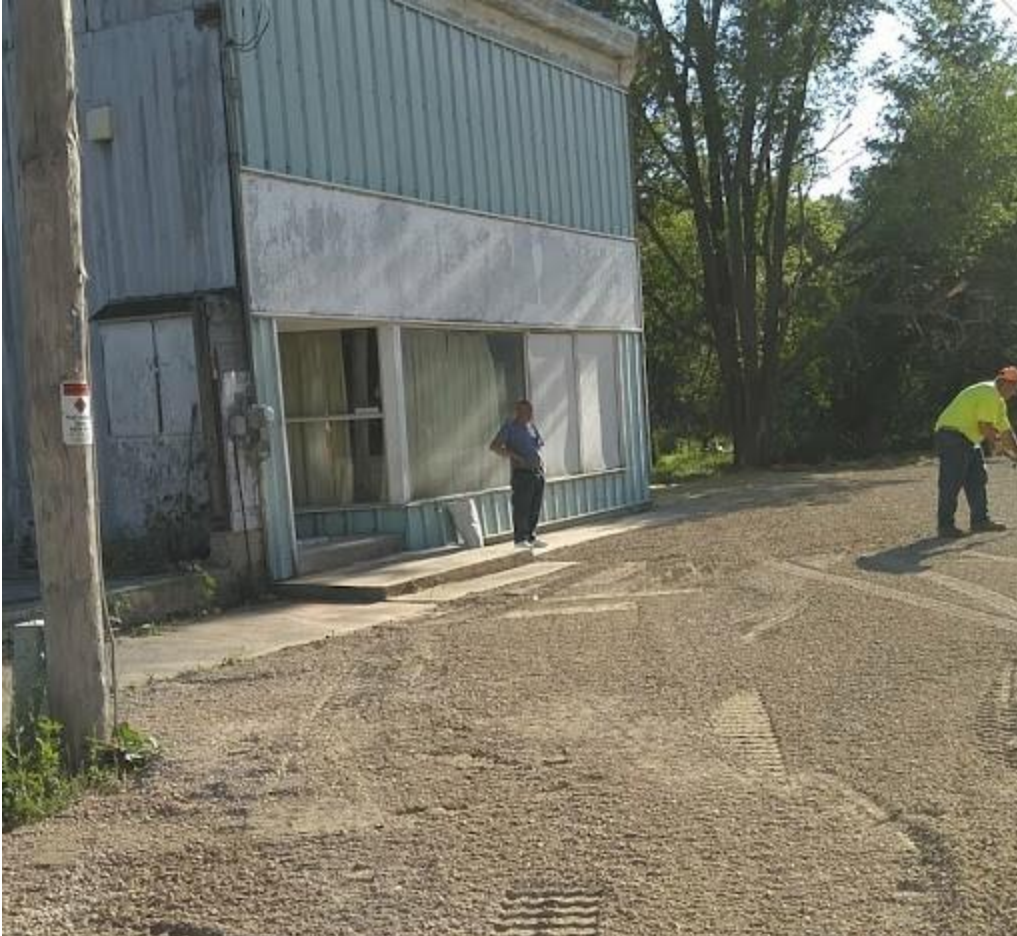
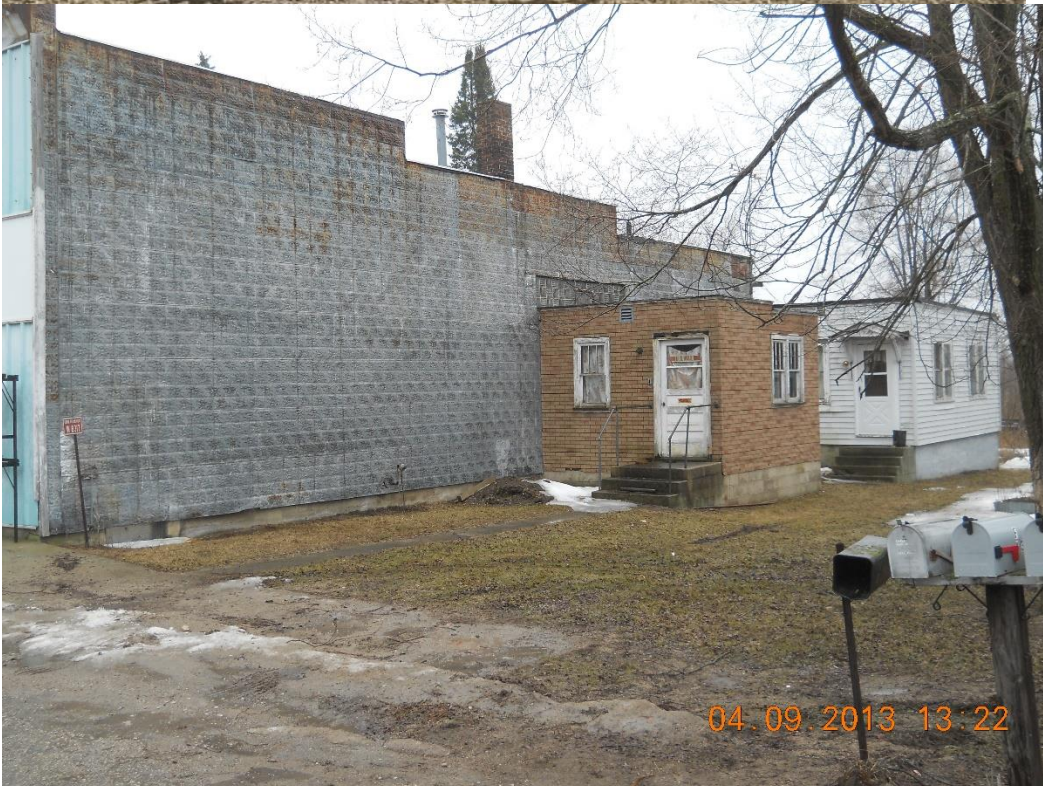
B.5 Structural Impediment Photos

Image looking southwest.

Image looking southeast.

Structural Impediments (s. 292.12 (2) (b), Wis. Stats., s. NR 726.15, s. NR 727.07, Wis. Adm. Code)
The remaining on-site building as shown on the attached map (Residual Soil Contamination, Figure B.2.b, August 29, 2019), made complete investigation and/or remediation of the soil contamination on this property impracticable. If the structural impediment is to be removed, the property owner shall notify the DNR at least 45 days before removal and conduct an investigation of the degree and extent of petroleum contamination below the structural impediment. If contamination is found at that time, the contamination shall be properly remediated in accordance with applicable statutes and rules.

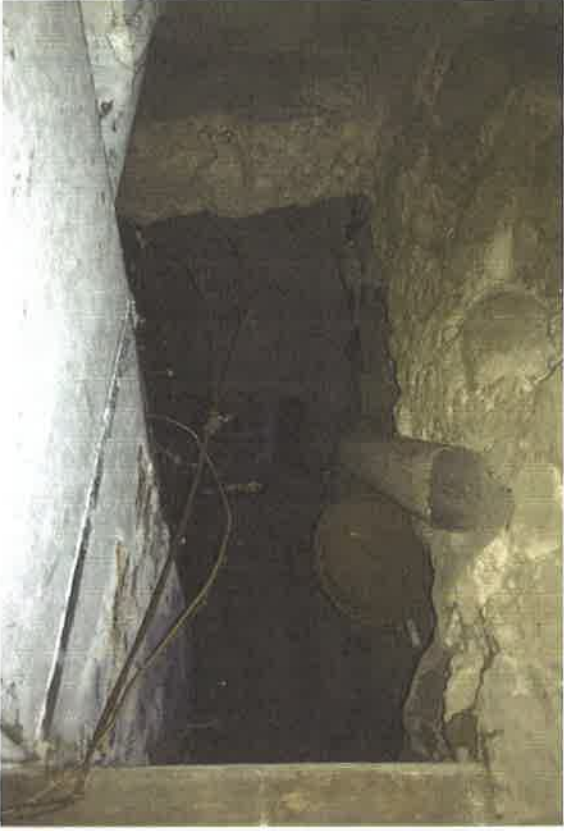
Crawl space under living room

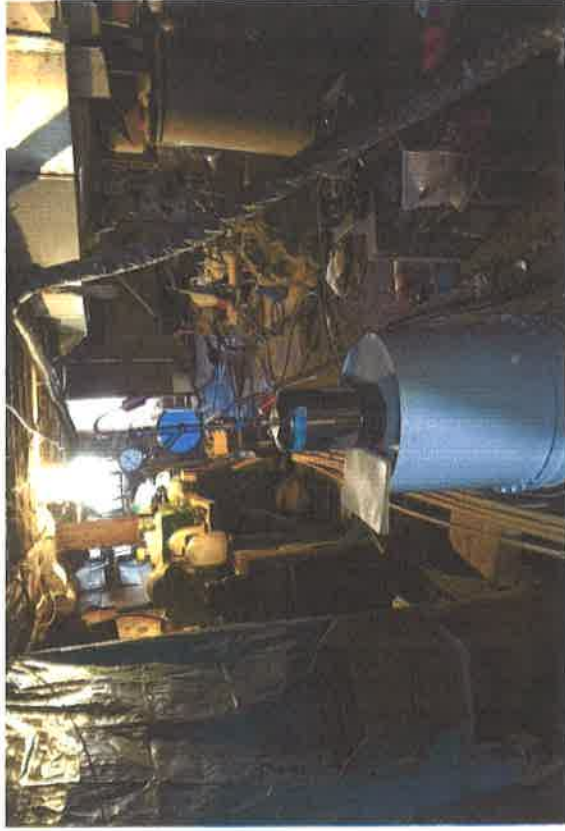
Ambient air sample in basement (AB-1)

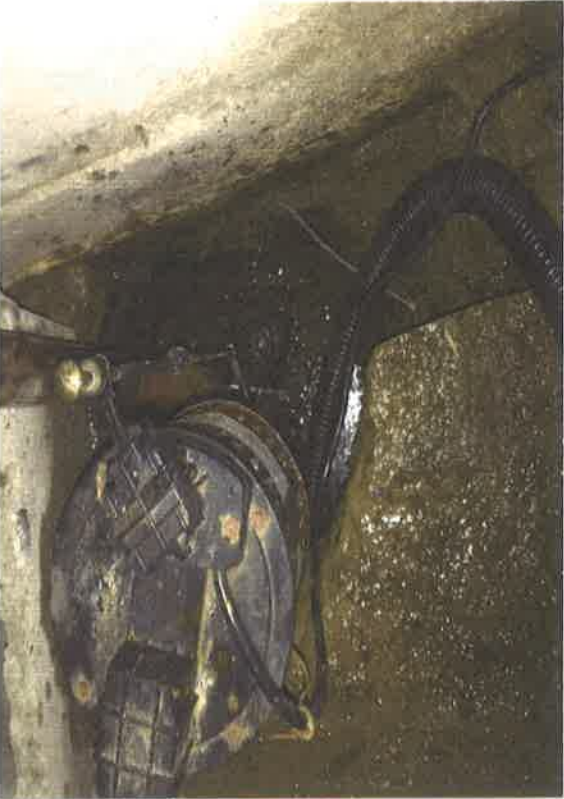
Sump pump/sump pit

On July 12, 2016, REI Engineering of Wausau, WI set up a seal over the sump in the Kopatz building basement. The sump was hand made through the concrete floor and adjacent to the basement wall. Due to the poor condition of the concrete floor in the area of the sump and that is was along the basement wall, sealing of the sump was difficult. However, it was sealed as well as possible using plastic sheeting and weighted objects. The seal was allowed to sit for 24 hours to equilibrate. (Letter Report - 1/9/2017).

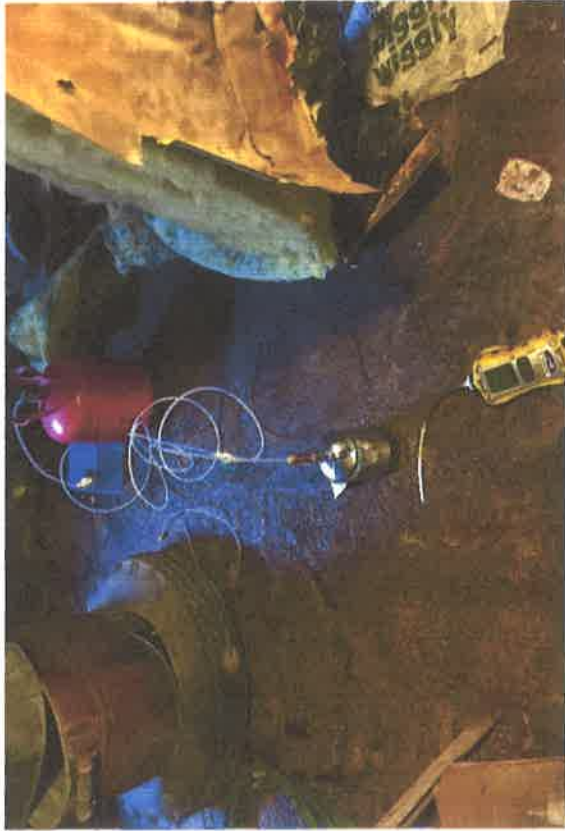
Sampling VP3

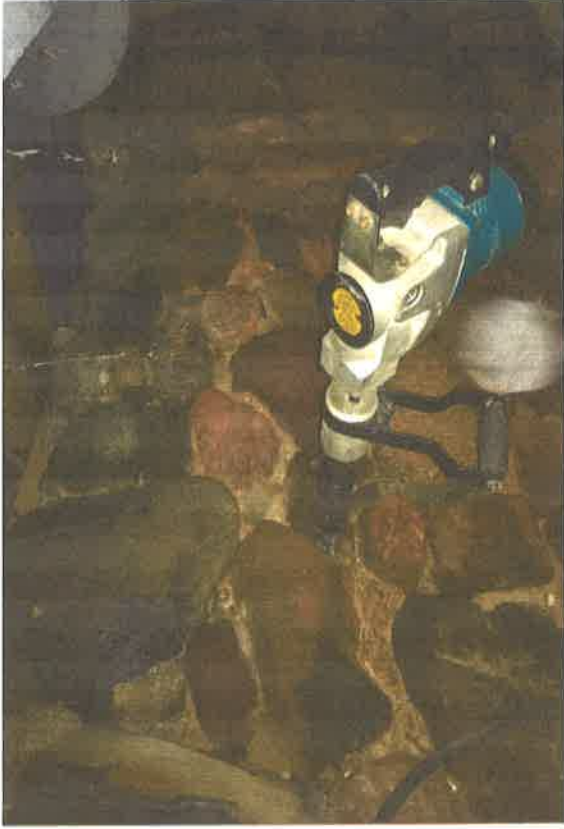
Drilling hole through north wall

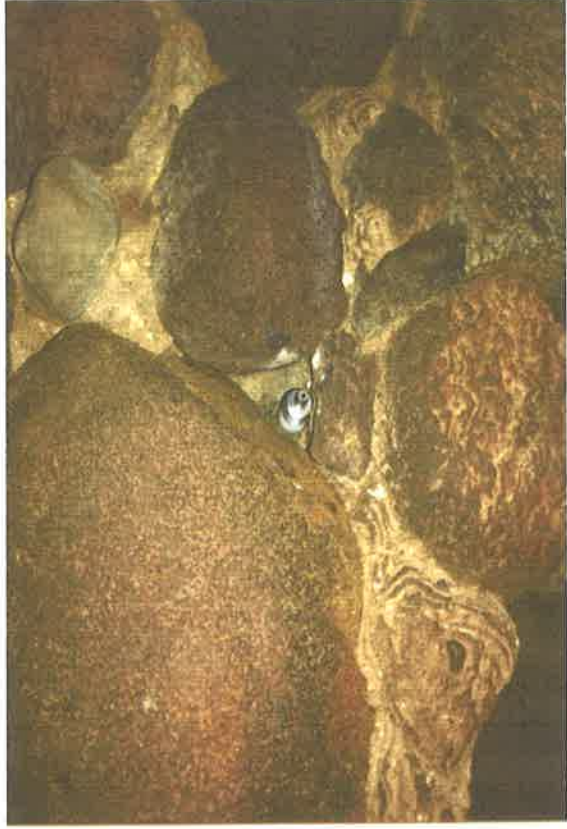
Vapor pin location

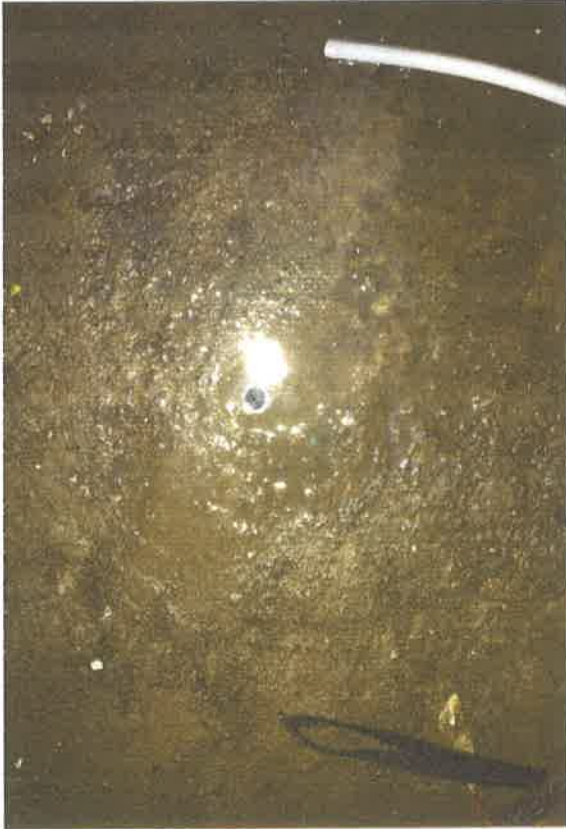
Water in VP2

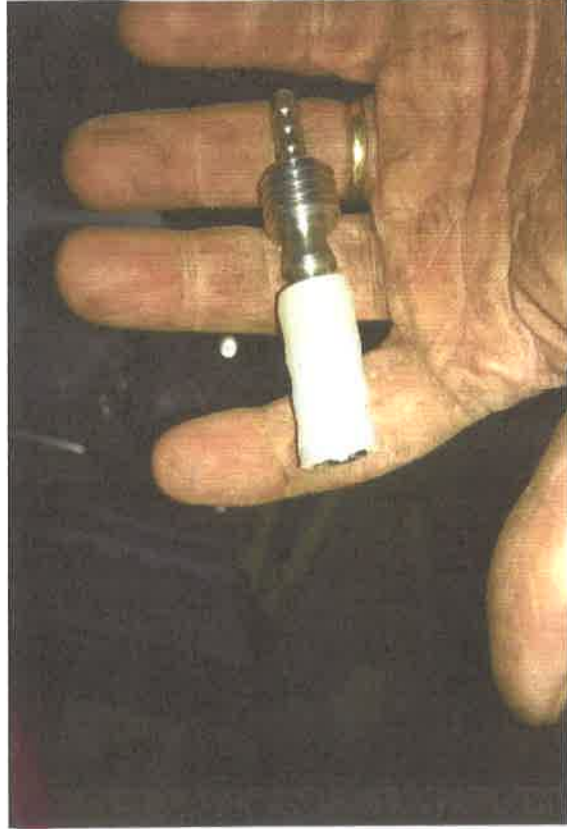
Vapor pin installed in north wall

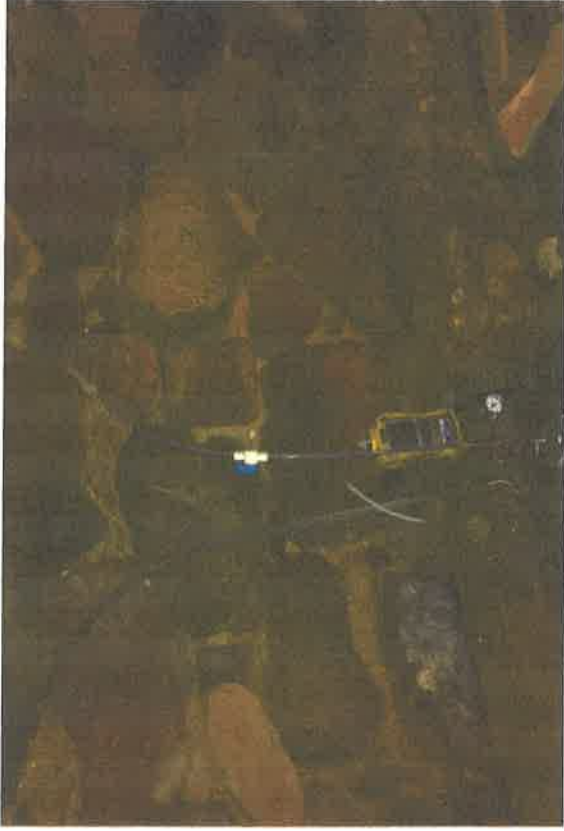
Sampling North Wall

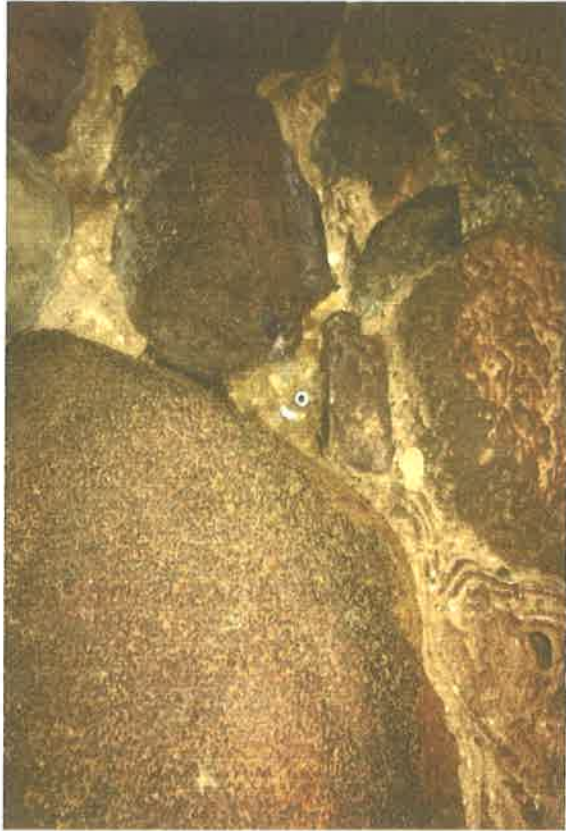
Vapor pin borehole sealed with wax
