February 10, 2020

SUBJECT: Final Case Closure with Continuing Obligations
Port Wing Automotive, 8950 State Highway 13, Port Wing, Wisconsin
DNR BRRTS Activity #03-04-234613
FID #804055120

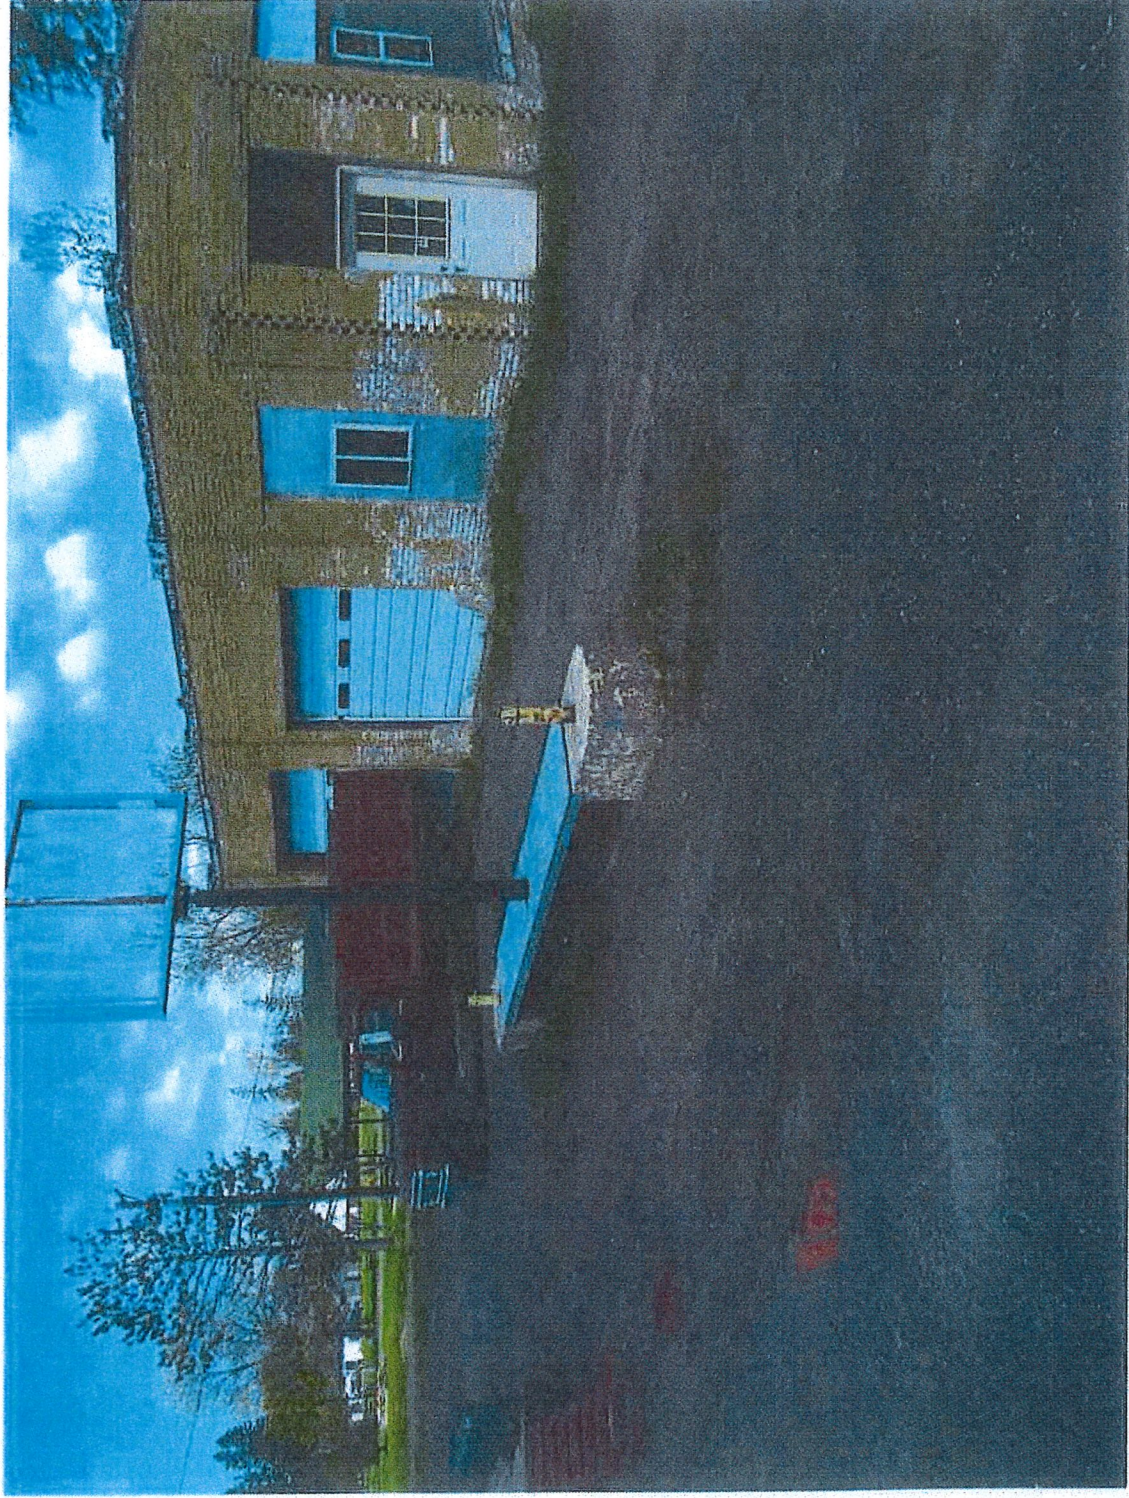
B.5 Structural Impediment Photos

The building as shown on Figure B.2.b Residual Soil Contamination and the attachment B.5 Structural Impediment Photos, prepared by METCO, made complete investigation and/or remediation of the soil contamination on this property impracticable. If the structural impediment is to be removed, the property owner shall notify the DNR at least 45 days before removal and conduct an investigation of the degree and extent of petroleum contamination below the structural impediment. If contamination is found at that time, the contamination shall be properly remediated in accordance with applicable statutes and rules.

Photo #1: On site building looking west.

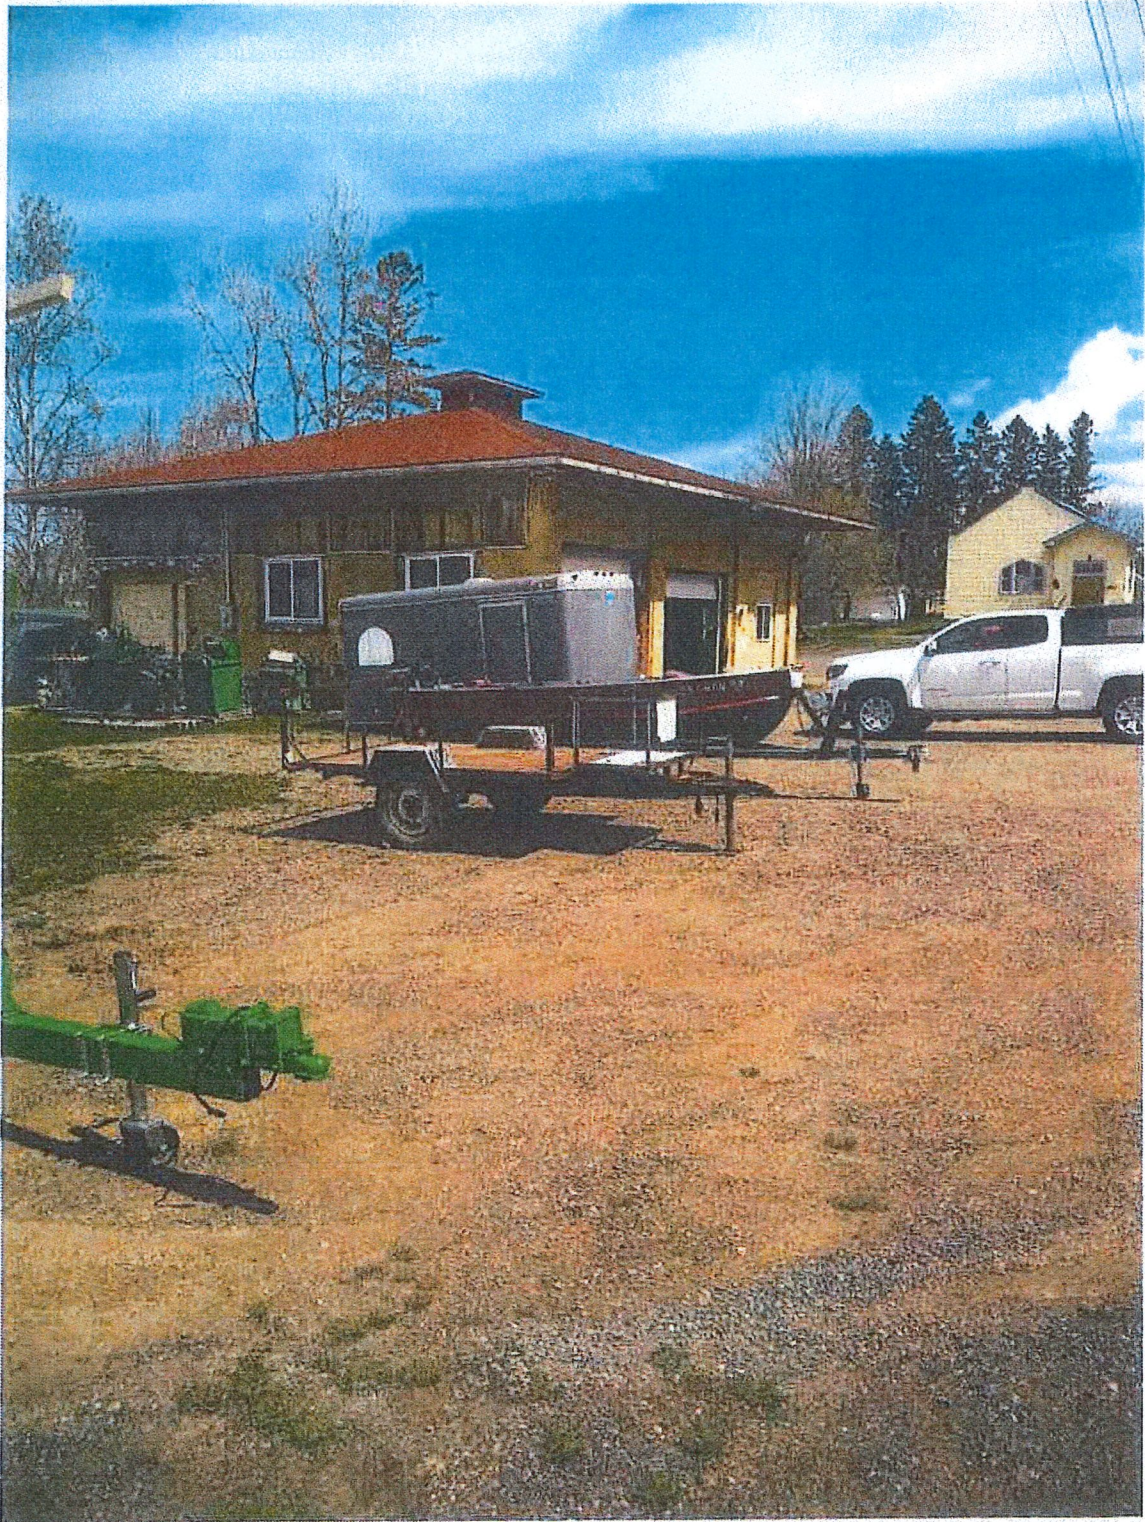
B.5 Structural Impediment Photos

Photo #2: On site building looking East.

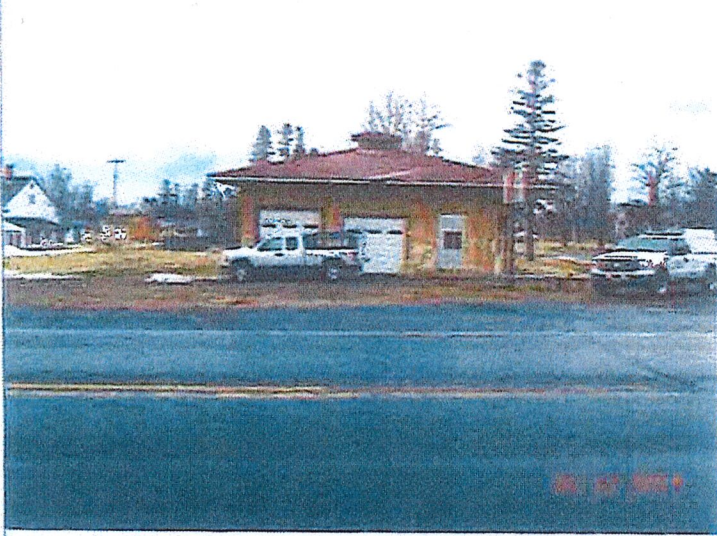
The building cap overlying the contaminated soil and as depicted in Attachment D.2 will be inspected once a year, normally in the spring after all snow and ice is gone, for deterioration, cracks and other potential problems that can cause exposure to underlying soils. The inspections will be performed by the property owner or their designated representative. The inspections will be performed to evaluate damage due to settling, exposure to the weather, wear from traffic, increasing age and other factors. Any area where soils have become or are likely to become exposed and where infiltration from the surface will not be effectively minimized will be documented.

Title: Photo 1#: Area of cap to be maintained (looking North)

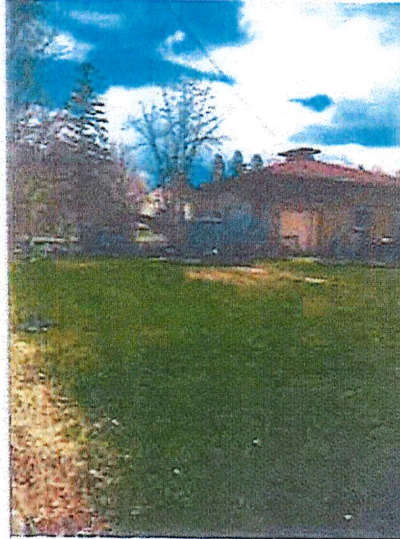
Title: Photo 2#: Area of cap to be maintained (looking South)

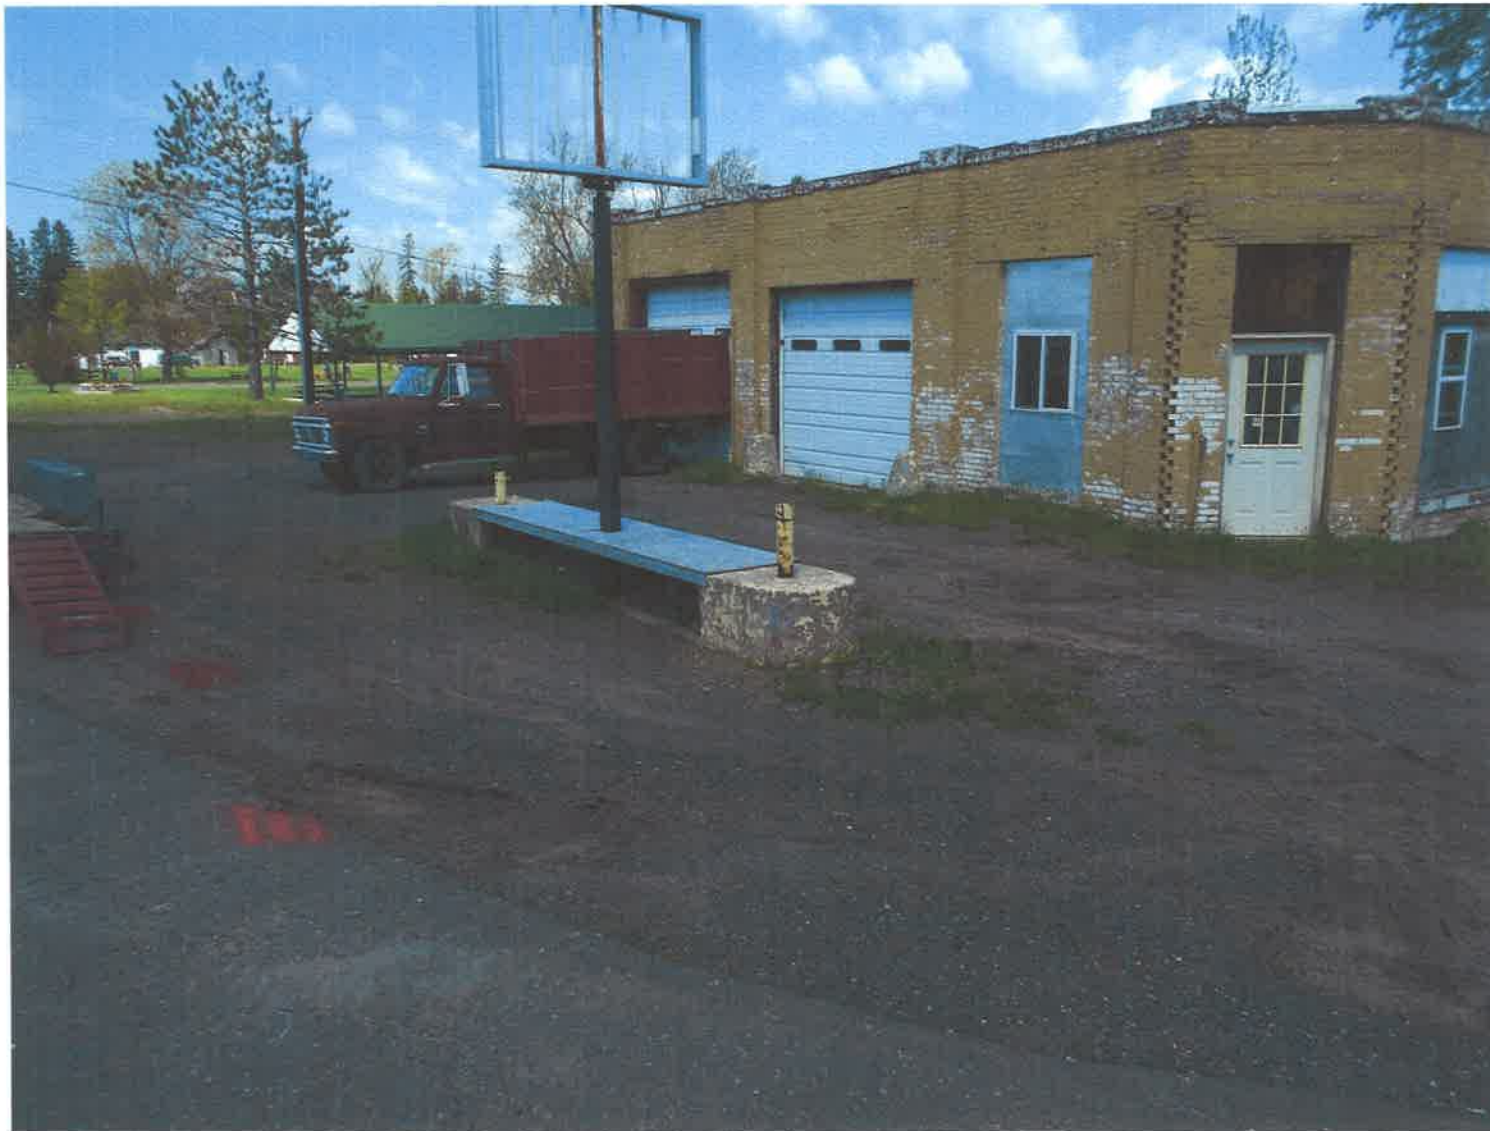
B.5 Structural Impediment Photos

Photo #1: On site building looking west.

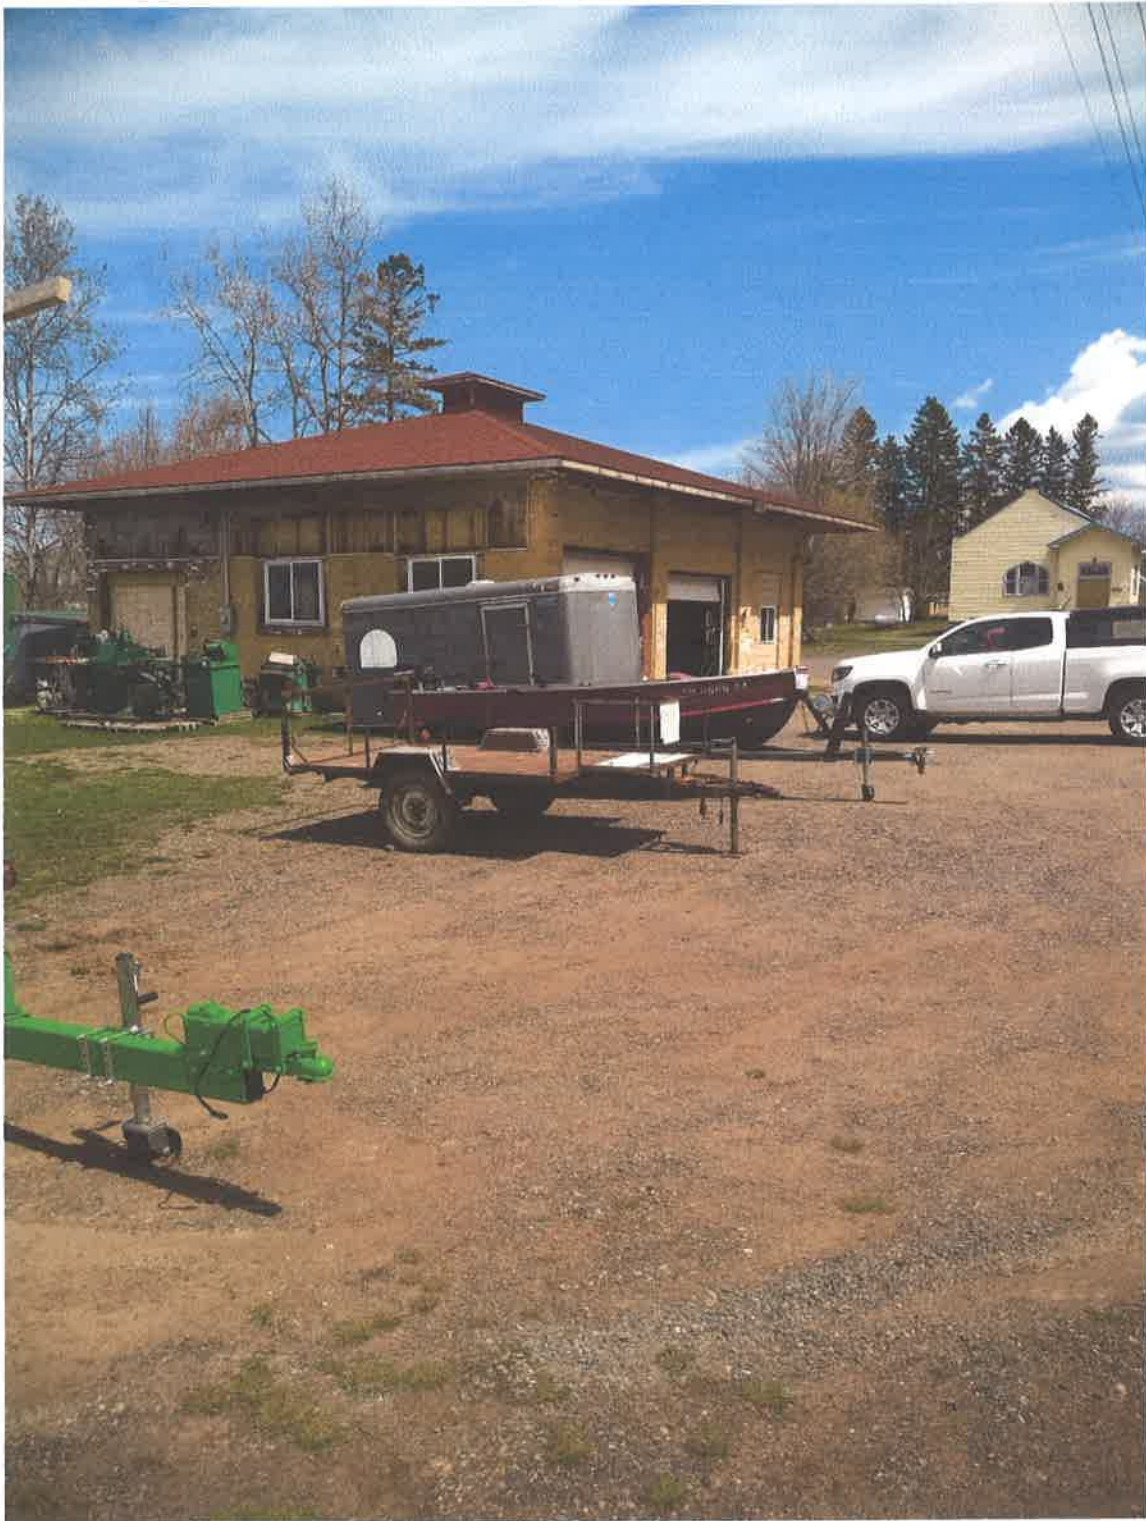
B.5 Structural Impediment Photos

Photo #2: On site building looking East.

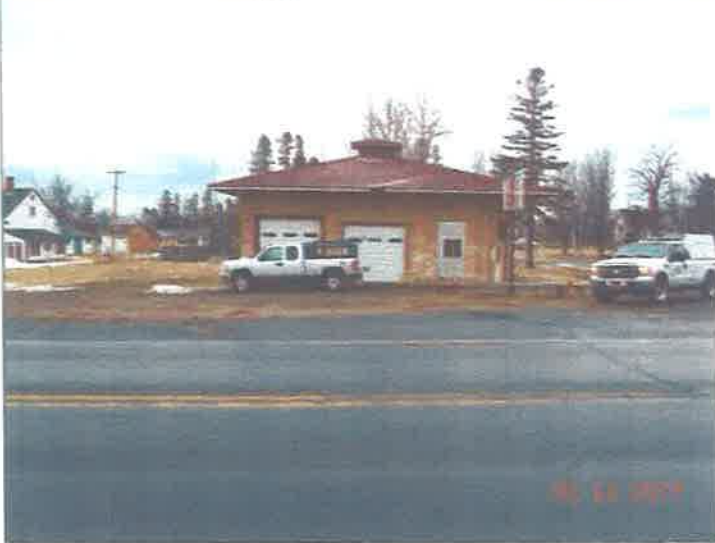
Title: Photo 1#: Area of cap to be maintained (looking North)

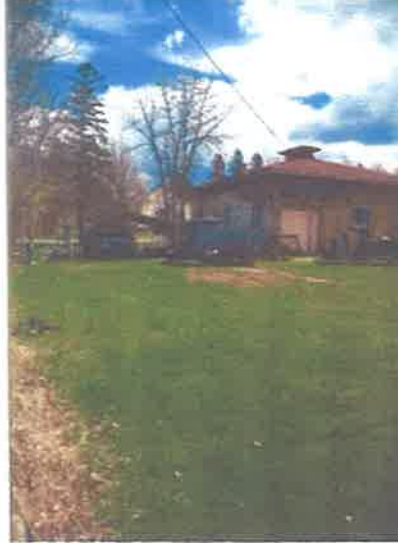
Title: Photo 2#: Area of cap to be maintained (looking South)
