**UNDERGROUND STORAGE TANK
ABANDONMENT
MILWAUKEE PLATING COMPANY
MILWAUKEE, WISCONSIN**

December 28, 1993

Project No.: 366115203

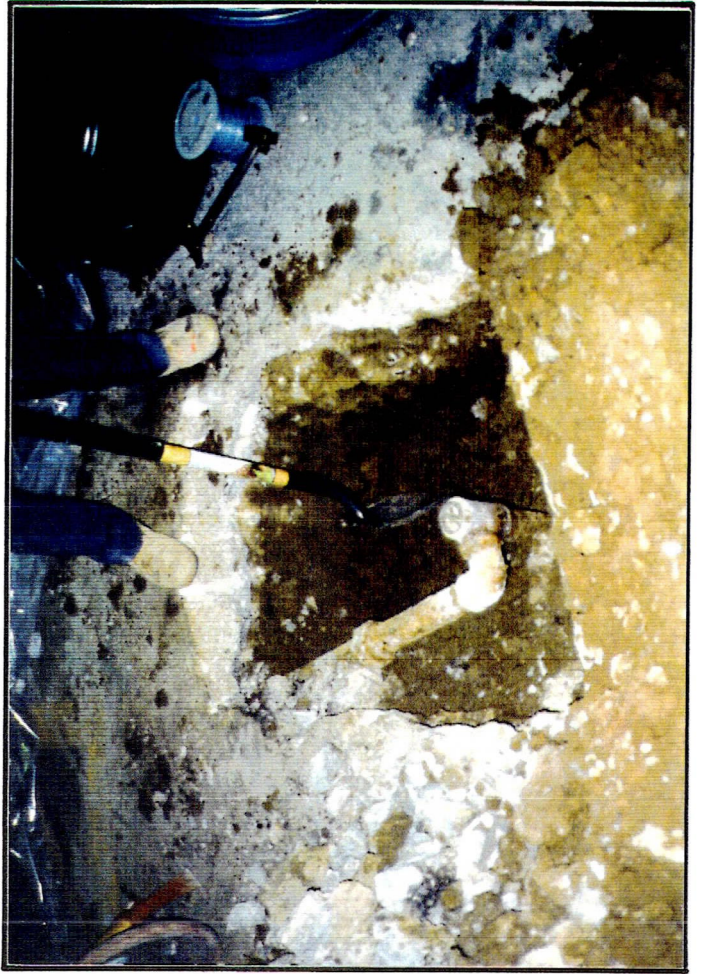
1

<u>Photo #</u>	<u>Description</u>
1.	Removal of concrete, facing east.
2.	Removal of silty clay soil above UST, facing east.
3.	Enclosure of working area with exhaust fan, facing east.

The concrete around the fill cap of the UST was broken using a jack hammer (see Photograph #1, Appendix A). Six inches of concrete was underlain by 2 feet of silty clay soil which covered the steel top of the UST. The silty clay fill was removed and stockpiled (Photograph #2). Two samples of this fill material were collected and analyzed for any volatile organic compounds (VOCs) present. This was accomplished using a headspace analysis utilizing the HNu Model PI-101 photoionization detector (PID) meter equipped with an 11.7 eV probe. All samples of soil were collected as they were removed from the soil outside to the UST. Each sample filled one-half of a 1-pint class jar which was covered with aluminum foil and secured with the cap ring. Soil samples were allowed to volatilize for a minimum of 30 minutes at room temperature (approximately 70°F). The probe was then inserted into the jar's headspace and the total VOCs present were shown on the PID

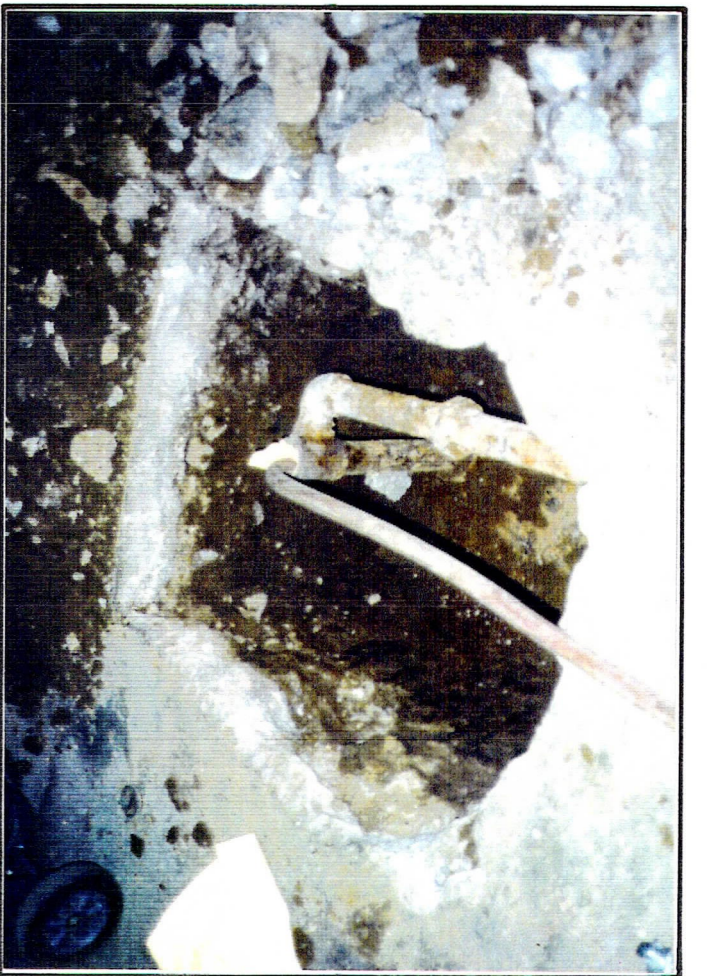
4

4.	Compressed air being pumped into UST, facing west.
5.	Compressed air being pumped into UST, facing east.
6.	Removal of UST top wall section, facing east

The working area was enclosed with plastic sheeting to capture UST vapors and dust (Photograph #3). Vapors from inside the UST were removed by inserting compressed air to displace the vapors out of the UST into an air removal unit which blew them out of an existing exhaust vent to the outside atmosphere (Photographs #4 and #5). When the atmosphere within the tank was reduced to 7% of the lower explosive limit (LEL), removal of a section of the steel UST tank top surface was initiated. The fill pipe was cut off and the top section of the UST was removed (Photographs #8, #9, and #10). Compressed air was also pumped into the UST during cleaning procedures in order to keep the atmosphere below 10% of the LEL (Photograph #11).

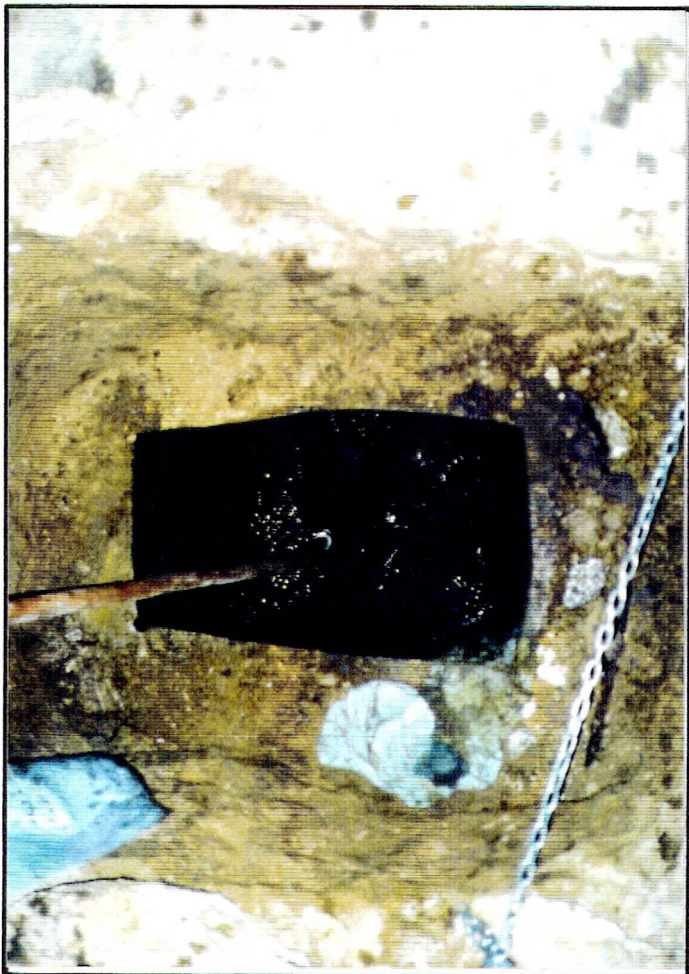
11

11.	Compressed air pumped into UST, facing east.
12.	Saturated sand from UST bottom.
13.	Liquid seeping into UST near bottom, facing north.
14.	Liquid seeping into UST near bottom, facing north.

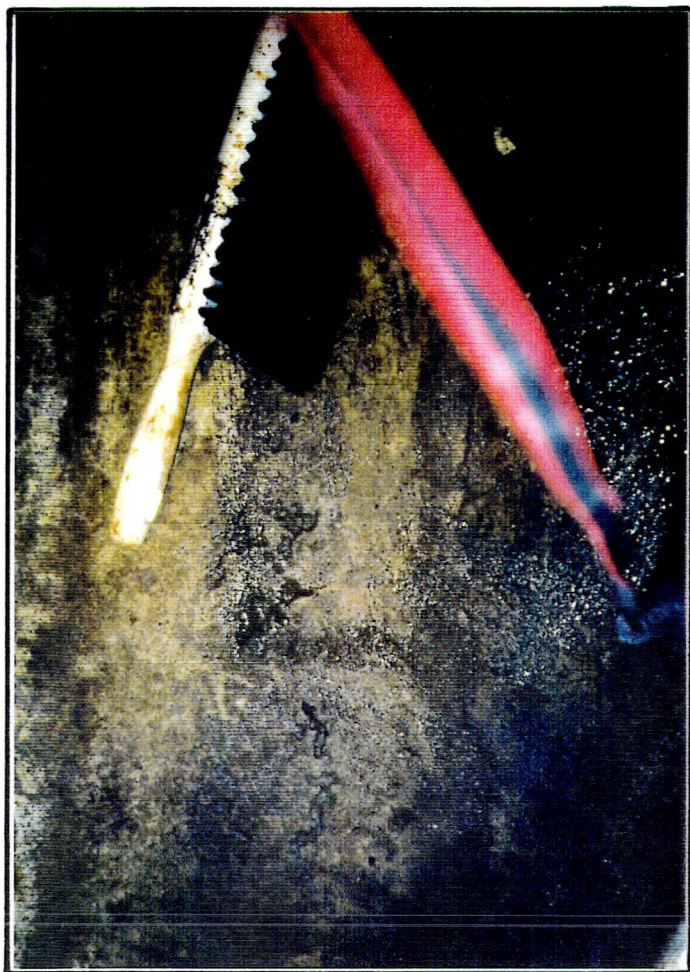
←
13

After the tank had been cleaned, liquid was observed seeping into the tank through a rusty portion in the tank bottom (Photographs #13 and #14). As about 8 inches of liquid was

originally present in the tank, it is assumed that the ground-water surface was approximately 8 inches above the bottom of the UST.

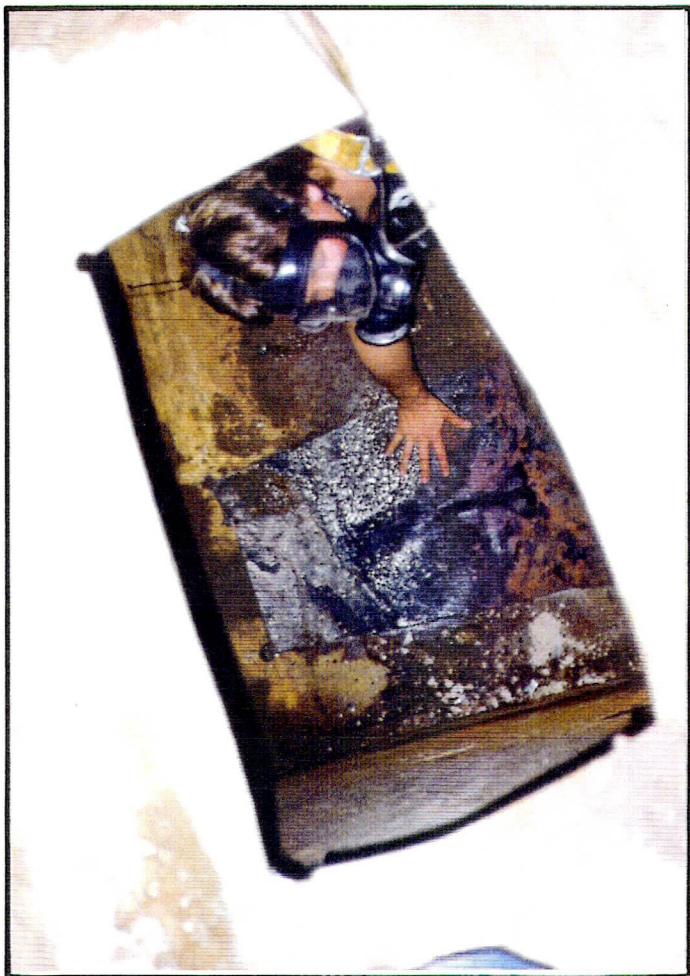
←
15

15.	Section of UST bottom wall removed, facing north.
16.	Rust holes in bottom section removed from UST.
17.	Sample and sump bottom location, west end of UST visible on left.

On November 2, 1993 following approval by the city inspector to abandon the UST in-place, a section of the steel was cut out of the bottom of the UST directly below the top opening (Photograph #15). When this section of the tank bottom was removed, several holes due to corrosion were observed (Photograph #16). An access hole was also drilled into the north wall of the UST and a soil sample was collected in the same manner as the samples collected from each end.

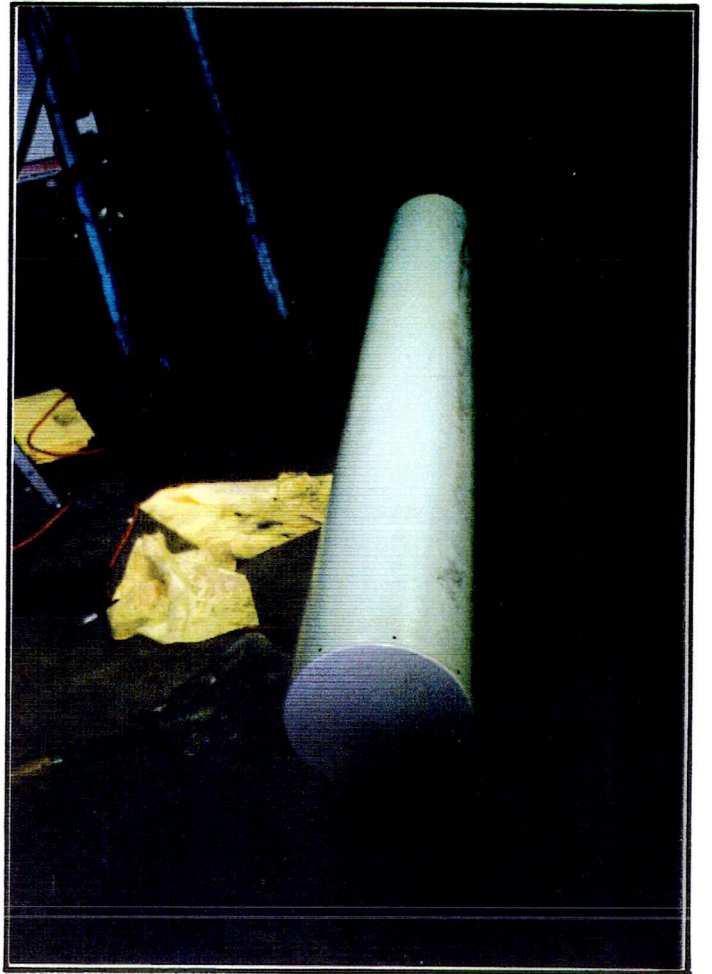
→
18

18.	Eight-foot length of PVC sump with screen and bottom piece.
19.	Backfilling UST with sand, facing east.
20.	Protective steel flush-mount installed.

An 8-foot length of 1.05-foot outside diameter, 0.98-foot inside diameter, schedule 80 polyvinylchloride (PVC) pipe with a 3-foot long factory cut 0.010-inch screen section (Photograph #18) was placed into the sump below the UST. The top of the PVC pipe was 2 inches below the concrete floor surface. Clean concrete that was removed to gain entry to the UST was placed in the eastern half of the tank bottom. Sand was then brought in to backfill the UST (Photograph #19). A flush-mount steel protective top was installed over the PVC sump and concrete was used to complete the floor repair and sump installation. (Photograph #20). Pipes leading to the tank from the east wall of the facility were cut and filled with hydrocarbon absorption towels or concrete.
