ENVIRONMENTAL ASSESSMENT

FOR THOMAS ABANDONED

SERVICE STATION

STATE T.H. 77 IRON COUNTY WDOT PROJECT ID 9250-09-00

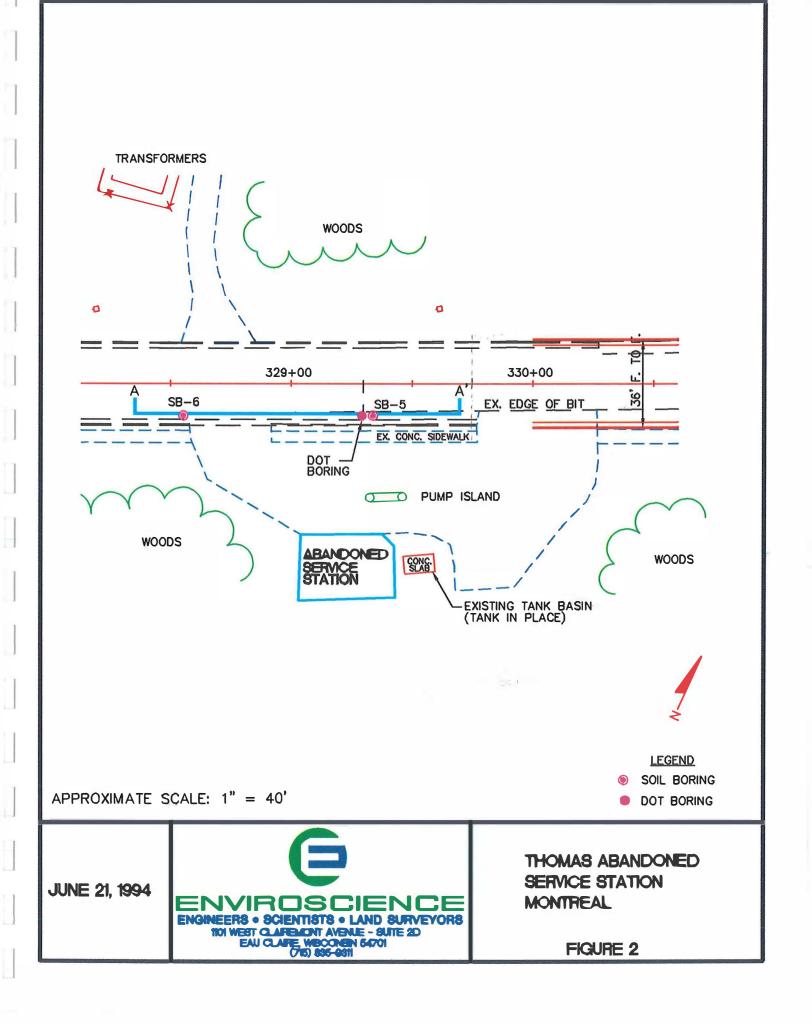
The Thomas site is located approximately 2 tenths of one mile north of the Montreal City Hall on STH 77 in the NW 1/4 SW1/4, Sec. 27, T 46N R2E, City of Montreal, Iron County, Wisconsin . The site is owned by Mr. Bill Thomas of 24 Nimikon, Gile, WI, (715) 561-5314. The site consists of one building, a single story service station with two service bays. The sites is not presently being use. The north side of the site is bounded by STH 77 and the adjacent properties to the east and west are undeveloped woods. The Montreal River runs along the south side of the property. The site is illustrated in Figure 2-2.

Two soil borings (SB-5 and SB-6) were advanced using a hollow stem auger drill rig and one sample from each boring was collected using split-spoon samplers and one duplicate sample was also taken (See Appendix D). Boring locations are illustrated in Figure 2-2.

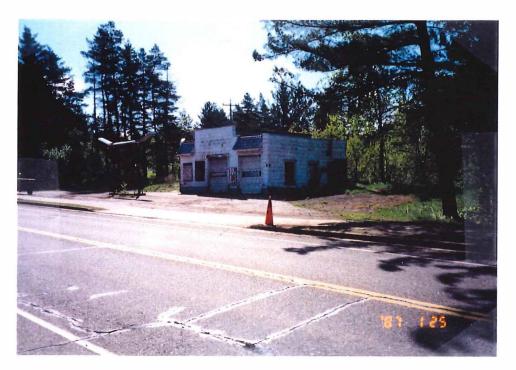
DESCRIPTION: The orange cone designates SB-6 located in the boulevard portion of sidewalk.

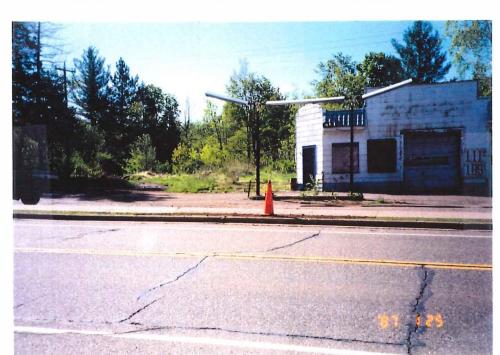
Laboratory analysis revealed DRO concentration of 100 ppm at a depth of 2.5 to 4.5 feet (bg) in soil boring SB-5. This level of contamination exceeds the 10 ppm WDNR remedial action guideline for petroleum impacted soils. Additionally a concentration of 1.7 ppm GRO was encountered in boring SB-5, but this level is below the remedial action guideline. Soil boring SB-6 showed a detection of DRO contamination of 9.4 ppm at the 5.0 to 7.0-feet (bg). This level is above background but below the remedial action limit.

DESCRIPTION: The orange cone designates SB-5 located in the boulevard portion of the sidewalk.

Based on the results of this investigation, Enviroscience recommends additional investigation of soil contamination in the anticipated construction zone (surface to five feet) within the WDOT right-of-way at this site. It should be noted that a 100 ppm level of DRO was identified in the 2.5 to 4.5-foot zone of SB-5. The
