SUBJECT: Final Case Closure with Continuing Obligations

Hunter's Corner Store, 108 S Sechlerville Rd, Hixton, WI

DNR BRRTS Activity #: 03-27-000811

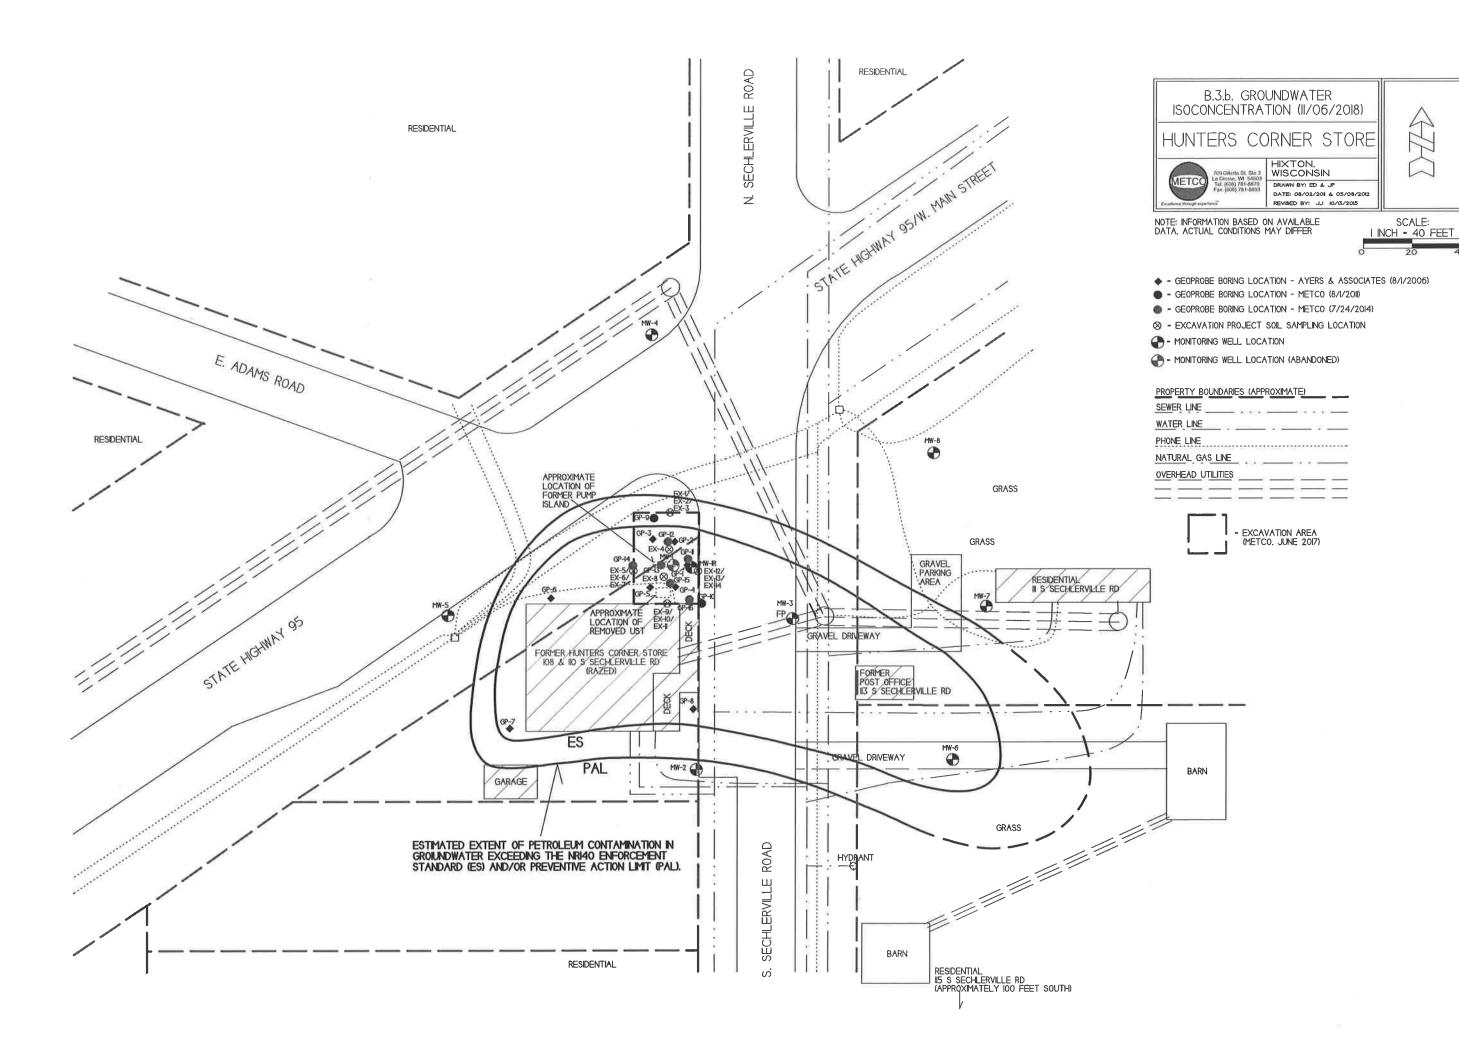
- Figure B.3.b, Residual Groundwater Contamination (11/06/2018)
- Figure B.2.b, Residual Soil Contamination

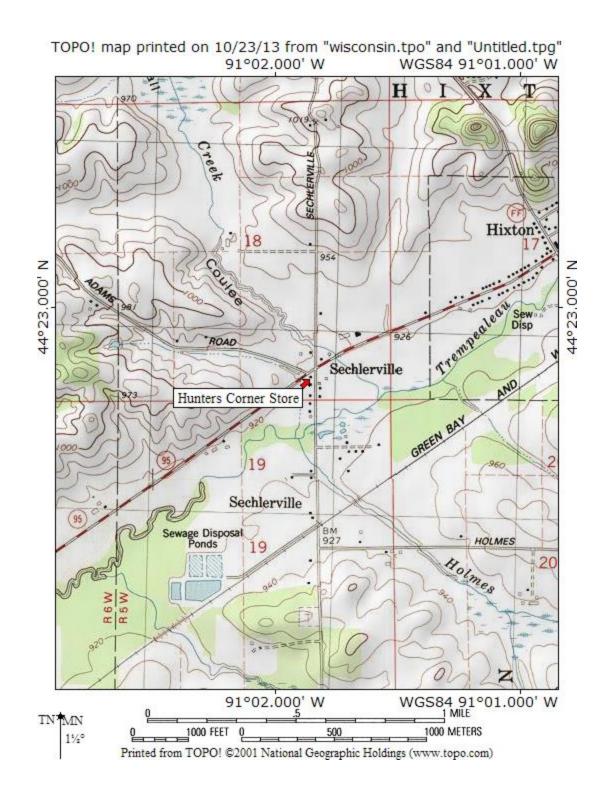
Figure B.1.a LOCATION MAP

CONTOUR INTERVAL 20 FEET

HUNTERS CORNER STORE – HIXTON, WI
