Subject: Trent Tube Plant 1 Group A Closure Application Form 4400-202 and Attachments

Trent Tube Plant No. 1 2188 Church St., East Troy, Wisconsin
FID # 265097030; BRRTS NO. 02-65-245827; U.S. EPA ID WID 006097281

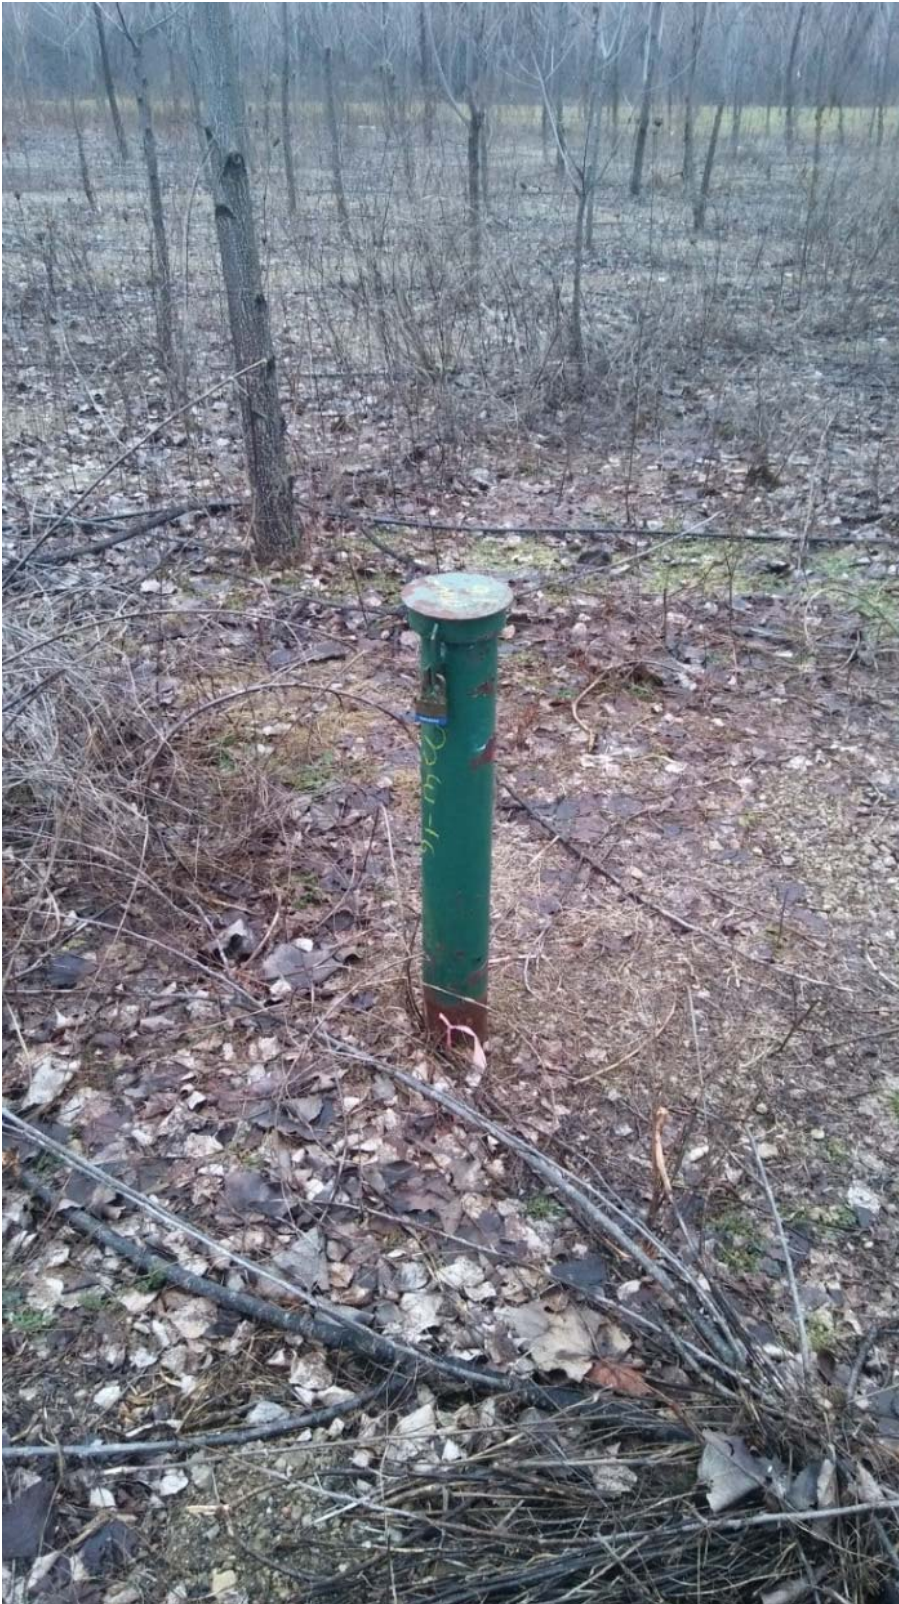
Trent Tube Plant 1 Group A Monitoring Well MW-16 – Photograph taken 1/17/17

The locations of these wells are shown in the location map provided under D.2 of this Plan. Photographs of each well are shown in Section D.3 of this Maintenance Plan. Each of the retained monitoring wells is equipped with a well seal and lock as shown in the photographs. In addition, the entire Trent Tube Plant 1 site is surrounded by a fence which has a locked gate deterring unauthorized access. The surface condition of each well for continued groundwater sampling operations is adequate.

Construction diagrams of the monitoring wells in Group A are not available, but surface seals are likely concrete grout or bentonite. The wells do not have apparent damage/degradation of the surface seal.

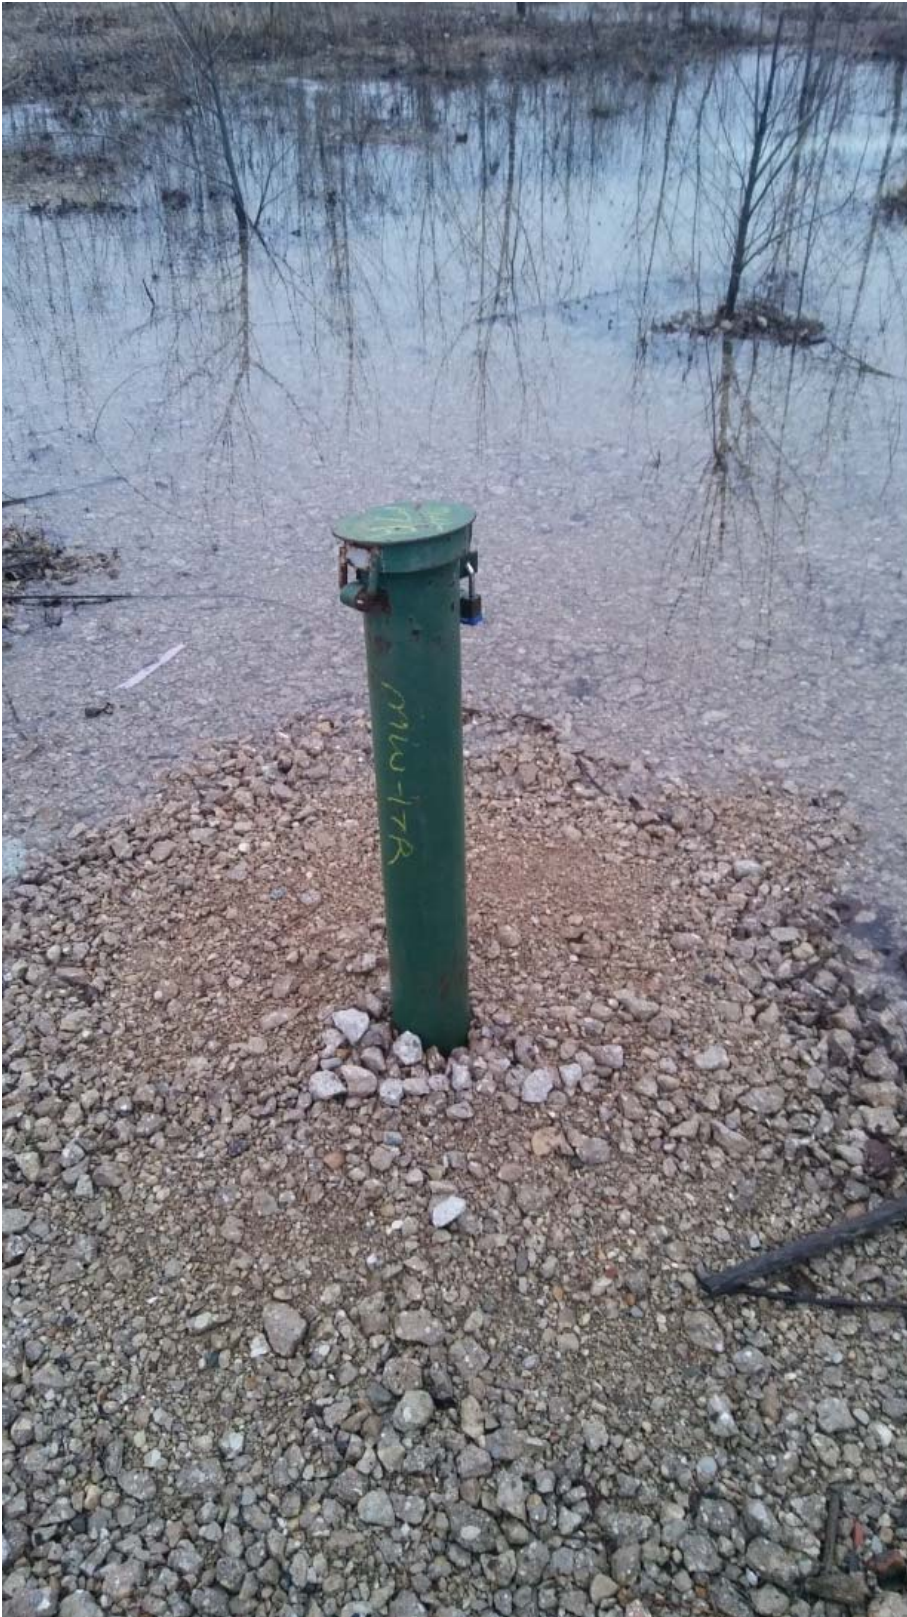
Trent Tube Plant 1 Group A Monitoring Well MW-17R – Photograph taken 1/17/17

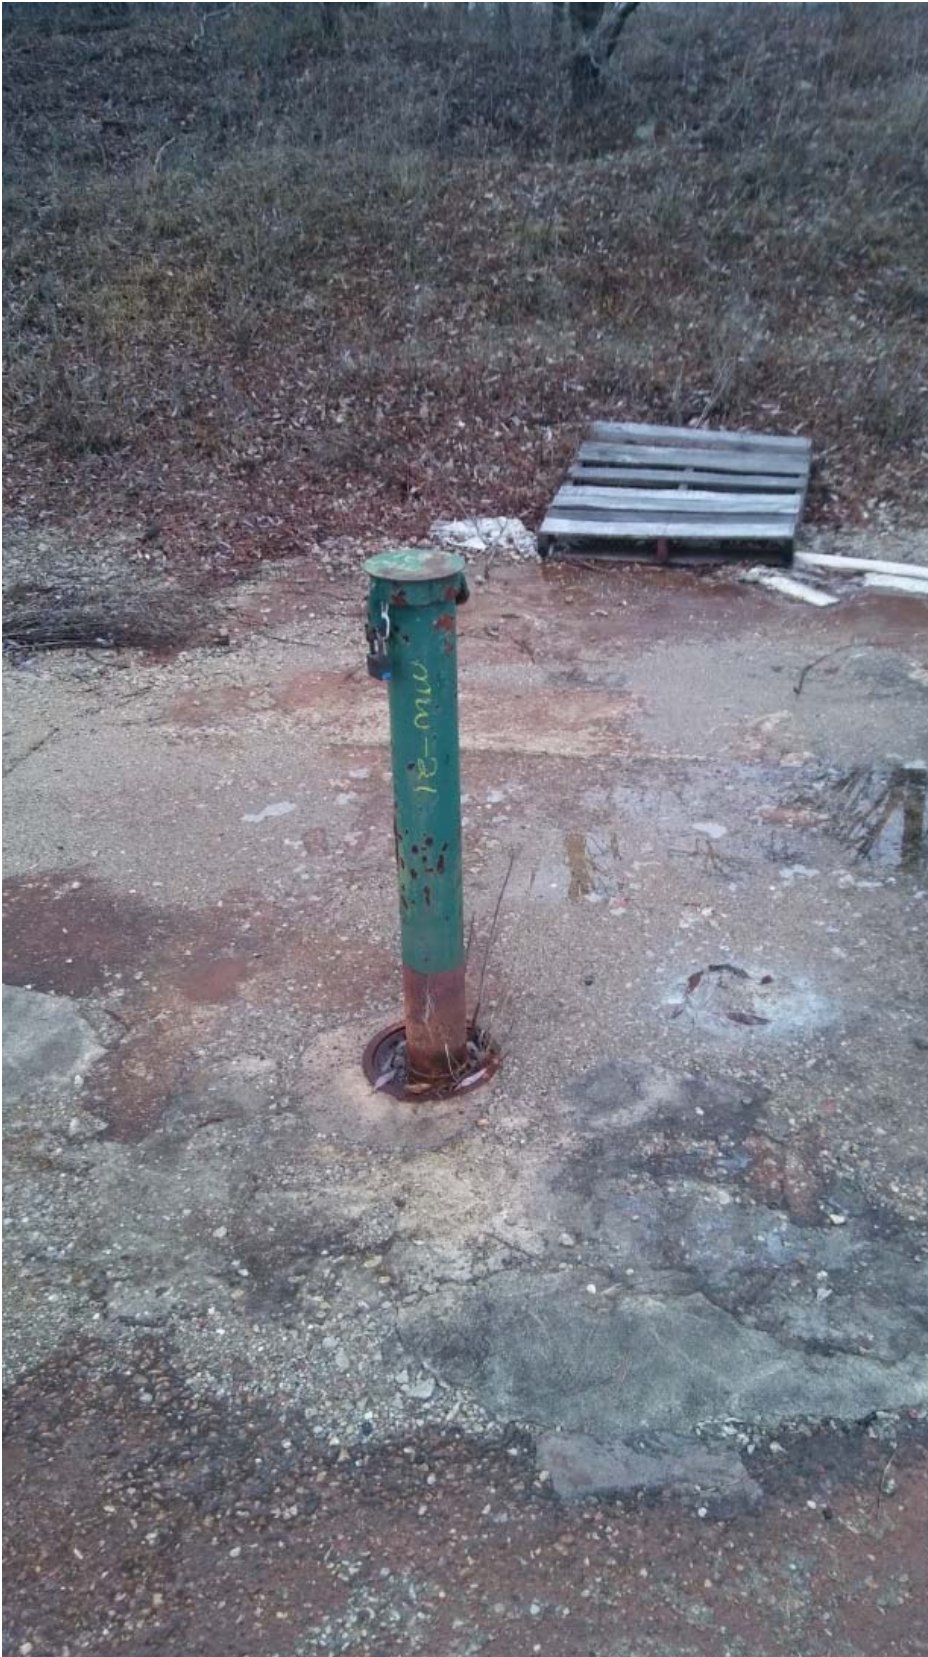
Trent Tube Plant 1 Group A Monitoring Well MW-21 – Photograph taken 1/17/17

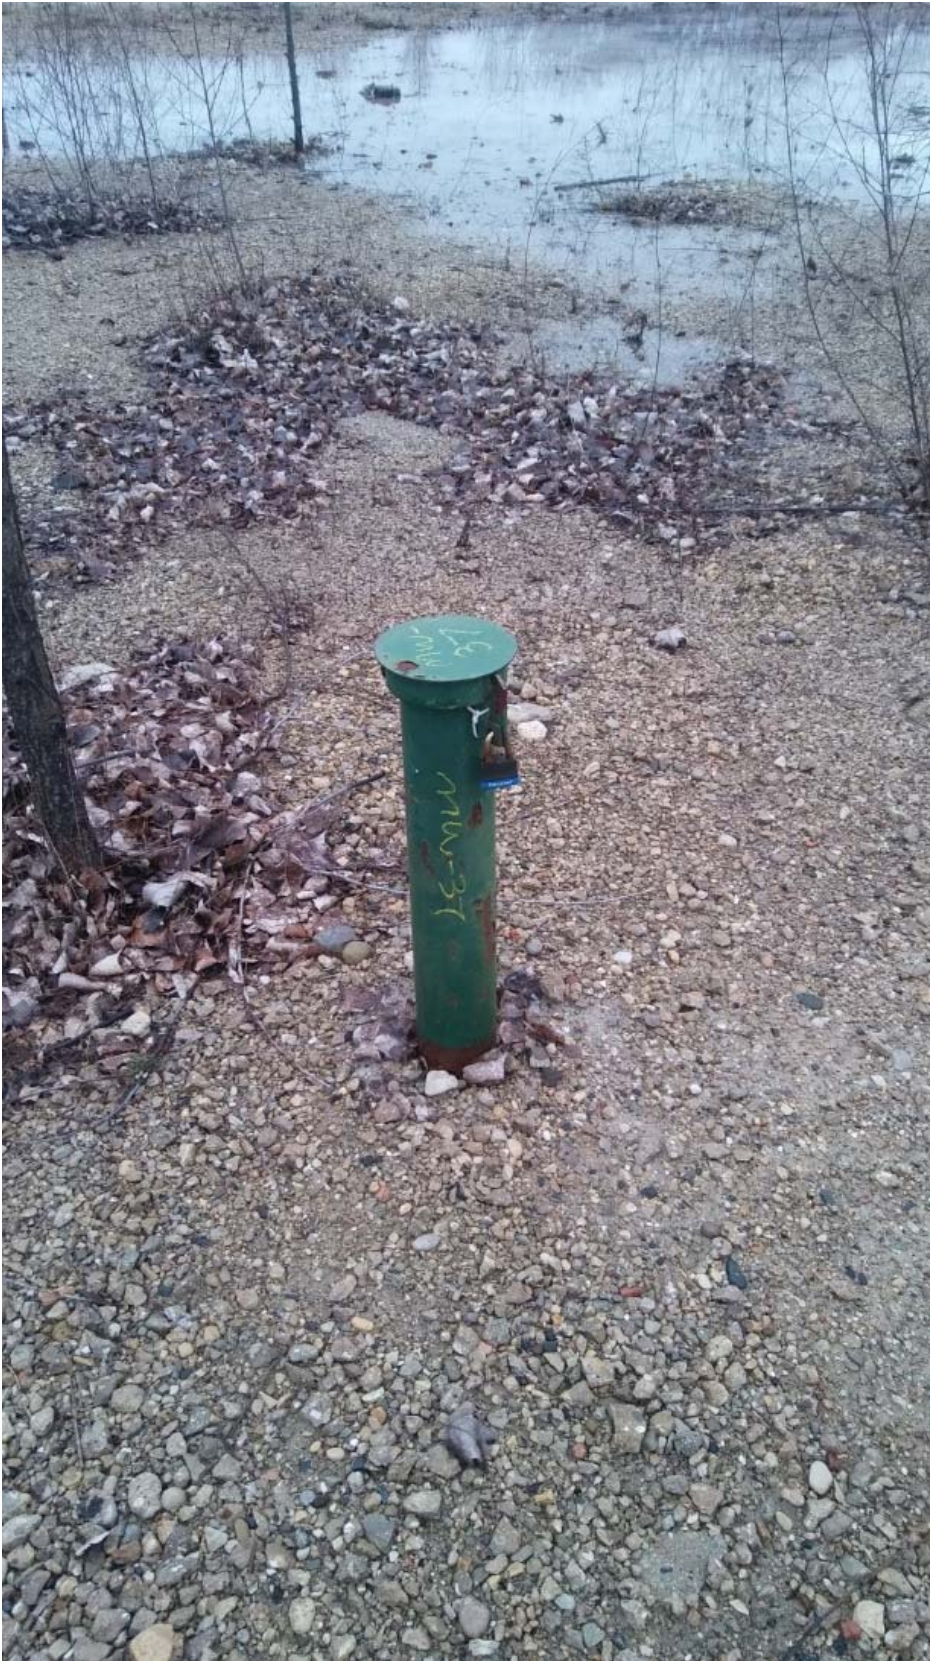
Trent Tube Plant 1 Group A Monitoring Well MW-37 – Photograph taken 1/17/17

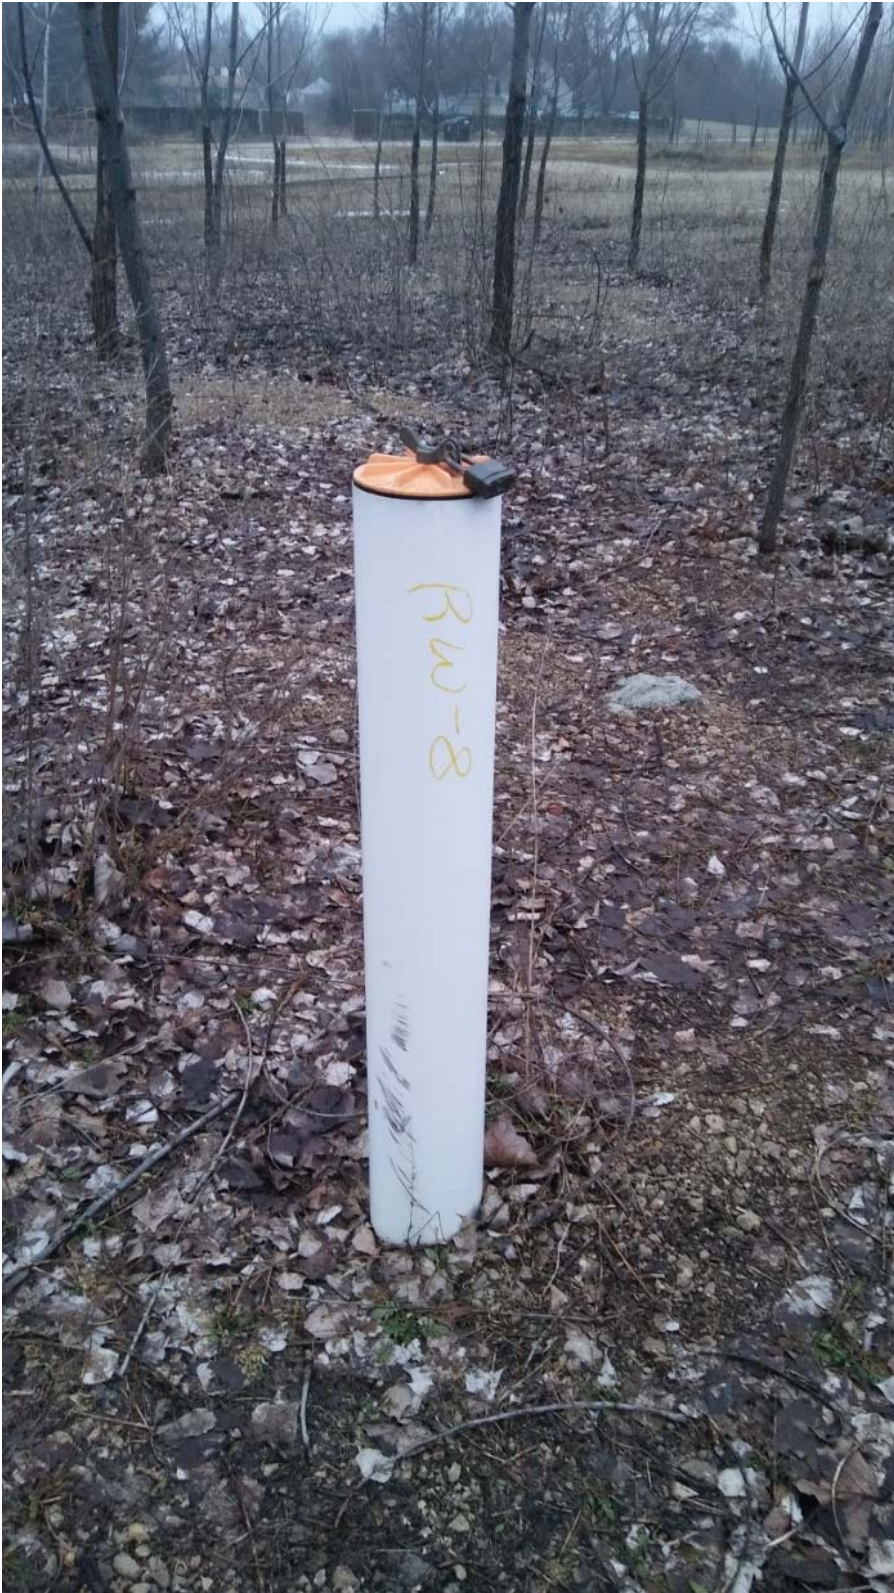
Trent Tube Plant 1 Group A Recovery Well RW-8 – Photograph taken 1/17/17

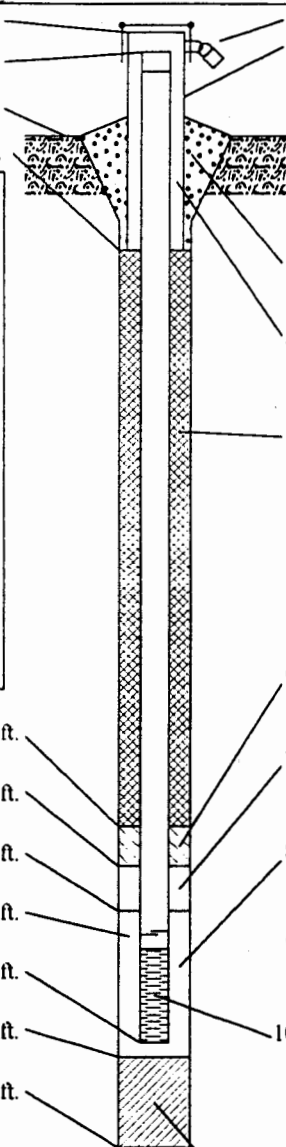
- 1. Cap and lock? Yes No
- 2. Protective cover pipe:
 - a. Inside diameter: 9.0 in.
 - b. Length: 1.0 ft.
 - c. Material: Steel 0 4
Other
 - d. Additional protection? Yes No
If yes, describe: Flushmount w/expandable geocap

- 3. Surface seal: Bentonite 3 0
Concrete 0 1
Other
- 4. Material between well casing and protective pipe: Bentonite 3 0
coarse sand Other
- 5. Annular space seal:

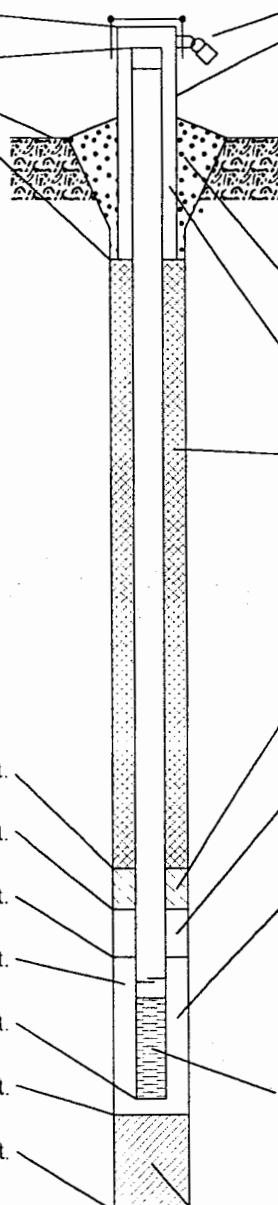
- E. Bentonite seal, top 842.2 ft. MSL or 0.5 ft.
- F. Fine sand, top 836.7 ft. MSL or 6.0 ft.
- G. Filter pack, top 835.9 ft. MSL or 6.8 ft.
- H. Screen joint, top 833.9 ft. MSL or 8.8 ft.
- I. Well bottom 828.9 ft. MSL or 13.8 ft.
- J. Filter pack, bottom 828.7 ft. MSL or 14.0 ft.
- K. Borehole, bottom 826.7 ft. MSL or 16.0 ft.
- L. Borehole, diameter 14.0 in.
- M. O.D. well casing 6.62 in.
- N. I.D. well casing 6.38 in.

- 1. Cap and lock? Yes No
- 2. Protective cover pipe:
 - a. Inside diameter: 12.0 in.
 - b. Length: 1.0 ft.
 - c. Material: Steel 0 4
Other
- d. Additional protection? Yes No
 If yes, describe: Flushmount w/expandable geocap

- 3. Surface seal: Bentonite 3 0
Concrete 0 1
Other
- 4. Material between well casing and protective pipe: Bentonite 3 0
Other
- 5. Annular space seal:
 - a. Granular Bentonite 3 3
