April 26, 2019
File No. 25213180.19

Subject: Summary of Soil Gas Sampling
WDNR Rimrock Road Investigation
Southdale Park, Town of Madison
BRRTS No. 02-13-248222

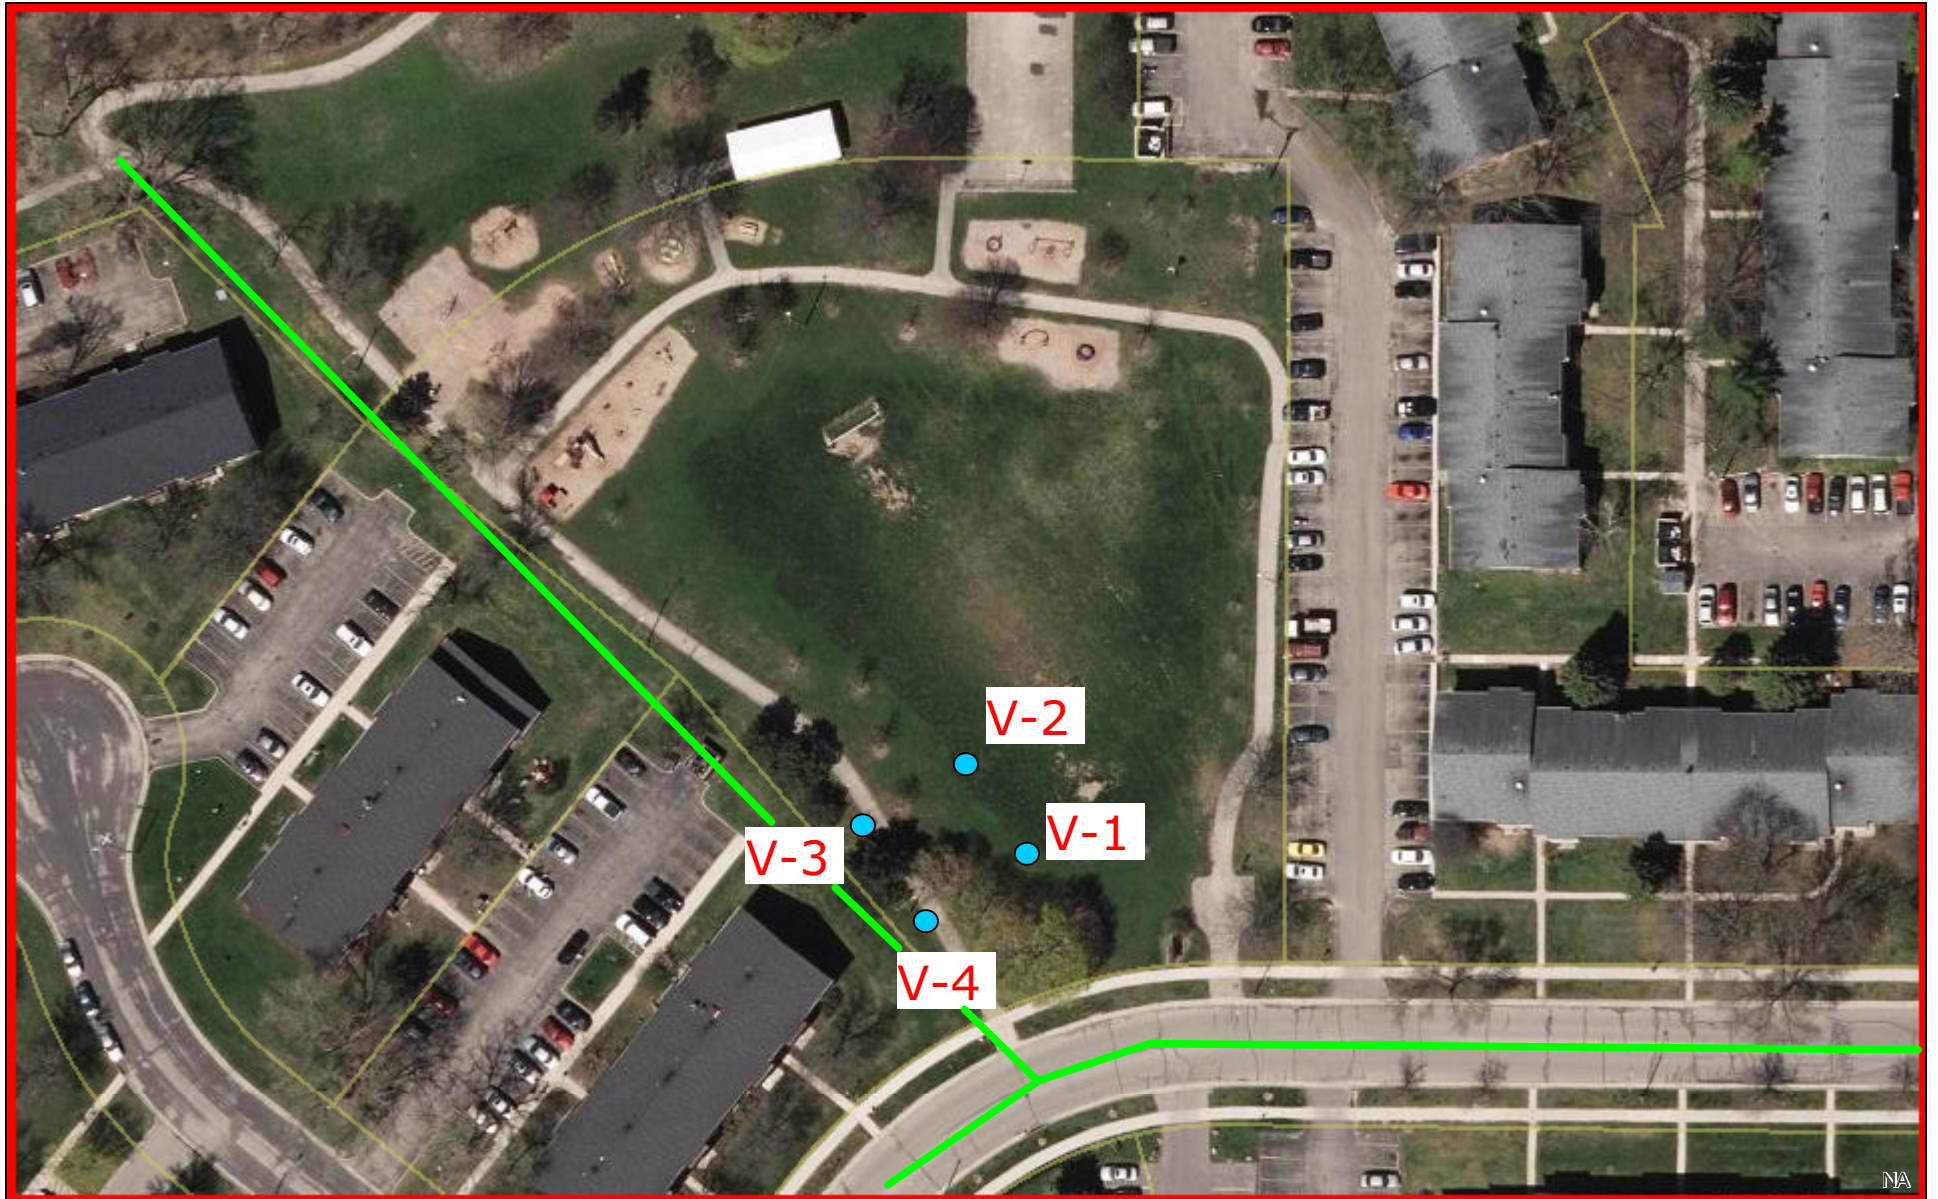
Figure 1 - Site Plan

SCS performed field sampling activities on April 5, 2019. Sample locations are shown on **Figure 1**. Soil gas samples were collected from locations V-1 through V-4 using a Geoprobe™ direct push drill rig and post run tubing (PRT) equipment operated by On-Site Environmental Services, Inc. of Sun Prairie, Wisconsin.

- TCE and/or PCE were detected in all four soil gas samples. No other VOCs were detected.
- PCE concentrations for samples V-3 and V-4 exceed the WDNR sub-slab and deep soil vapor risk screening levels (VRSLs).
- TCE sample concentrations do not exceed VRSLs.

Based on investigation findings, SCS recommends additional soil gas sampling be performed to evaluate the degree and extent of chlorinated VOCs in soil gas. We also recommend that a building vapor intrusion assessment be performed for the apartment building located immediately west of the elevated soil gas concentrations. Our proposed scope of work includes the following sampling activities for the property at 200 Deer Valley Road:

- Installation and sampling of two additional soil gas probes to be installed close to the apartment building sewer lateral, between the sanitary sewer line and the apartment building on the property located at 200 Deer Valley Road.
- Installation and sampling of two building sub-slab vapor ports inside the apartment building.
- Collection of one indoor air sample and one outdoor (background) air sample for the above-noted apartment building.

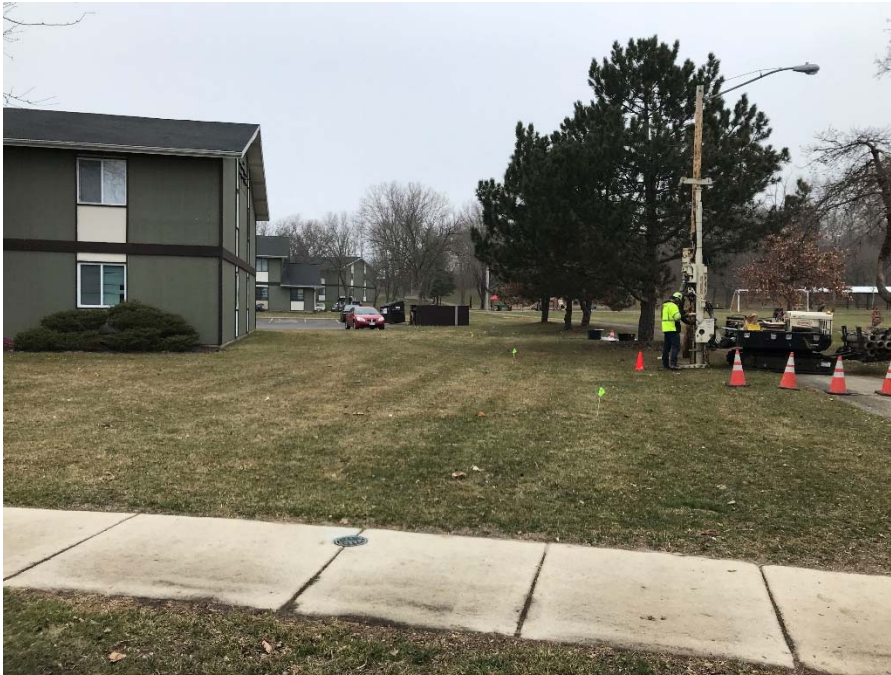
Photo 1: Looking north at installation of temporary soil gas sampling probe V-4 with V-3 in background. Green flags mark sanitary sewer.

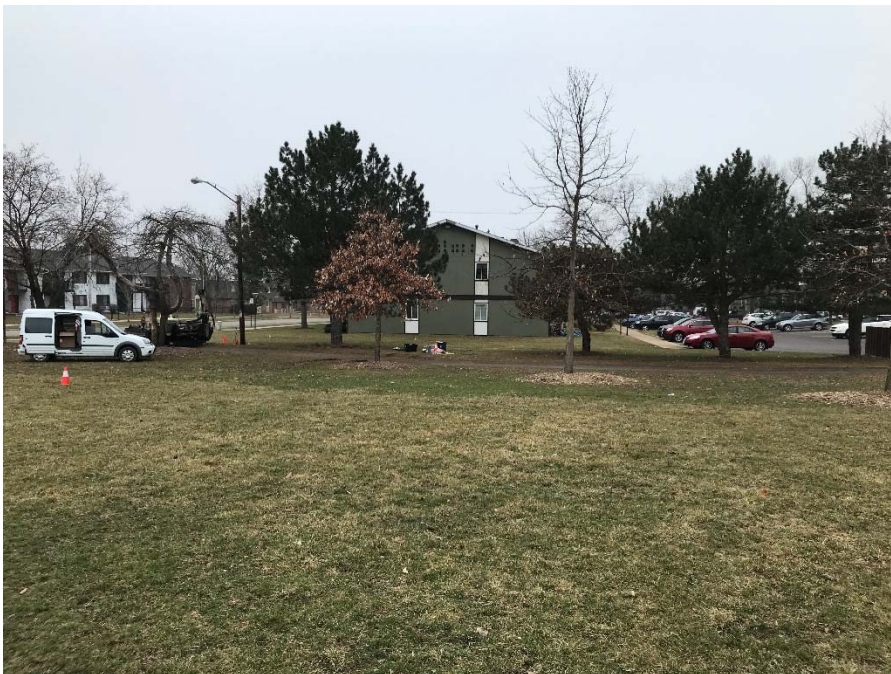
Photo 2: Looking west at soil gas sampling point V-3, located between bike path and apartment building.

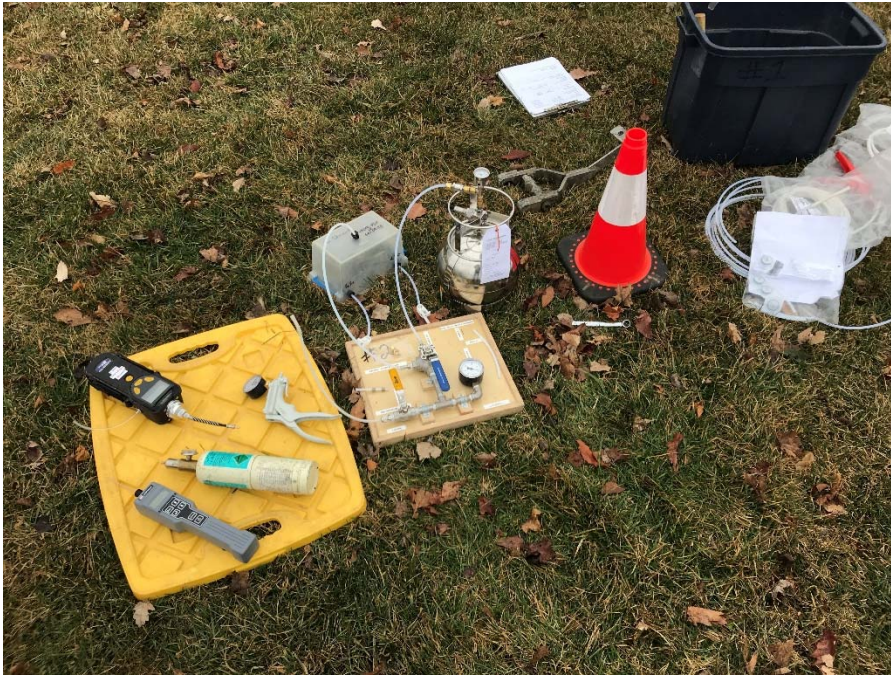
At the ground surface, SCS connected the PRT tubing to a manifold and a summa canister for purging and sampling. Prior to sampling, the manifold and sampling lines were tested for leaks by conducting a vacuum shut-in test. The drive casing surface seal was then tested for leaks using a helium shroud. For this test, the helium shroud was placed over the drive casing and filled with helium. Approximately 1 liter of air was then purged from the PRT using a miniRAE photo-ionization detector (PID). A Gascheck™ helium meter was used to check for the presence of helium in the PID

Photo 3: Sample equipment including flow manifold, helium shroud, summa canister, photoionization detector, and helium meter.

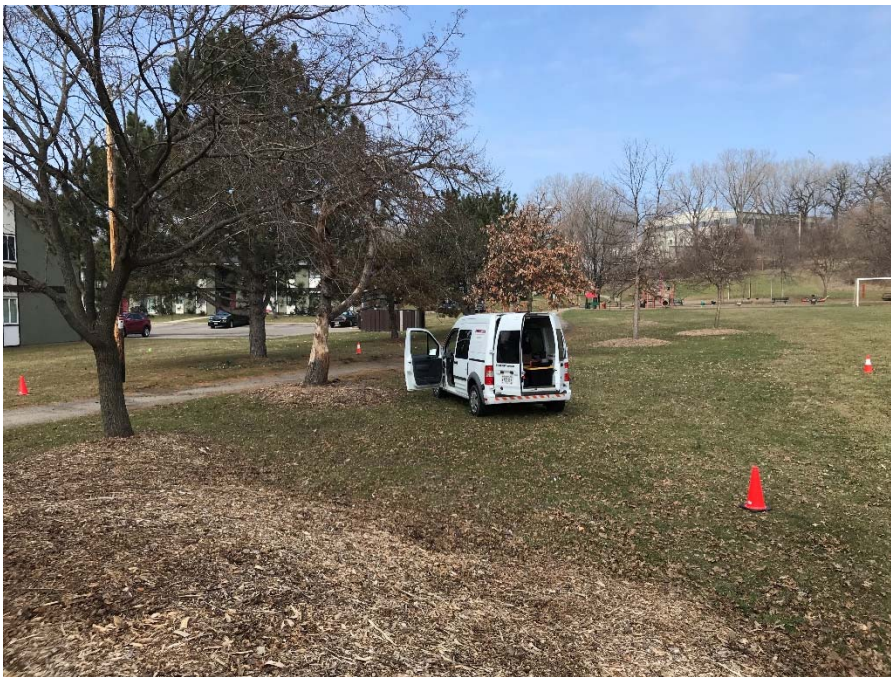
Photo 4: Looking north at traffic cones marking abandoned soil gas borings VP-1 through VP-4.

After leak checks and purging was completed, a soil gas sample was collected from the PRT using a laboratory-supplied vacuum summa canister equipped with a 30-minute flow controller. Following sampling, the drive casing and PRT system were retracted from each location and the borehole was sealed with bentonite granules.
