Wisconsin Department of Natural Resources
Case Closure – GIS Registry
NR 4400-202

For: Dick's Car Care
BRRTS # 03-57-258614

January 9, 2018

RE: Dick's Car Care

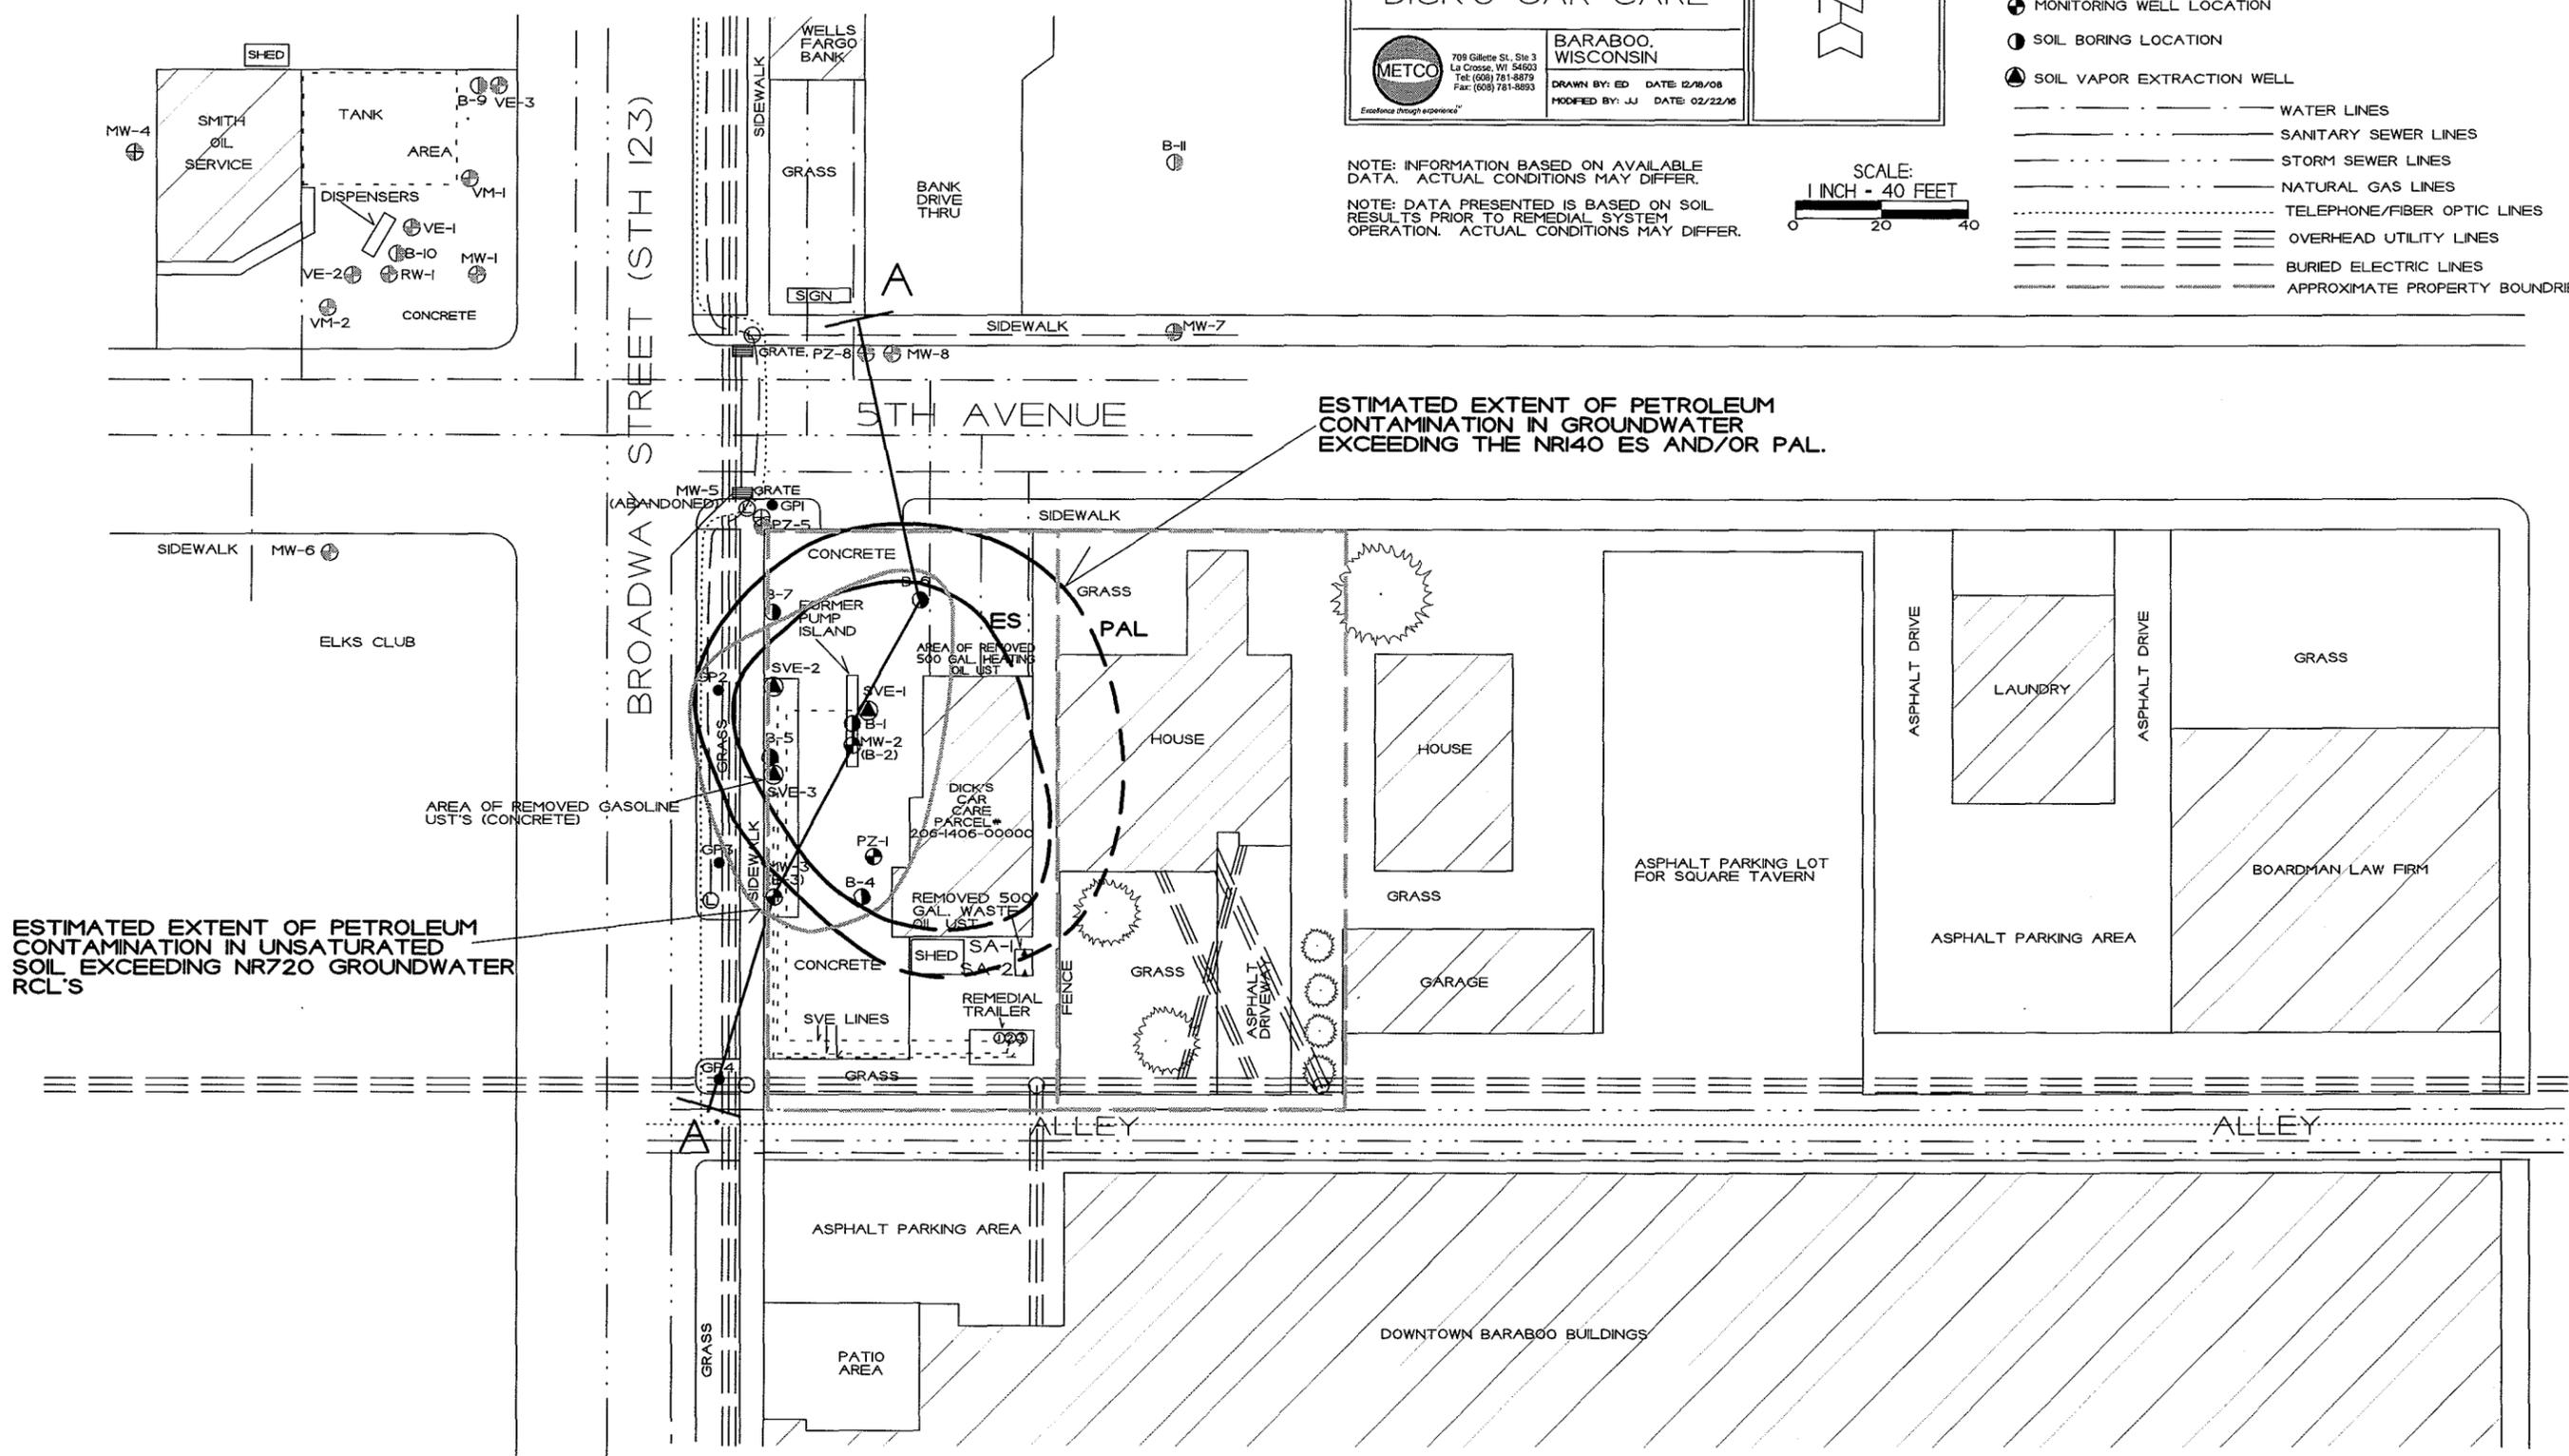
ESTIMATED EXTENT OF PETROLEUM CONTAMINATION IN UNSATURATED SOIL EXCEEDING NR720 GROUNDWATER RCL'S

ESTIMATED EXTENT OF PETROLEUM CONTAMINATION IN GROUNDWATER EXCEEDING THE NR140 ES AND/OR PAL.

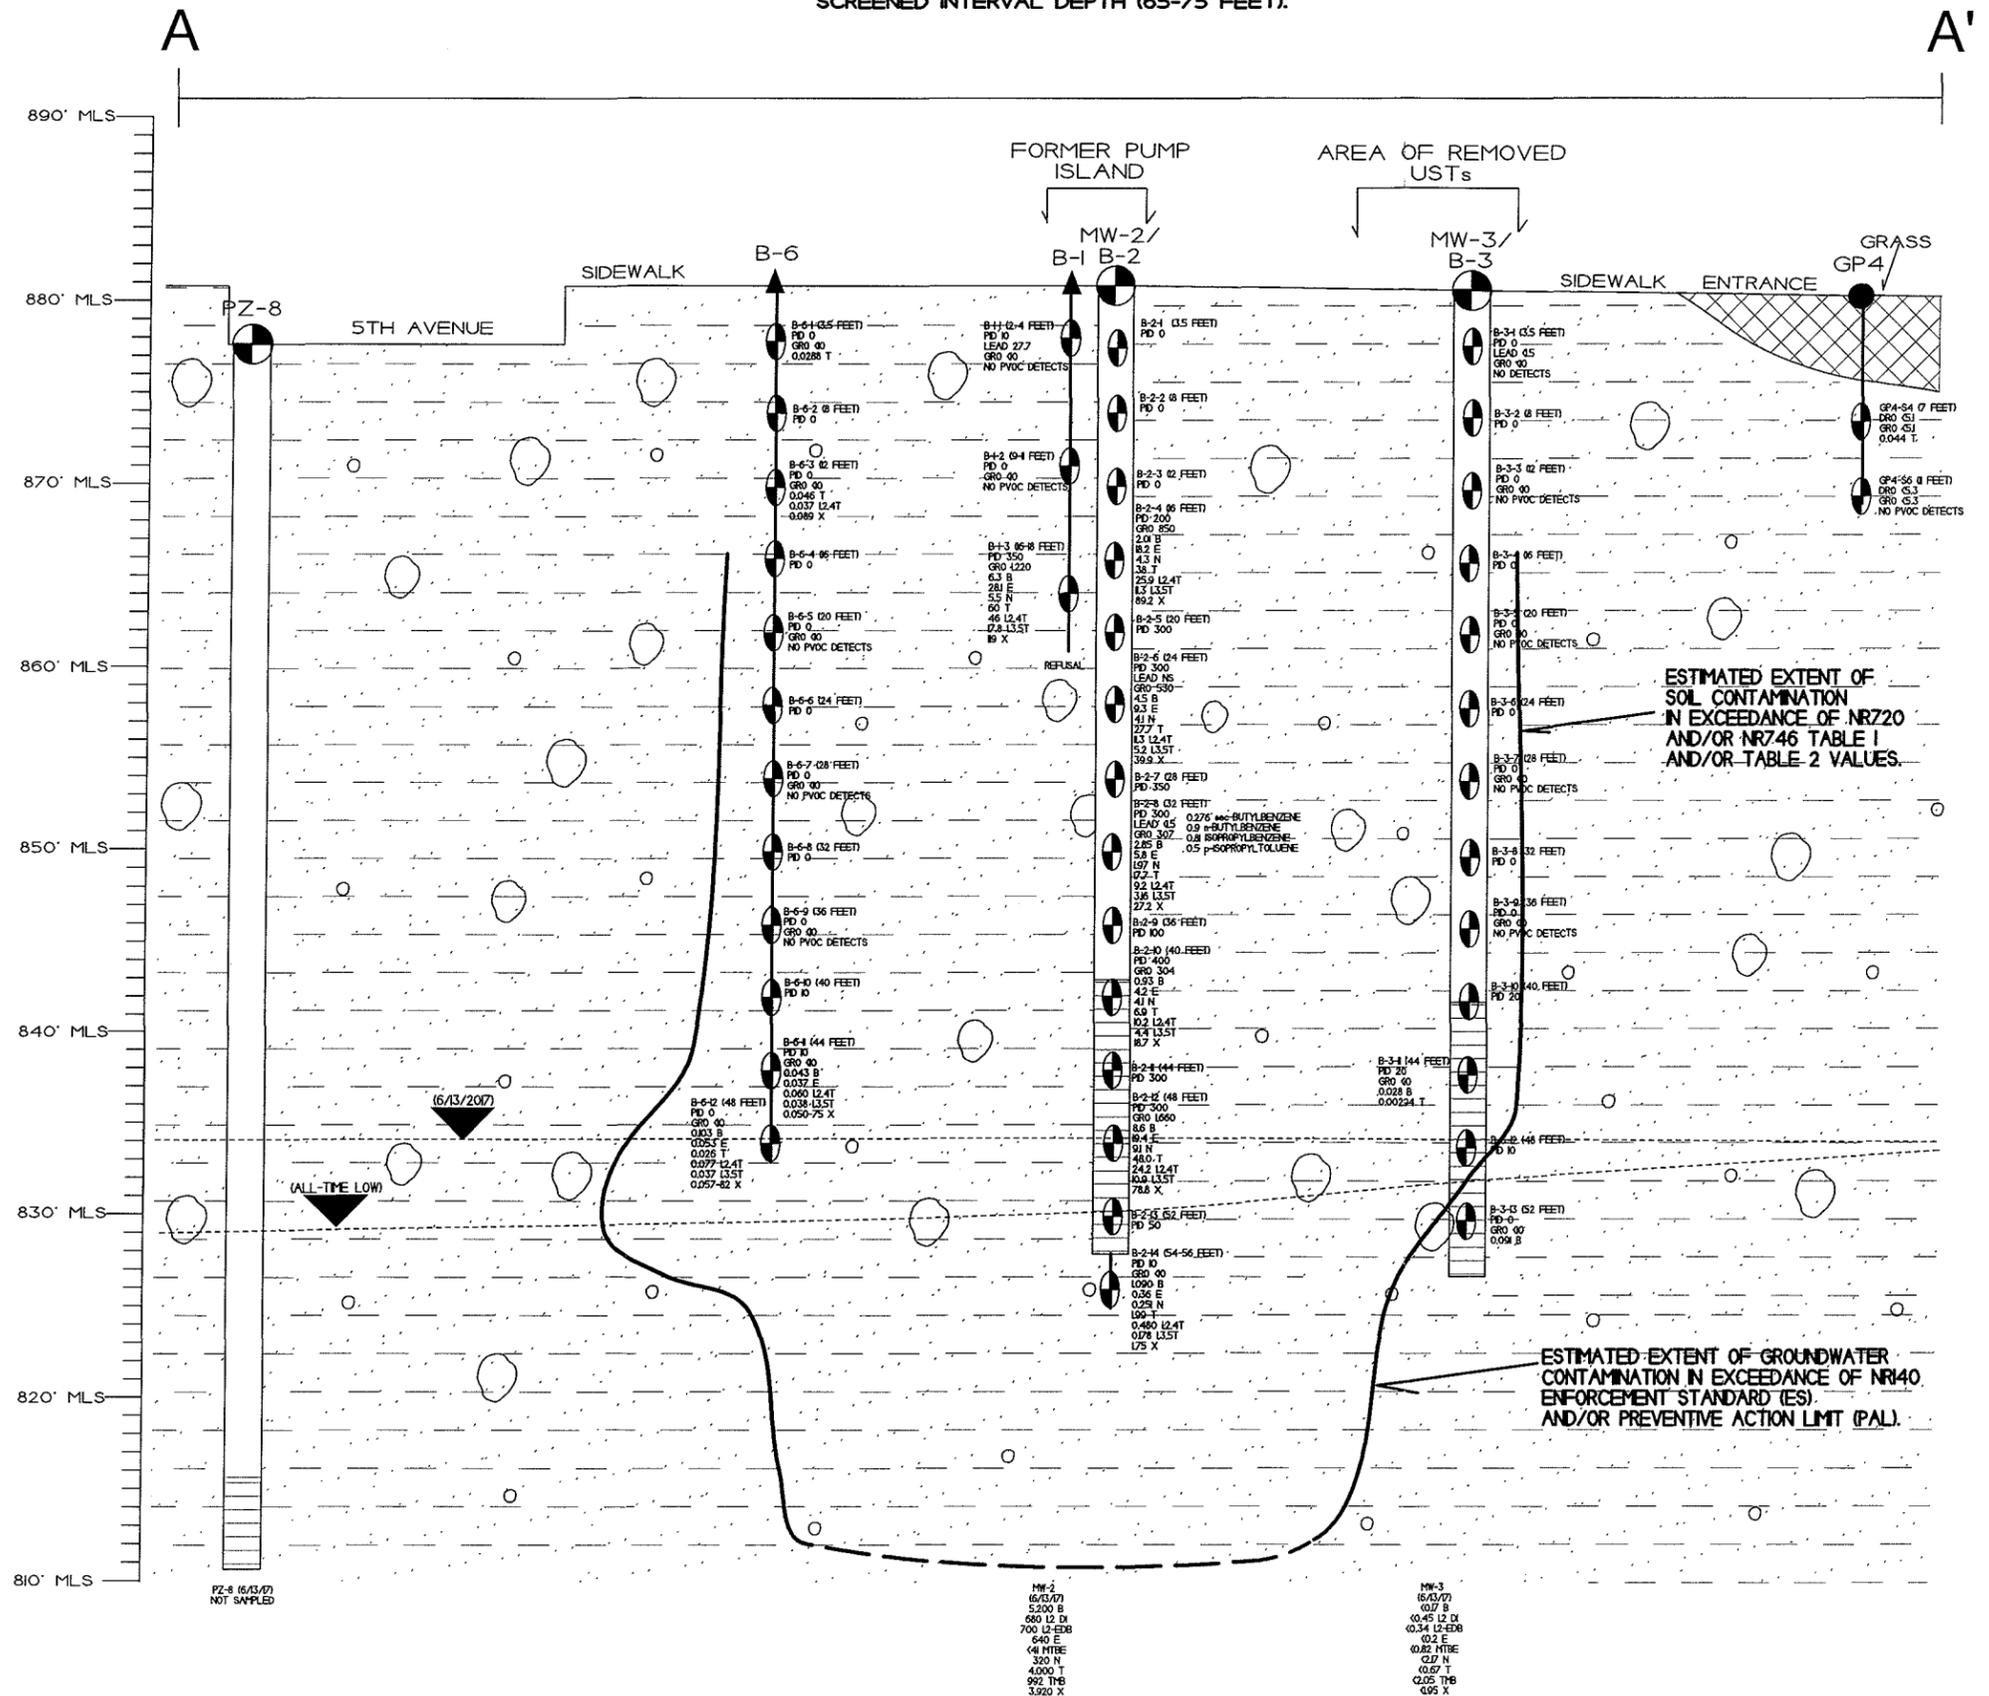
B.3.b. GROUNDWATER ISOCONCENTRATION (6/13/17)

PLEASE NOTE: PZ-1, LOCATED 25 FEET NORTH EAST OF MW-3, SHOWED ES EXCEEDANCES AT SCREENED INTERVAL DEPTH (65-75 FEET).

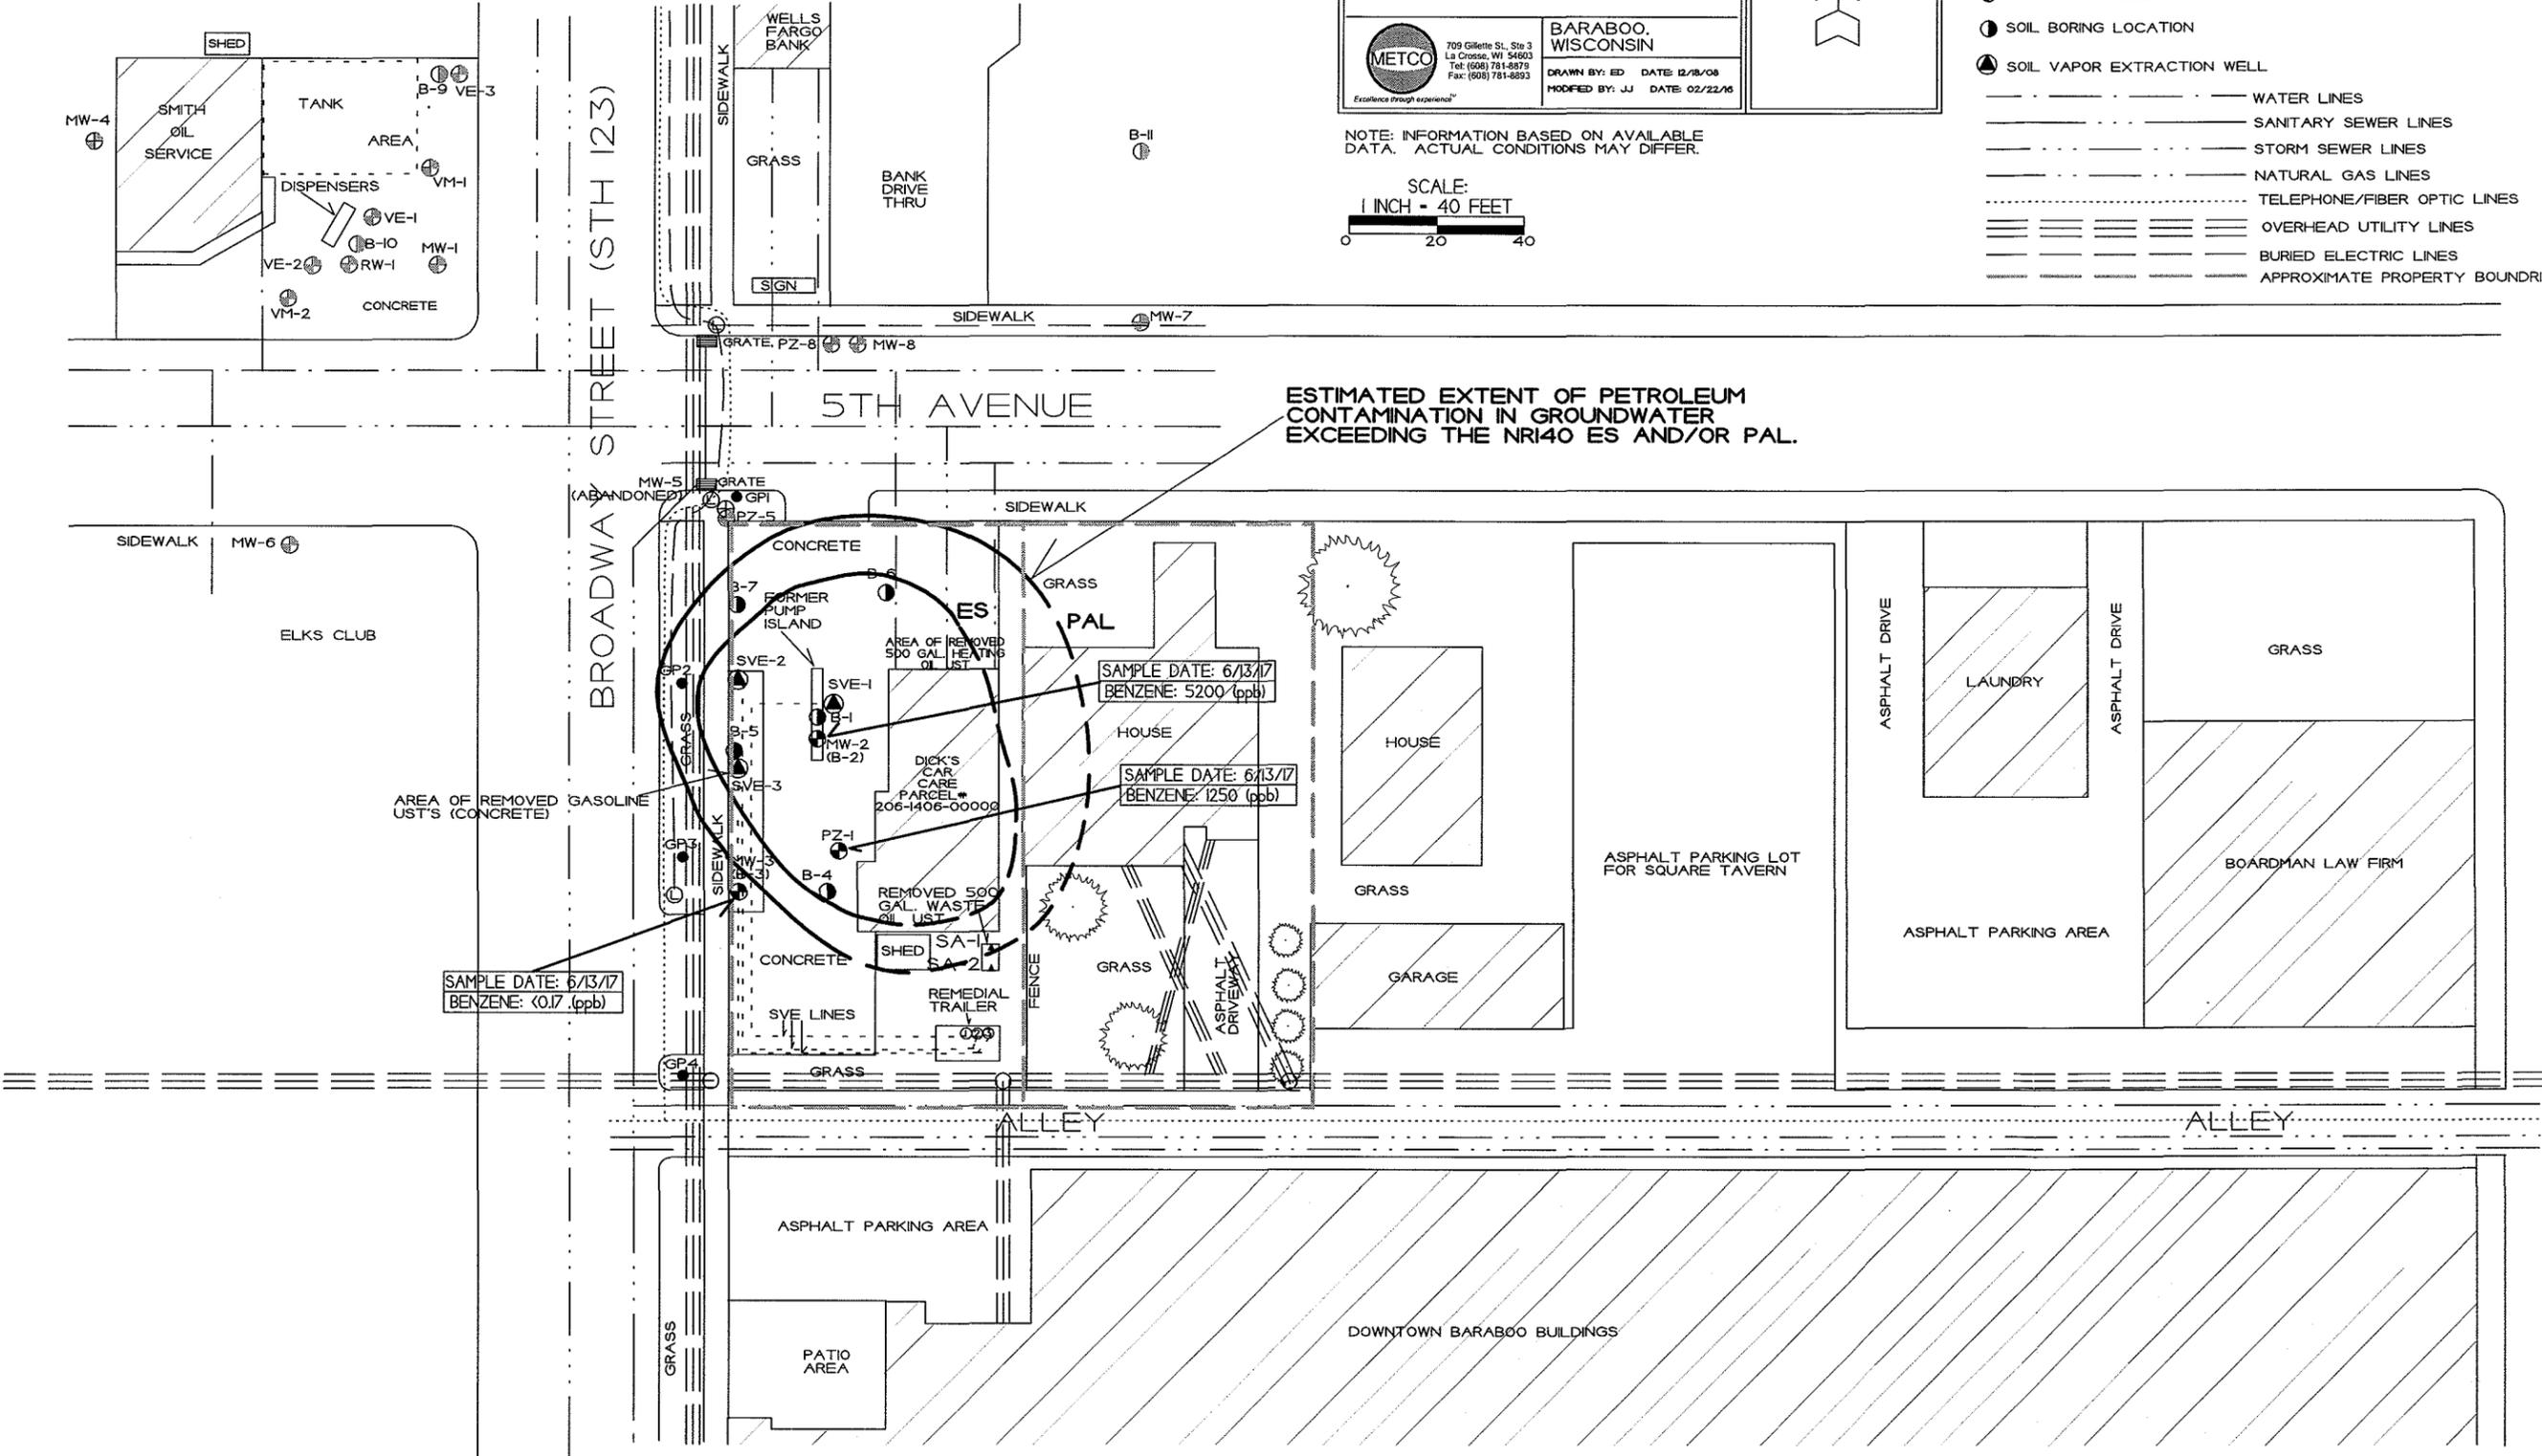
SAMPLE DATE: 6/13/17
BENZENE: 0.17 (ppb)

SAMPLE DATE: 6/13/17
BENZENE: 5200 (ppb)

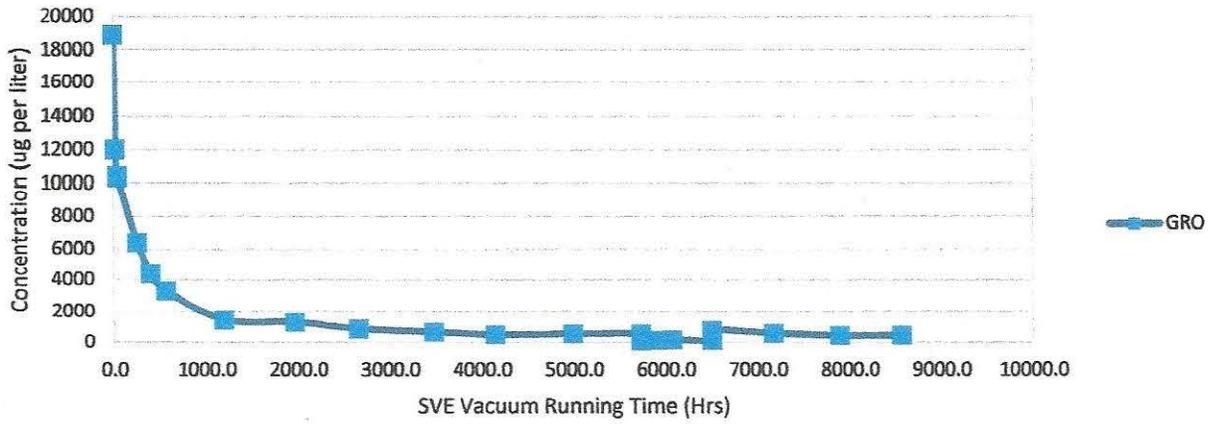
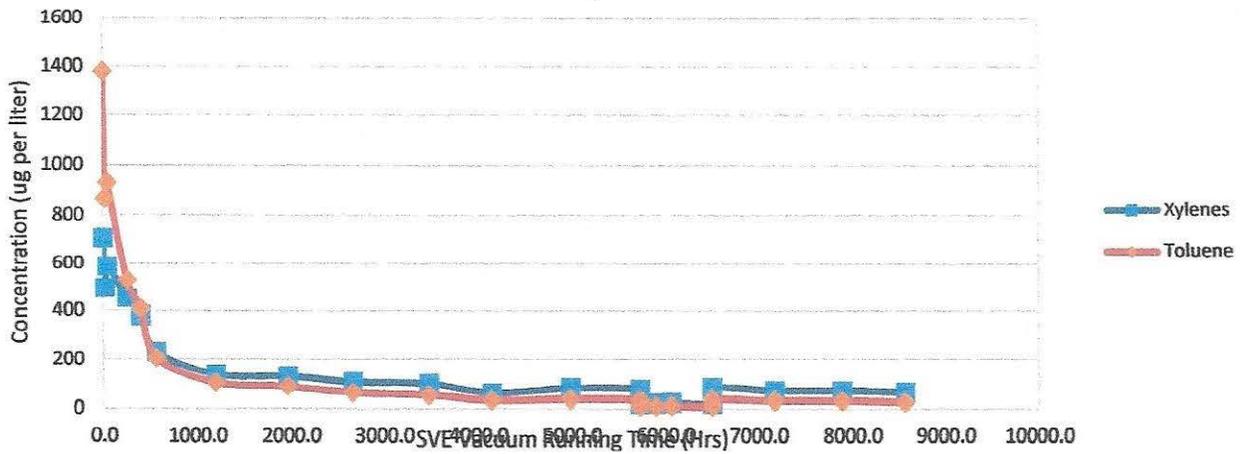
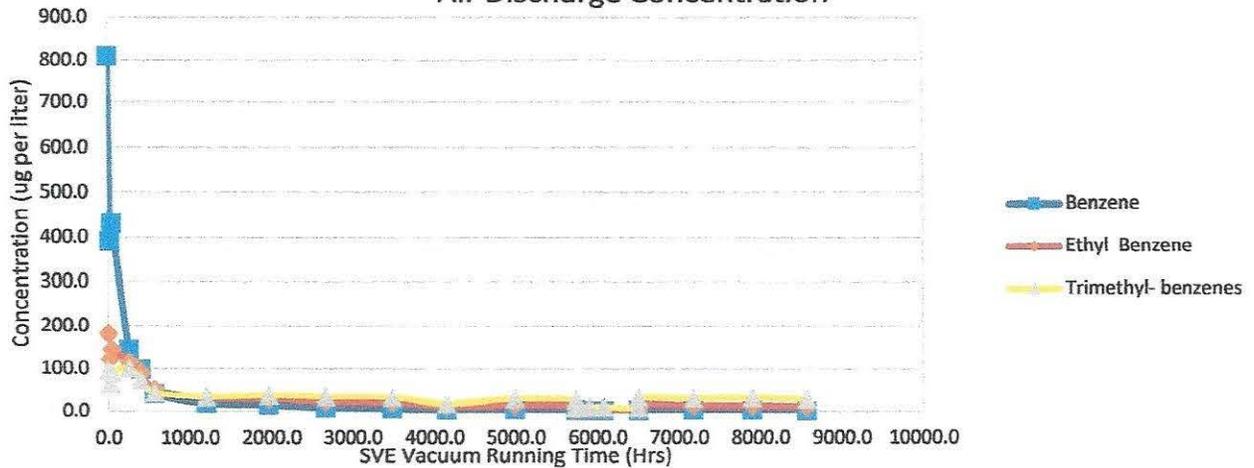
Figure 1a

Air Discharge Concentration

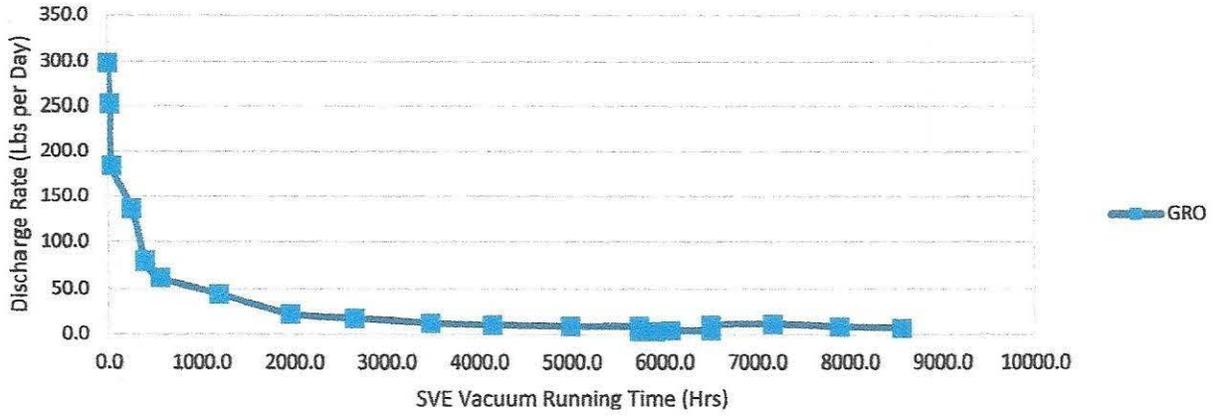
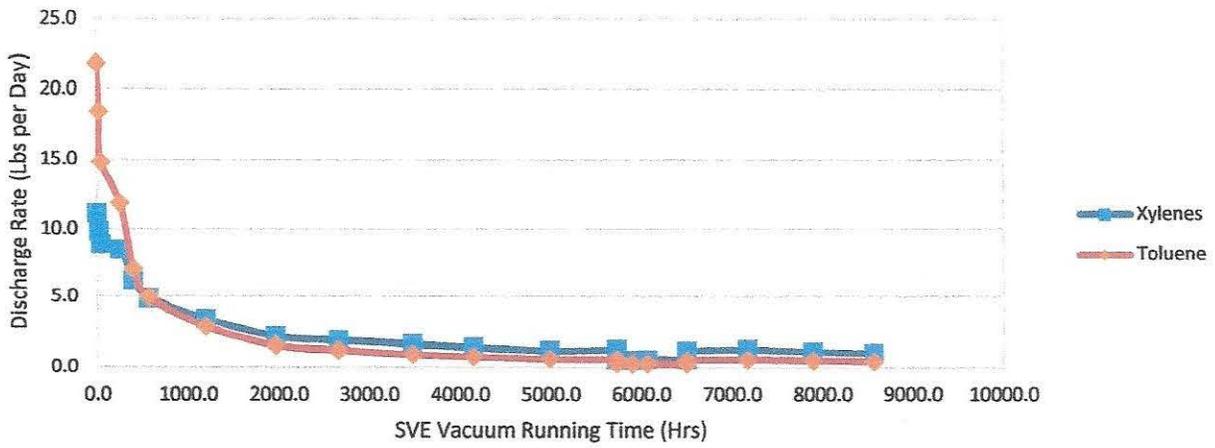
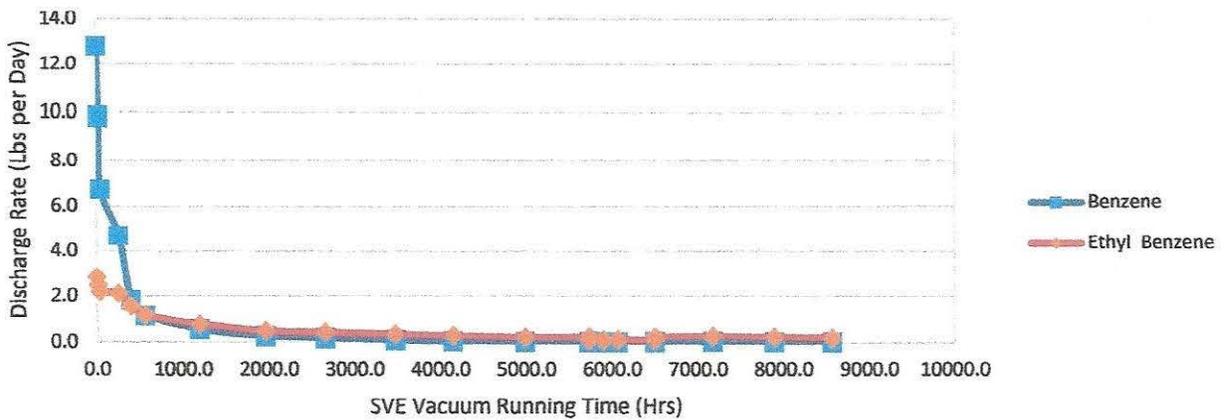
Figure 1b

Air Discharge Mass Rate

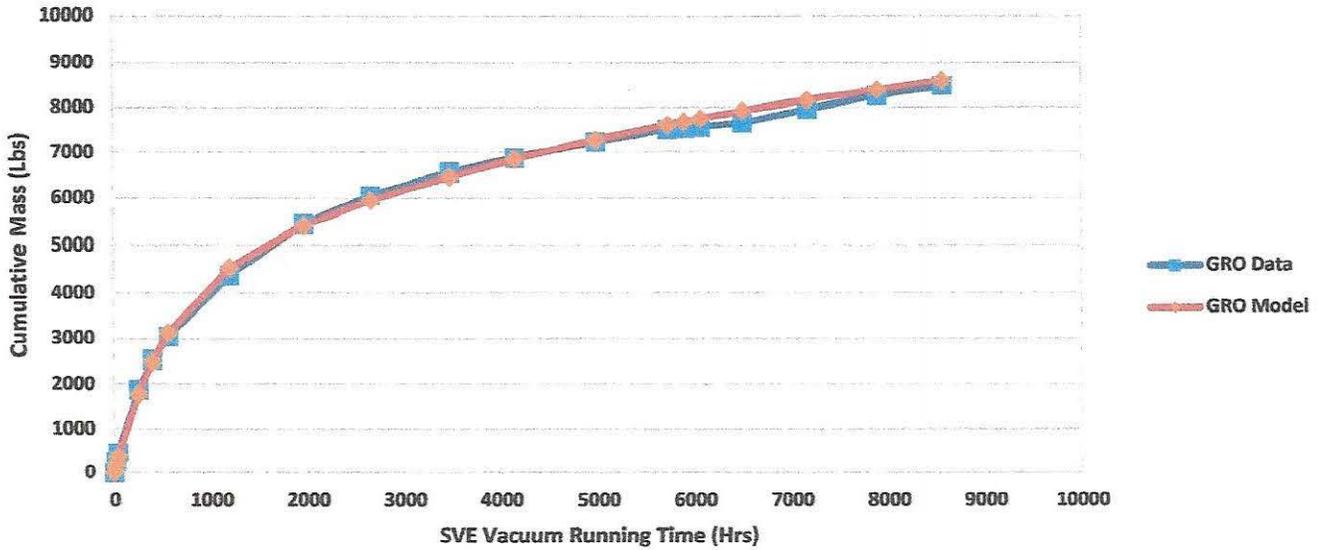
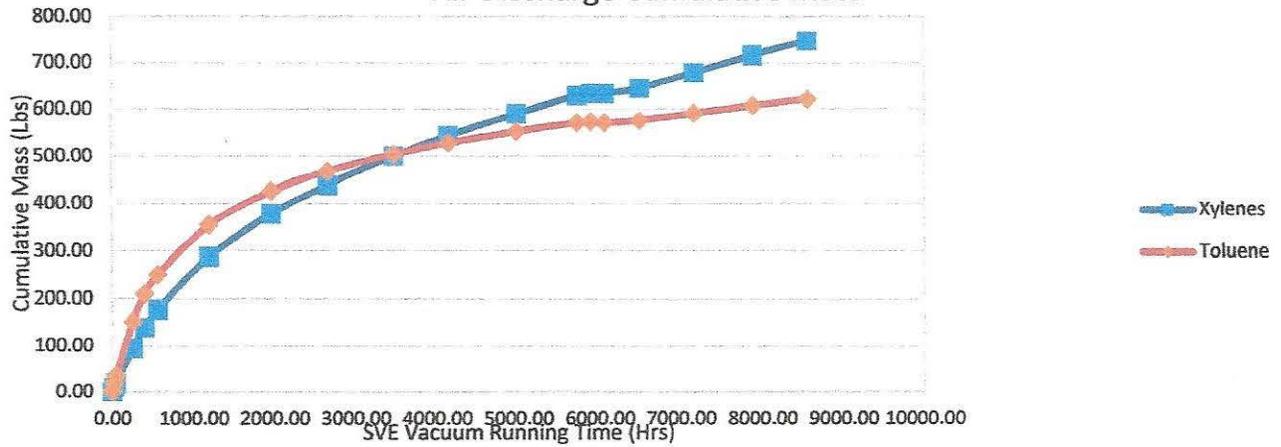
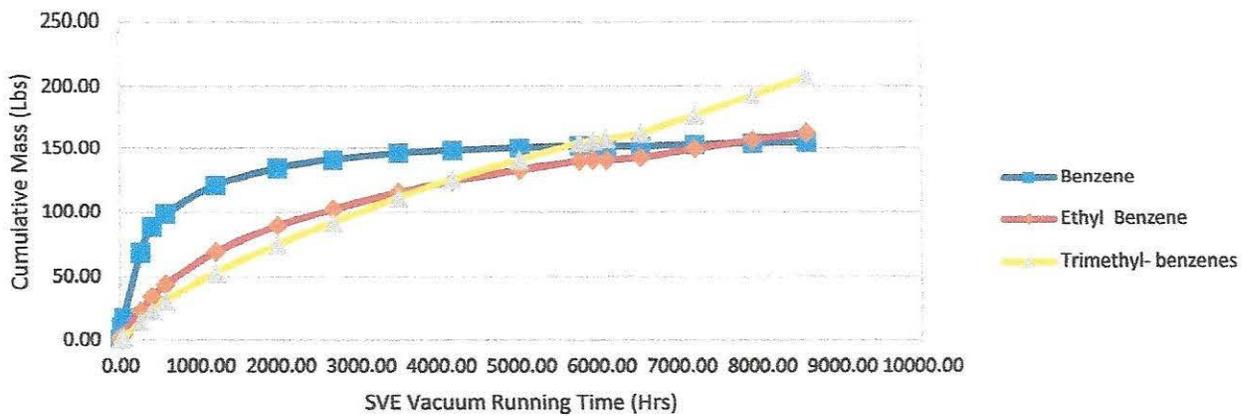
Figure 1c

Air Discharge Contamination - Cumulative Mass

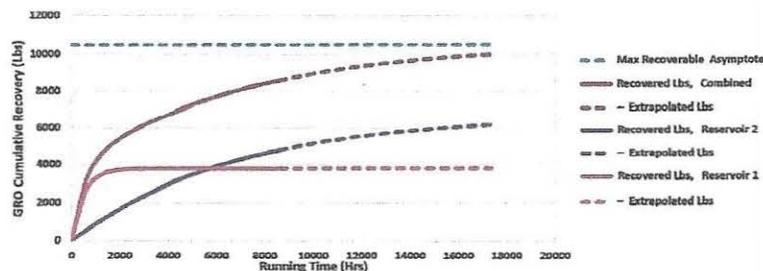
Then note the Figure below indicating the 2 sub-parts of the regression model, extrapolated to twice as far as the empirical data.

Dick's Car Care - SVE Cumulative Recovery (GRO)

The model assumes that uniform imposed conditions generated the data. Therefore, for the regression analysis, the last 4 months of cumulative-lbs data had 180 lbs (each) added to them to correct for the estimated lost recovery during the 1 month of lower vacuum testing (mid-July to mid-August, 2016). Also, the extra samples taken during the month of the test were not included in the regression.

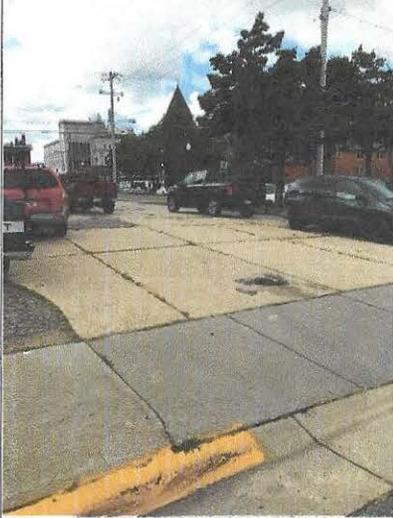
Title: Looking southwest at the area of concrete cap.

The cover consists of 4-6 inches of concrete and an existing building foundation (concrete slab on-grade, 4-6 inches thick). The Cap area is shown on Attachment D.2.

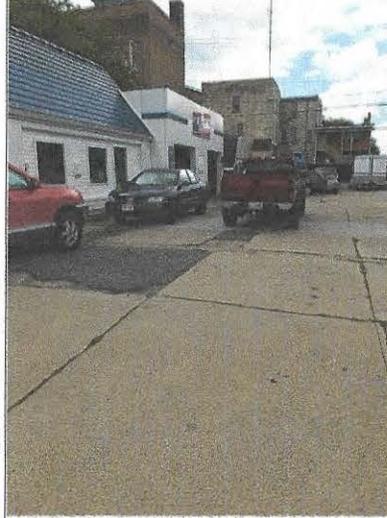
Title: Looking south at the area of concrete cap.

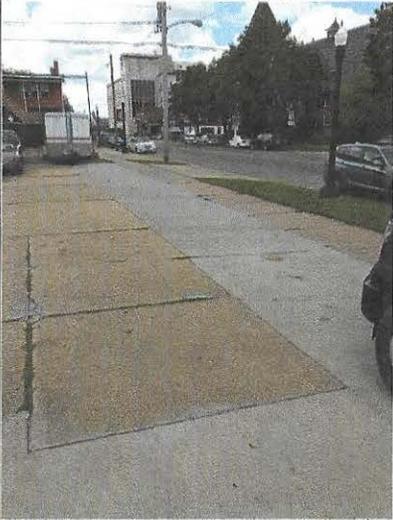
Title: Looking southeast at the area of concrete cap.

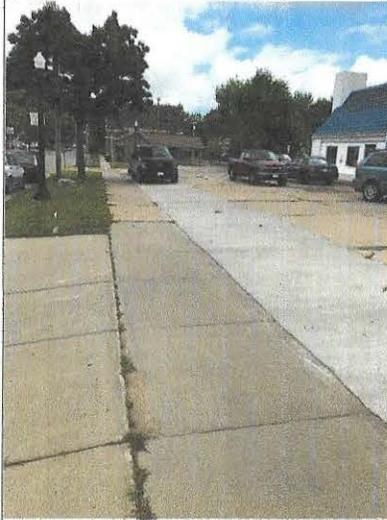
Title: Looking northeast at the area of concrete cap.
