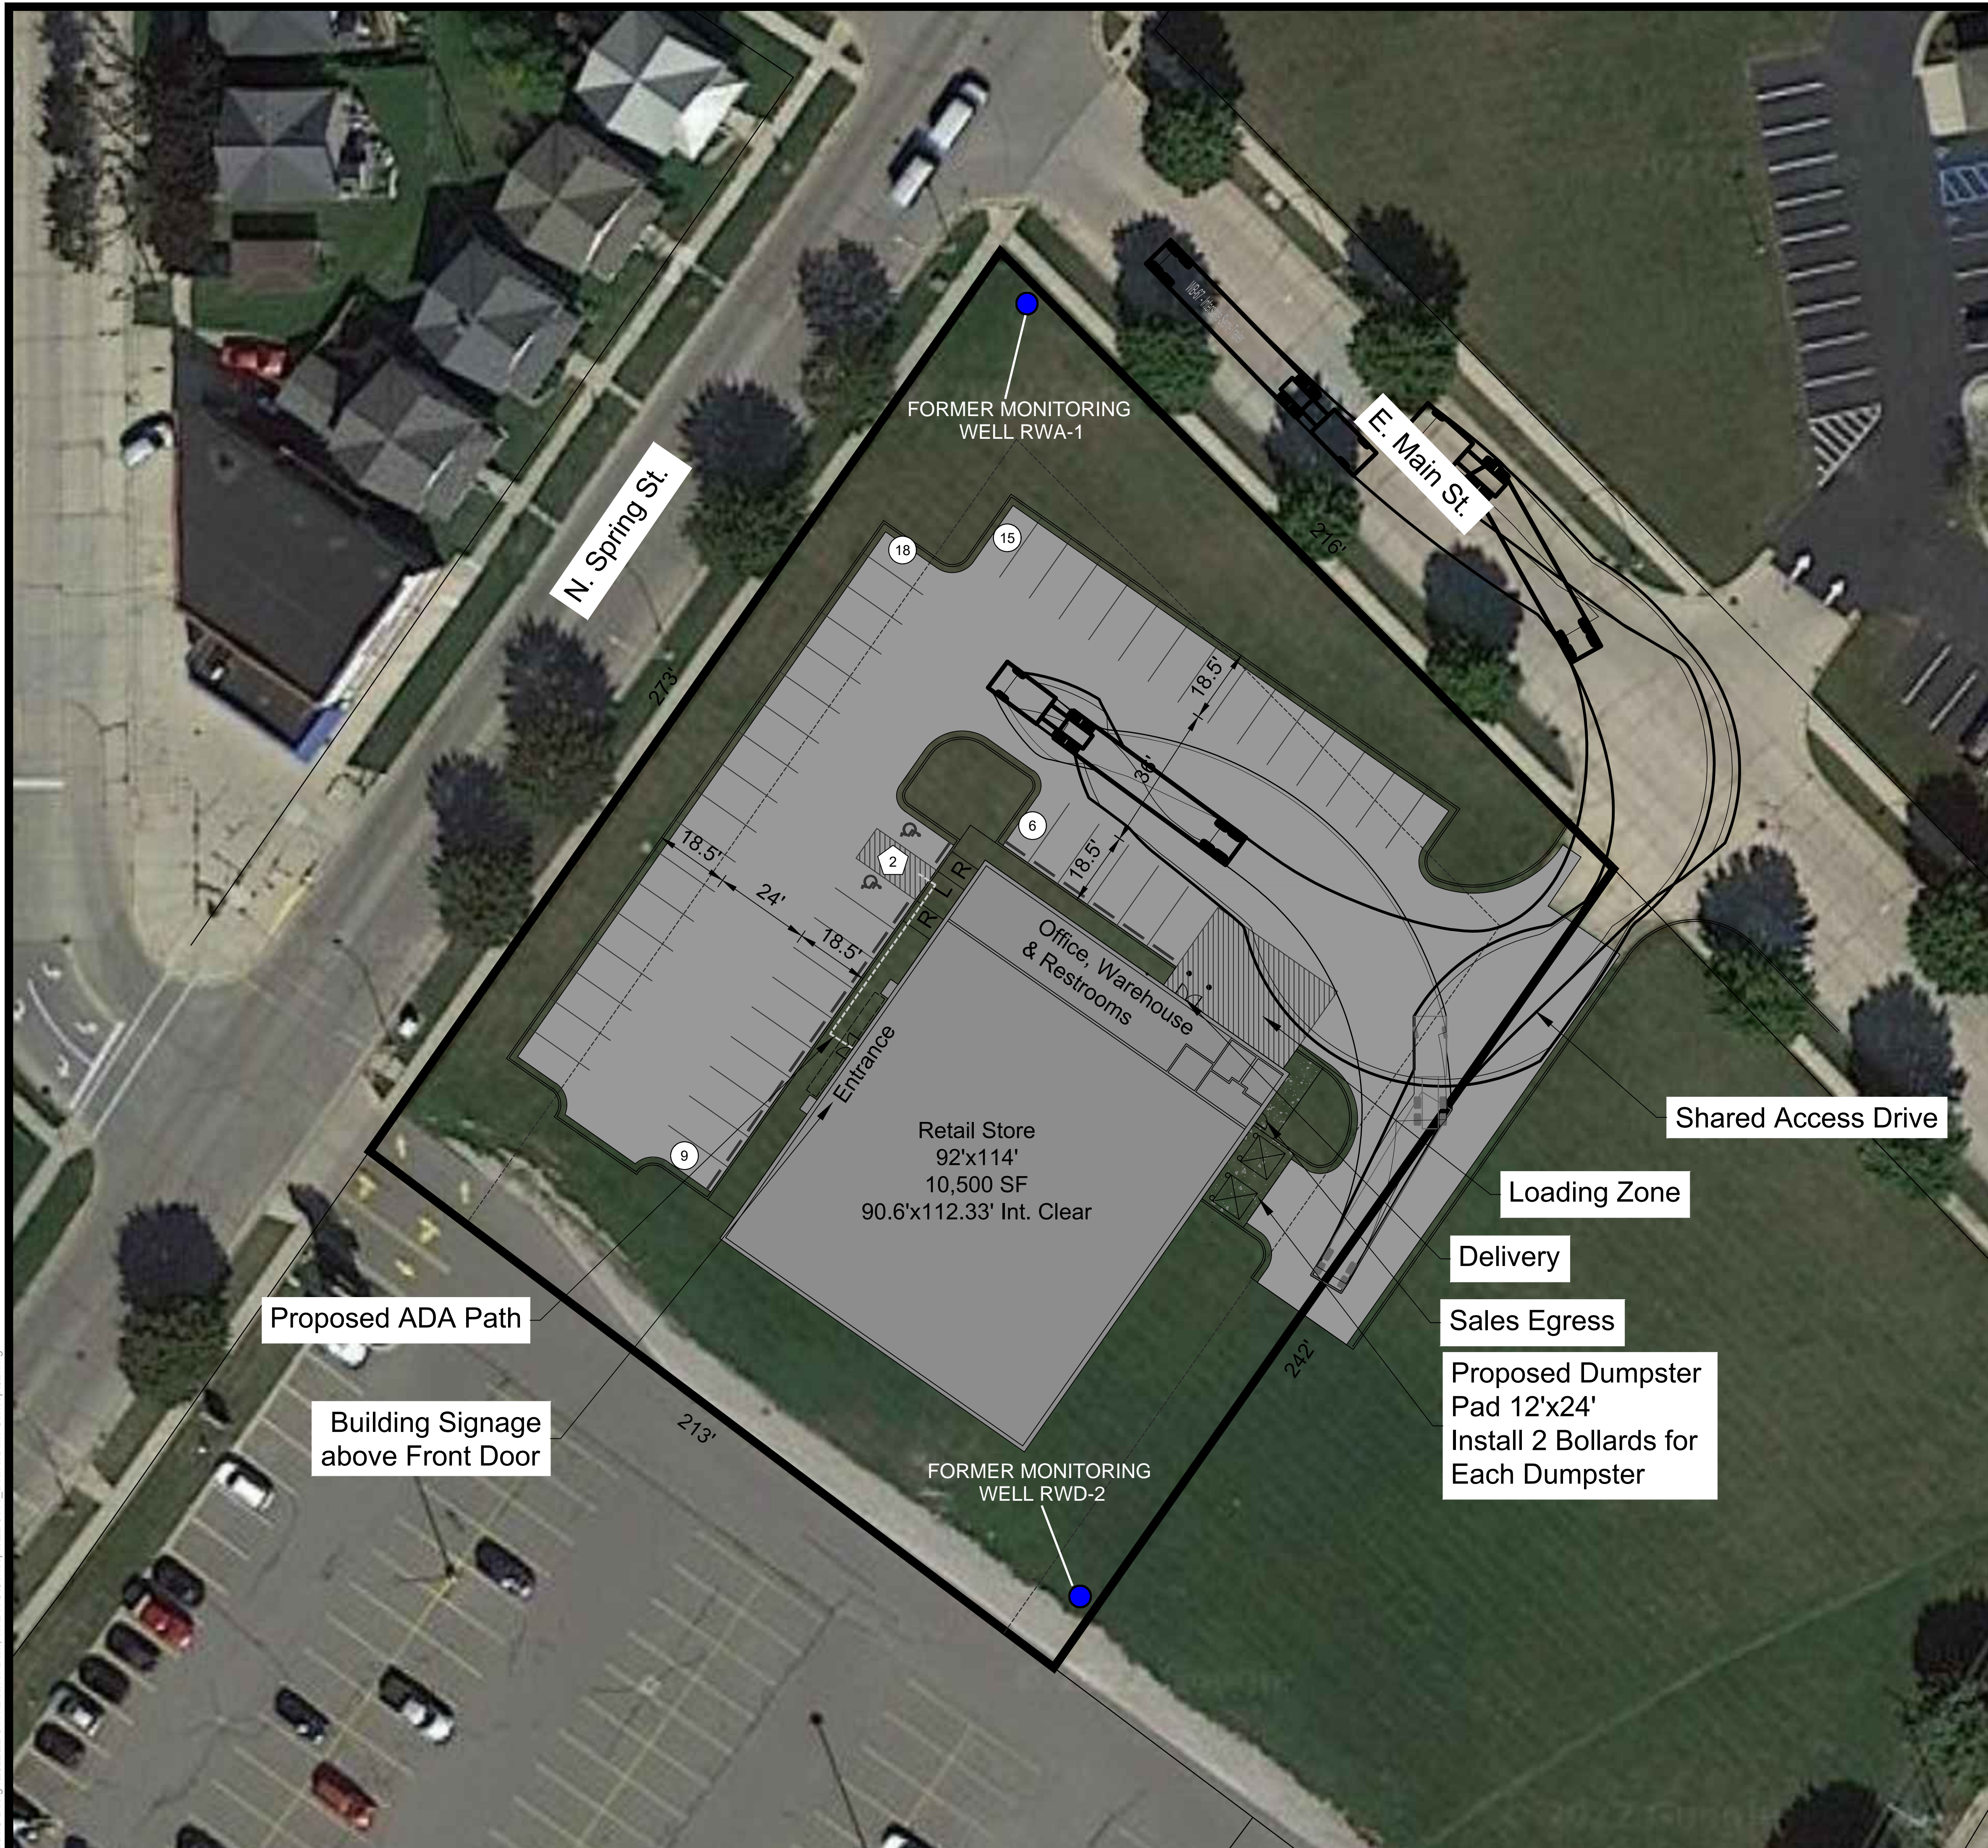
**FIGURE**

Nearby Address  
806 US-151 BUS, Beaver Dam, WI 53916

Site Data Table  
Proposed Overall Lot Area - 1.25 Acres

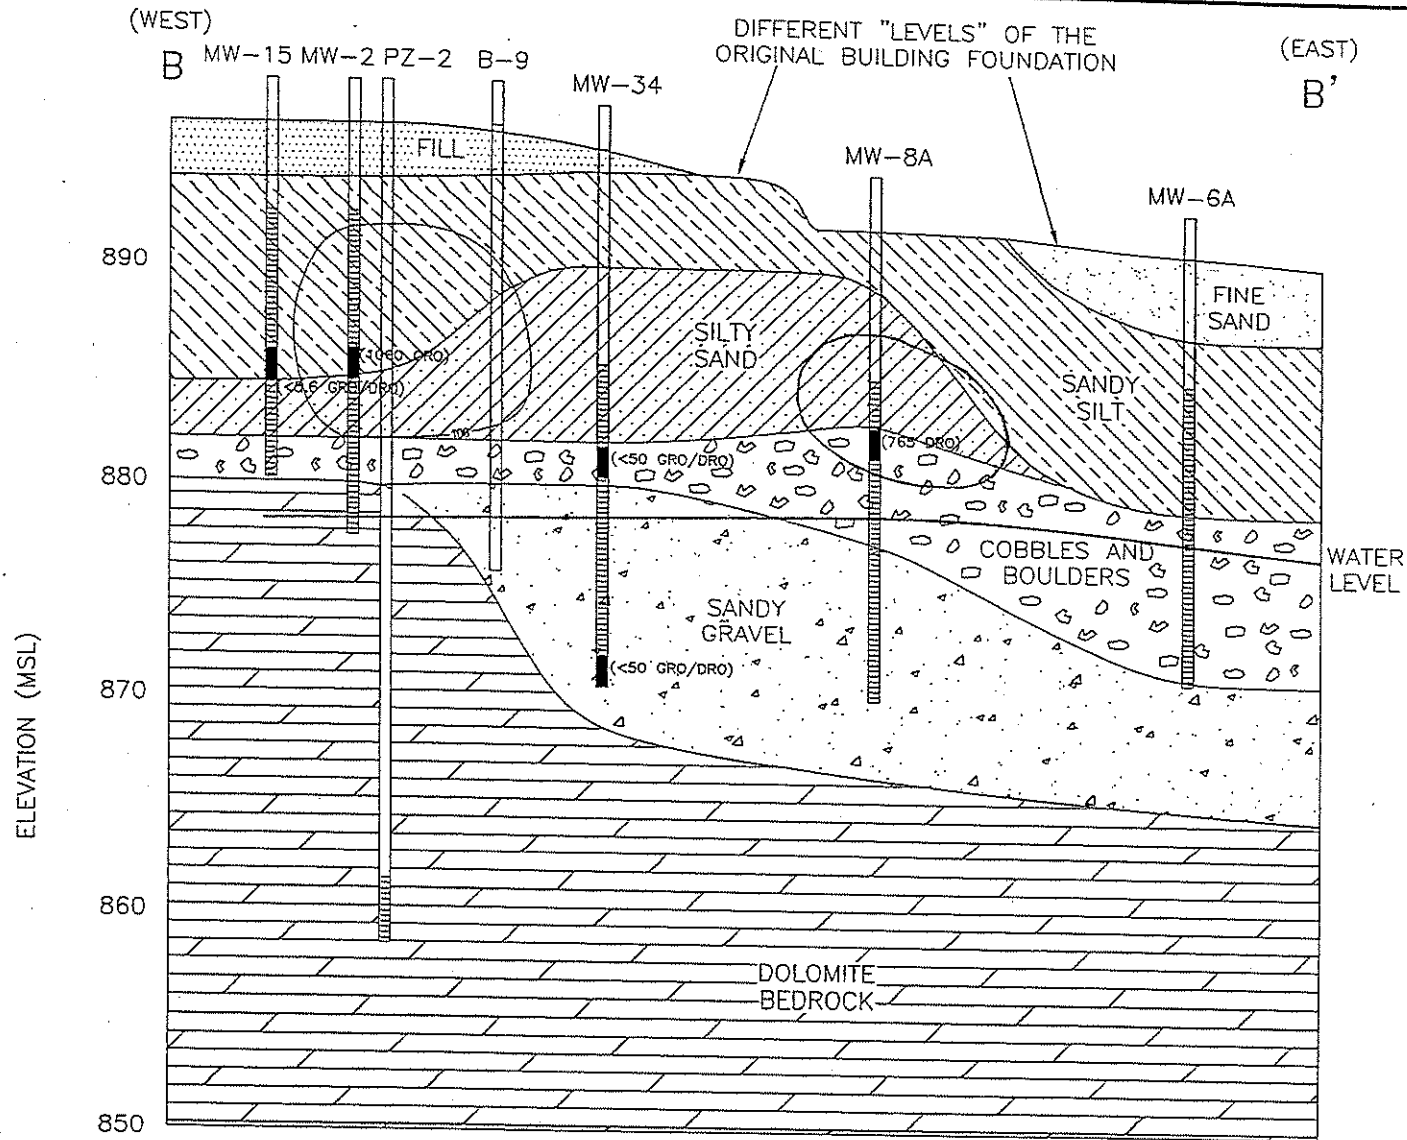
Sample ID notation: Example SC-D-5-15 where SC=South-central excavation, D=row, 5=column, and 15=depth of sample

- NOTES:
- NOT TO SCALE
  - CONCRETE AND PAVEMENT HAVE BEEN OMITTED FROM THE FIGURE
  - 100 NR720 STANDARD ISOCONTOUR
  - (100) GRO/DRO CONCENTRATION IN PPM
  - █ SAMPLE INTERVAL

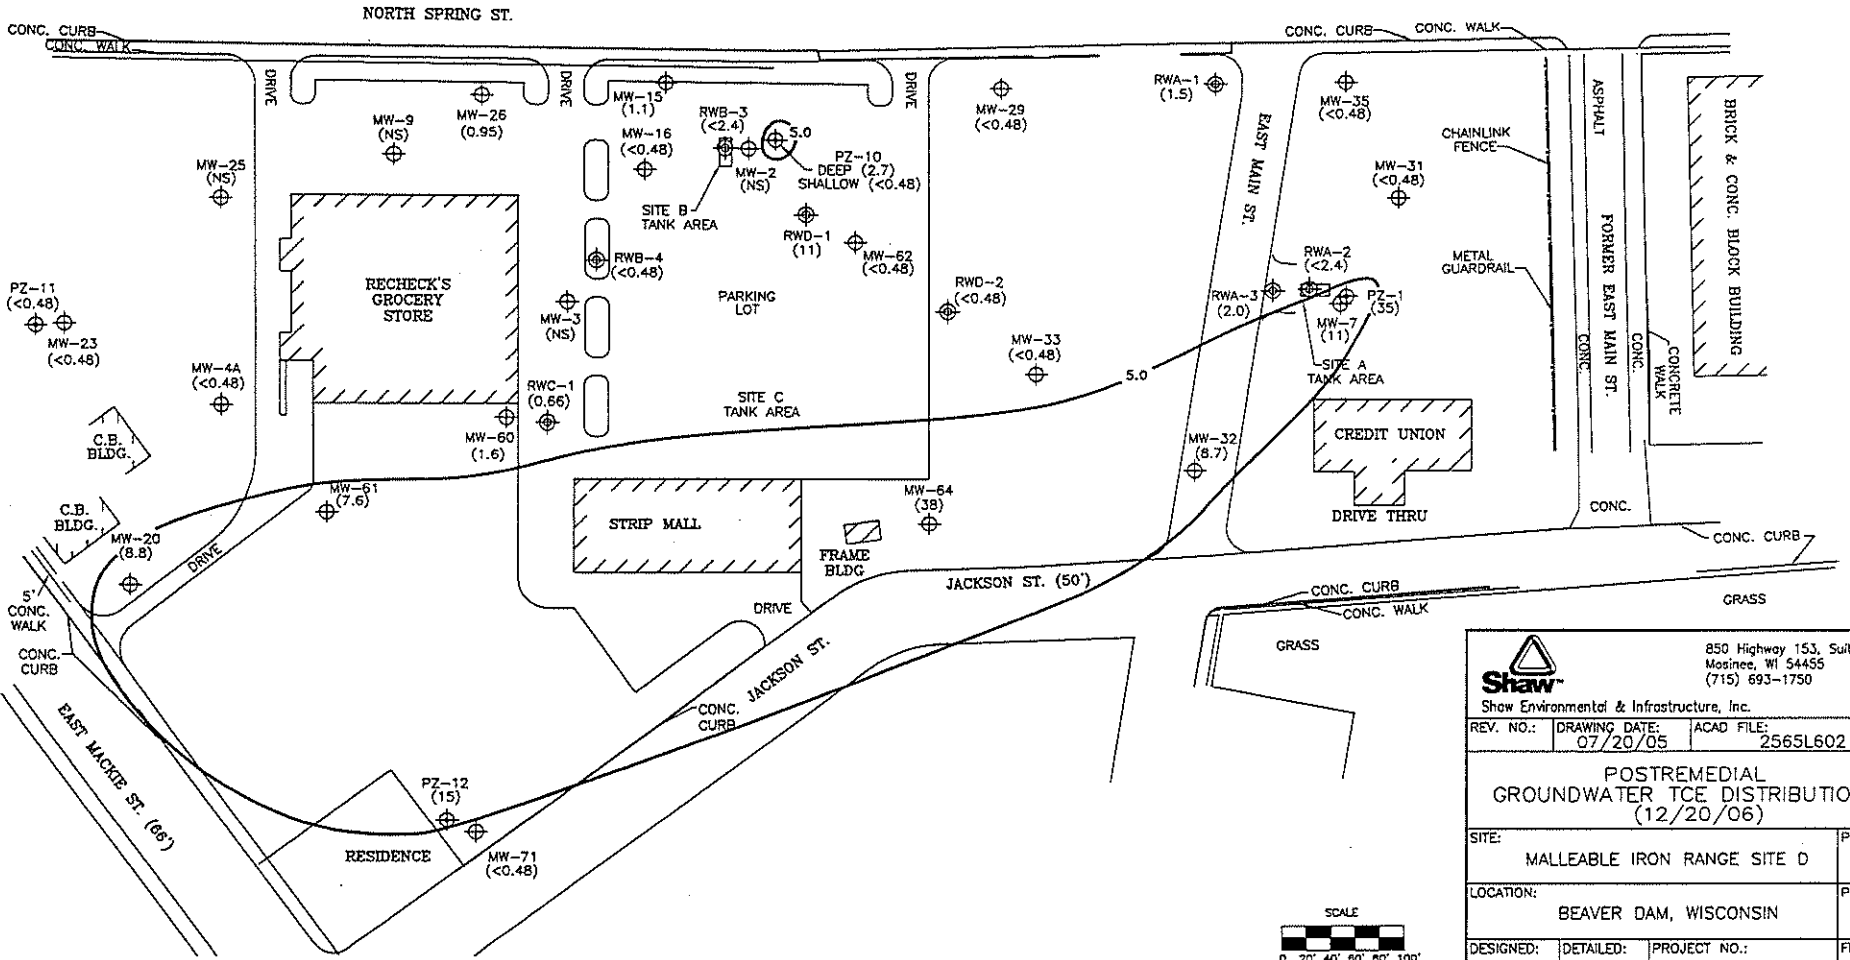
- LEGEND**
- ⊕ MONITORING WELL
  - ⊕ PIEZOMETER
  - ⊕ RECOVERY WELL
  - 5.0 ISOCOCONCENTRATION CONTOUR
  - ( ) TCE CONCENTRATION IN ppb
  - NS NOT SAMPLED
  - NOTE: THE NR140 ENFORCEMENT STANDARD FOR TCE IS 5.0 ppb

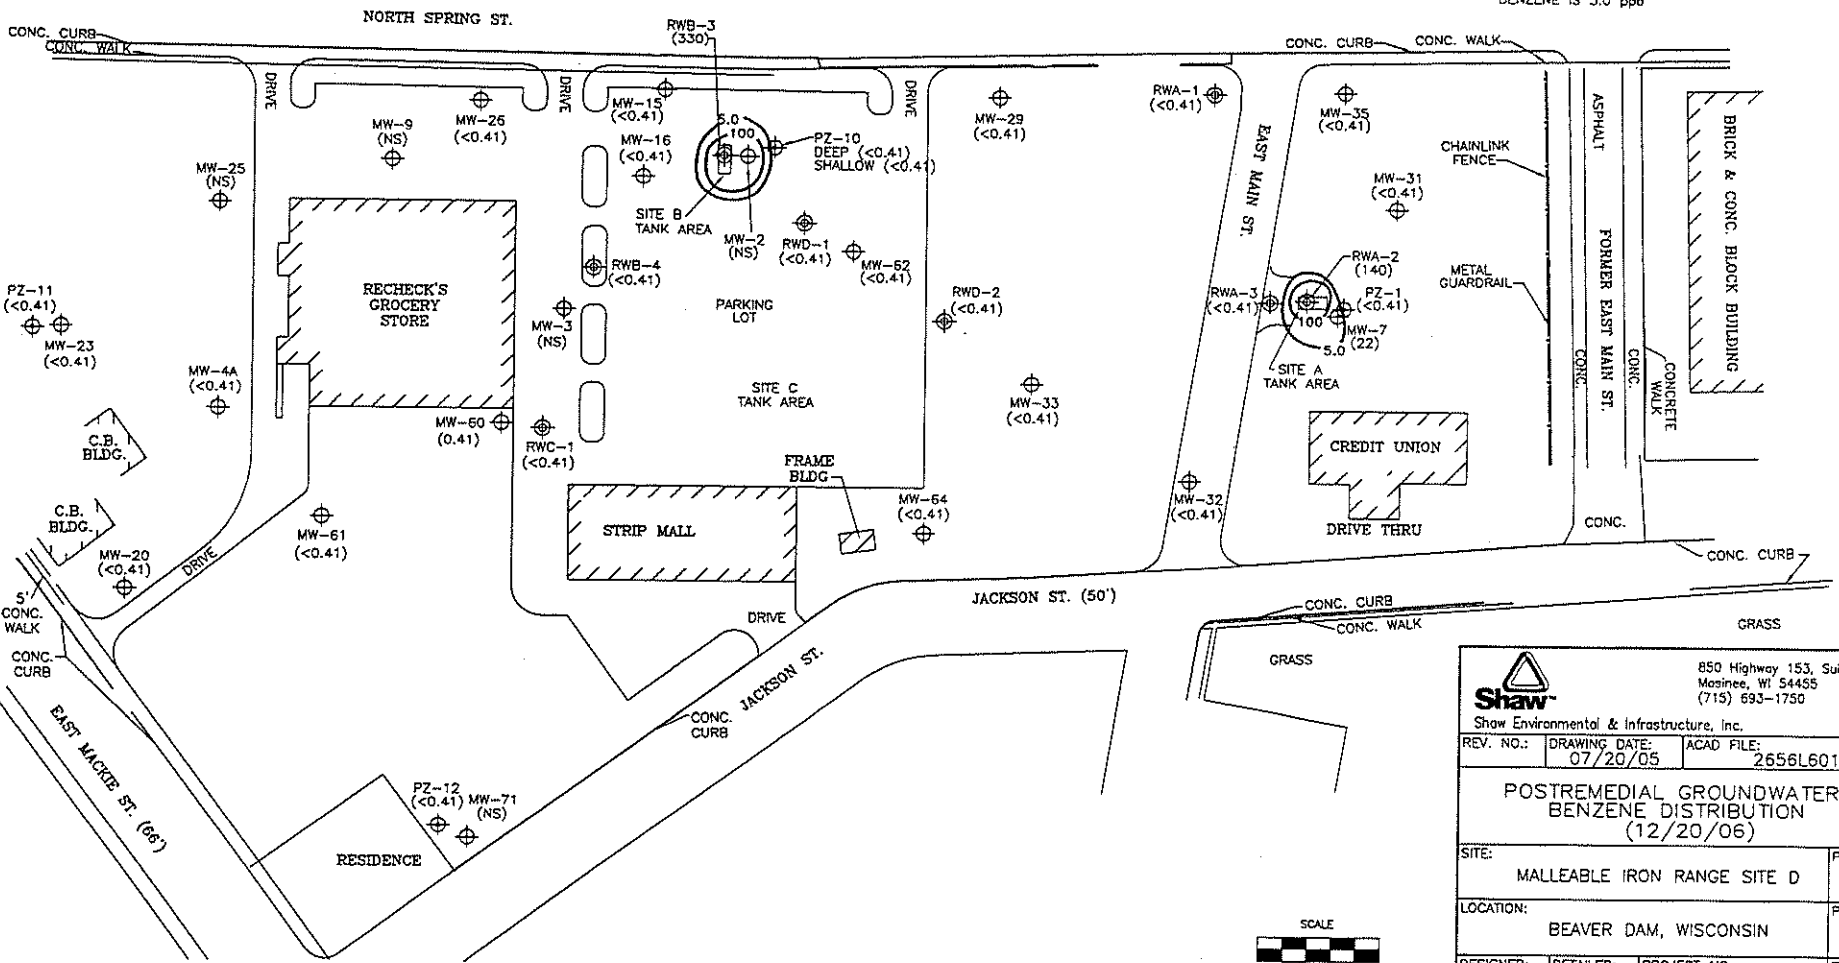
- ⊕ MONITORING WELL
- ⊕ PIEZOMETER
- ⊕ RECOVERY WELL
- 5.0 ISOCONCENTRATION CONTOUR
- ( ) BENZENE CONCENTRATION IN ppb
- NS NOT SAMPLED
- NOTE: THE NR140 ENFORCEMENT STANDARD FOR BENZENE IS 5.0 ppb

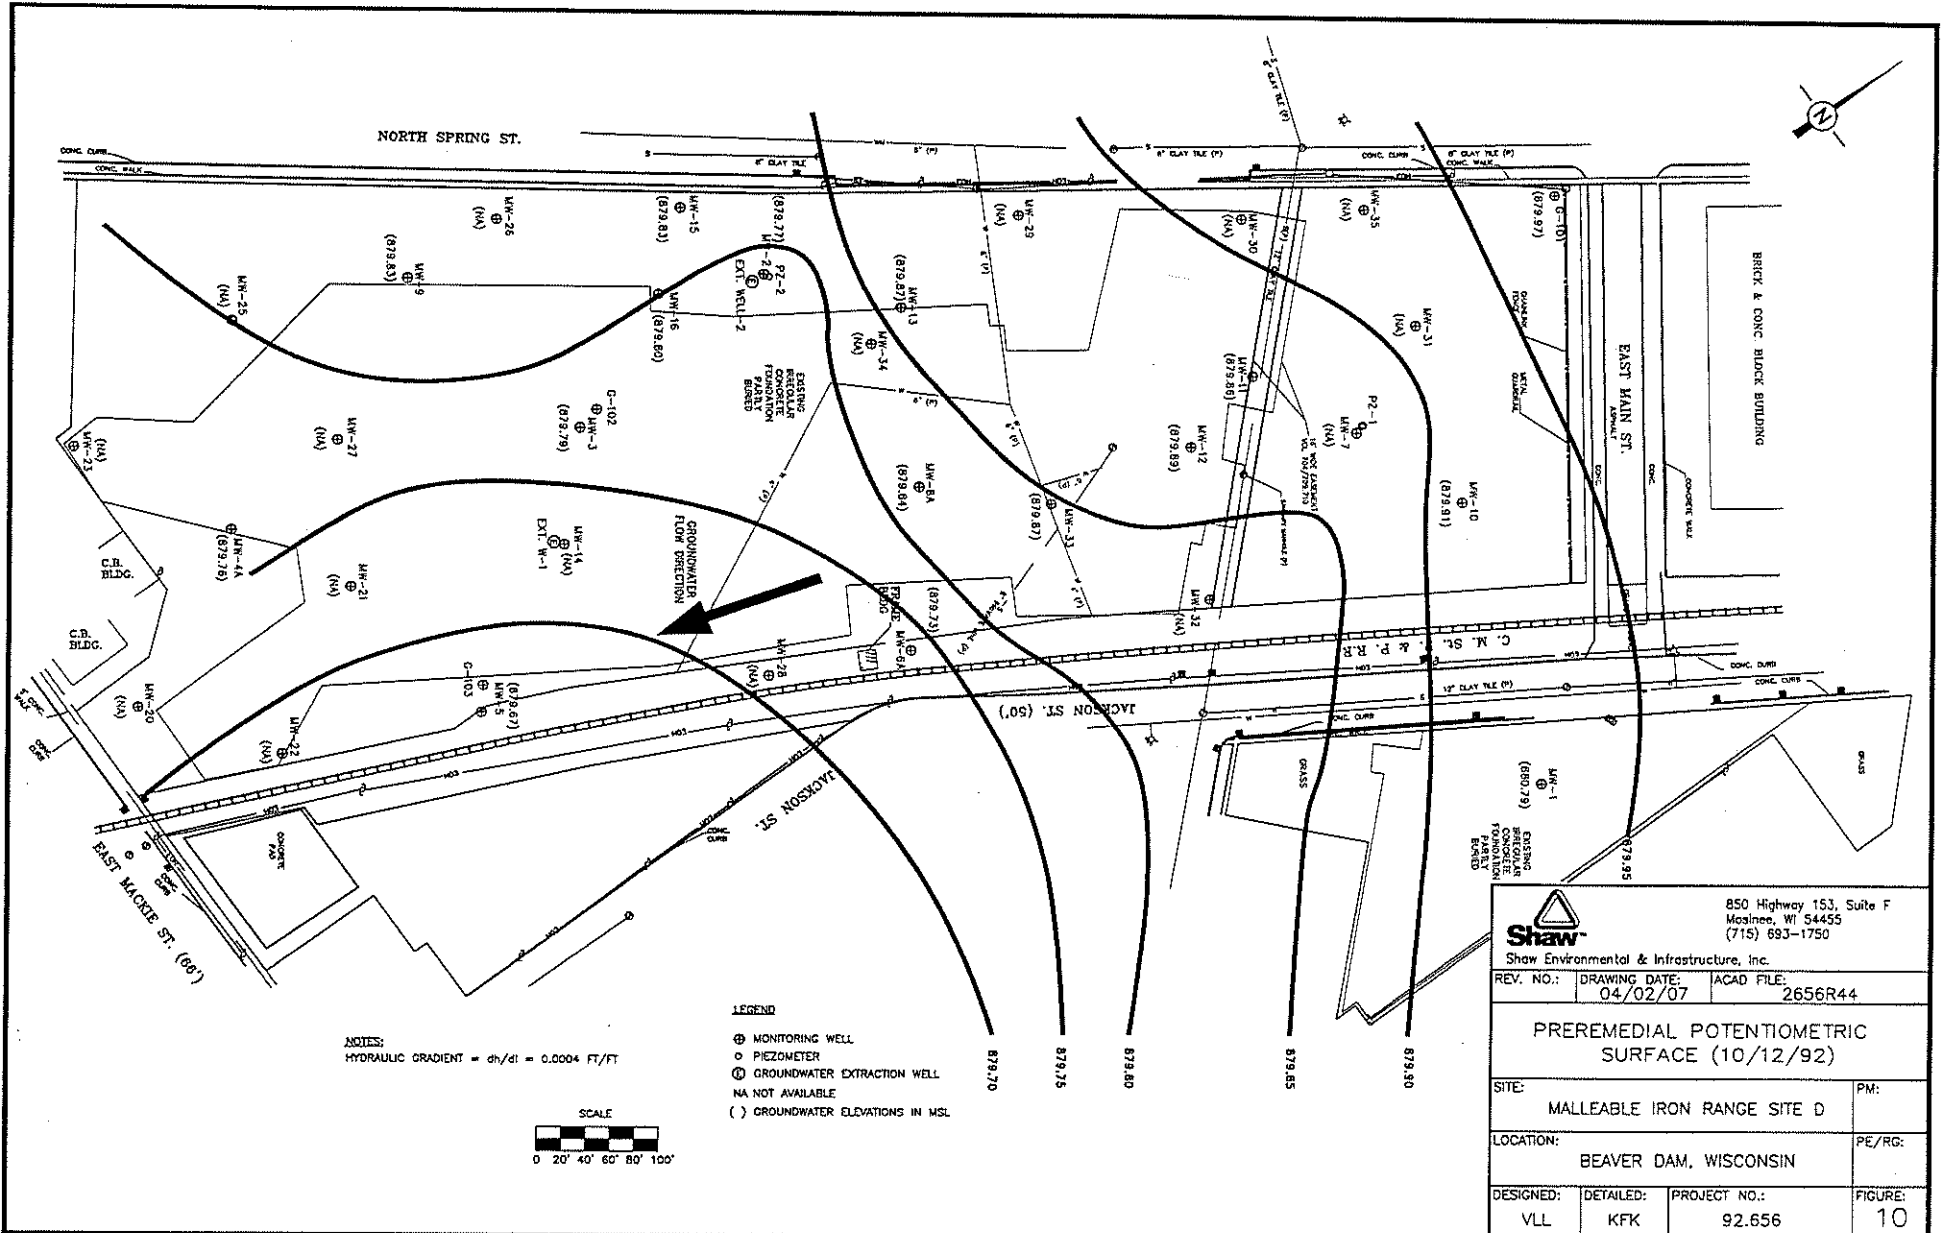
NOTES:  
HYDRAULIC GRADIENT =  $dh/dl = 0.0004$  FT/FT

- LEGEND
- ⊕ MONITORING WELL
  - PIEZOMETER
  - ⊖ GROUNDWATER EXTRACTION WELL
  - NA NOT AVAILABLE
  - ( ) GROUNDWATER ELEVATIONS IN MSL

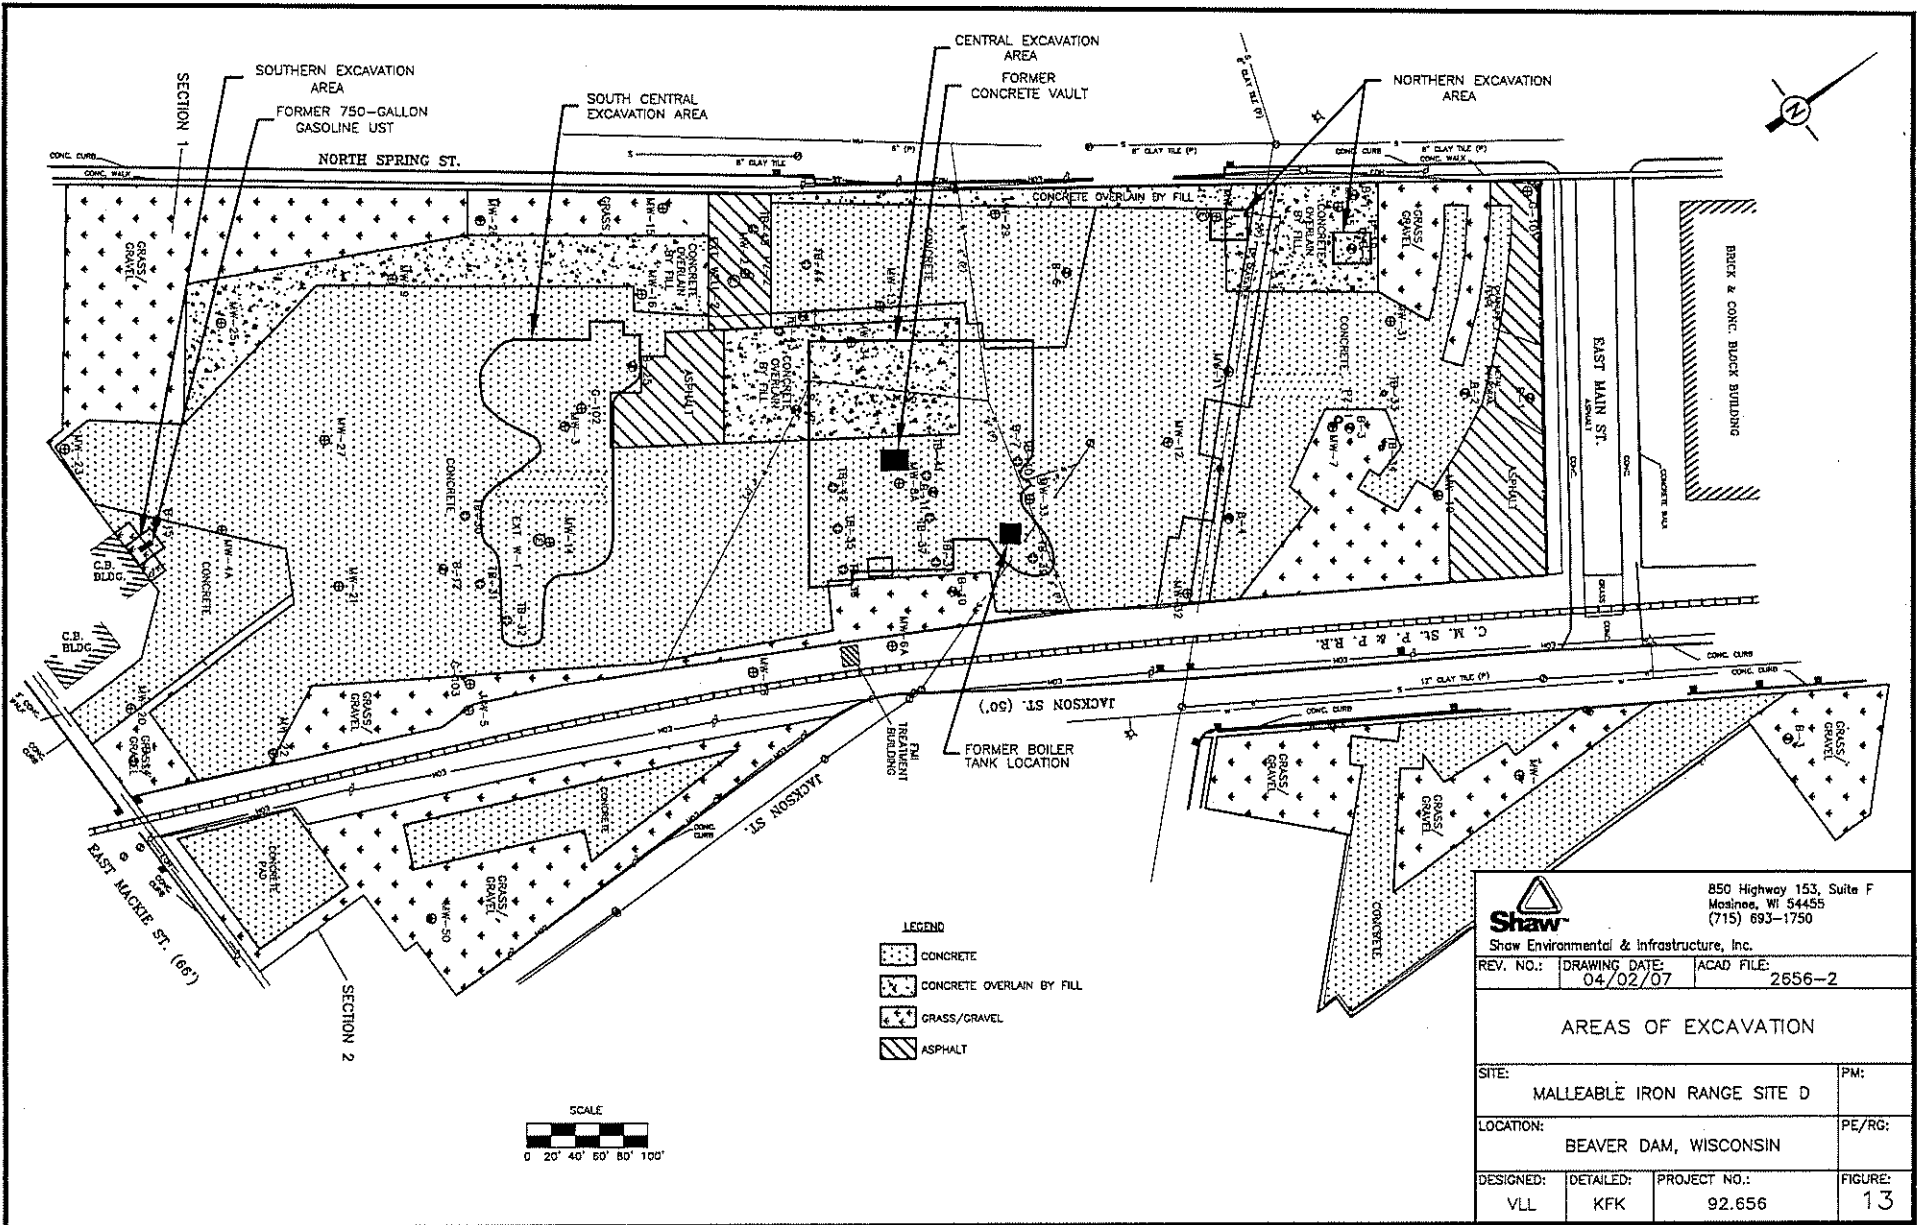
- LEGEND**
- CONCRETE
  - CONCRETE OVERLAIN BY FILL
  - GRASS/GRAVEL
  - ASPHALT

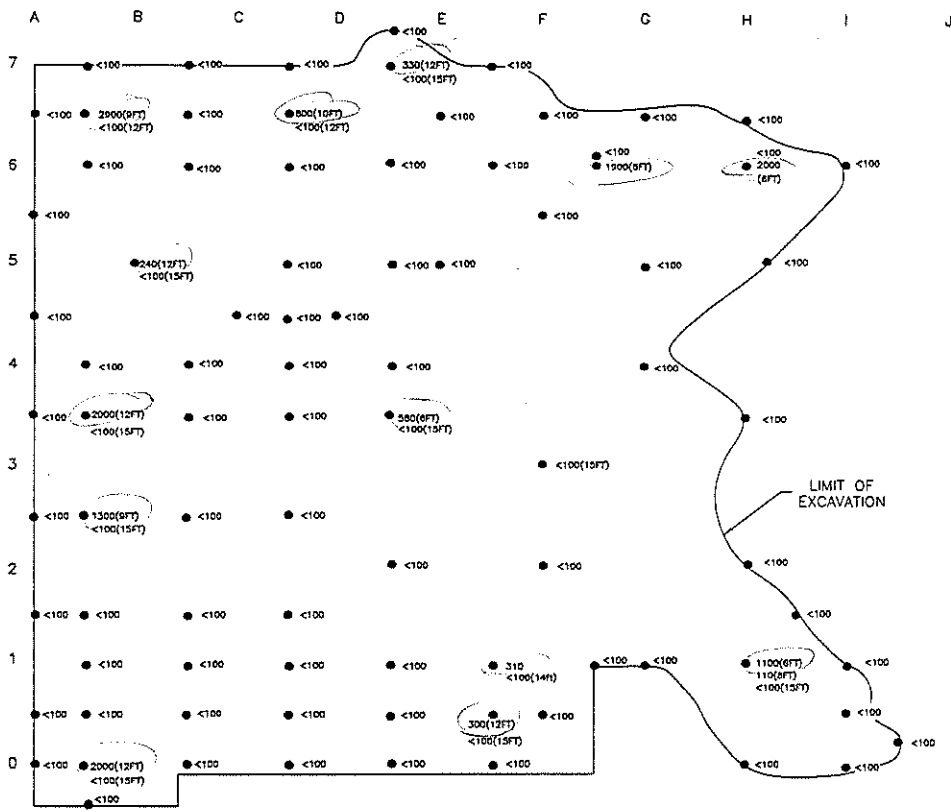
- SAMPLE LOCATION
- 300 (15) SOIL DRO CONCENTRATION IN ppm AND SAMPLE DEPTH
- SAMPLES WERE ACQUIRED FROM A DEPTH OF 12FT UNLESS OTHERWISE STATED

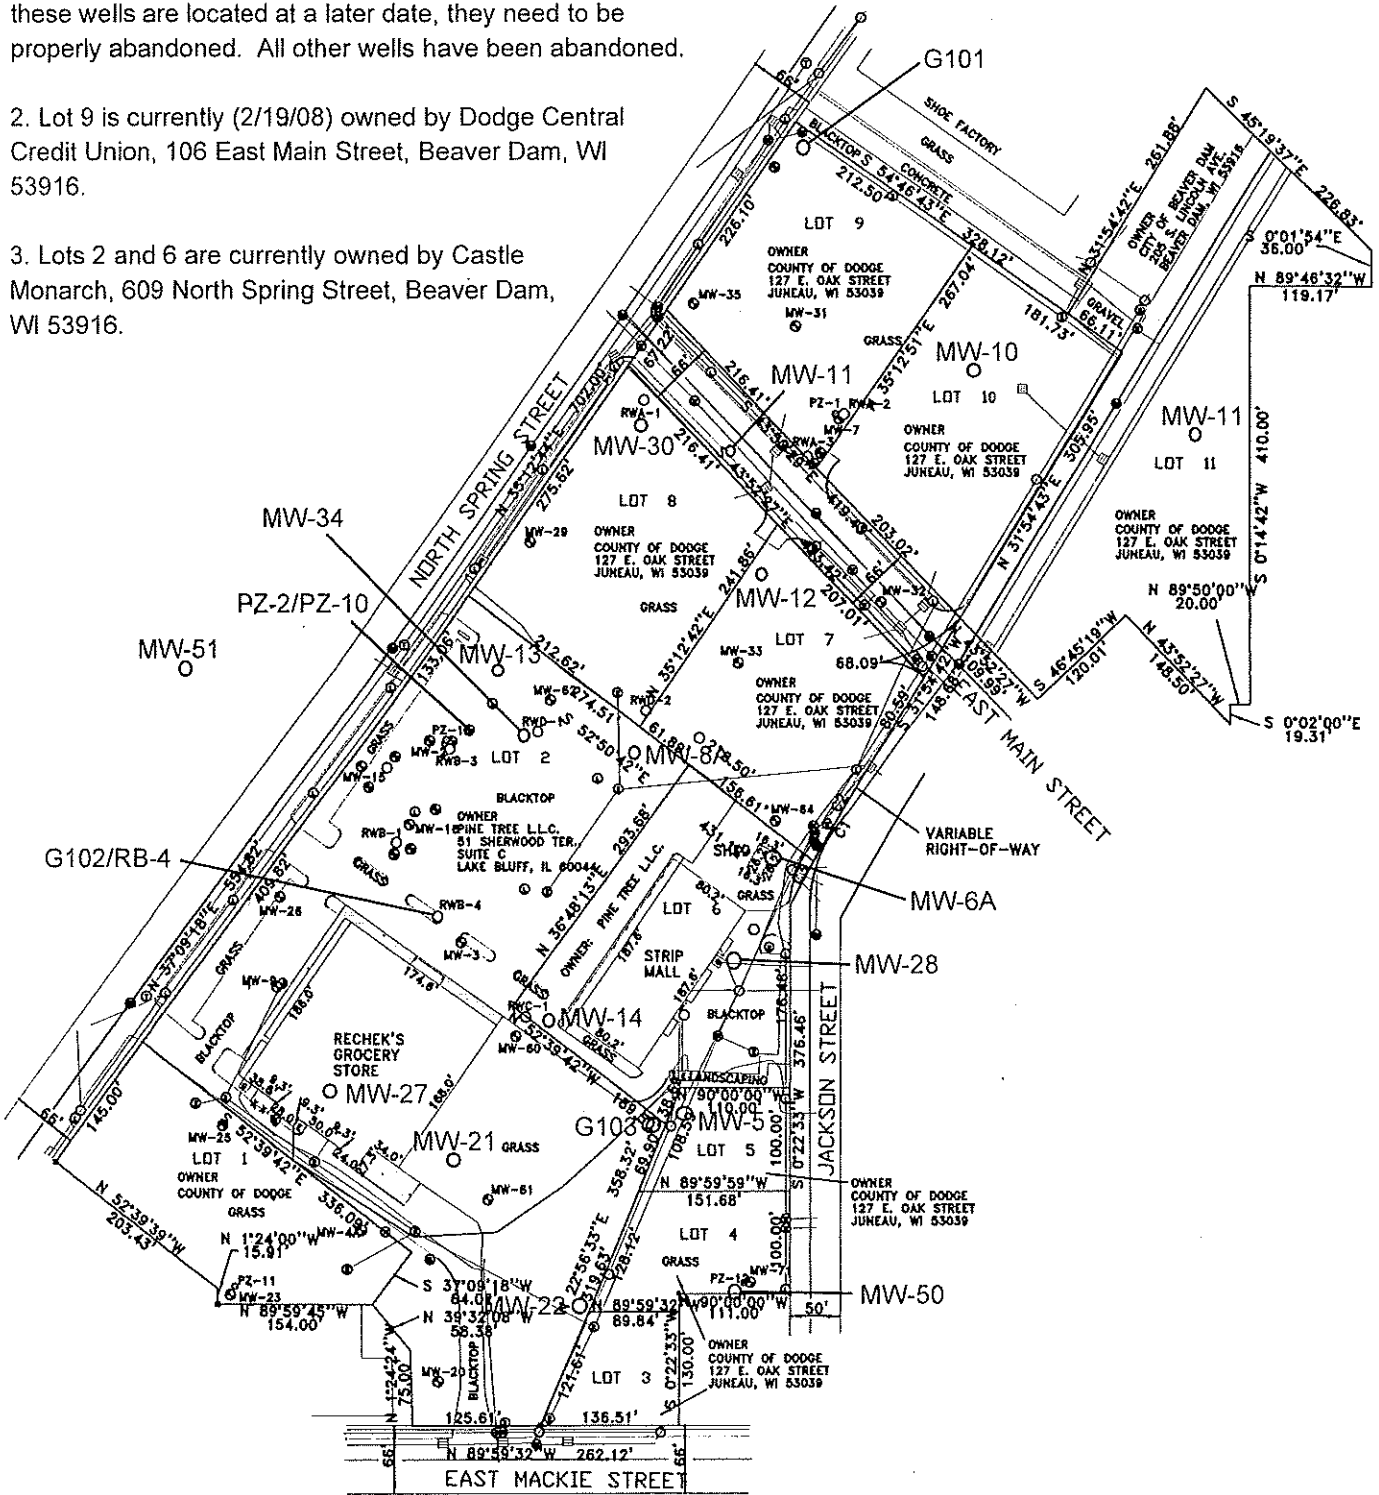
1. Monitoring wells G101, G103, MW-27, and MW28 were not able to be located during well abandonment activities. If these wells are located at a later date, they need to be properly abandoned. All other wells have been abandoned.

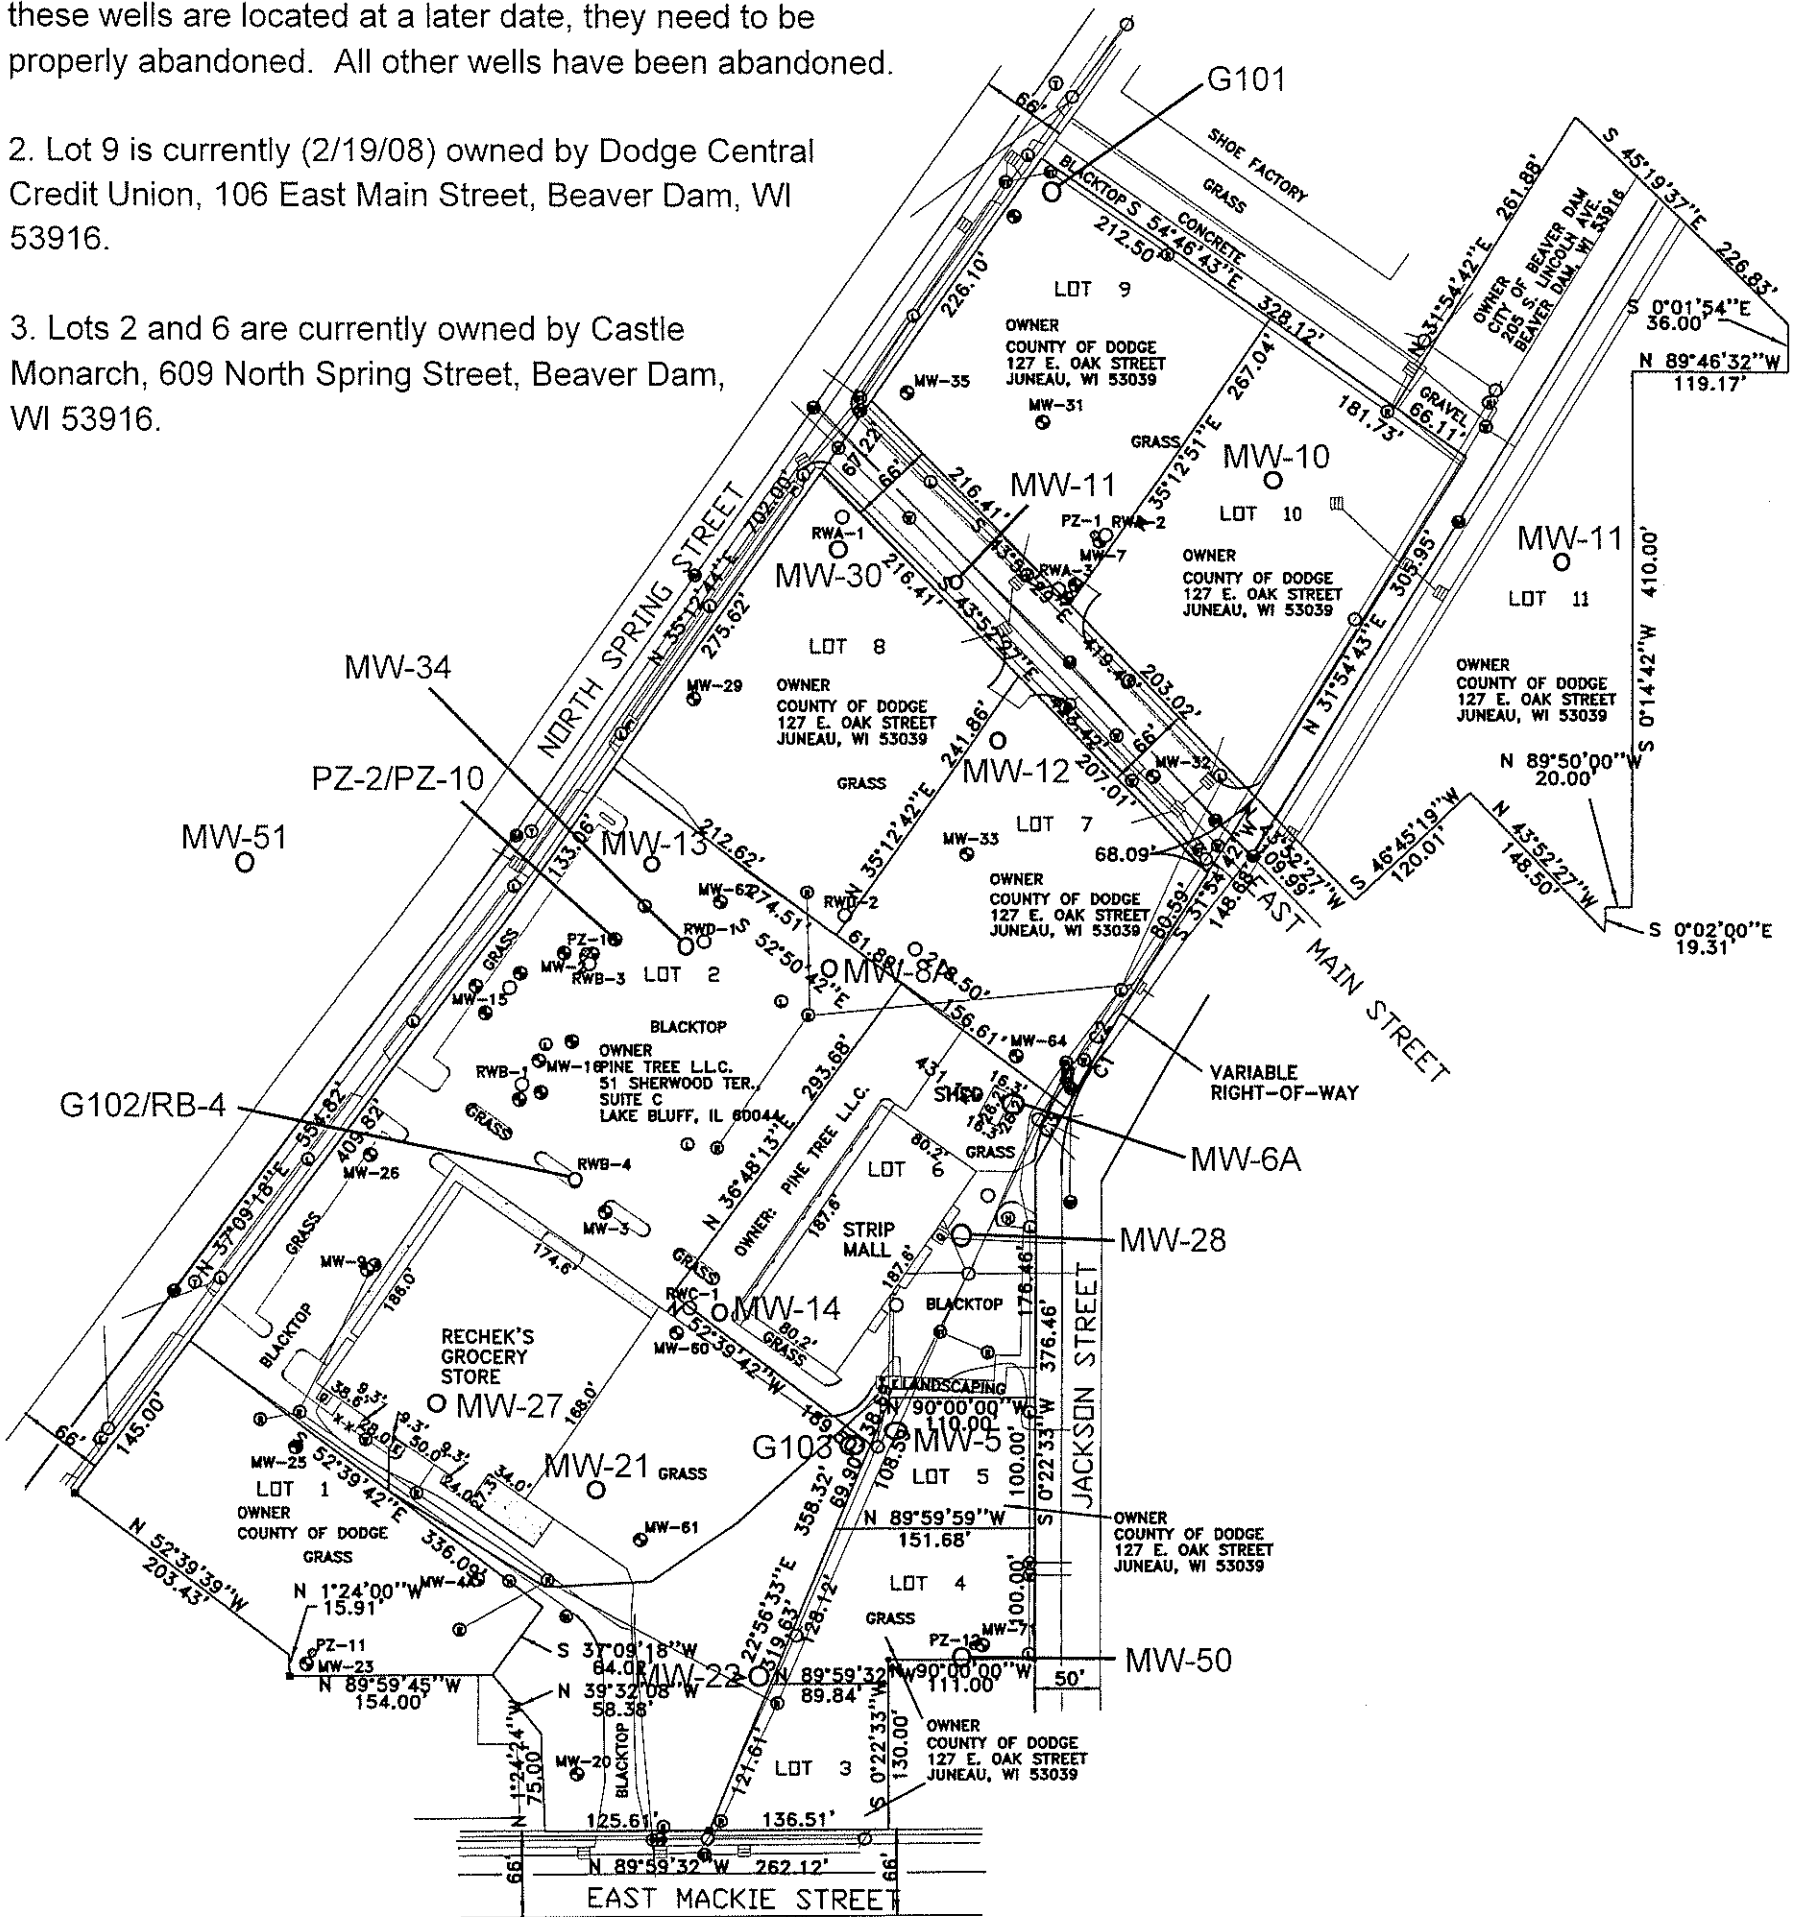
WELL DETAIL INFORMATION SHEET

JOB NO. 1858

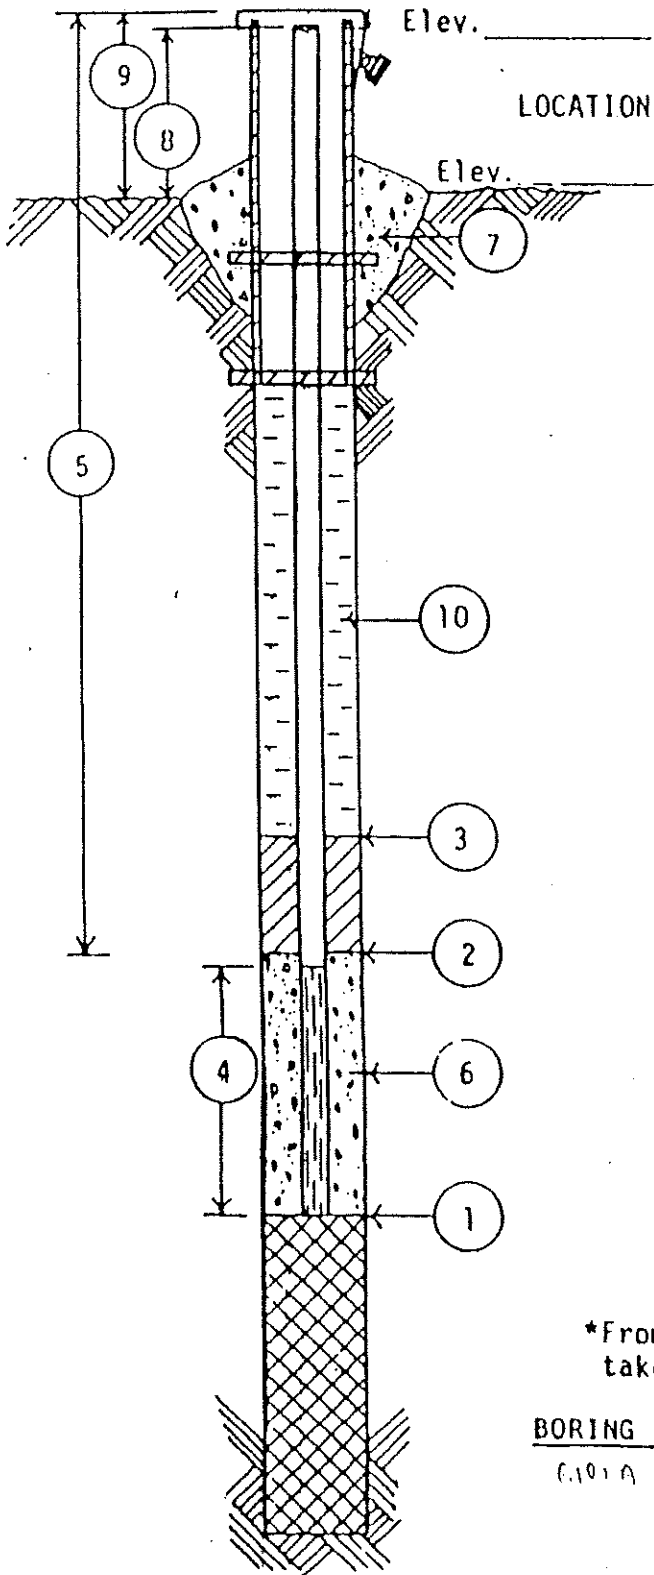
- ① DEPTH TO BOTTOM OF WELL POINT OR SLOTTED PIPE 18.8 18' 8" FEET.
- ② DEPTH OF BOTTOM OF SEAL (if installed) 9.8 9' 8" FEET.
- ③ DEPTH TO TOP OF SEAL (if installed) 7.8 7' 8" FEET.
- ④ LENGTH OF WELL POINT, PVC WELL SCREEN OR SLOTTED PIPE 5.0 FEET. (Circle One)
- ⑤ TOTAL LENGTH OF PIPE 14.8 FEET @ 2 IN. DIAMETER.
- ⑥ TYPE OF FILTER MATERIAL AROUND WELL POINT OR SLOTTED PIPE #30 Flint Sand.
- ⑦ CONCRETE CAP,  YES  NO (Circle One)
- ⑧ HEIGHT OF WELL CASING ABOVE GROUND 1.0 FEET.
- ⑨ PROTECTIVE CASING?  YES  NO (Circle One)  
HEIGHT ABOVE GROUND 1.2  
LOCKING CAP?  YES  NO (Circle One)
- ⑩ TYPE OF BACKFILL: Hole Plug  
Quick Set Mortar Drilling

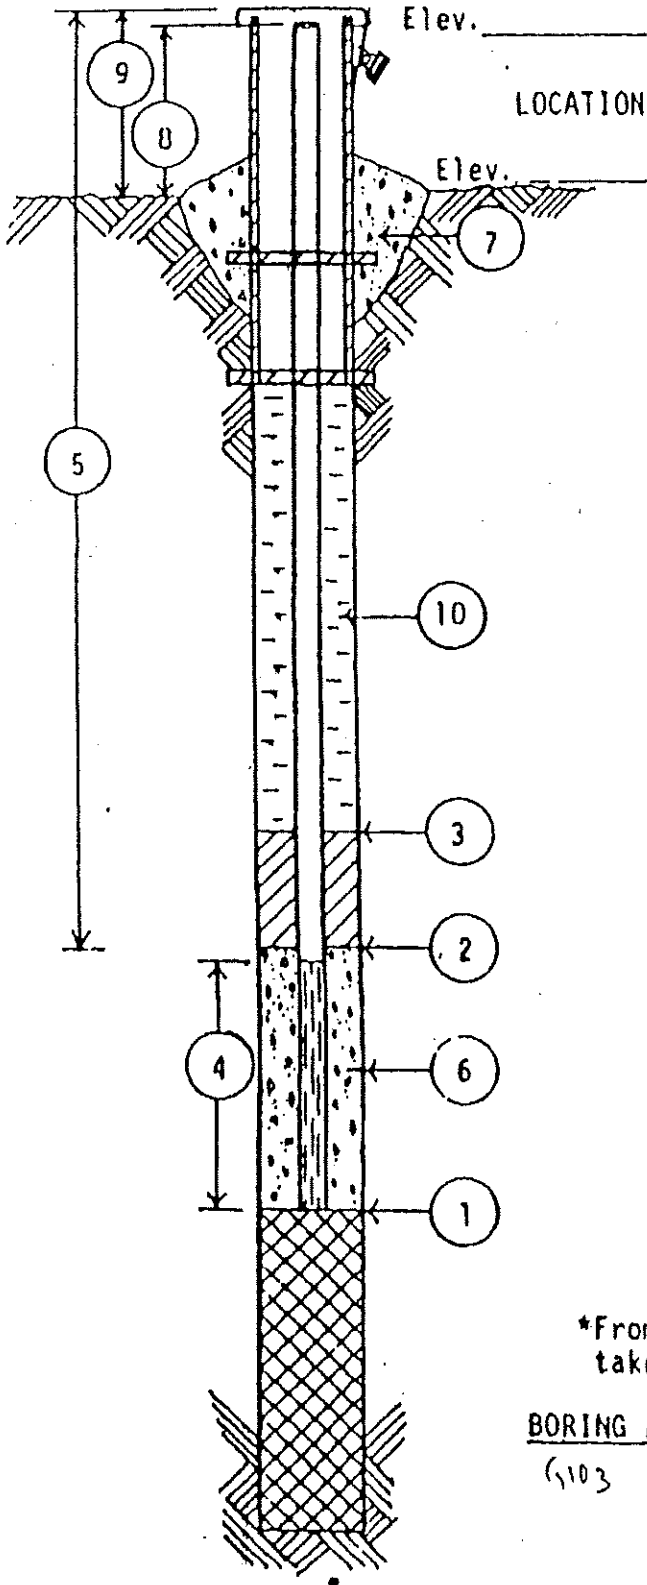
- ① DEPTH TO BOTTOM OF WELL POINT OR SLOTTED PIPE 17.8 FEET.
- ② DEPTH OF BOTTOM OF SEAL (if installed) 10.0 FEET.
- ③ DEPTH TO TOP OF SEAL (if installed) 8.5 8'6" FEET.
- ④ LENGTH OF WELL POINT, PVC WELL SCREEN, OR SLOTTED PIPE 5.0 FEET. (Circle One)
- ⑤ TOTAL LENGTH OF PIPE 13.8 FEET @ 2 IN. DIAMETER.
- ⑥ TYPE OF FILTER MATERIAL AROUND WELL POINT OR SLOTTED PIPE #30 Flint Sand.
- ⑦ CONCRETE CAP,  YES  NO (Circle One)
- ⑧ HEIGHT OF WELL CASING ABOVE GROUND 1.0 FEET.
- ⑨ PROTECTIVE CASING?  YES  NO (Circle One)  
HEIGHT ABOVE GROUND 1.3  
LOCKING CAP?  YES  NO (Circle One)
- ⑩ TYPE OF BACKFILL: Hole Plug
