SUBJECT: Final Case Closure with Continuing Obligations  
Walkers One Stop Coop, 10410 Bridge St, Gratiot, WI 53541  
DNR BRRTS Activity #: 03-33-001415

**B.2.b RESIDUAL SOIL CONTAMINATION**  
**WALKER'S ONE STOP**

B.I.b DETAILED SITE MAP  
WALKER'S ONE STOP

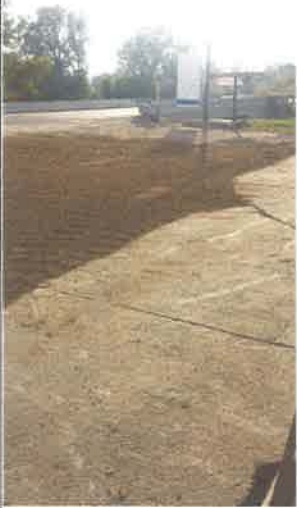
Title: Area of concrete cap to be maintained looking southwest.

The concrete cap overlying the contaminated soil and as depicted in Attachment D.2 will be inspected once a year, normally in the spring after all snow and ice is gone, for deterioration, cracks and other potential problems that can cause exposure to underlying soils. The inspections will be performed by the property owner or their designated representative. The inspections will be performed to evaluate damage due to settling, exposure to the weather, wear from traffic, increasing age and other factors. Any area where soils have become or are likely to become exposed and where infiltration from the surface will not be effectively minimized will be documented.

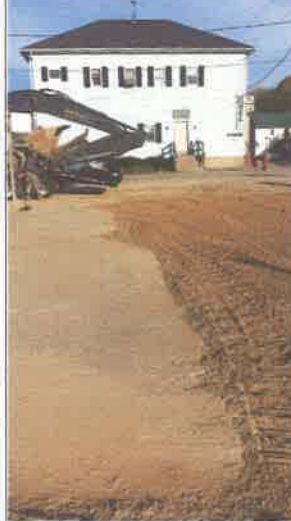
Title: Area of concrete cap to be maintained looking east.

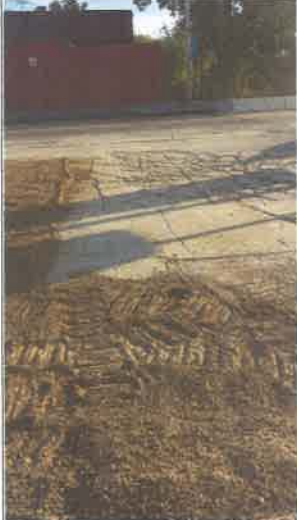
Title: Area of concrete cap to be maintained looking south.

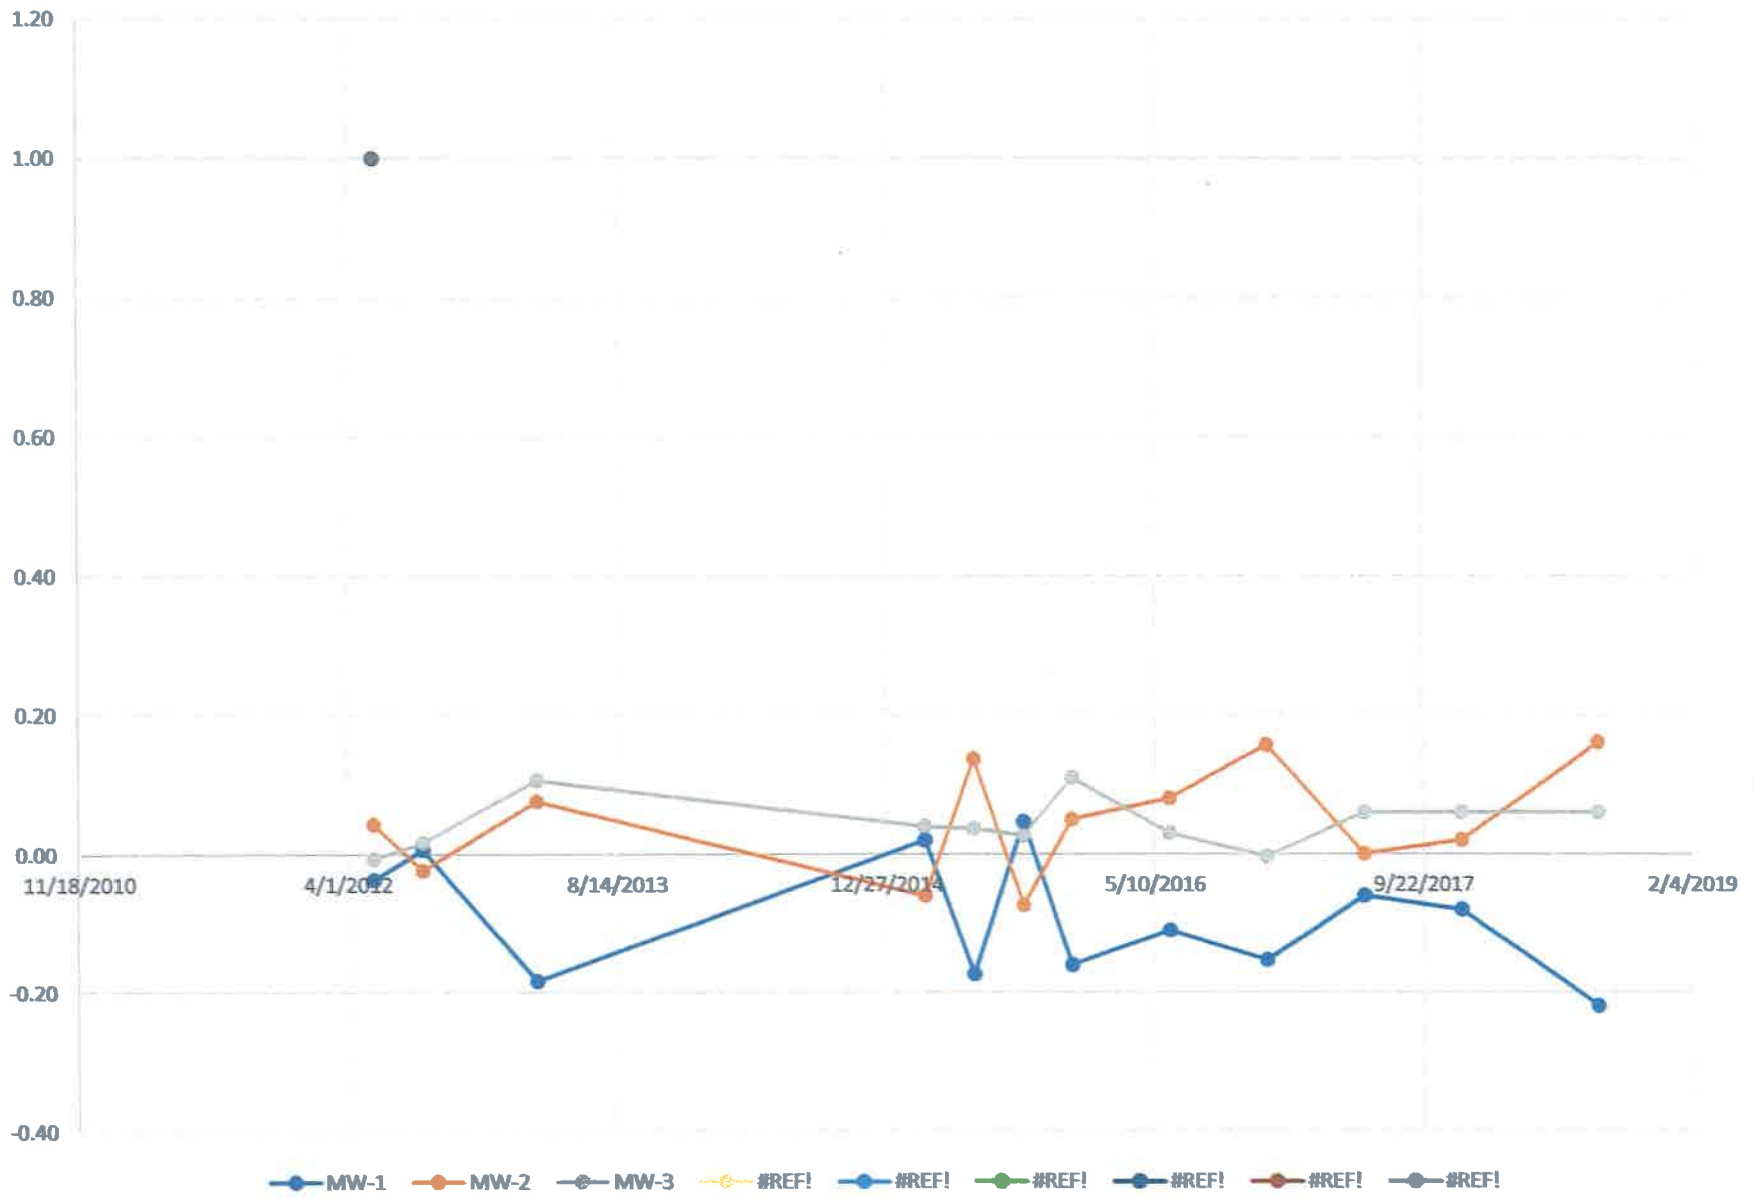
A.7 Hydrograph

walkers water level vs average of that round

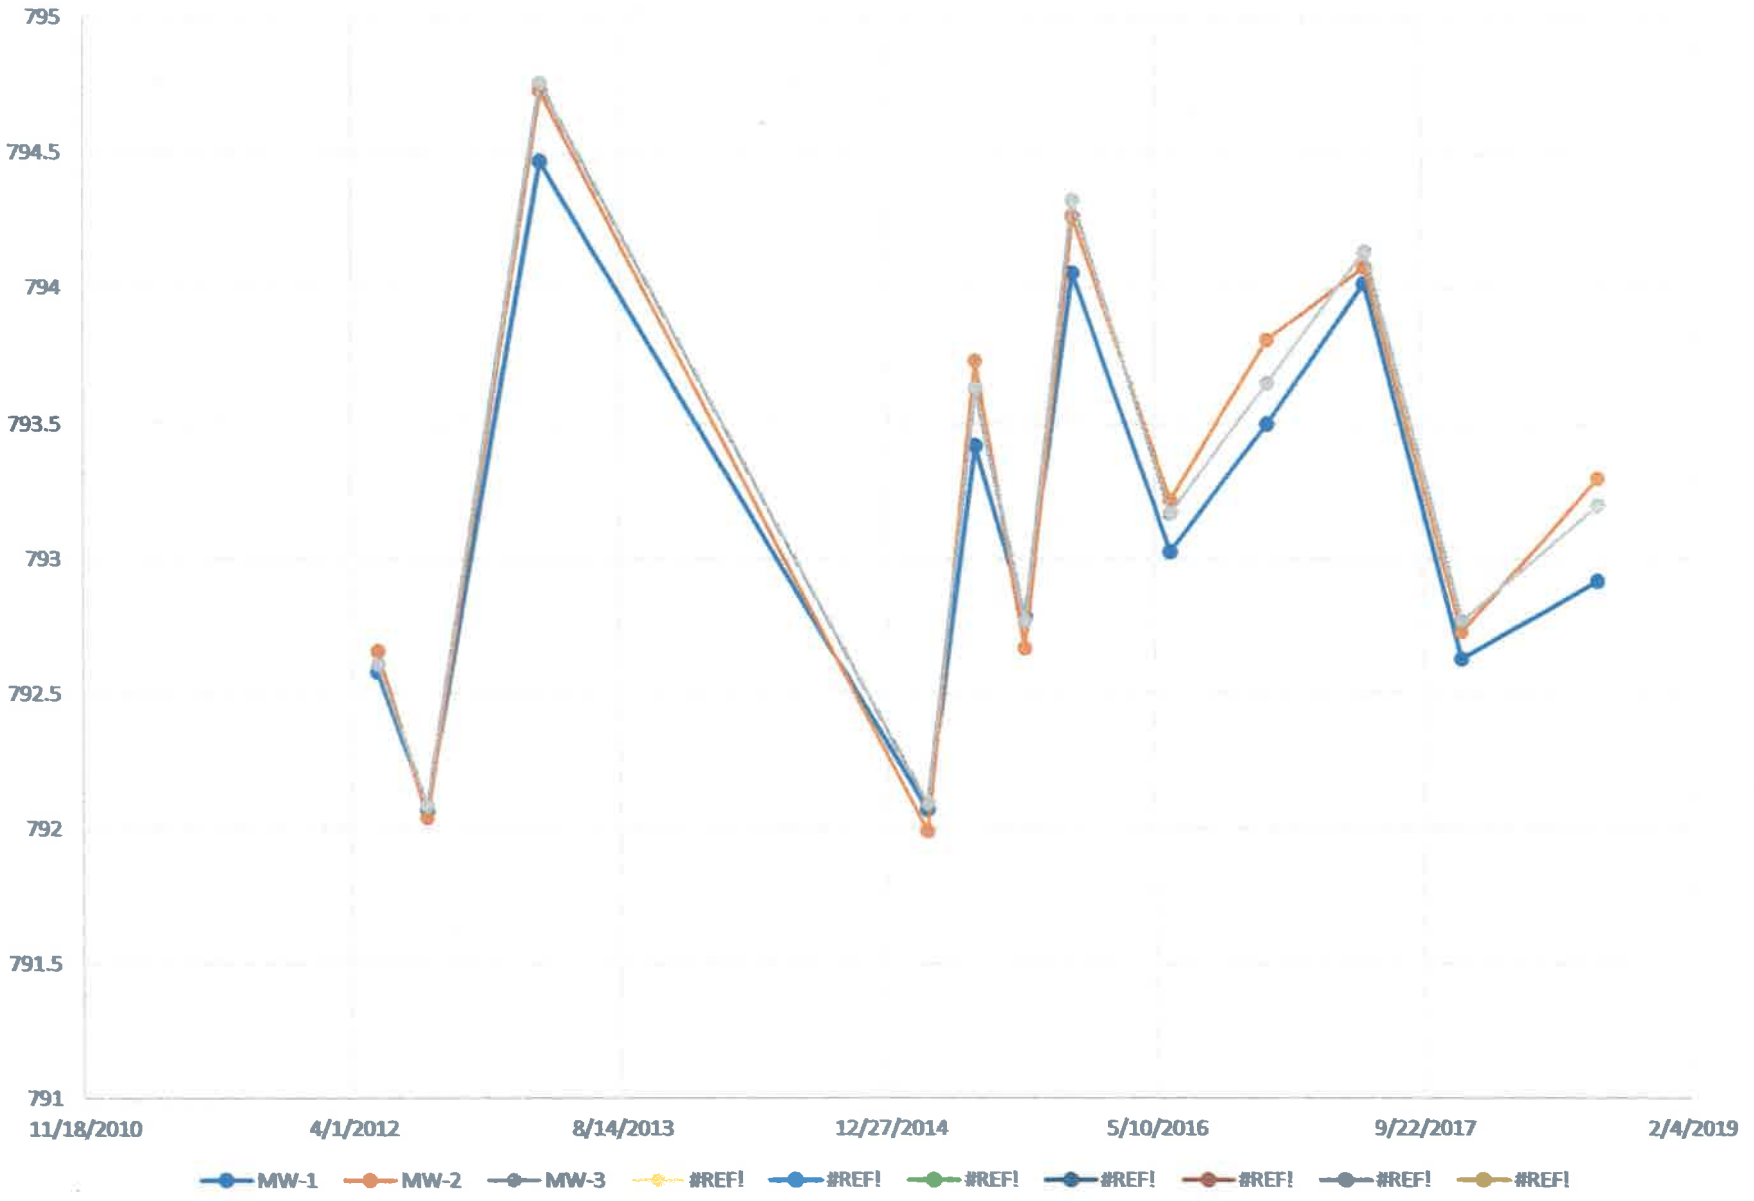
A-7 Hydrograph

### Walkers' water levels

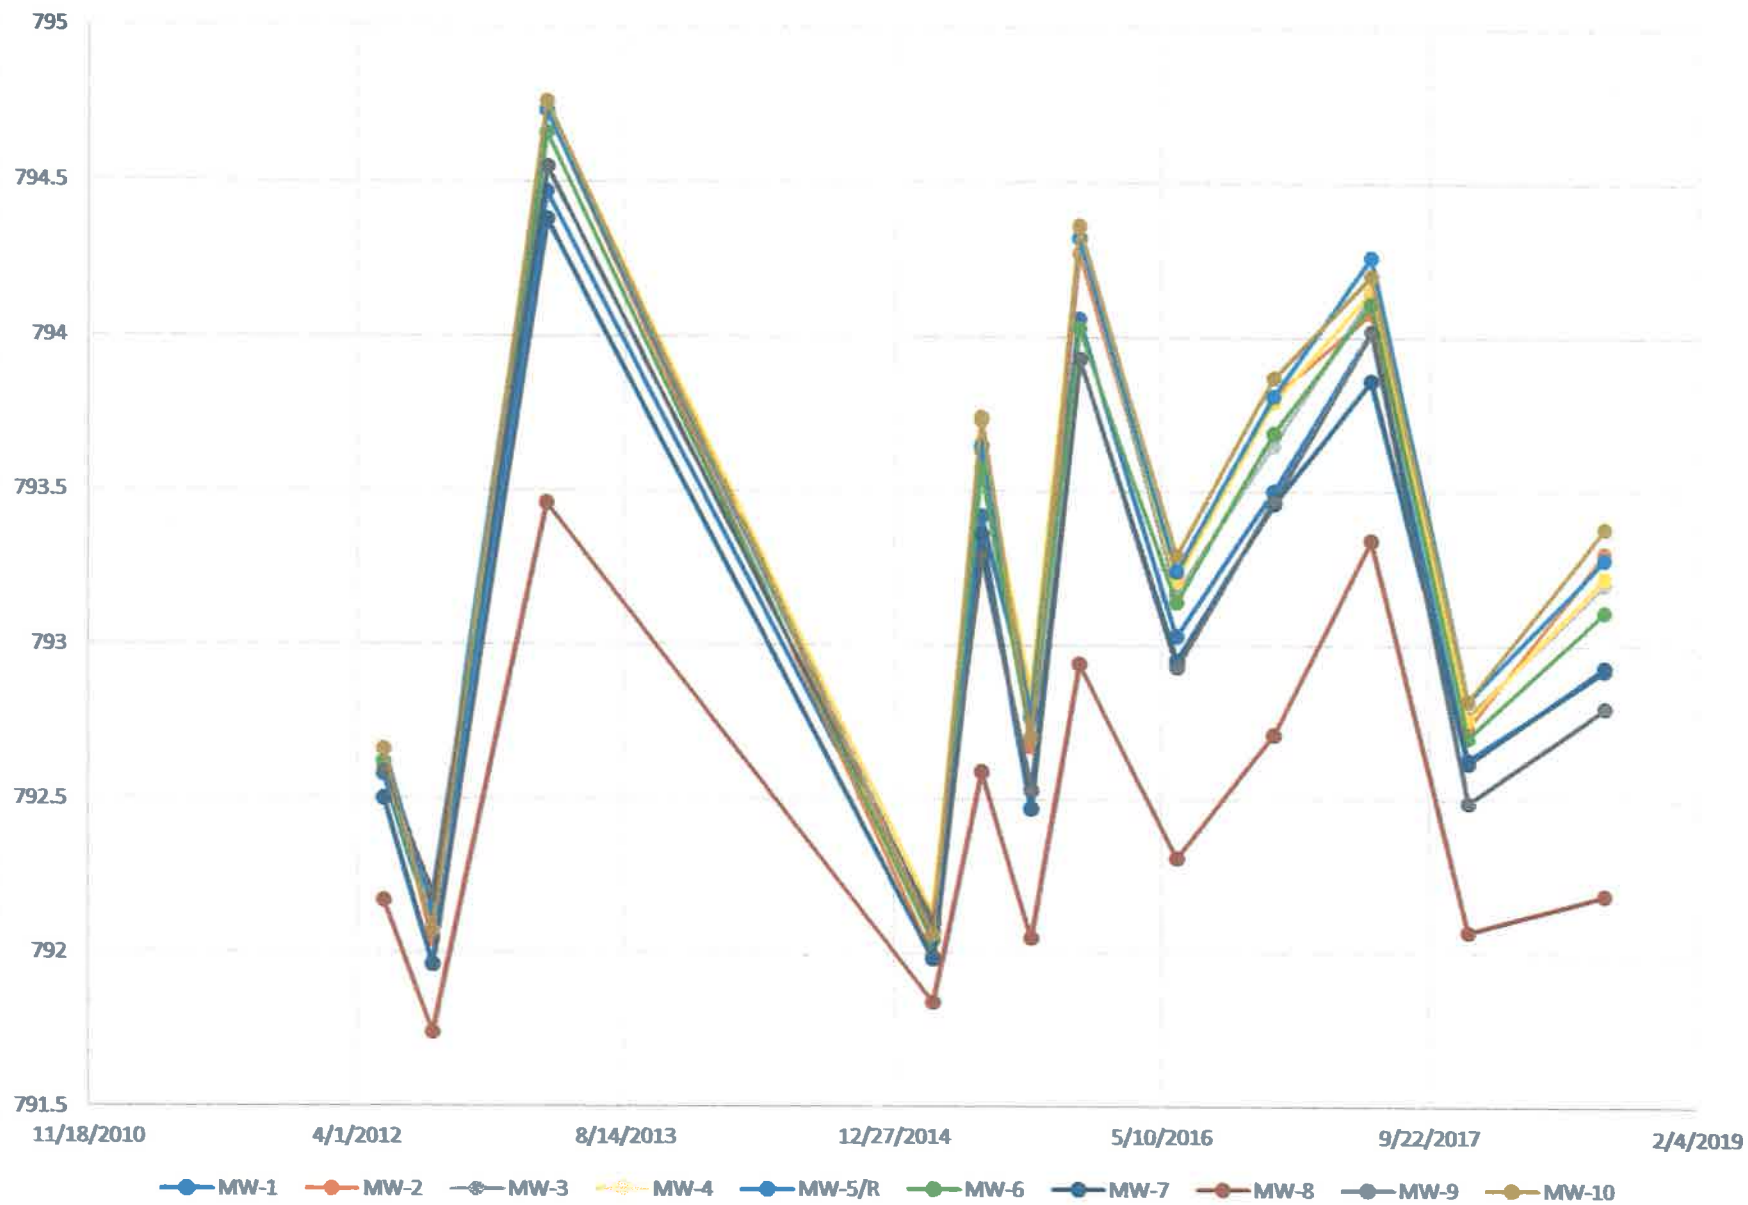
A. F. Hydrograph

### Walkers' water levels

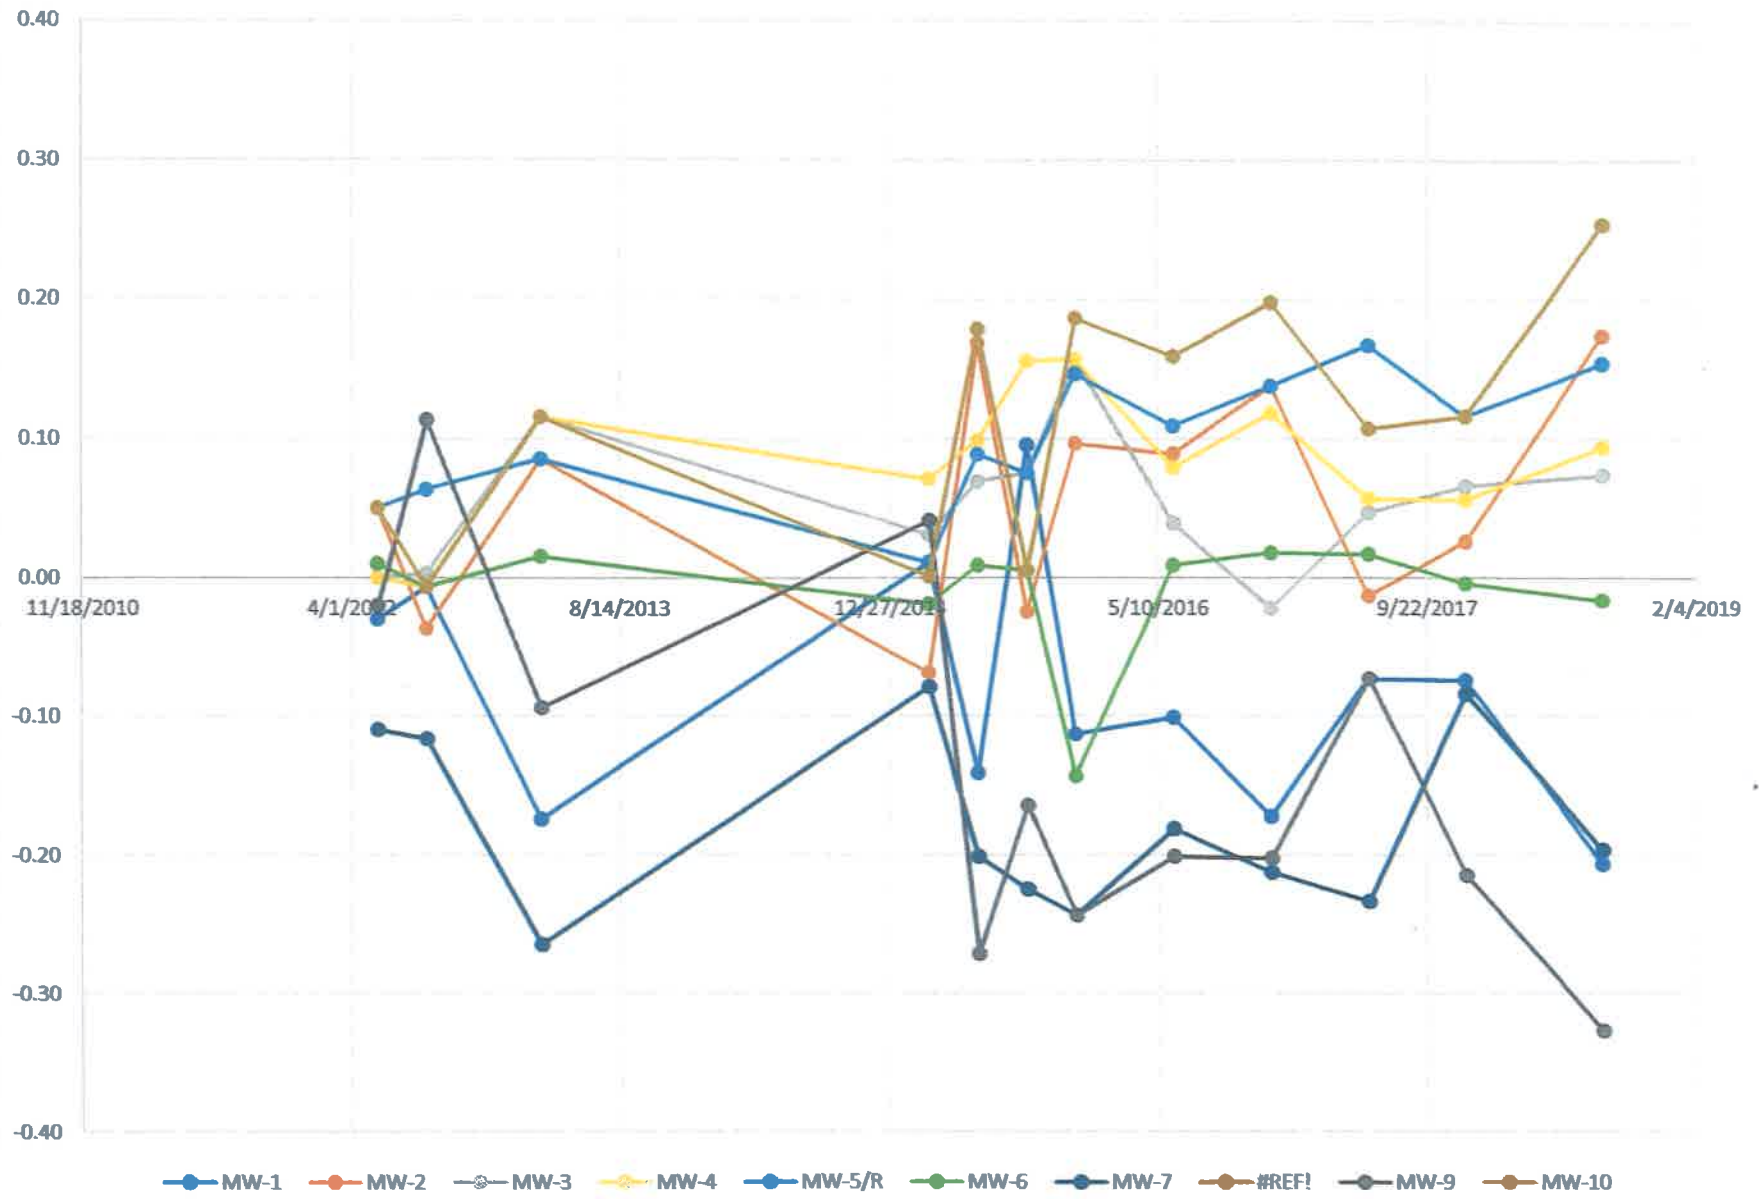
A.T Hydrograph

walkers water level vs average of that round sans MW-8

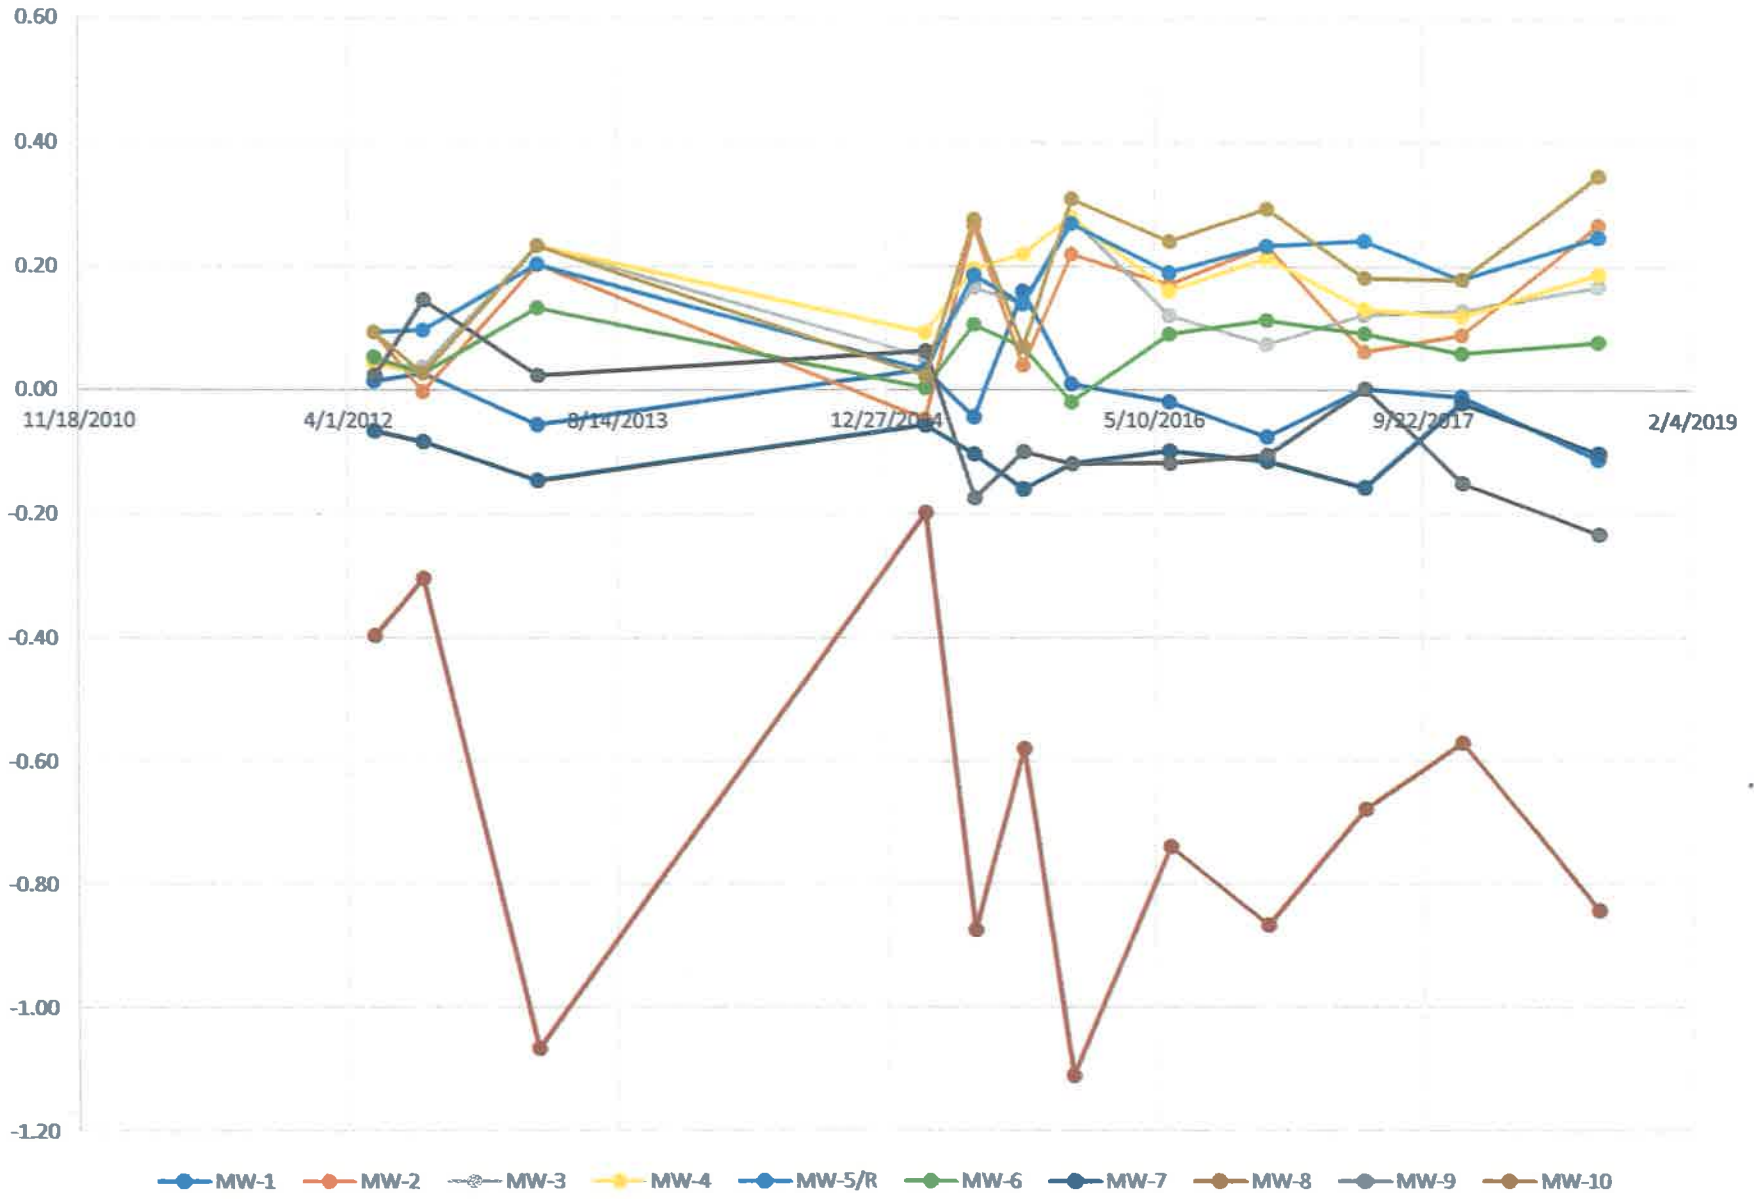
A. J. Hydrograph

walkers water level vs average of that round

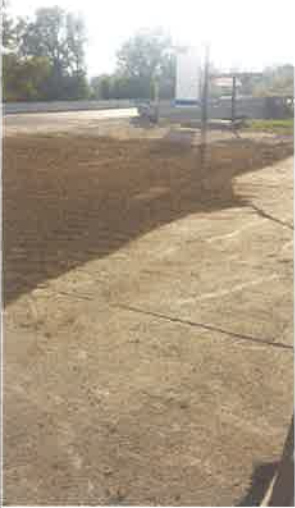
Title: Area of concrete cap to be maintained looking southwest.

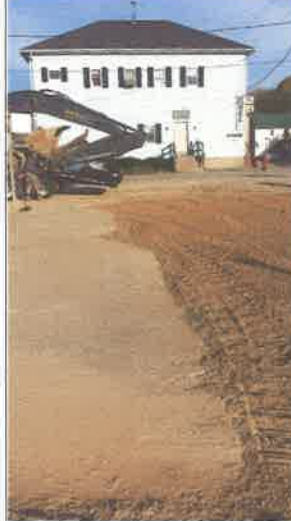
Title: Area of concrete cap to be maintained looking east.

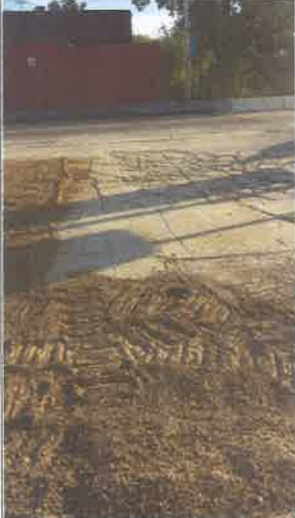
Title: Area of concrete cap to be maintained looking south.
