SUBJECT: Final Case Closure with Continuing Obligations
Dave's Gas Station (Former), 405 N Washington St, Merrilan, WI
DNR BRRTS Activity #: 03-27-001459

B.2.b RESIDUAL SOIL CONTAMINATION DAVE'S GAS STATION (FORMER)

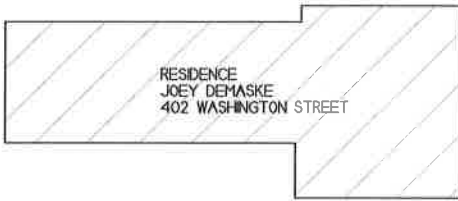
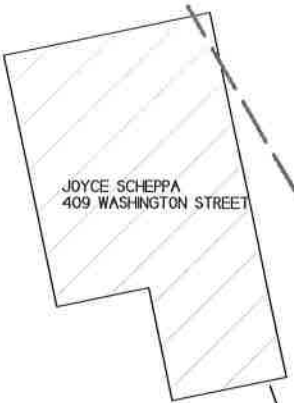
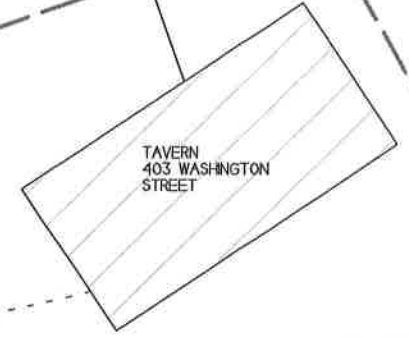
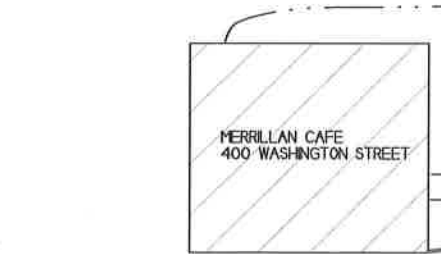
- WATER LINE
- SANITARY SEWER LINE
- NATURAL GAS LINE
- OVERHEAD UTILITIES
- PROPERTY BOUNDARY
- TELEPHONE LINE
- BURIED ELECTRIC LINE

CANADIAN NATIONAL RAILROAD RIGHT OF WAY (200 FEET WIDE)

UNION PACIFIC RAILROAD RIGHT OF WAY (100 FEET WIDE)

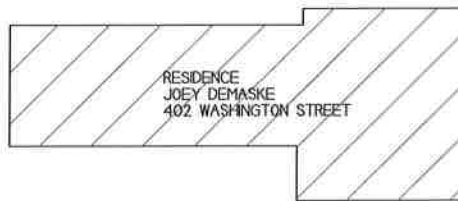
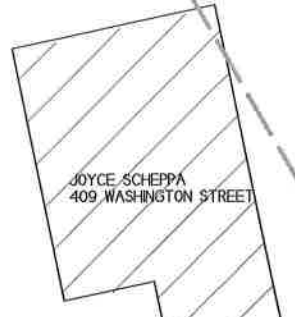
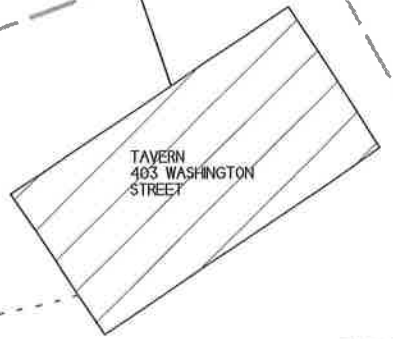
- EXCAVATION AREA (METCO, JUNE 2017)

APPROXIMATE LIMITS OF
 WDNR OVEREXCAVATION:

WASHINGTON STREET USH 12/STH 27
