**Subject: Supplemental Site Investigations Report
Former Dutch Cleaners
403 S. Main Street, Cedar Grove, Wisconsin
BRRTS# 02-60-271527**

Title: Groundwater Isoconcentration August 13, 2014		FEHR GRAHAM ENGINEERING & ENVIRONMENTAL	
Site: Former Dutch Cleaners 403 S. Main St. Cedar Grove, WI 53013			
Description:		Job # 14-1115 BRRTS# 02-60-271527	Date: DATE: 10/11/13
Rev:	Date:	Appvd:	File: F:Base Map-Dutch-14.1115.skf
		Drawn: KAE	Figure: B.3.b

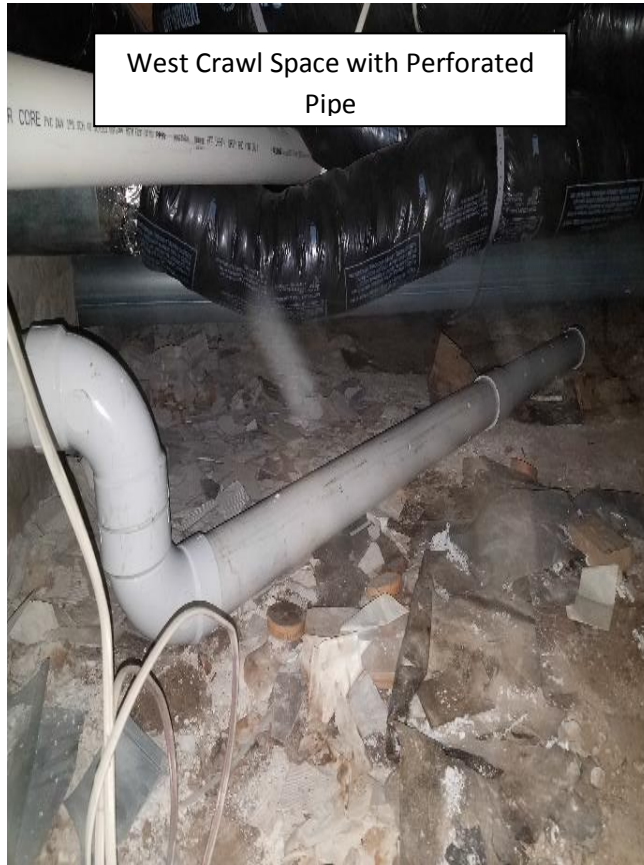
West Crawl Space with Perforated Pipe

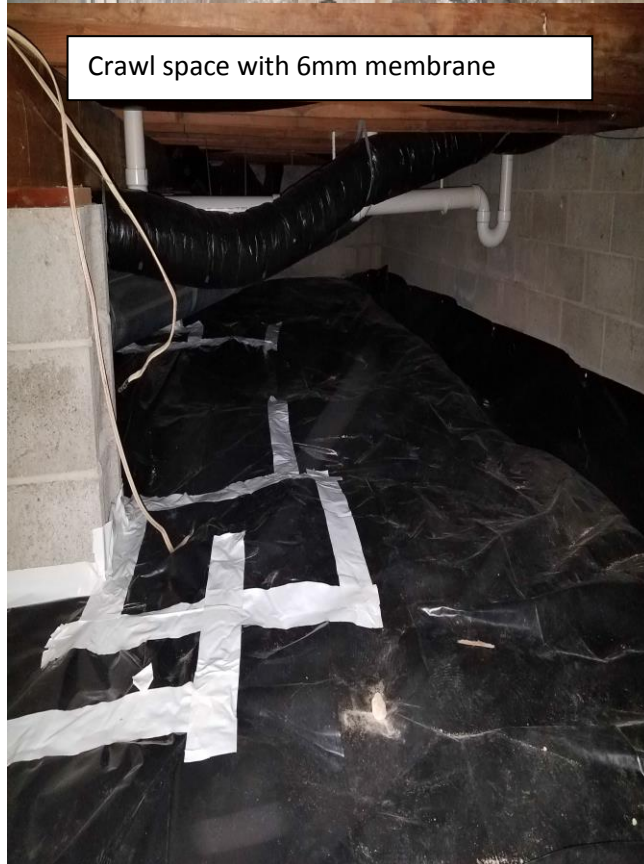
Crawl space with 6mm membrane

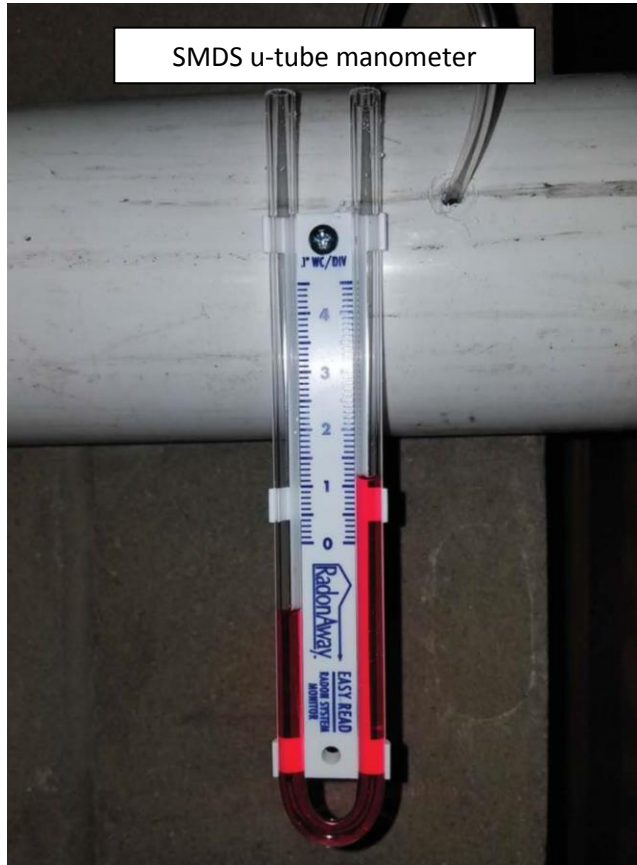
SMDS u-tube manometer

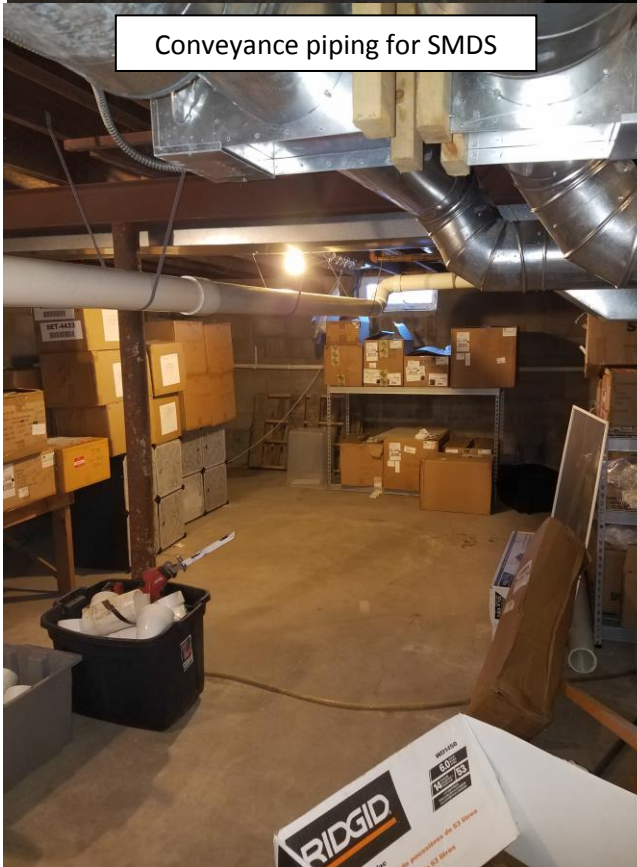
Conveyance piping for SMDS
