2018 Annual Report

West Avenue Landfill

License #521, FID #268145680

February 2019

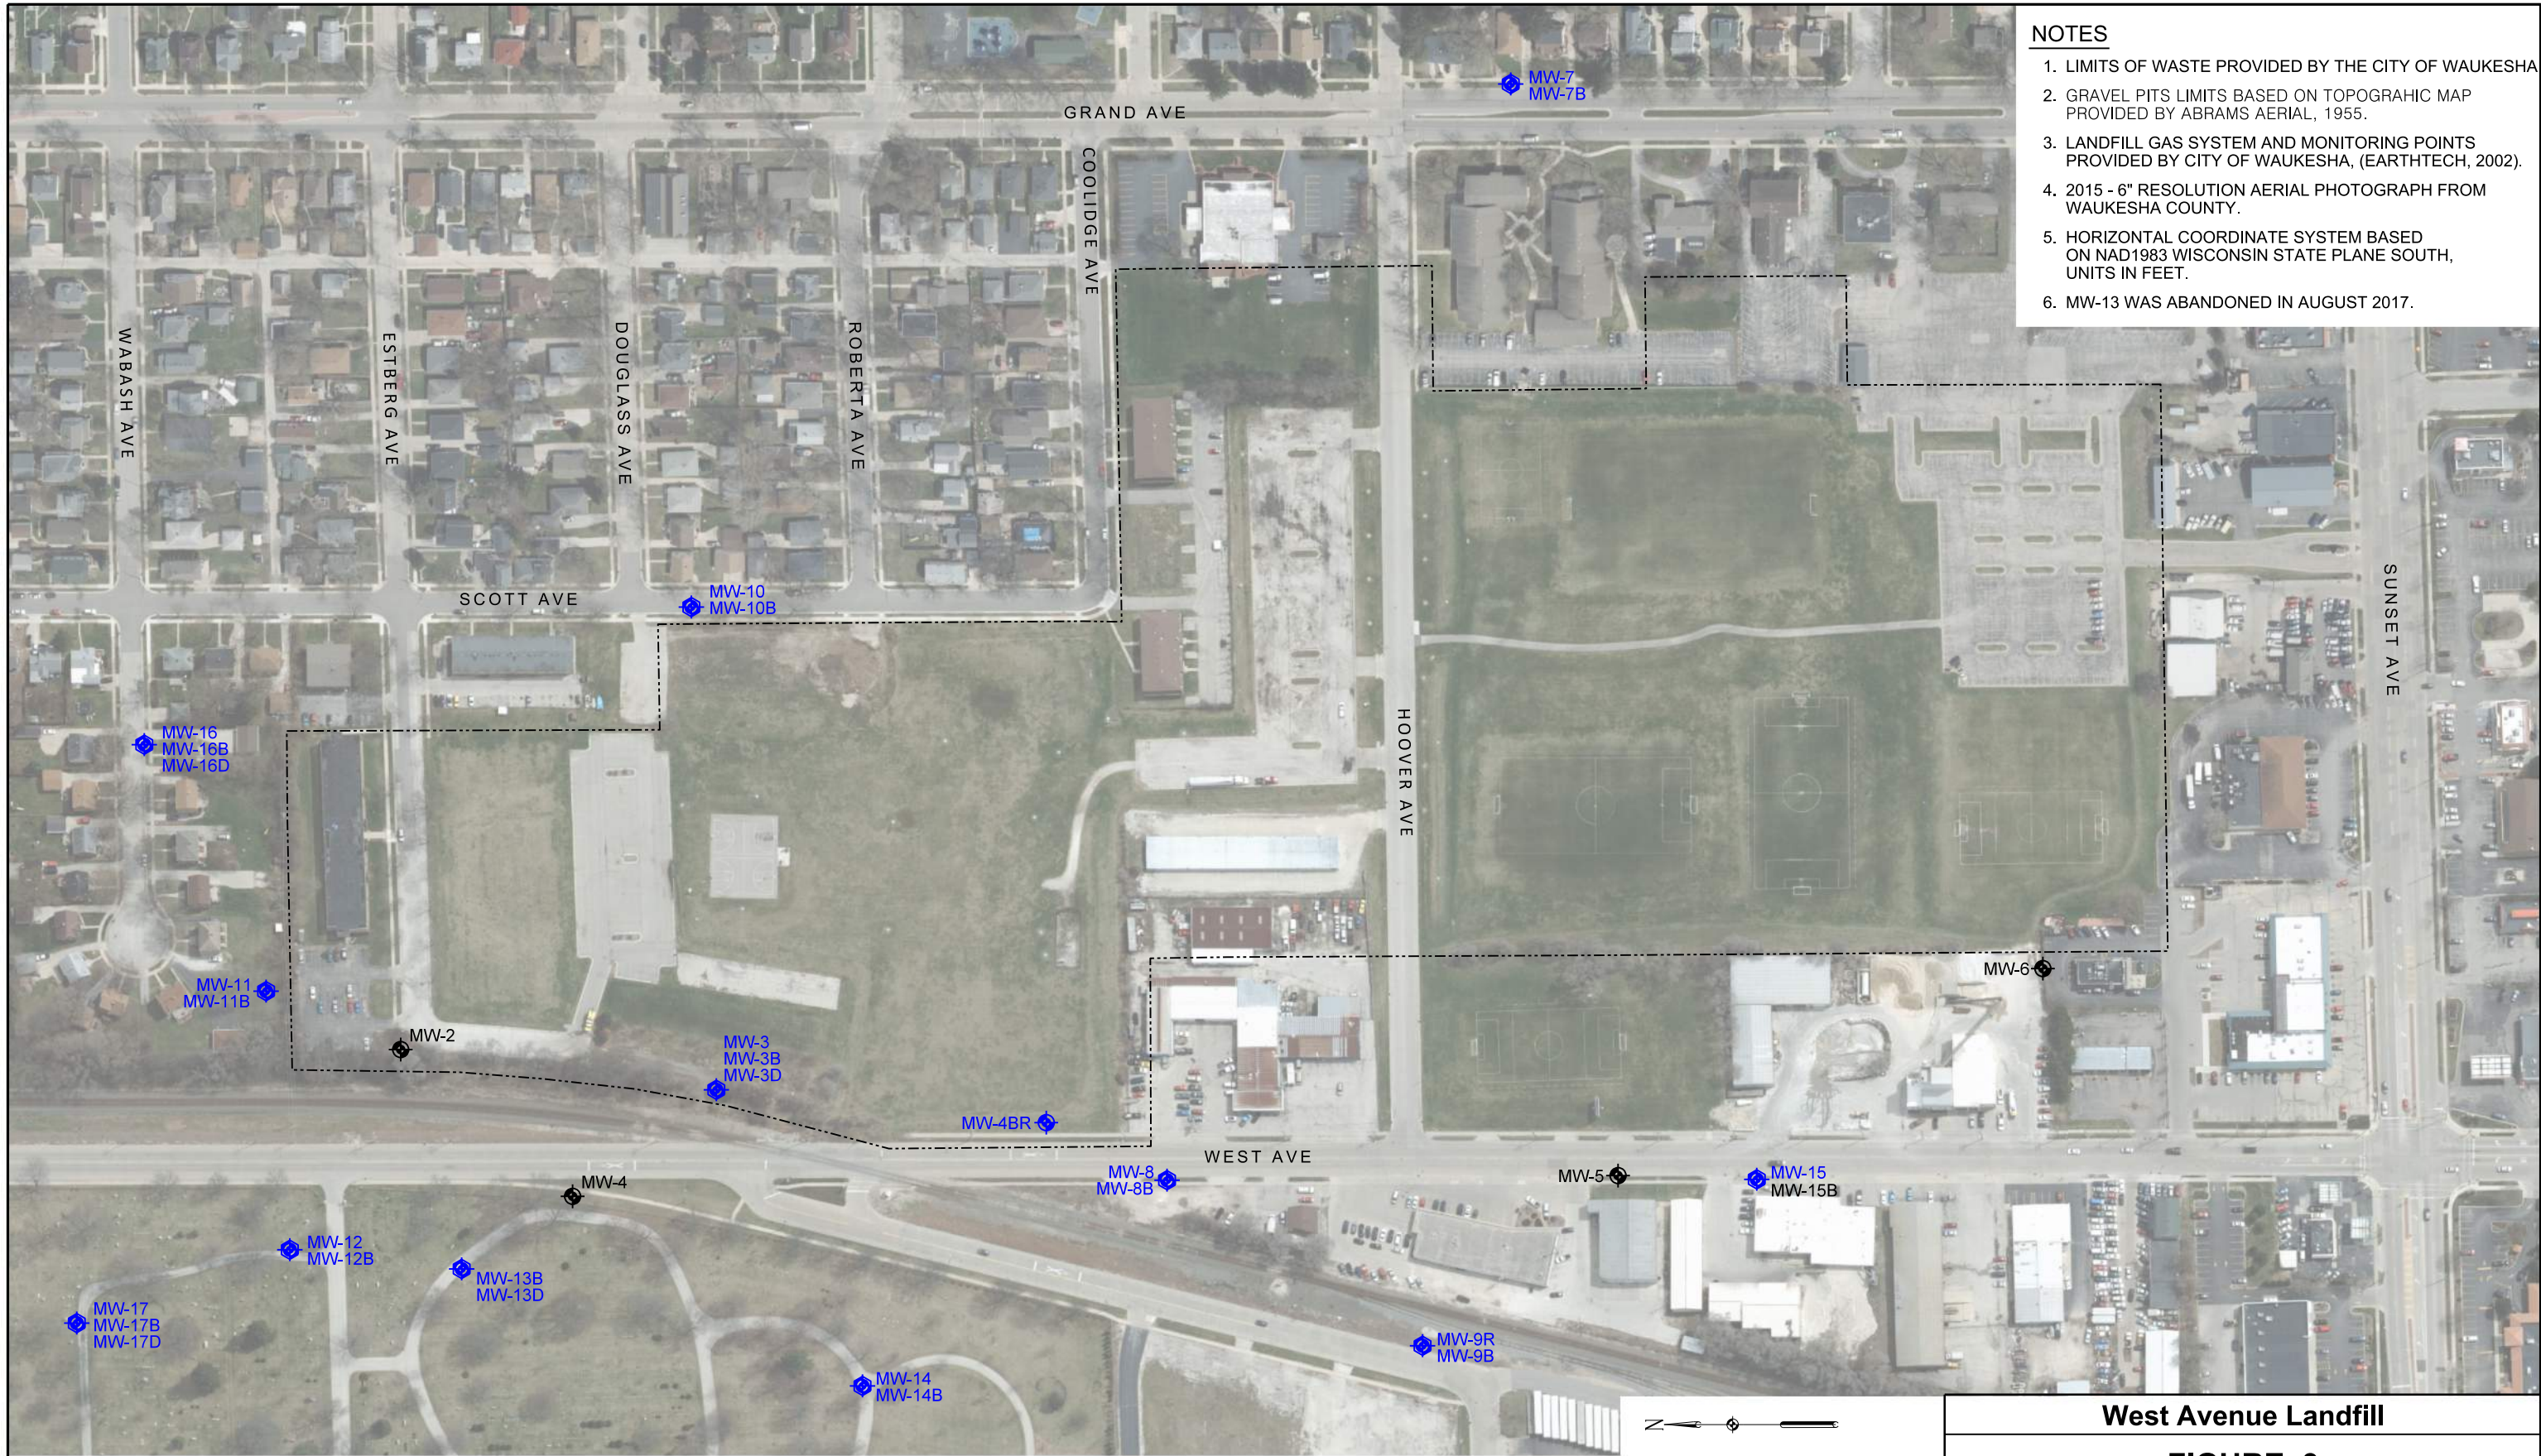
FIGURE 2
LANDFILL GAS COLLECTION SYSTEM
SITE FEATURES

In accordance with the *O&M Plan*, the city of Waukesha performs semiannual inspections of the principal landfill cover areas of the West Avenue Landfill. The areas of final cover are shown on Figure 2. The inspections include, but are not limited to, vegetation integrity, cover integrity, erosion control, surface stabilization, settlement, and animal intrusion.

The layout of the landfill gas and condensate management system is shown on Figure 2. In accordance with the *O&M Plan*, the city of Waukesha performs quarterly inspections of the

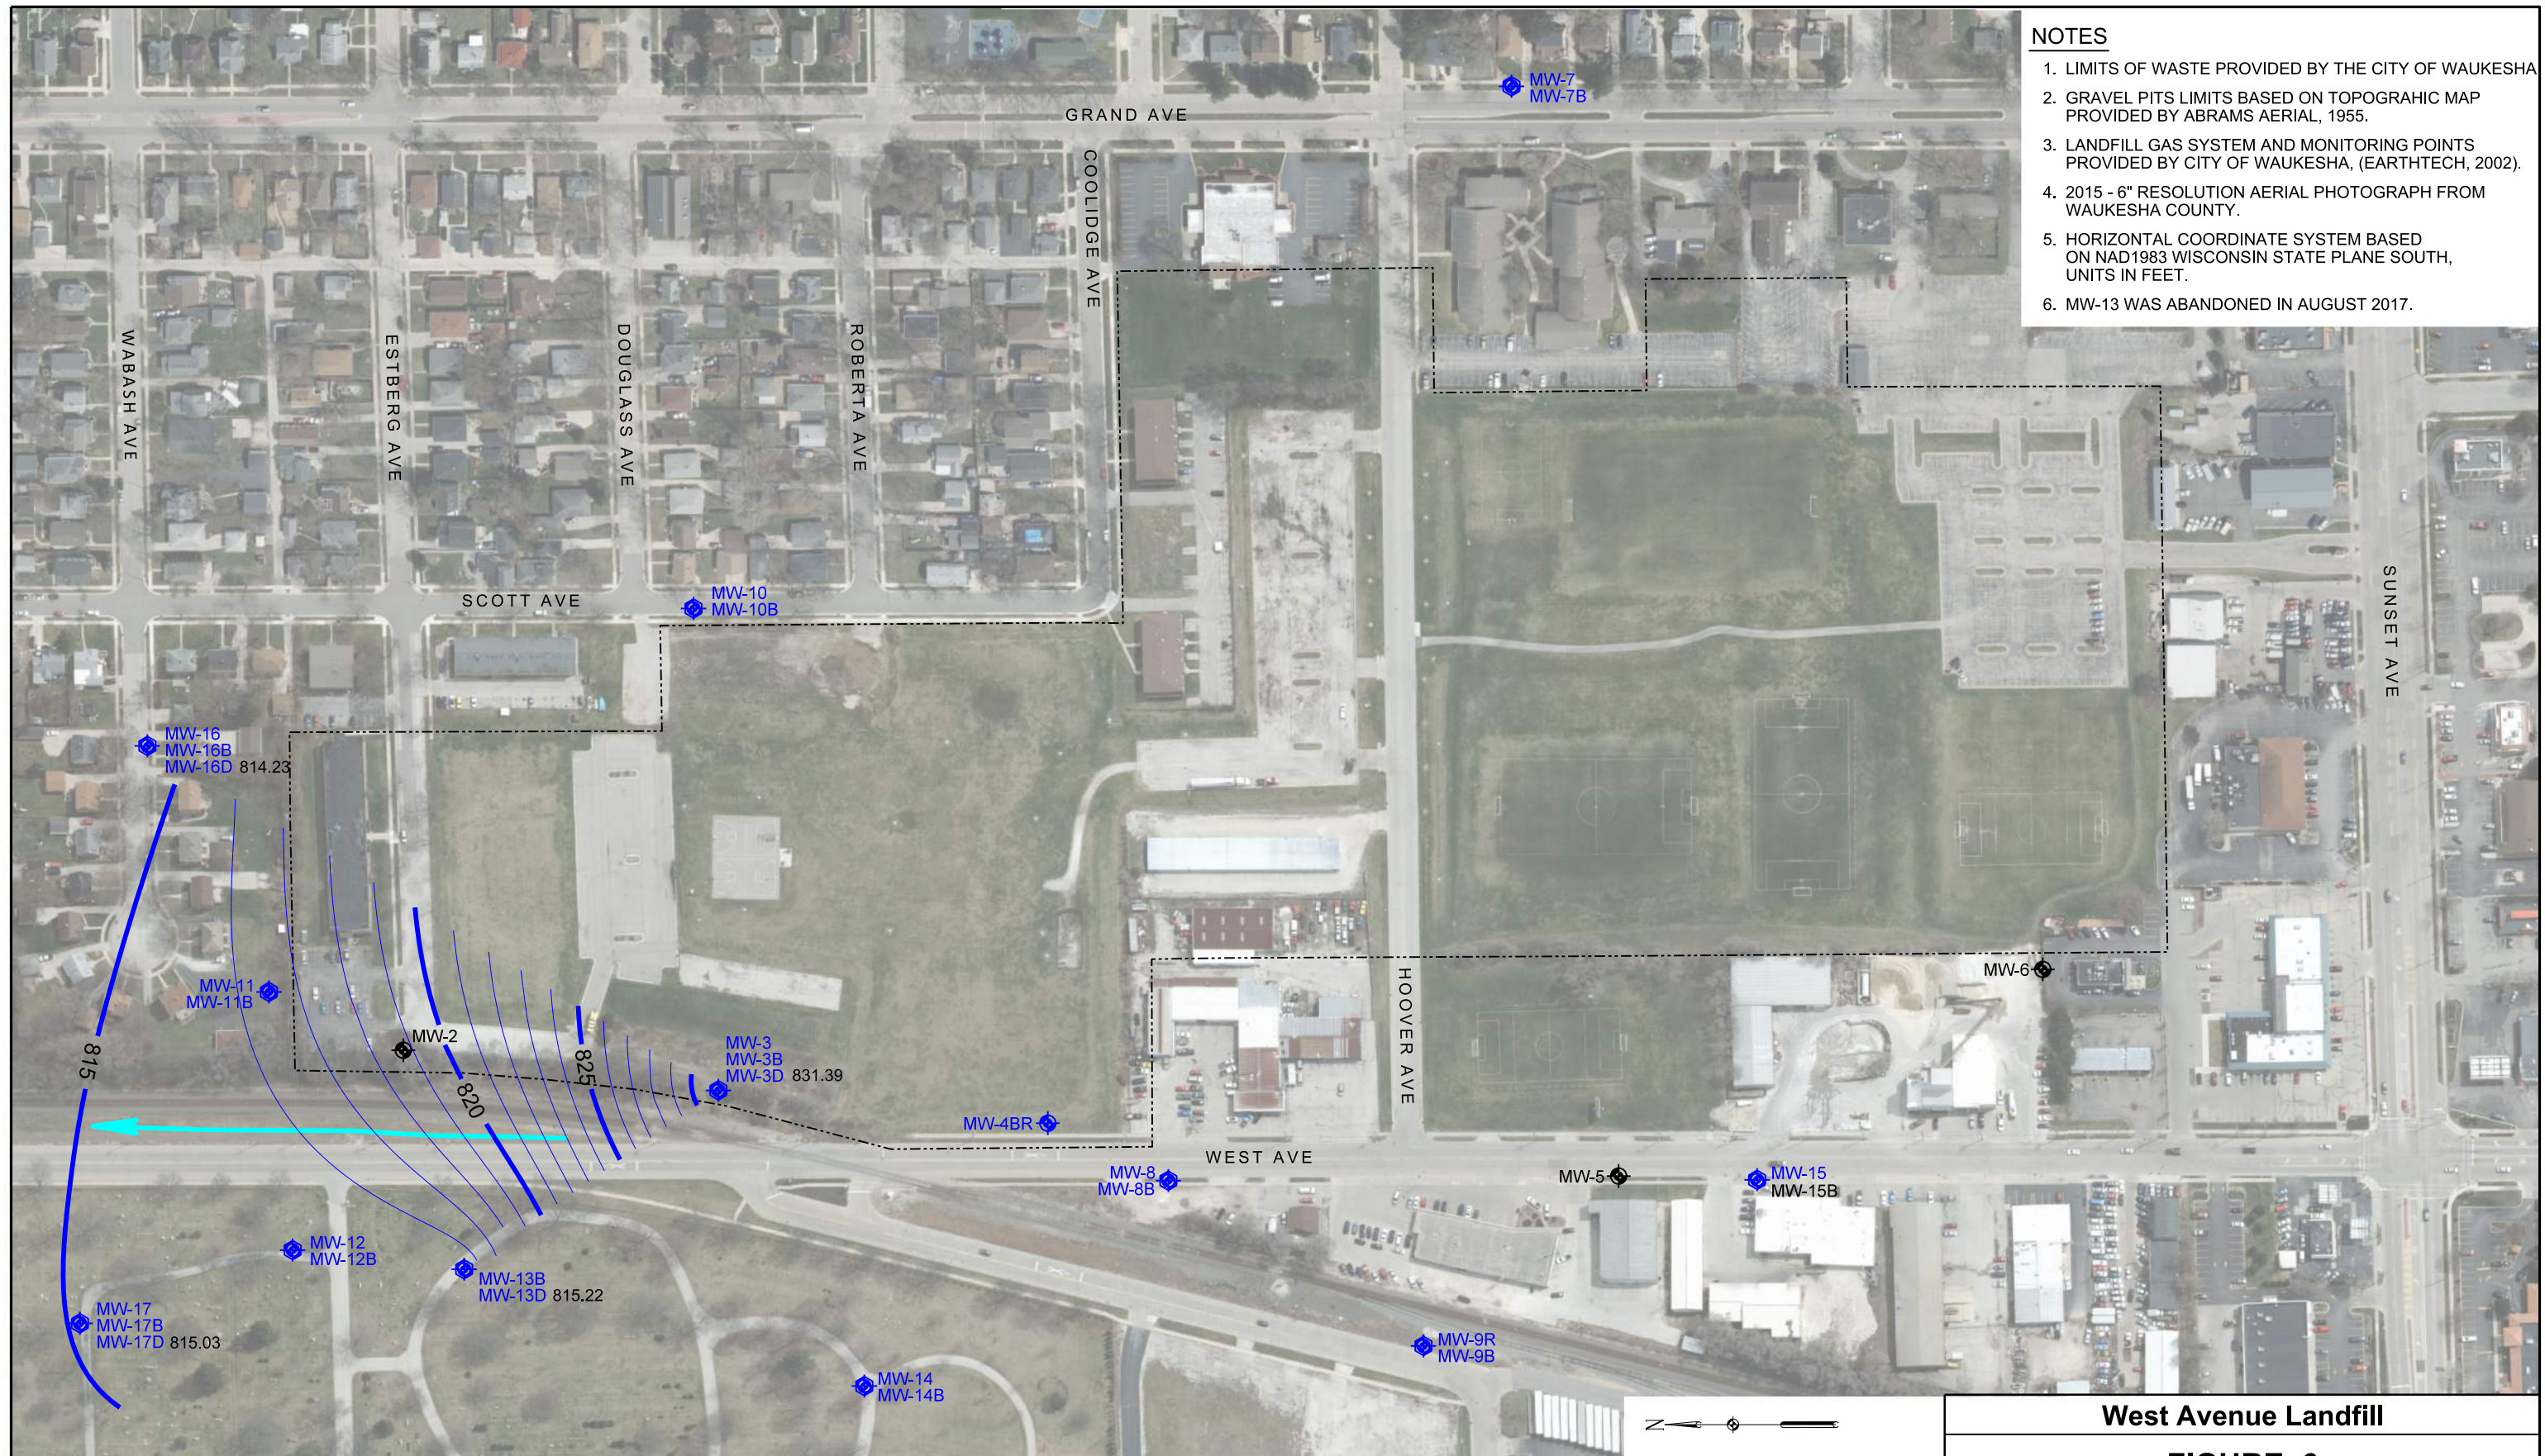
- LIMITS OF WASTE PLACEMENT
- ◆ MW-17D 815.03 MONITORING WELL NEST LOCATION AND WATER TABLE ELEVATION
- 820 — WATER TABLE CONTOUR (2 FOOT INTERVAL)
- ← GROUNDWATER FLOW LINE
