The Department of Natural Resources (DNR) considers the Fort McCoy LF (Landfill) #2 site closed, with continuing obligations. No further investigation or remediation is required at this time. However, you, future property owners, and occupants of the property must comply with the continuing obligations as explained in the conditions of closure in this letter. Please read over this letter closely to ensure that you comply with all conditions and other on-going requirements. Provide this letter and any attachments listed at the end of this letter to anyone who purchases, rents or leases this property from you.

**ATTACHMENT B.3.b.
GROUNDWATER ISOCONCENTRATION MAP
CLOSURE REQUEST
CLOSED LANDFILL 2 BRRTS NO. 02-42-279977
FORT McCOY, WISCONSIN**

ATTACHMENT D.3. PHOTOGRAPHS
FORT MCCOY CLOSED LANDFILL #2: BRRTS. NO. 02-42-279977
PHOTOS TAKEN 17 & 18 DECEMBER 2015

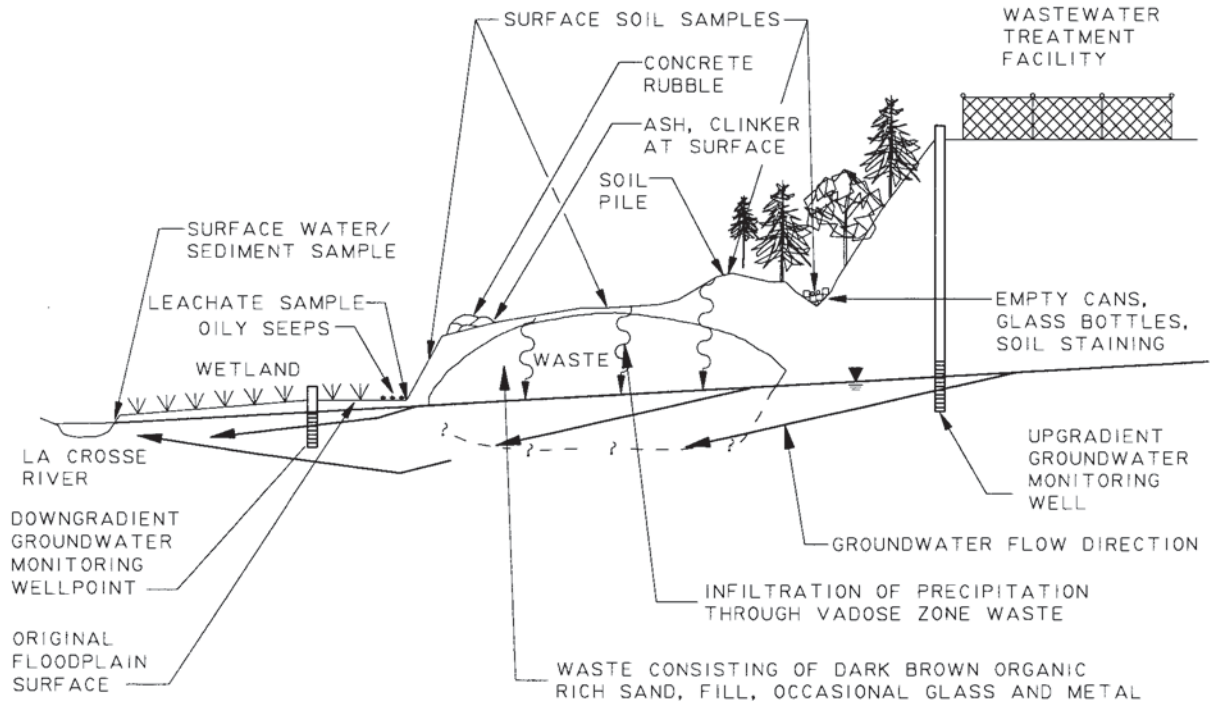
ATTACHMENT B.3.a. GEOLOGIC CROSS SECTION

FIGURE 6-3
 CLOSED LANDFILL 2
 SITE CONCEPTUAL MODEL
 FORT McCOY RFI
 MONROE COUNTY, WISCONSIN

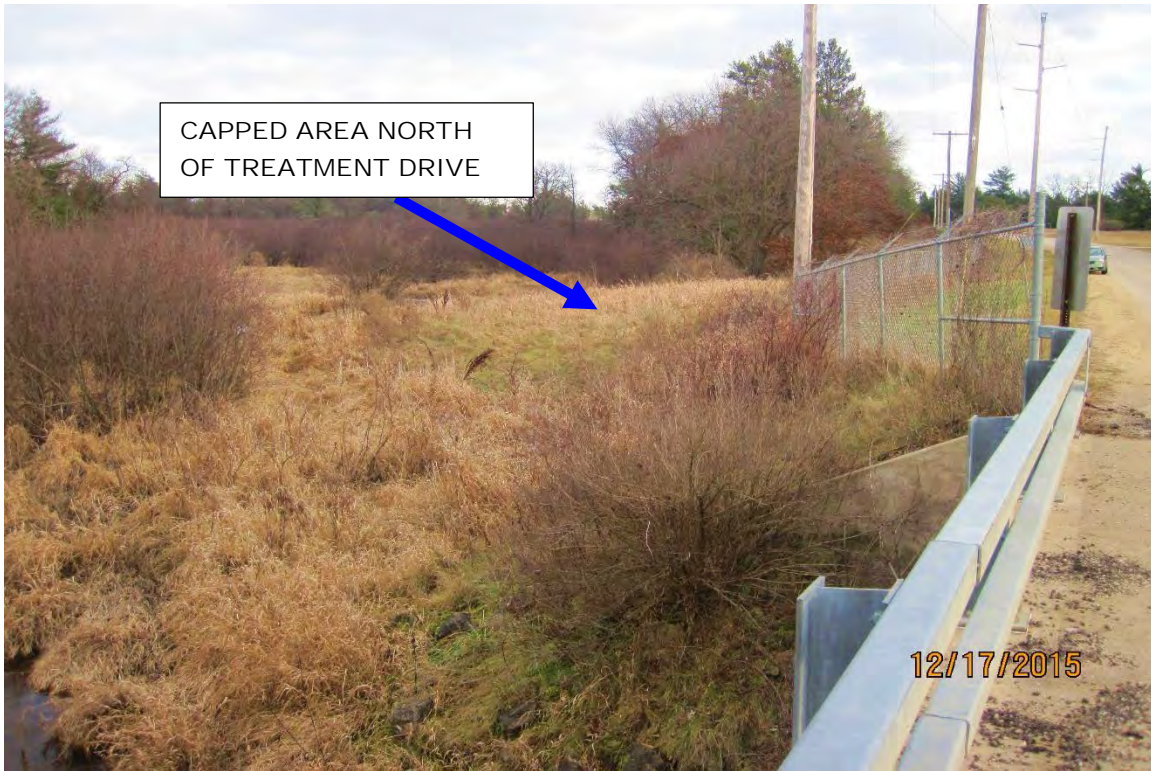
CAPPED AREA NORTH
OF TREATMENT DRIVE

THE CAP NORTH OF TREATMENT DRIVE IS COMPOSED OF TWO FEET OF SOIL COVERED BY TOPSOIL WITH GRASS VEGETATION TO MINIMIZE THE POTENTIAL FOR EROSION (VIEW IS TO THE EAST)

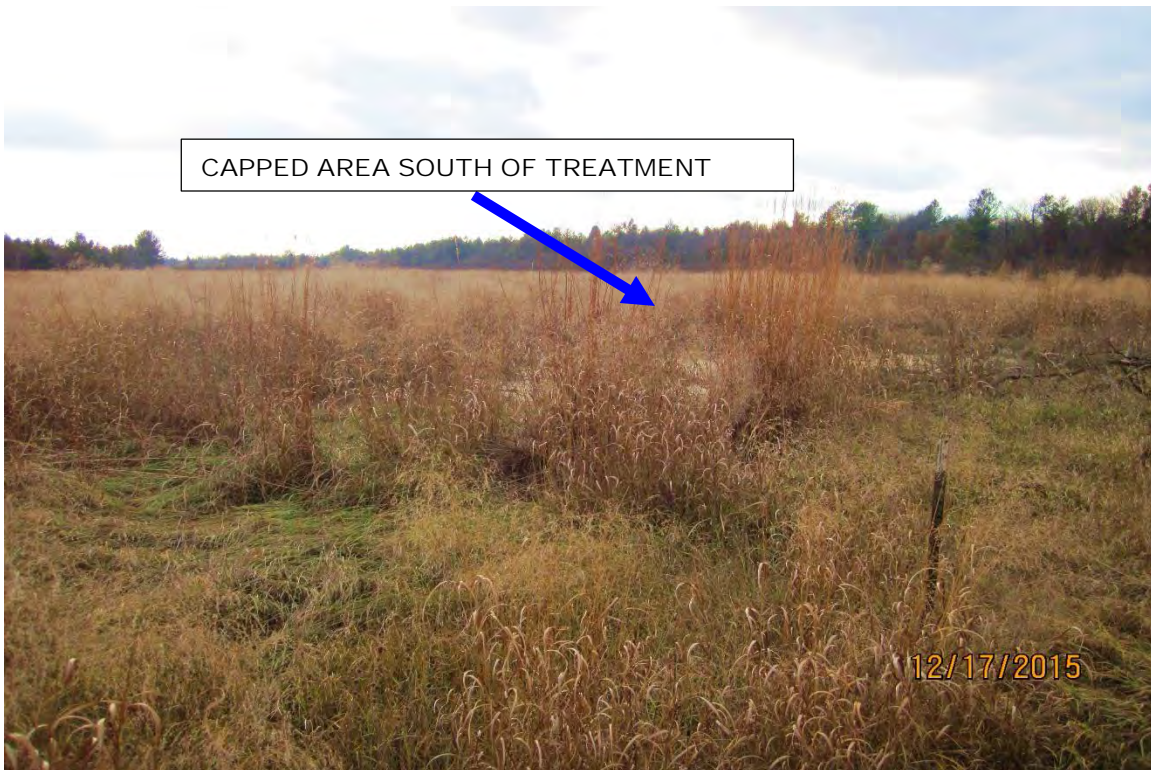
CAPPED AREA SOUTH OF TREATMENT

THE CAP CONSISTS OF A MINIMUM OF 18 INCHES OF CLEAN SAND, WITH MOST AREAS HAVING 22 TO 32 INCHES OF SAND. THE CAP IS VEGETATED WITH NATIVE PRAIRE GRASS. (VIEW IS TO THE SOUTHWEST)

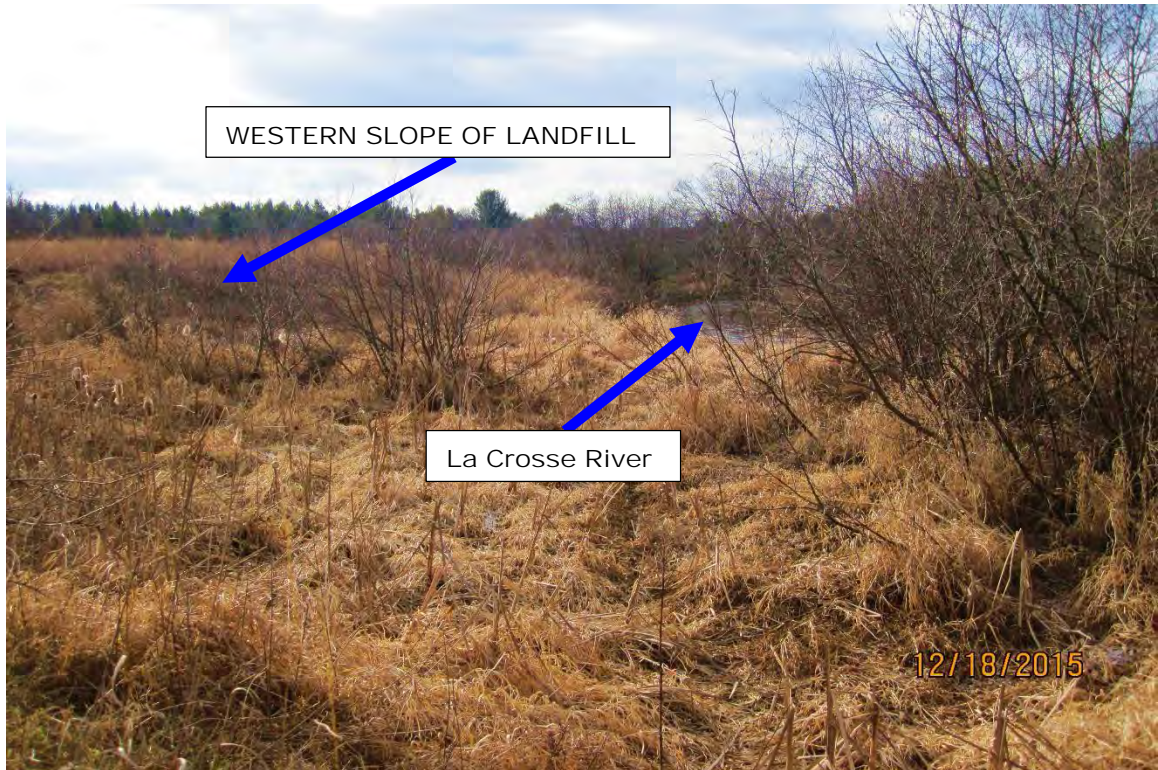
THE CAP OVER THE WESTERN SLOPE ALONG THE RIVER IS CONSTRUCTED OF 12 INCHES OF FILL OVERLAIN BY A GEOTEXTILE FABRIC, WHICH IS OVERLAIN BY 18-24 INCH RIPRAP ARMORING COVERED BY 2-4 INCHES OF SAND VEGETATED WITH NATIVE PRAIRE GRASS. (VIEW IS TO THE SOUTH)

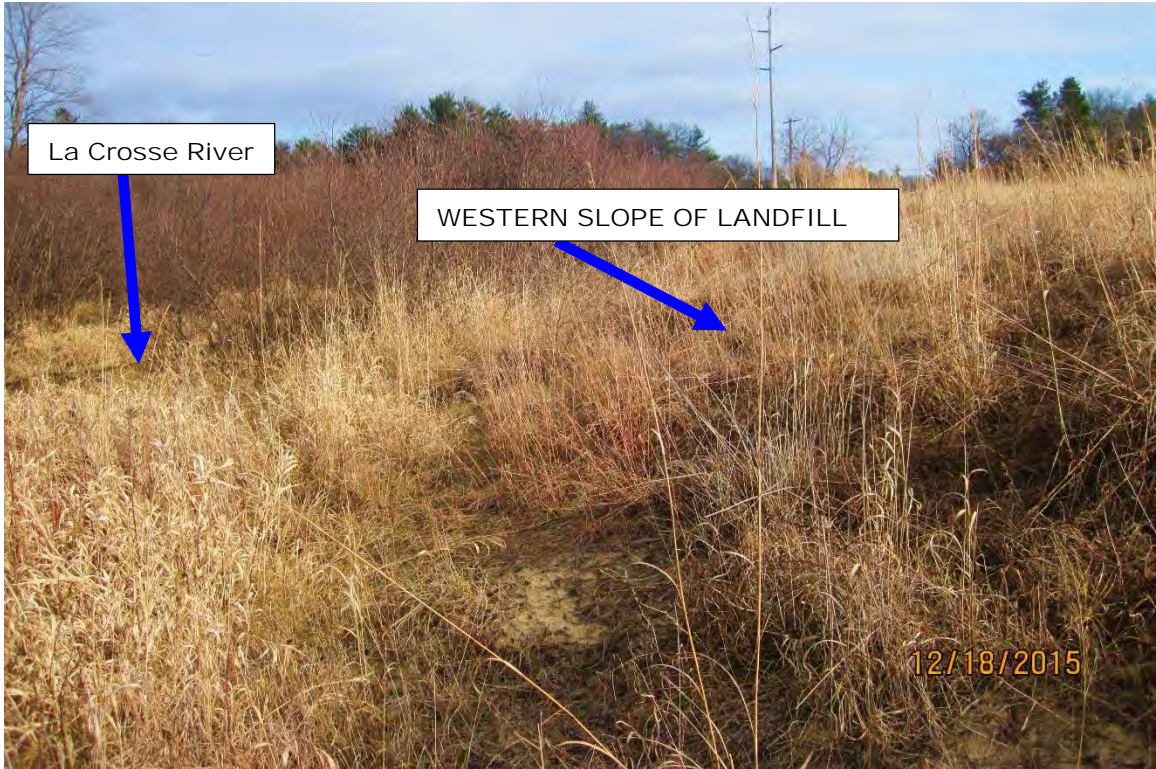
THE CAP OVER THE WESTERN SLOPE ALONG THE RIVER IS CONSTRUCTED OF 12 INCHES OF FILL OVERLAIN BY A GEOTEXTILE FABRIC, WHICH IS OVERLAIN BY 18-24 INCH RIPRAP ARMORING COVERED BY 2-4 INCHES OF SAND VEGETATED WITH NATIVE PRAIRE GRASS. (VIEW IS TO THE NORTH)
