**Subject:** Fort McCoy Water Main Issue (UNCLASSIFIED)

The general route of the water main we discussed the other day is shown on the attached map (Water Main Route from Ski Hill to WWTP). Last Thursday I went out to walk the trench over the Grit Area & Closed Landfill 3 (CLF3; BRRTS No. 02-42-279983). The contractor was in the process of backfilling the trench along the north side of Treatment Drive (formerly Buckley Court), just north of Closed Landfill 2 (CLF2; BRRTS No. 02-42-279977; see Area North of CLF2 and Map of CLF2-CLF3 Aerial Photo). As shown on the attached map (Area North of CLF2), hand auger borings were advanced along the fence-line in 2010. Incinerator ash was observed in those hand auger borings. At that time it was believed that the CLF2 waste (which is incinerator ash) might extend beneath the roadway. However, an investigation conducted during 2011 showed that any ash that extended south of the hand auger borings was removed when the ditch was installed along the roadway many years ago. The ash north of the road, between the fence and the creek in this area, contained two locations where transite was visible, and Mae requested that the area be capped with 2 f

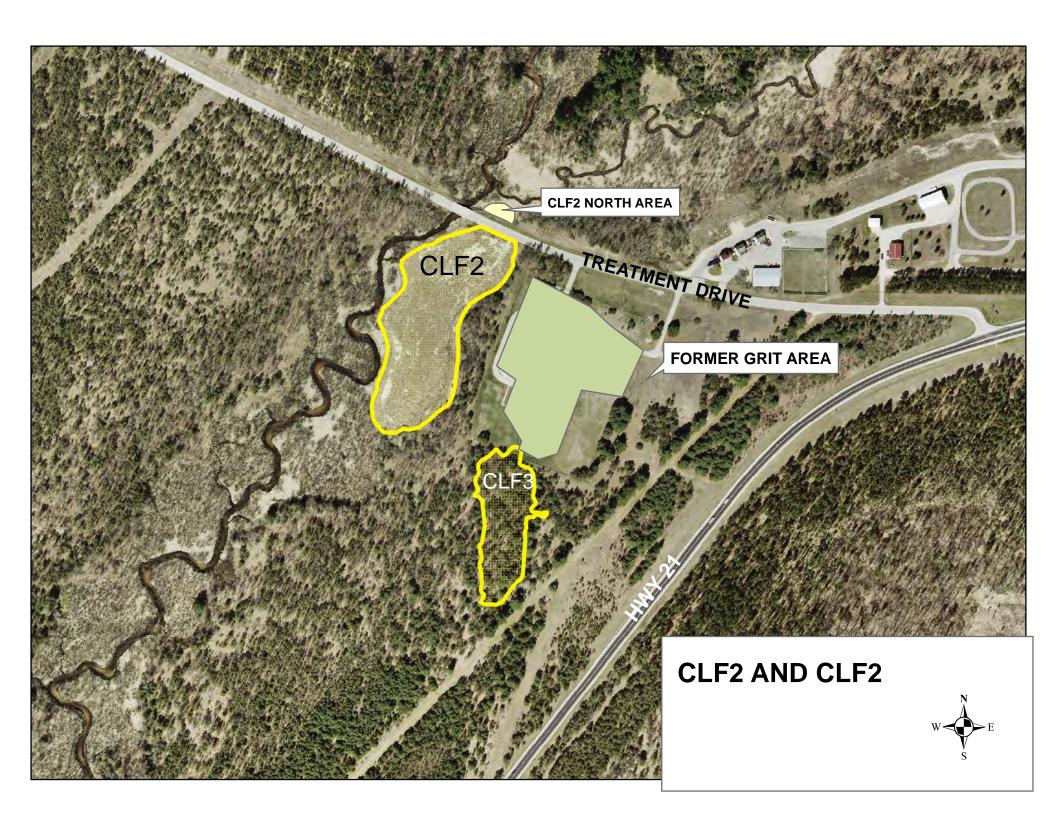
Figure 3

## Site B Features

Corrective Action Implementation Report Remedial Action - Ash Excavation Fort McCoy Sparta, Wisconsin
