**Re: Remedial Action Standards Documentation Report  
Hayton Area Remediation Project  
BRRTS 02-08-281506**

# Remedial Action Standards Documentation Report

Hayton Area Remediation Project  
Chilton, Wisconsin

**BRRTS No. 02-08-281506**

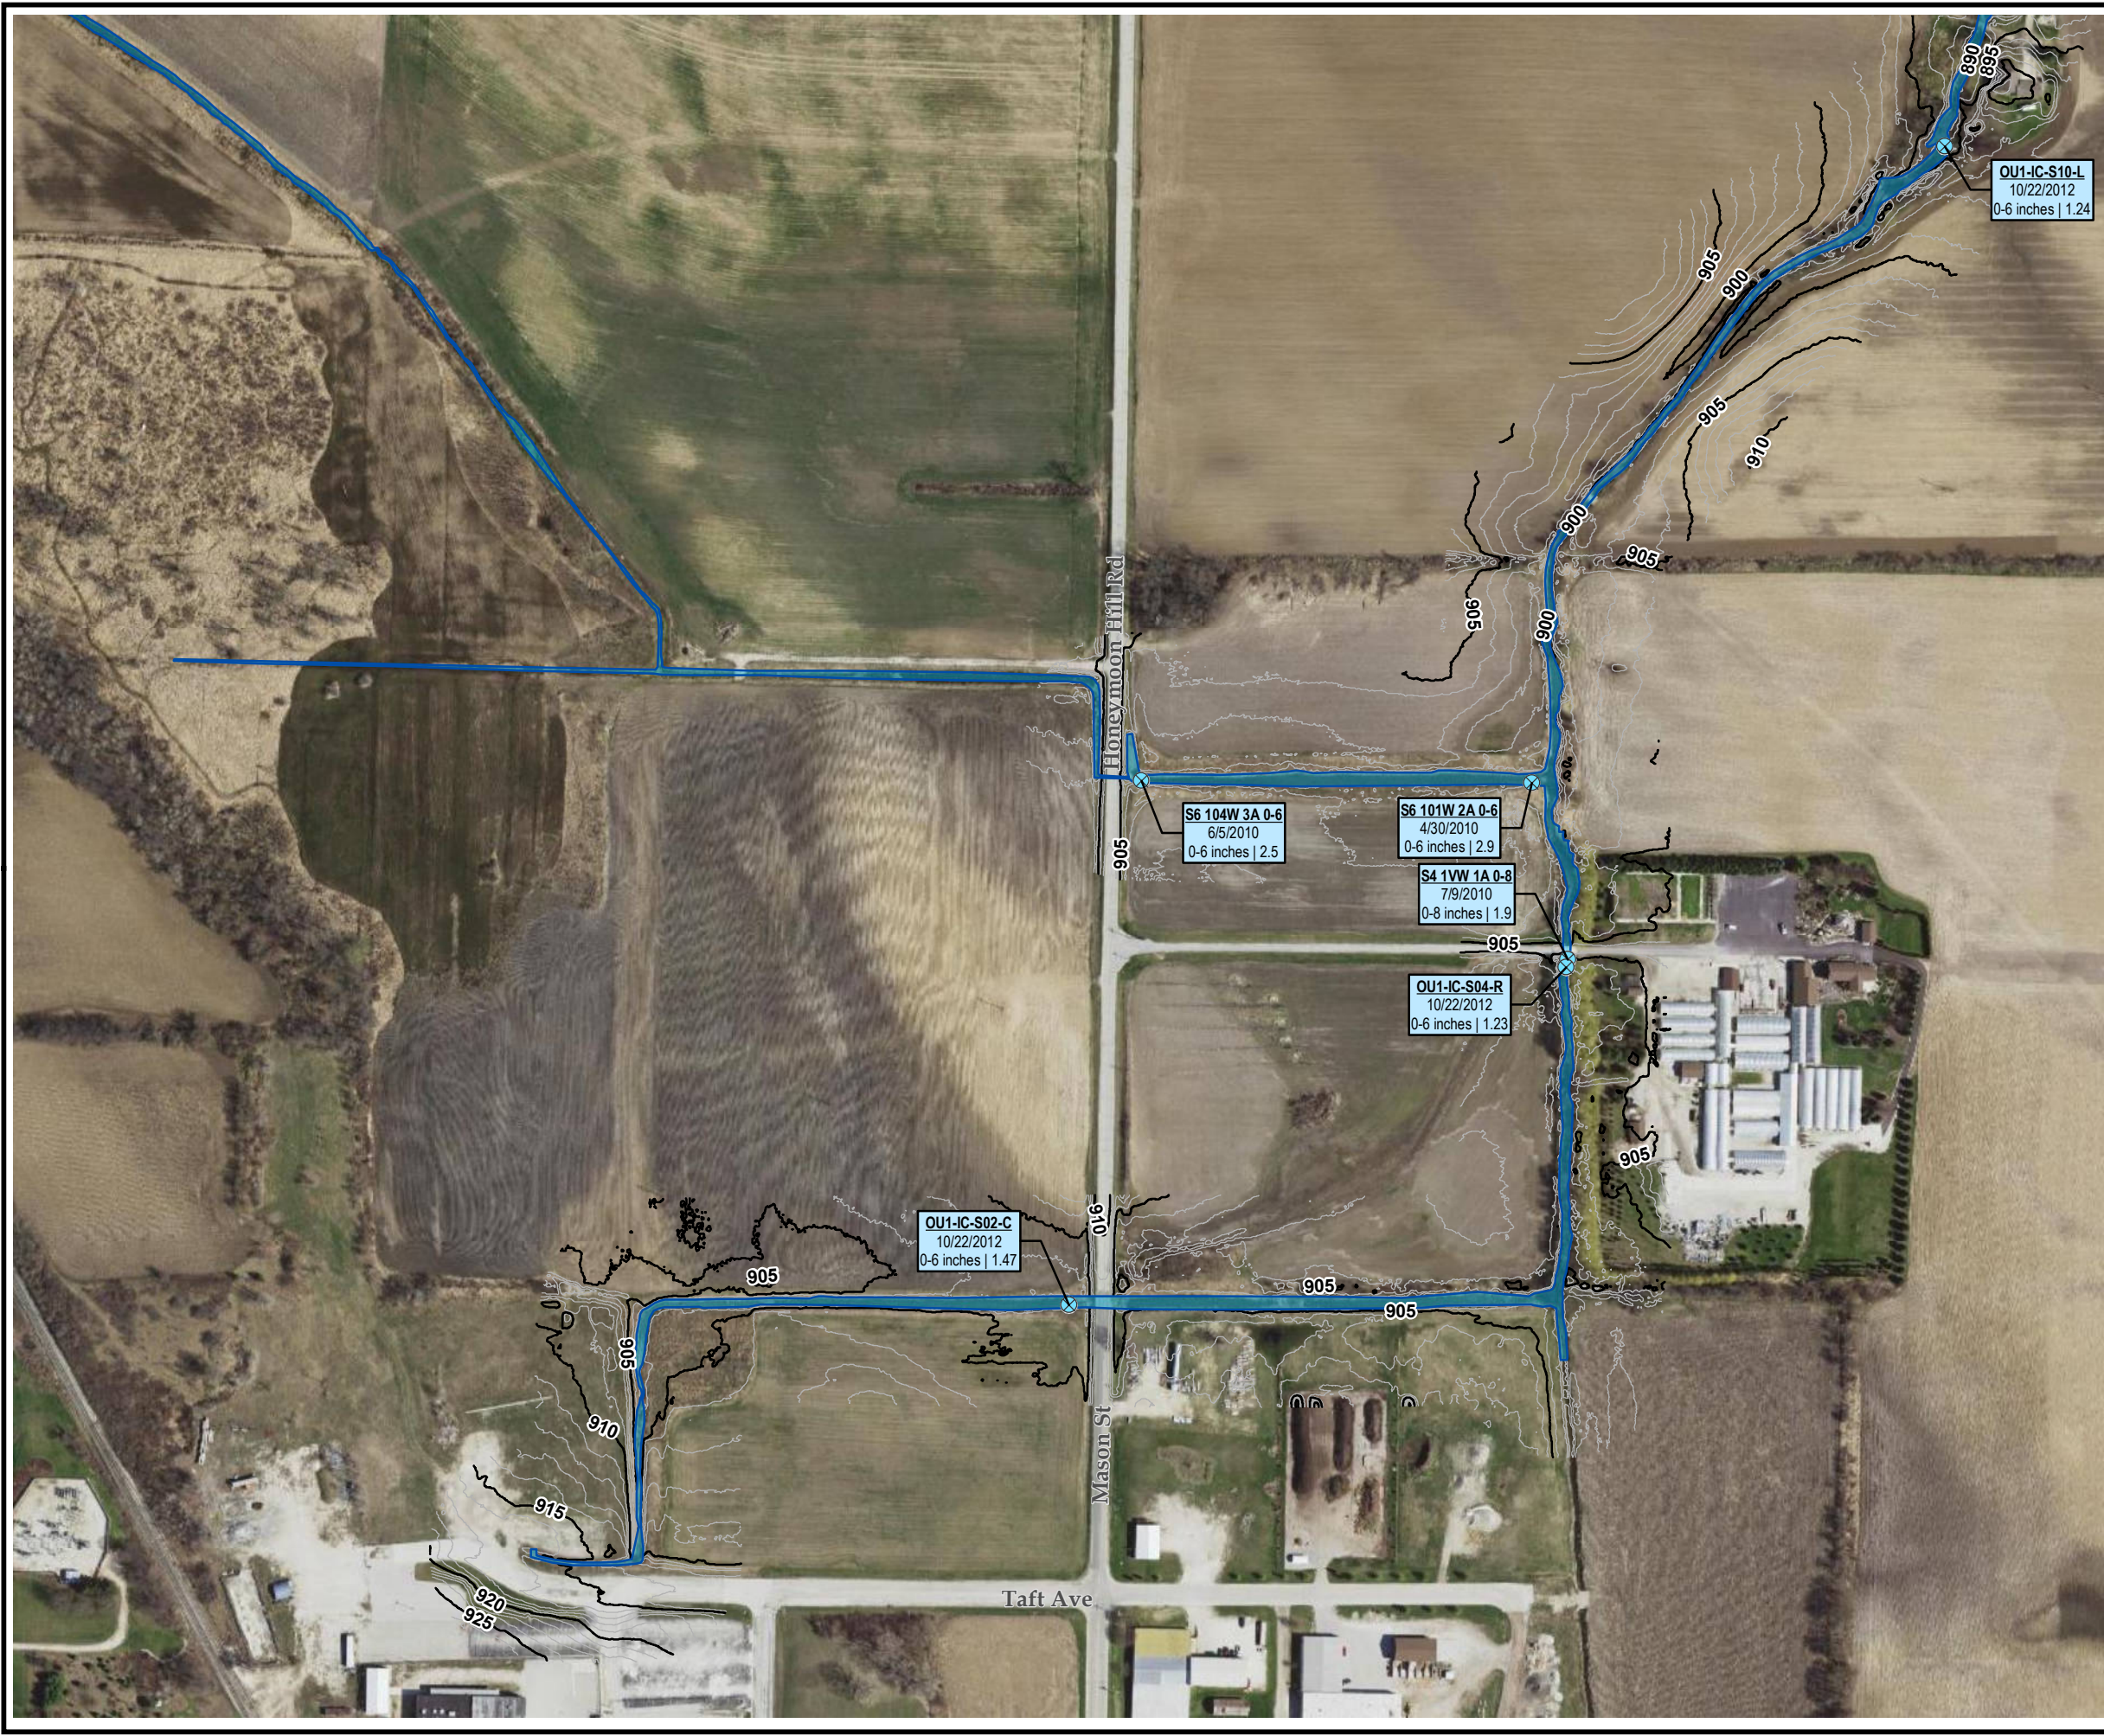
<b>PROJECT:</b>		<b>TECUMSEH &amp; HARP REMEDIAL ACTION STANDARDS REPORT CALUMET COUNTY, WISCONSIN</b>	
<b>TITLE:</b>		<b>OU1 - SAMPLE LOCATIONS</b>	
DRAWN BY:	R. SUEMNICHT	PROJ NO.:	107927
CHECKED BY:	J. RICE	<b>FIGURE 2</b>	
APPROVED BY:	C. HARVEY		
DATE:	JUNE 2021		
		505 East Huntland Drive, Suite 250 Austin, TX 78752 Phone: 512.329.6080 www.trcsolutions.com	
FILE NO.:		107927-2019-001mb.mxd

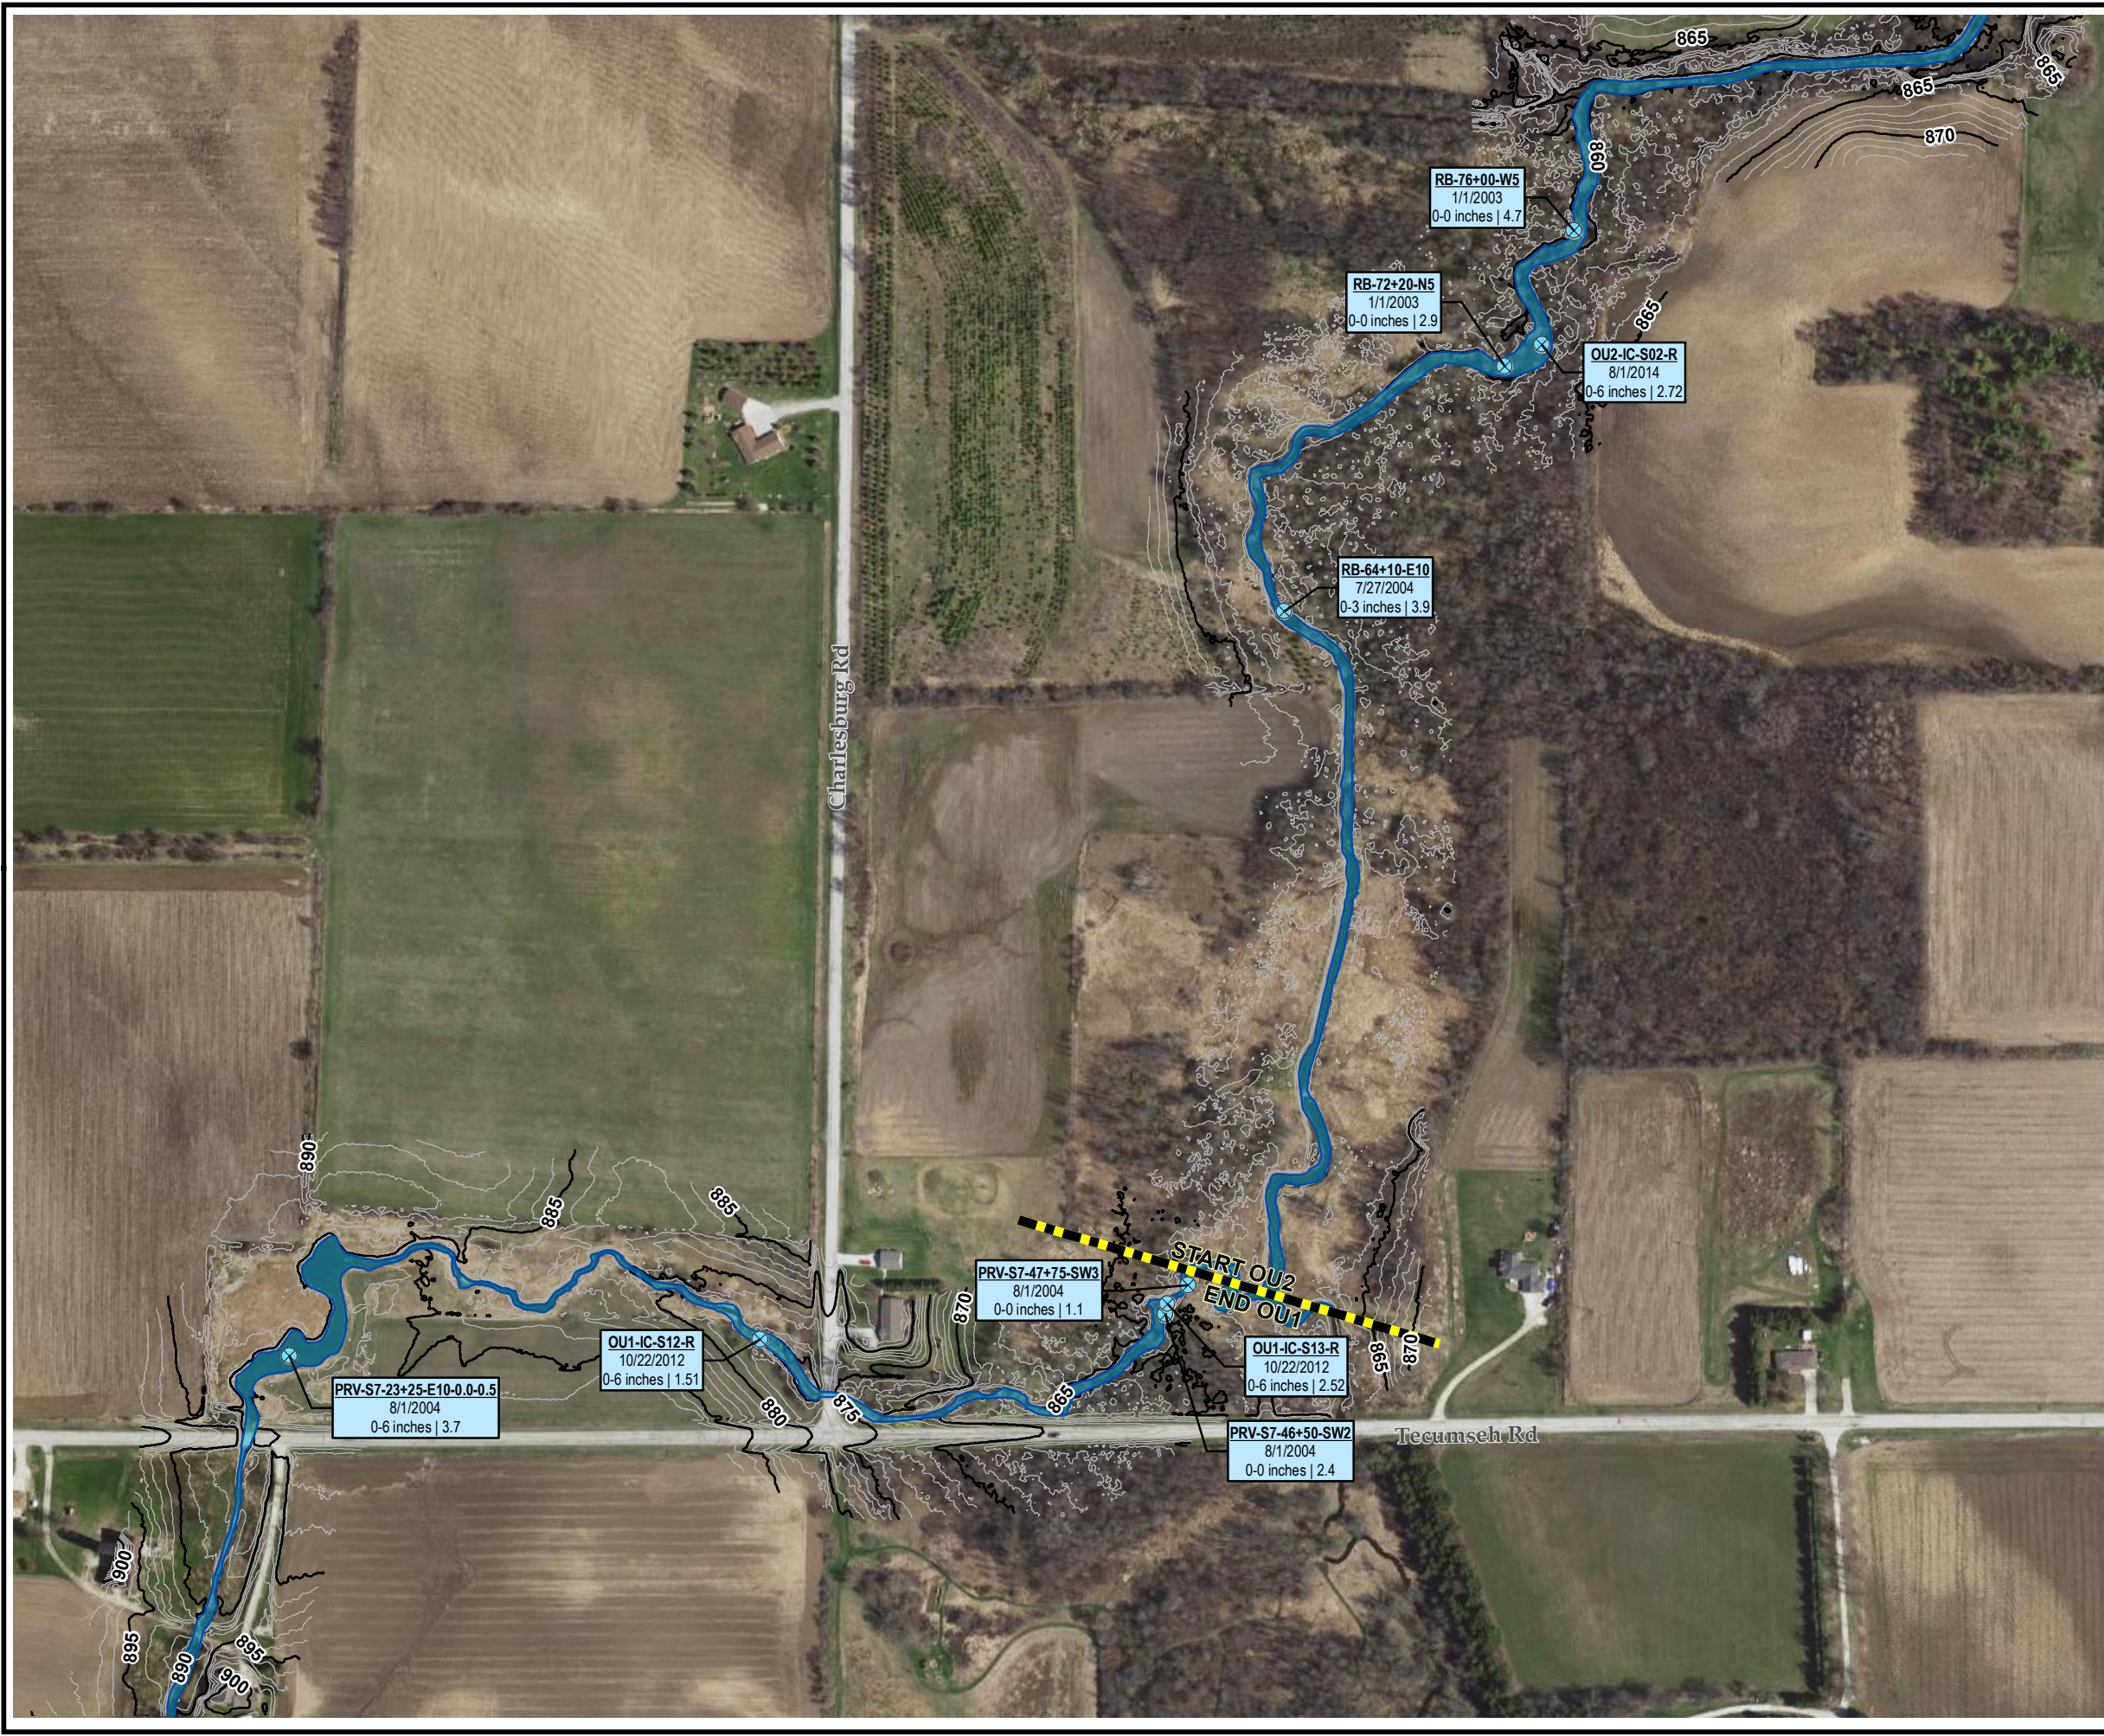
OU1-OU2/UPPER

<b>PROJECT:</b>		<b>TECUMSEH &amp; HARP REMEDIAL ACTION STANDARDS REPORT CALUMET COUNTY, WISCONSIN</b>	
<b>TITLE:</b>		<b>OU1-OU2/UPPER - SAMPLE LOCATIONS</b>	
DRAWN BY:	R. SUEMNICHT	PROJ NO.:	107927
CHECKED BY:	J. RICE	<b>FIGURE 3</b>	
APPROVED BY:	C. HARVEY		
DATE:	JUNE 2021		
		505 East Huntland Drive, Suite 250 Austin, TX 78752 Phone: 512.329.6080 www.trcsolutions.com	
FILE NO.:		107927-2019-001mb.mxd

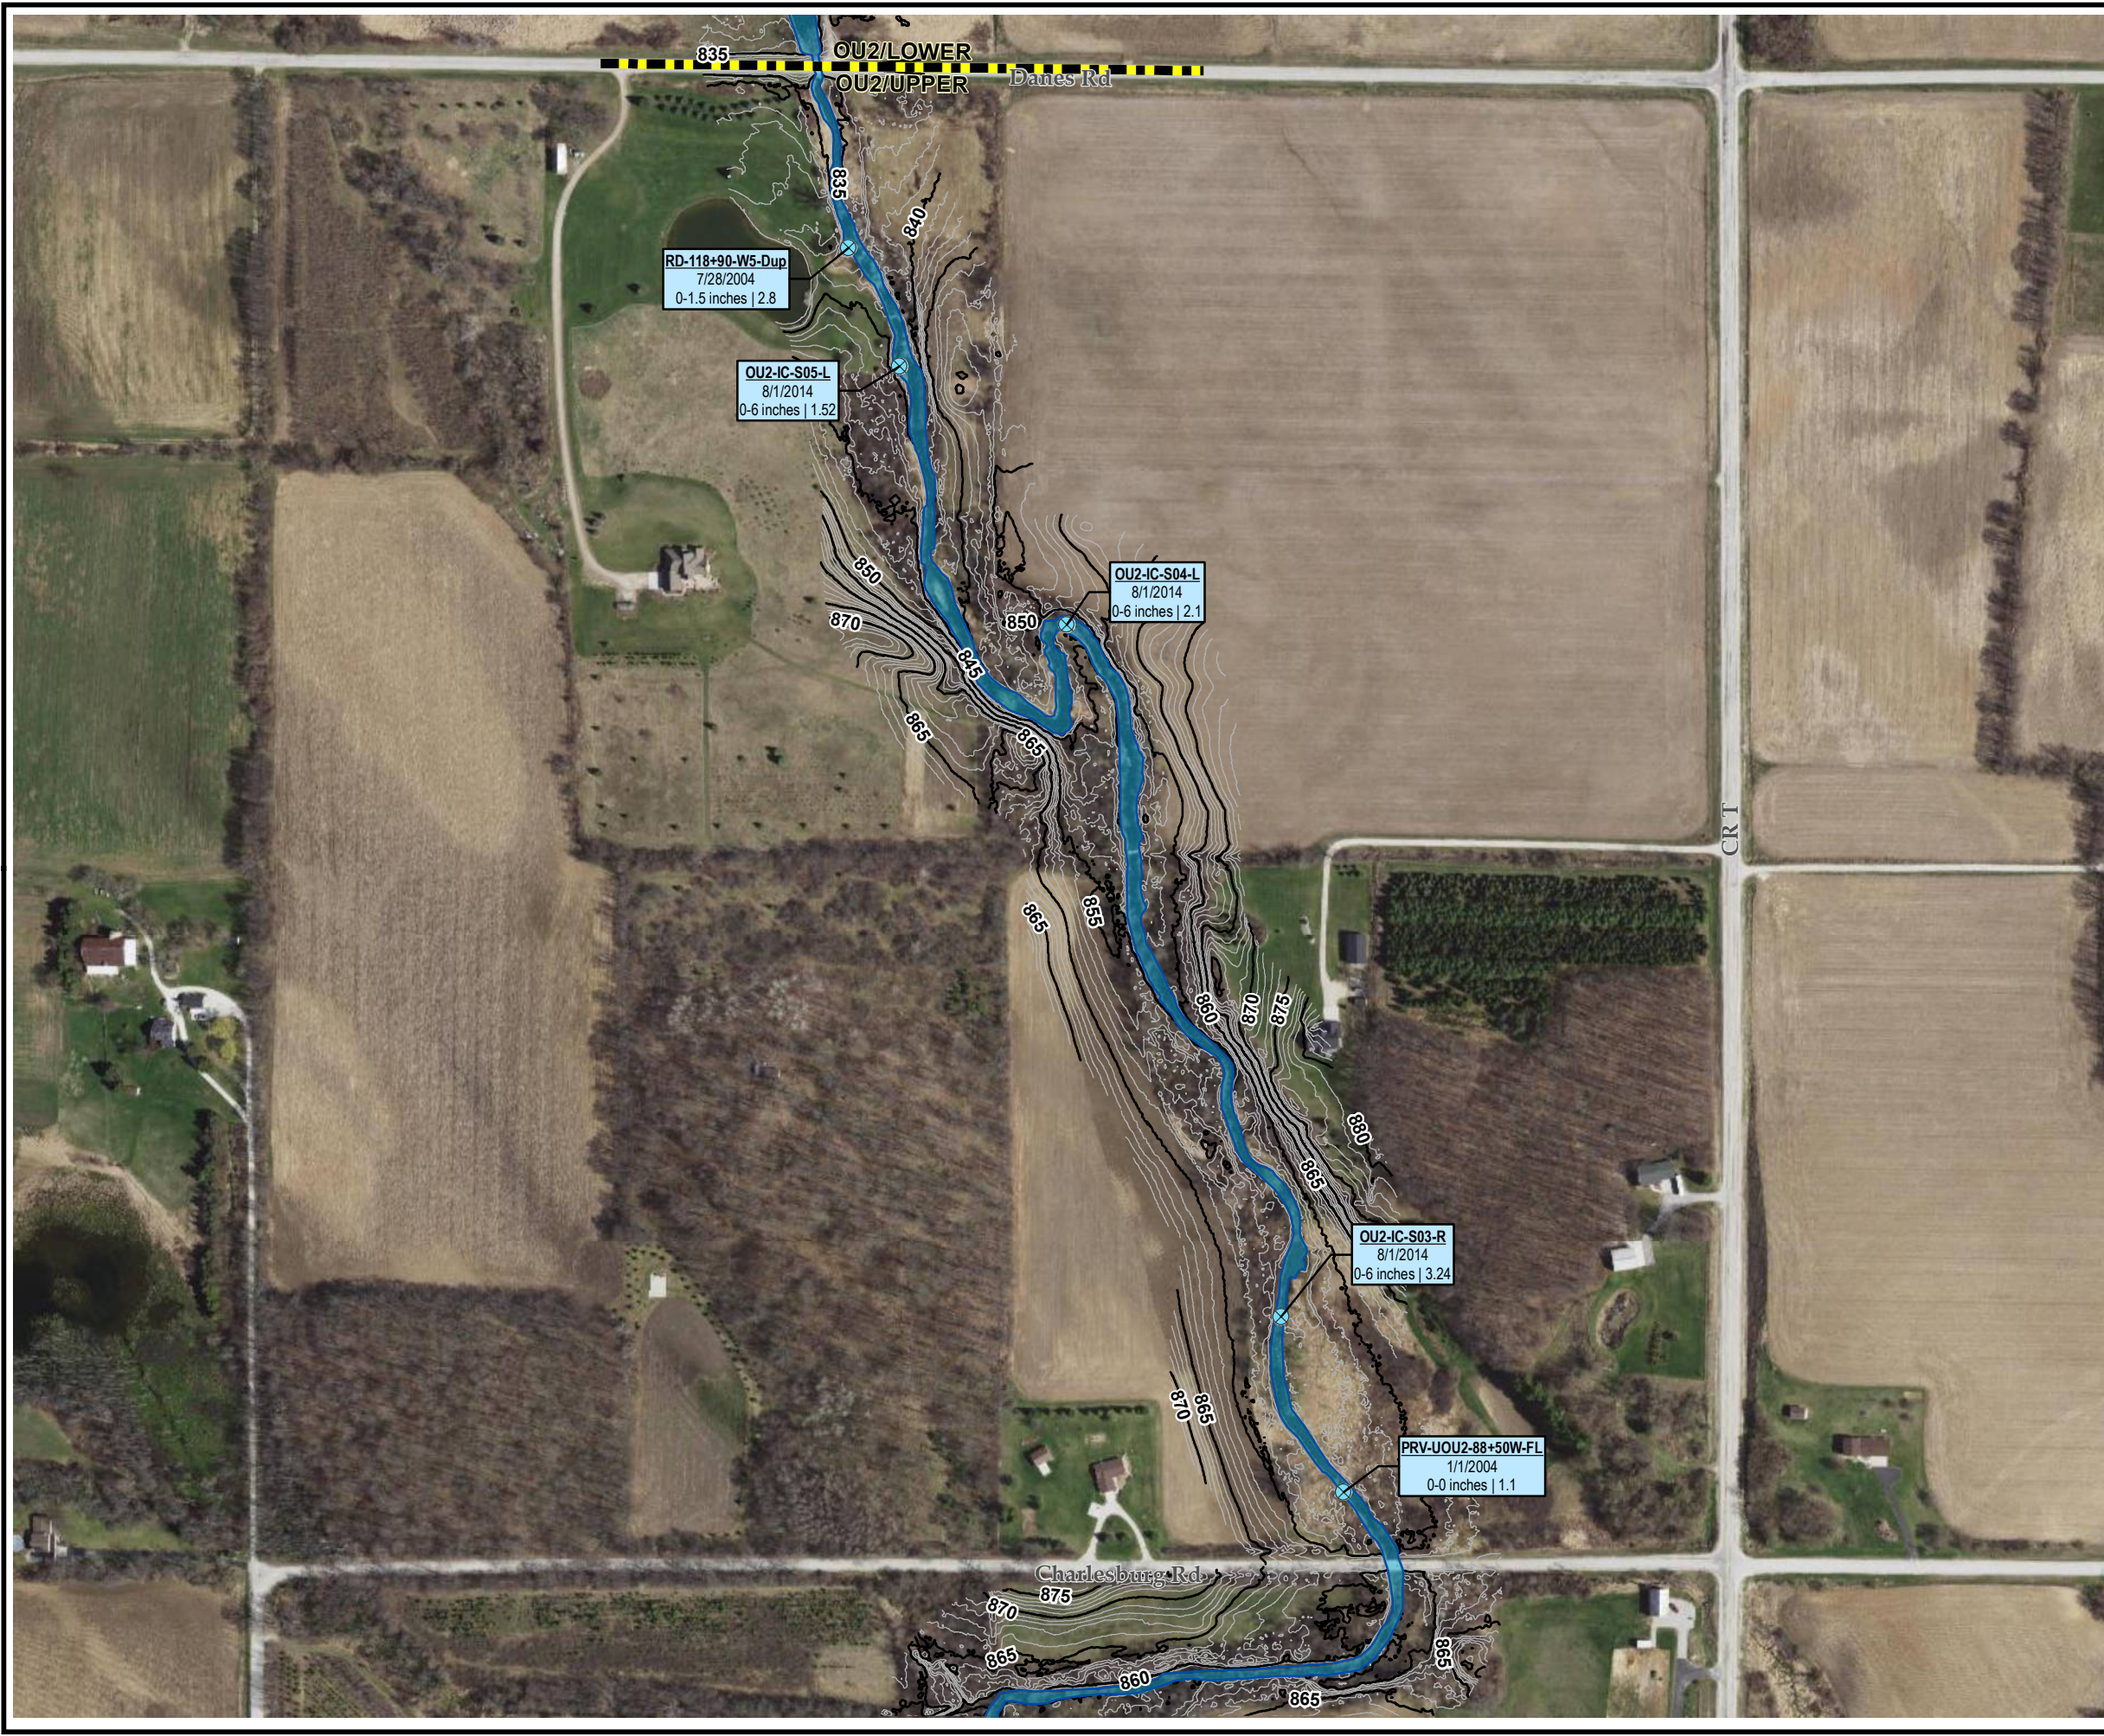
OU2/UPPER-OU2/LOWER

<b>PROJECT:</b>	
<b>TECUMSEH &amp; HARP REMEDIAL ACTION STANDARDS REPORT CALUMET COUNTY, WISCONSIN</b>	
<b>TITLE:</b>	
<b>OU2/UPPER-OU2/LOWER - SAMPLE LOCATIONS</b>	
DRAWN BY: R. SUEMNICHT	PROJ NO.: 107927
CHECKED BY: J. RICE	<b>FIGURE 4</b>
APPROVED BY: C. HARVEY	
DATE: JUNE 2021	
505 East Huntland Drive, Suite 250 Austin, TX 78752 Phone: 512.329.6080 www.trcsolutions.com	
FILE NO.: 107927-2019-001mb.mxd

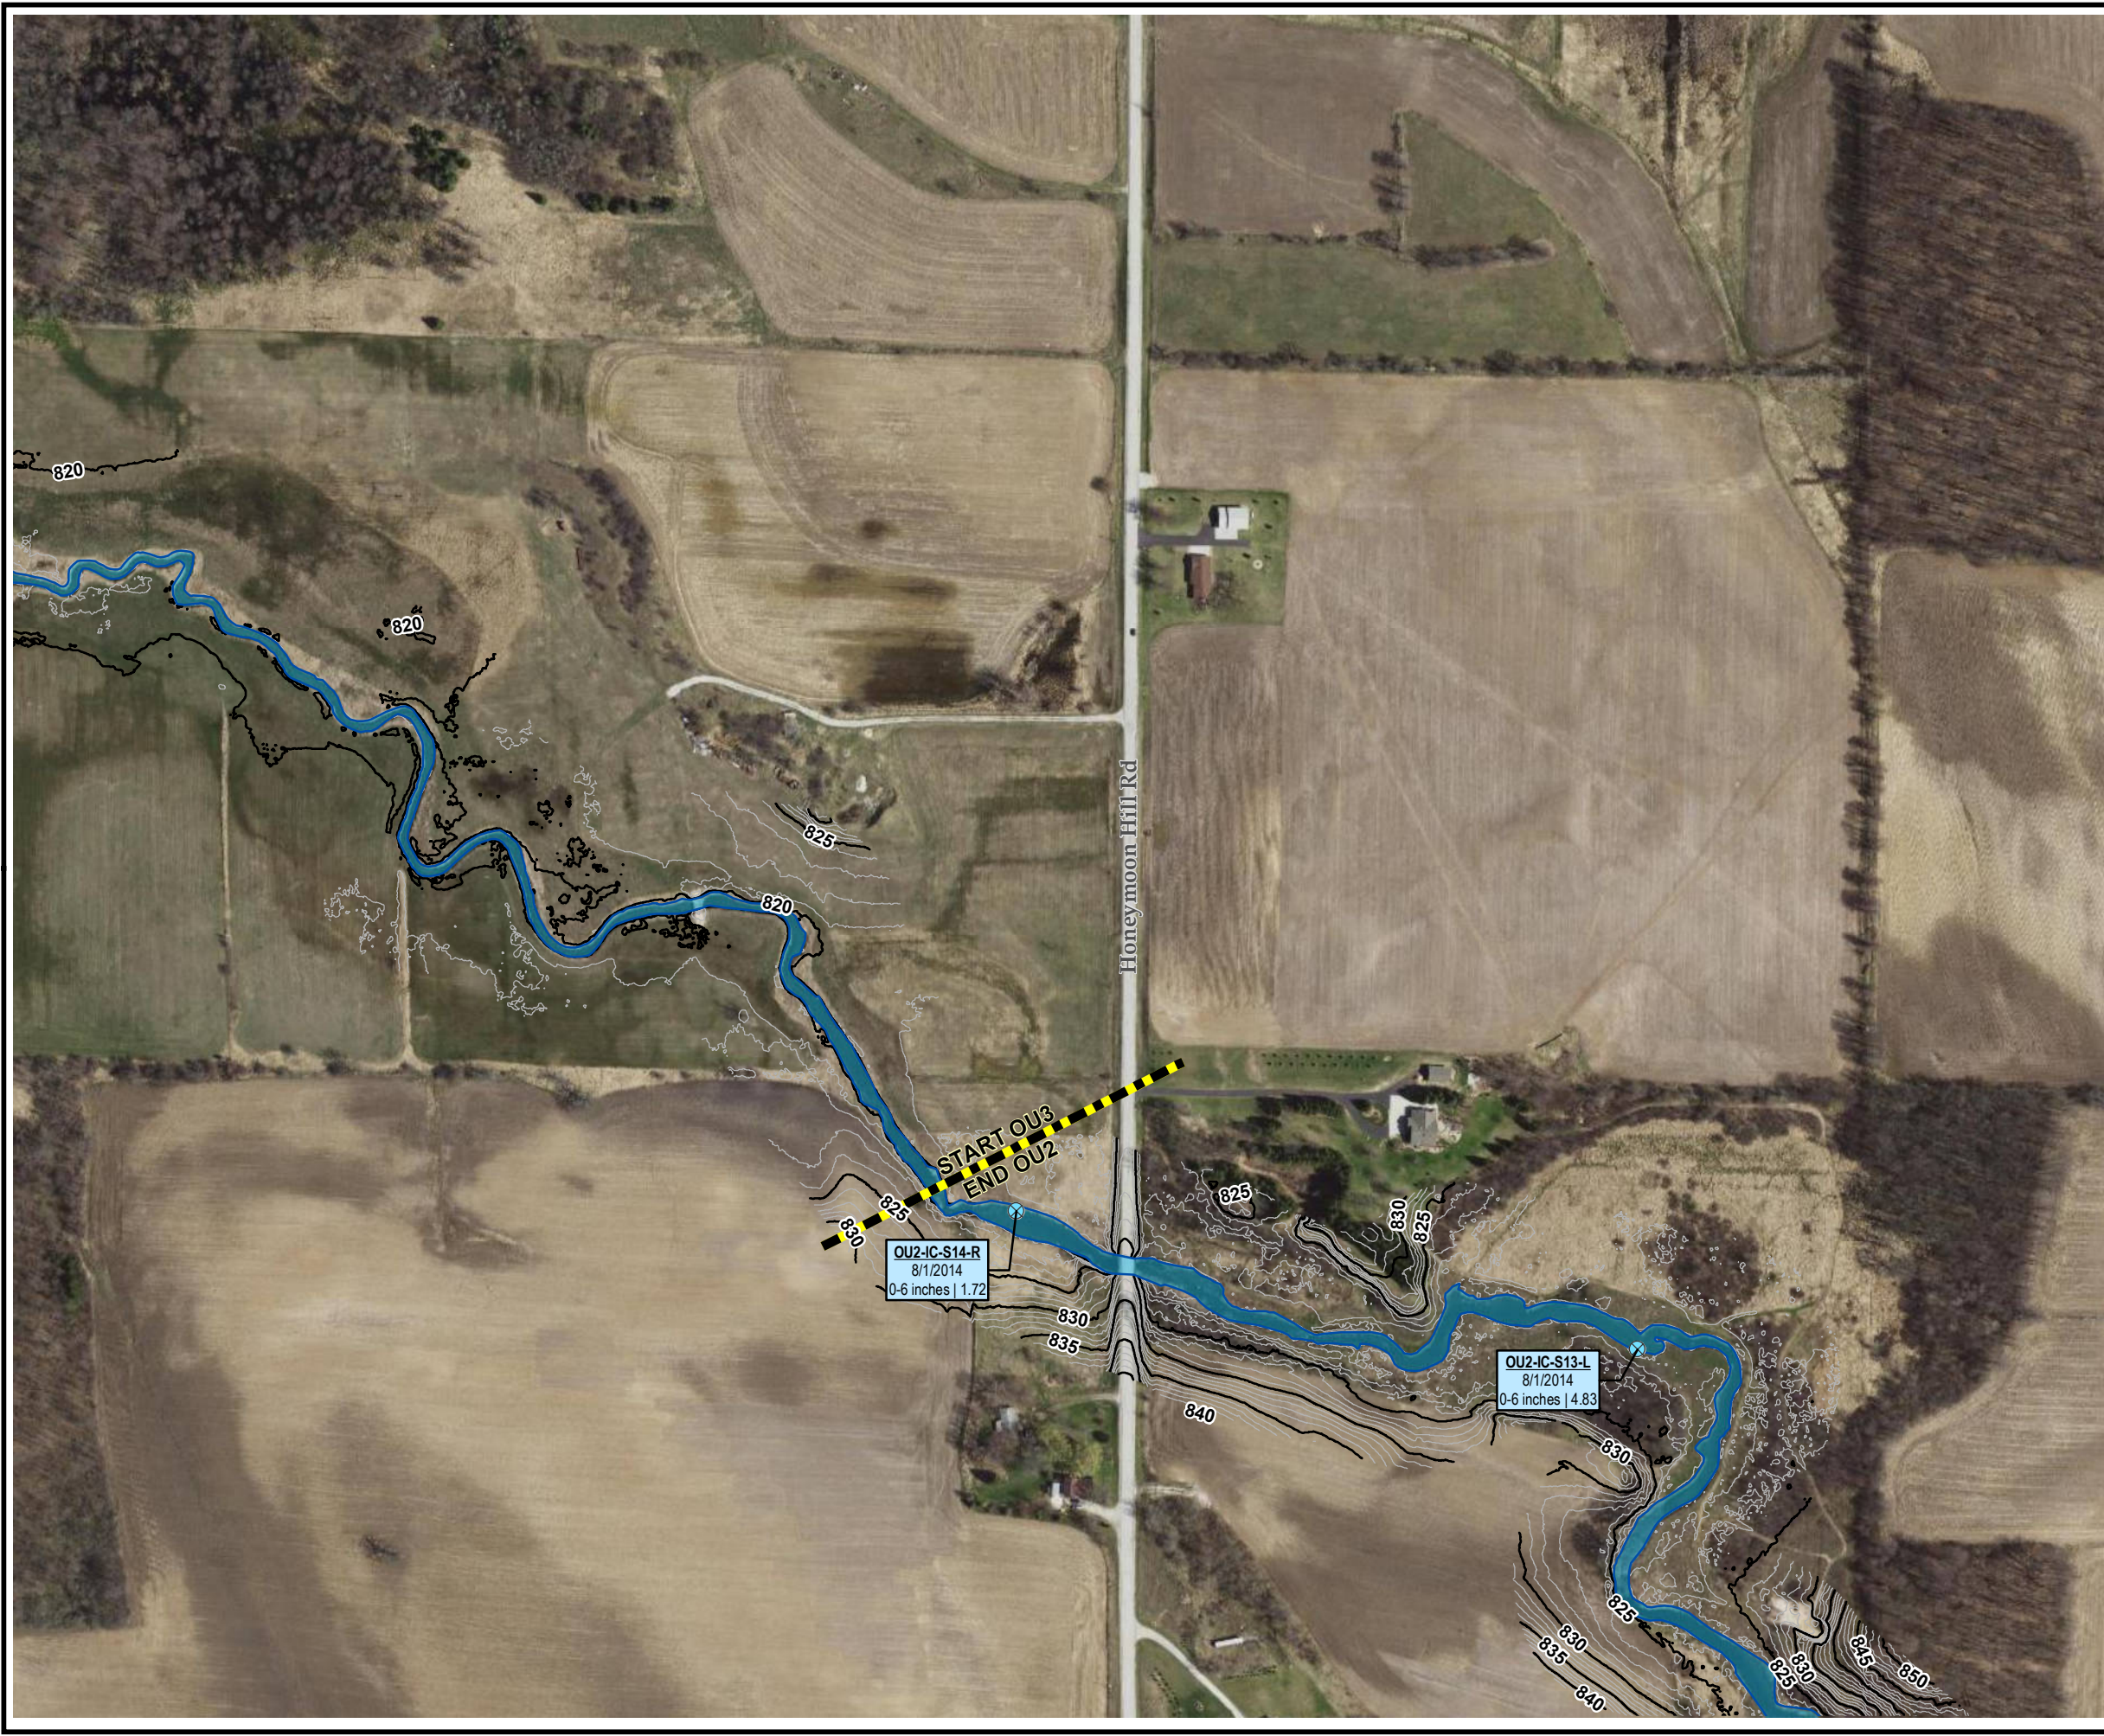
OU2/LOWER-OU3/UPPER

<b>PROJECT:</b>	
<b>TECUMSEH &amp; HARP REMEDIAL ACTION STANDARDS REPORT CALUMET COUNTY, WISCONSIN</b>	
<b>TITLE:</b>	
<b>OU2/LOWER-OU3/UPPER - SAMPLE LOCATIONS</b>	
<b>DRAWN BY:</b> R. SUEMNICHT	<b>PROJ NO.:</b> 107927
<b>CHECKED BY:</b> J. RICE	<b>FIGURE 6</b>
<b>APPROVED BY:</b> C. HARVEY	
<b>DATE:</b> JUNE 2021	
505 East Huntland Drive, Suite 250 Austin, TX 78752 Phone: 512.329.6080 www.trcsolutions.com	
<b>FILE NO.:</b>	107927-2019-001mb.mxd
