Request for Bid
WDNR State Funded Response Investigation
Montello Lodge/Former Econo Wash
Main St. Montello WI

FIELD PHOTOGRAPHY LOG SHEET

SITE NAME: **Montello Lodge**

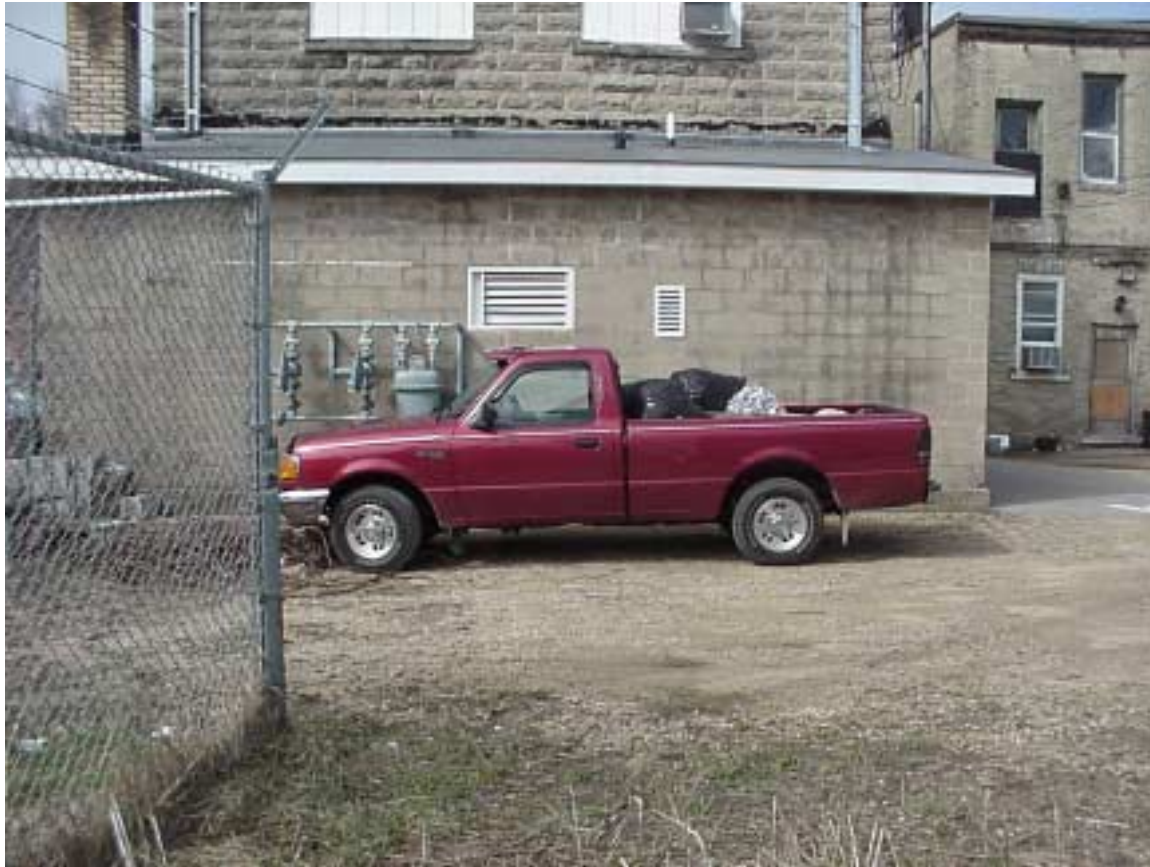
DATE: 4/10/2001 TIME: AM DIRECTION OF PHOTOGRAPH: West PHOTOGRAPHED BY: KMS

DESCRIPTION: Back of Montello Lodge Building, facing west.

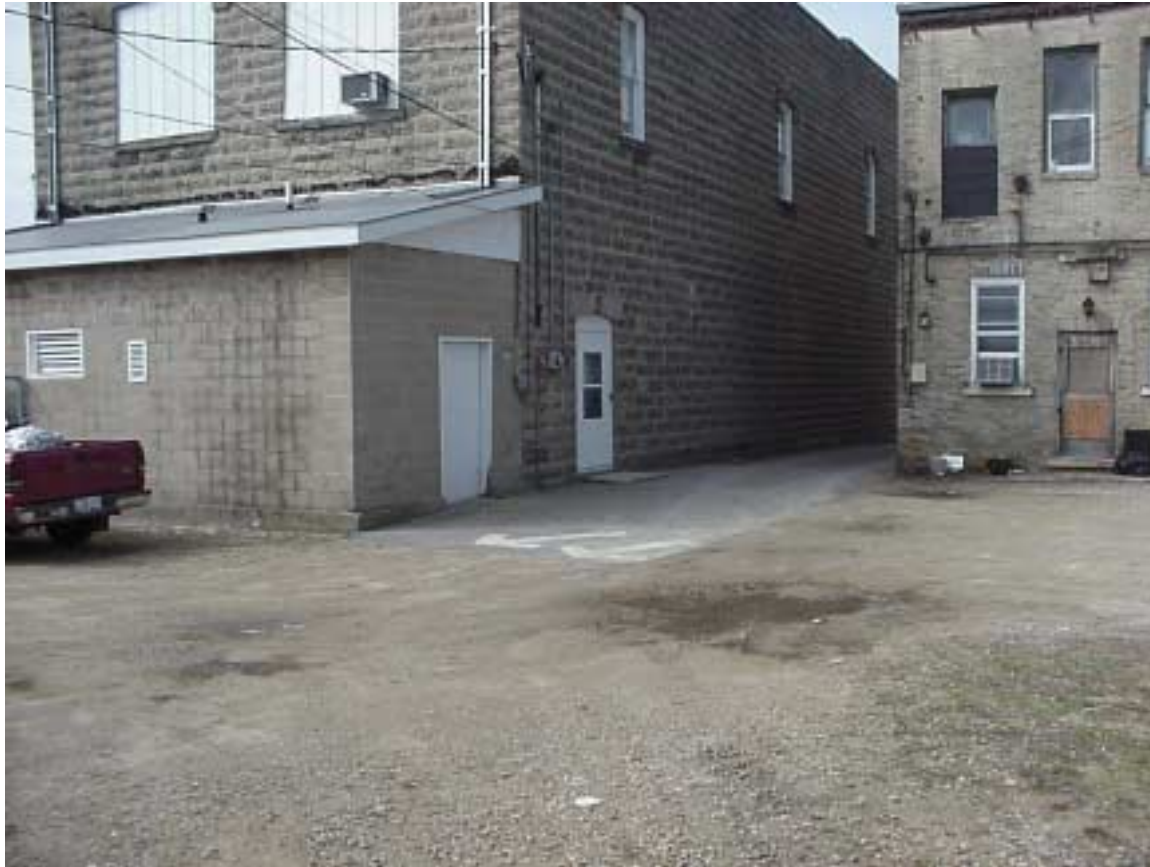
DATE: 4/10/2001 TIME: AM DIRECTION OF PHOTOGRAPH: Southwest PHOTOGRAPHED BY: KMS

DESCRIPTION: View to Southwest from behind building

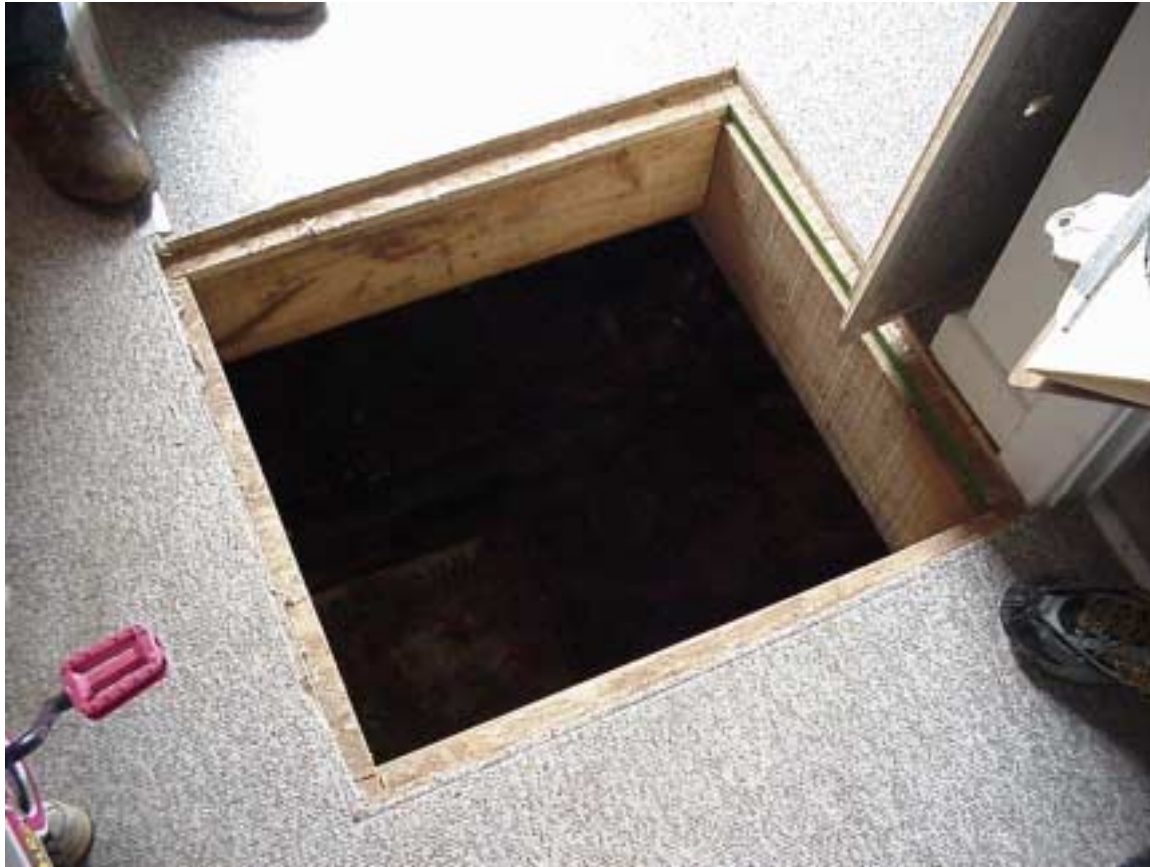
DESCRIPTION: Access panel to crawlspace

The building was built in the early 1900's and has a field stone foundation with a dirt floor crawlspace. Access to the crawlspace is by a removable floor panel into the approximately 3.5-4' crawlspace. Field staff would also have to crawl through a centerline wall which has had stone removed to get to the sampling location under the location of the former dry cleaning machines. The Lodge representative is about 6'2" and has stated that he goes into the crawlspace to work on plumbing and has no problems with access. A visual inspection found the crawlspace to be quite clean. Pictures are attached.

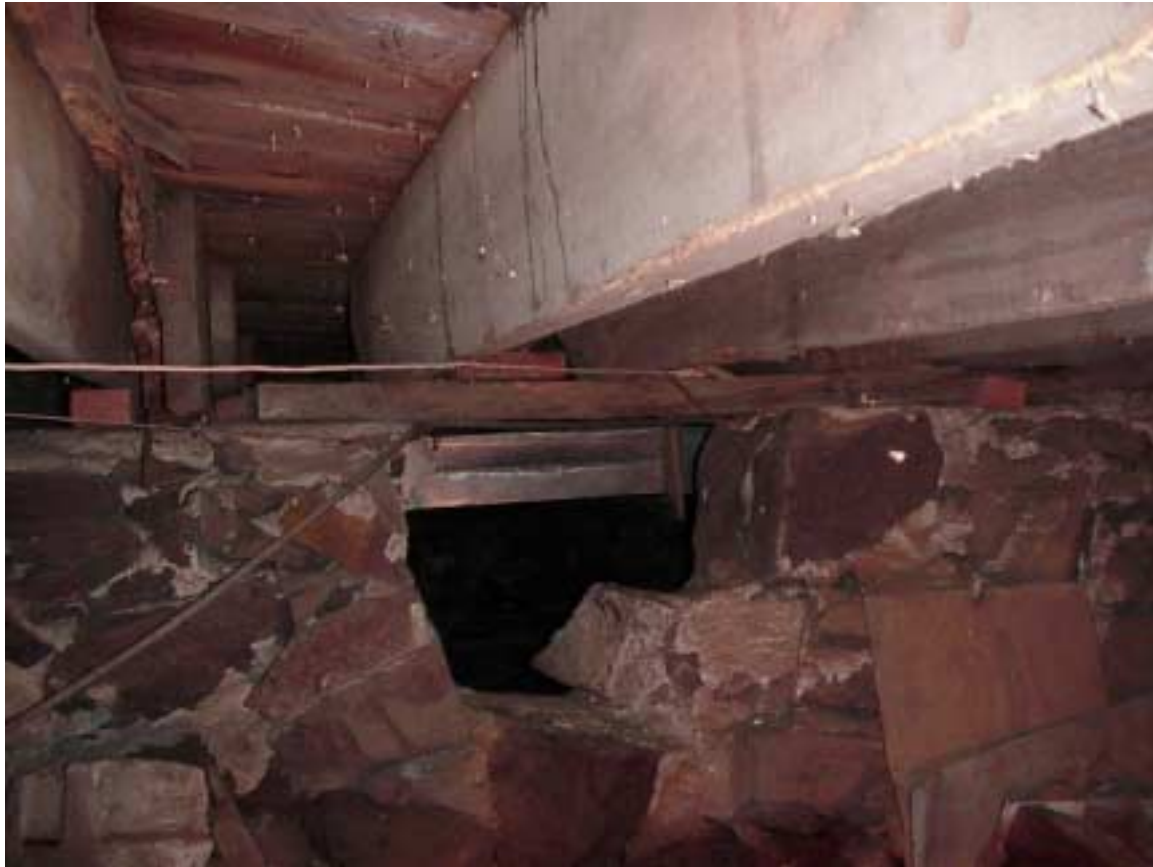
DATE: 4/10/2001 TIME: AM DIRECTION OF PHOTOGRAPH: South PHOTOGRAPHED BY: KMS

DESCRIPTION: View of centerline wall and hole facing south. Far wall is about 12 feet away (sampling location)
