SUBJECT: Final Case Closure with Continuing Obligations  
Korth Property, 1629 W. Washington Street, Appleton, WI  
DNR BRRTS Activity #: 03-45-002078

The Department of Natural Resources (DNR) considers the Korth Property contamination case closed, with continuing obligations. This closure applies to lead, Polycyclic Aromatic Hydrocarbons (PAHs) and/or Volatile Organic Compounds (VOCs) in soil, groundwater and/or vapor. No further investigation or remediation is required at this time. However, you, future property owners, and occupants of the property must comply with the continuing obligations as explained in the conditions of closure in this letter. Please read over this letter closely to ensure that you comply with all conditions and other on-going requirements. Provide this letter and any attachments listed at the end of this letter to anyone who purchases, rents or leases this property from you. Certain continuing obligations also apply to affected property owners or rights-of-way holders. These are identified within each continuing obligation.

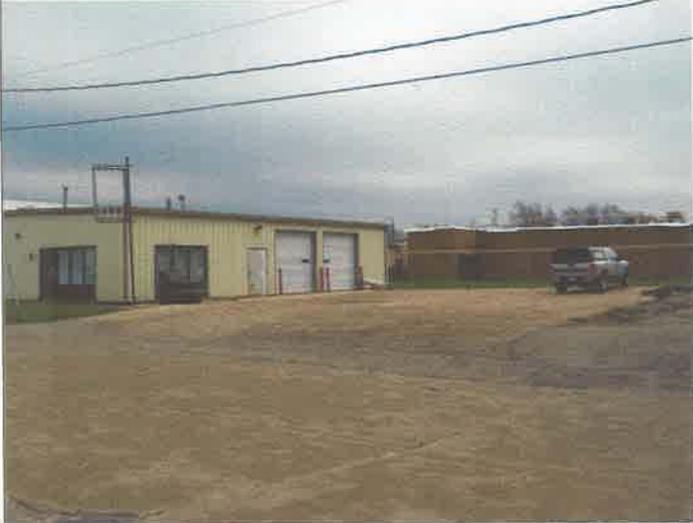
Title: Photo #1: Cap to be maintained looking southeast.

The asphalt, building, and grass cap overlying the contaminated soil and as depicted in Attachment D.2 will be inspected once a year, normally in the spring after all snow and ice is gone, for deterioration, cracks and other potential problems that can cause exposure to underlying soils or additional infiltration through asphalt. The inspections will be performed by the property owner or their designated representative. The inspections will be performed to evaluate damage due to settling, exposure to the weather, wear from traffic, increasing age and other factors. Any area where soils have become or are likely to become exposed and where infiltration from the surface will not be effectively minimized will be documented.

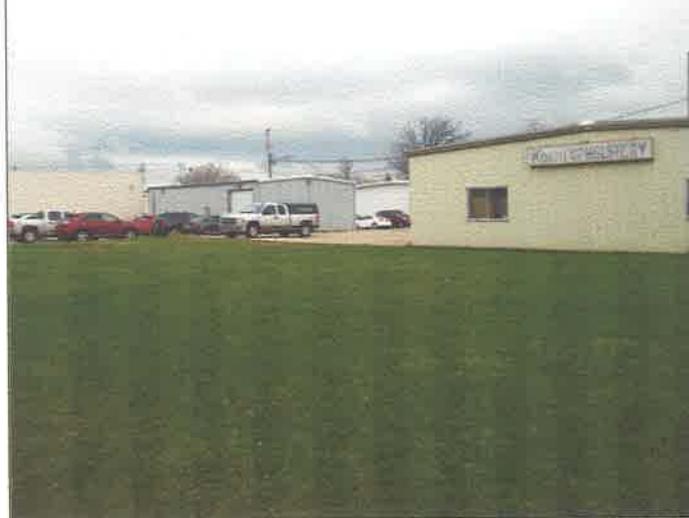
Title: Photo #2: Cap to be maintained looking northwest.

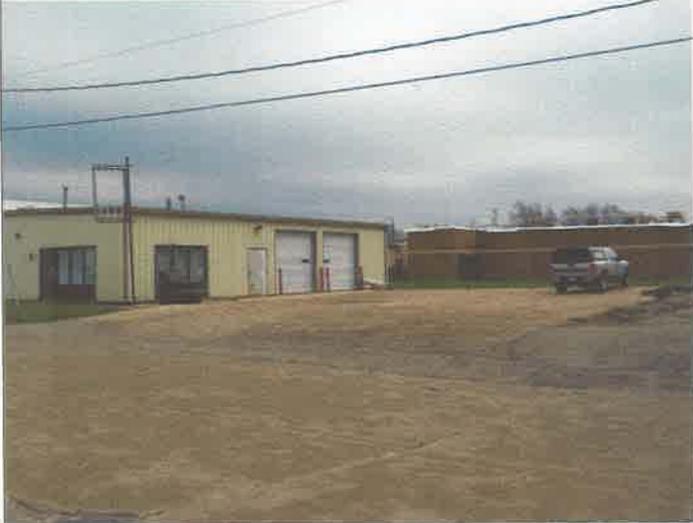
Title: Photo #1: Cap to be maintained looking southeast.

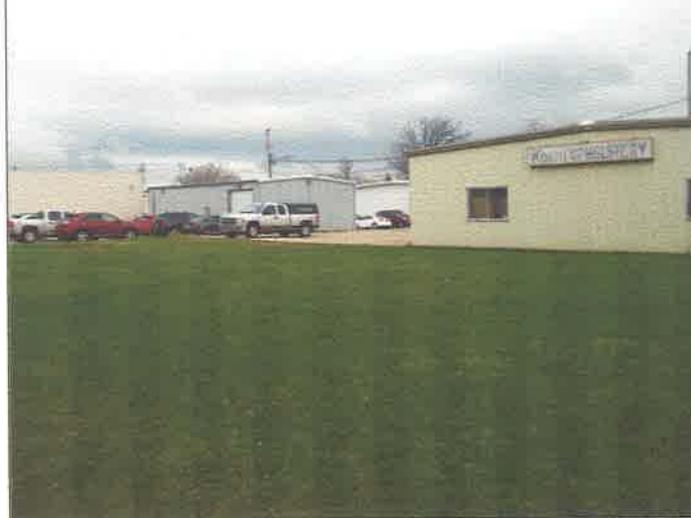
Title: Photo #2: Cap to be maintained looking northwest.
