SUBJECT: STATUS UPDATE REPORT
Templin Property
102 W Maple
Lime Ridge, Sauk County, Wisconsin
WDNR 03-57-002197

Status Update Report

Templin Property
102 W. Maple St., Lime Ridge, Sauk County, WI
Page 2

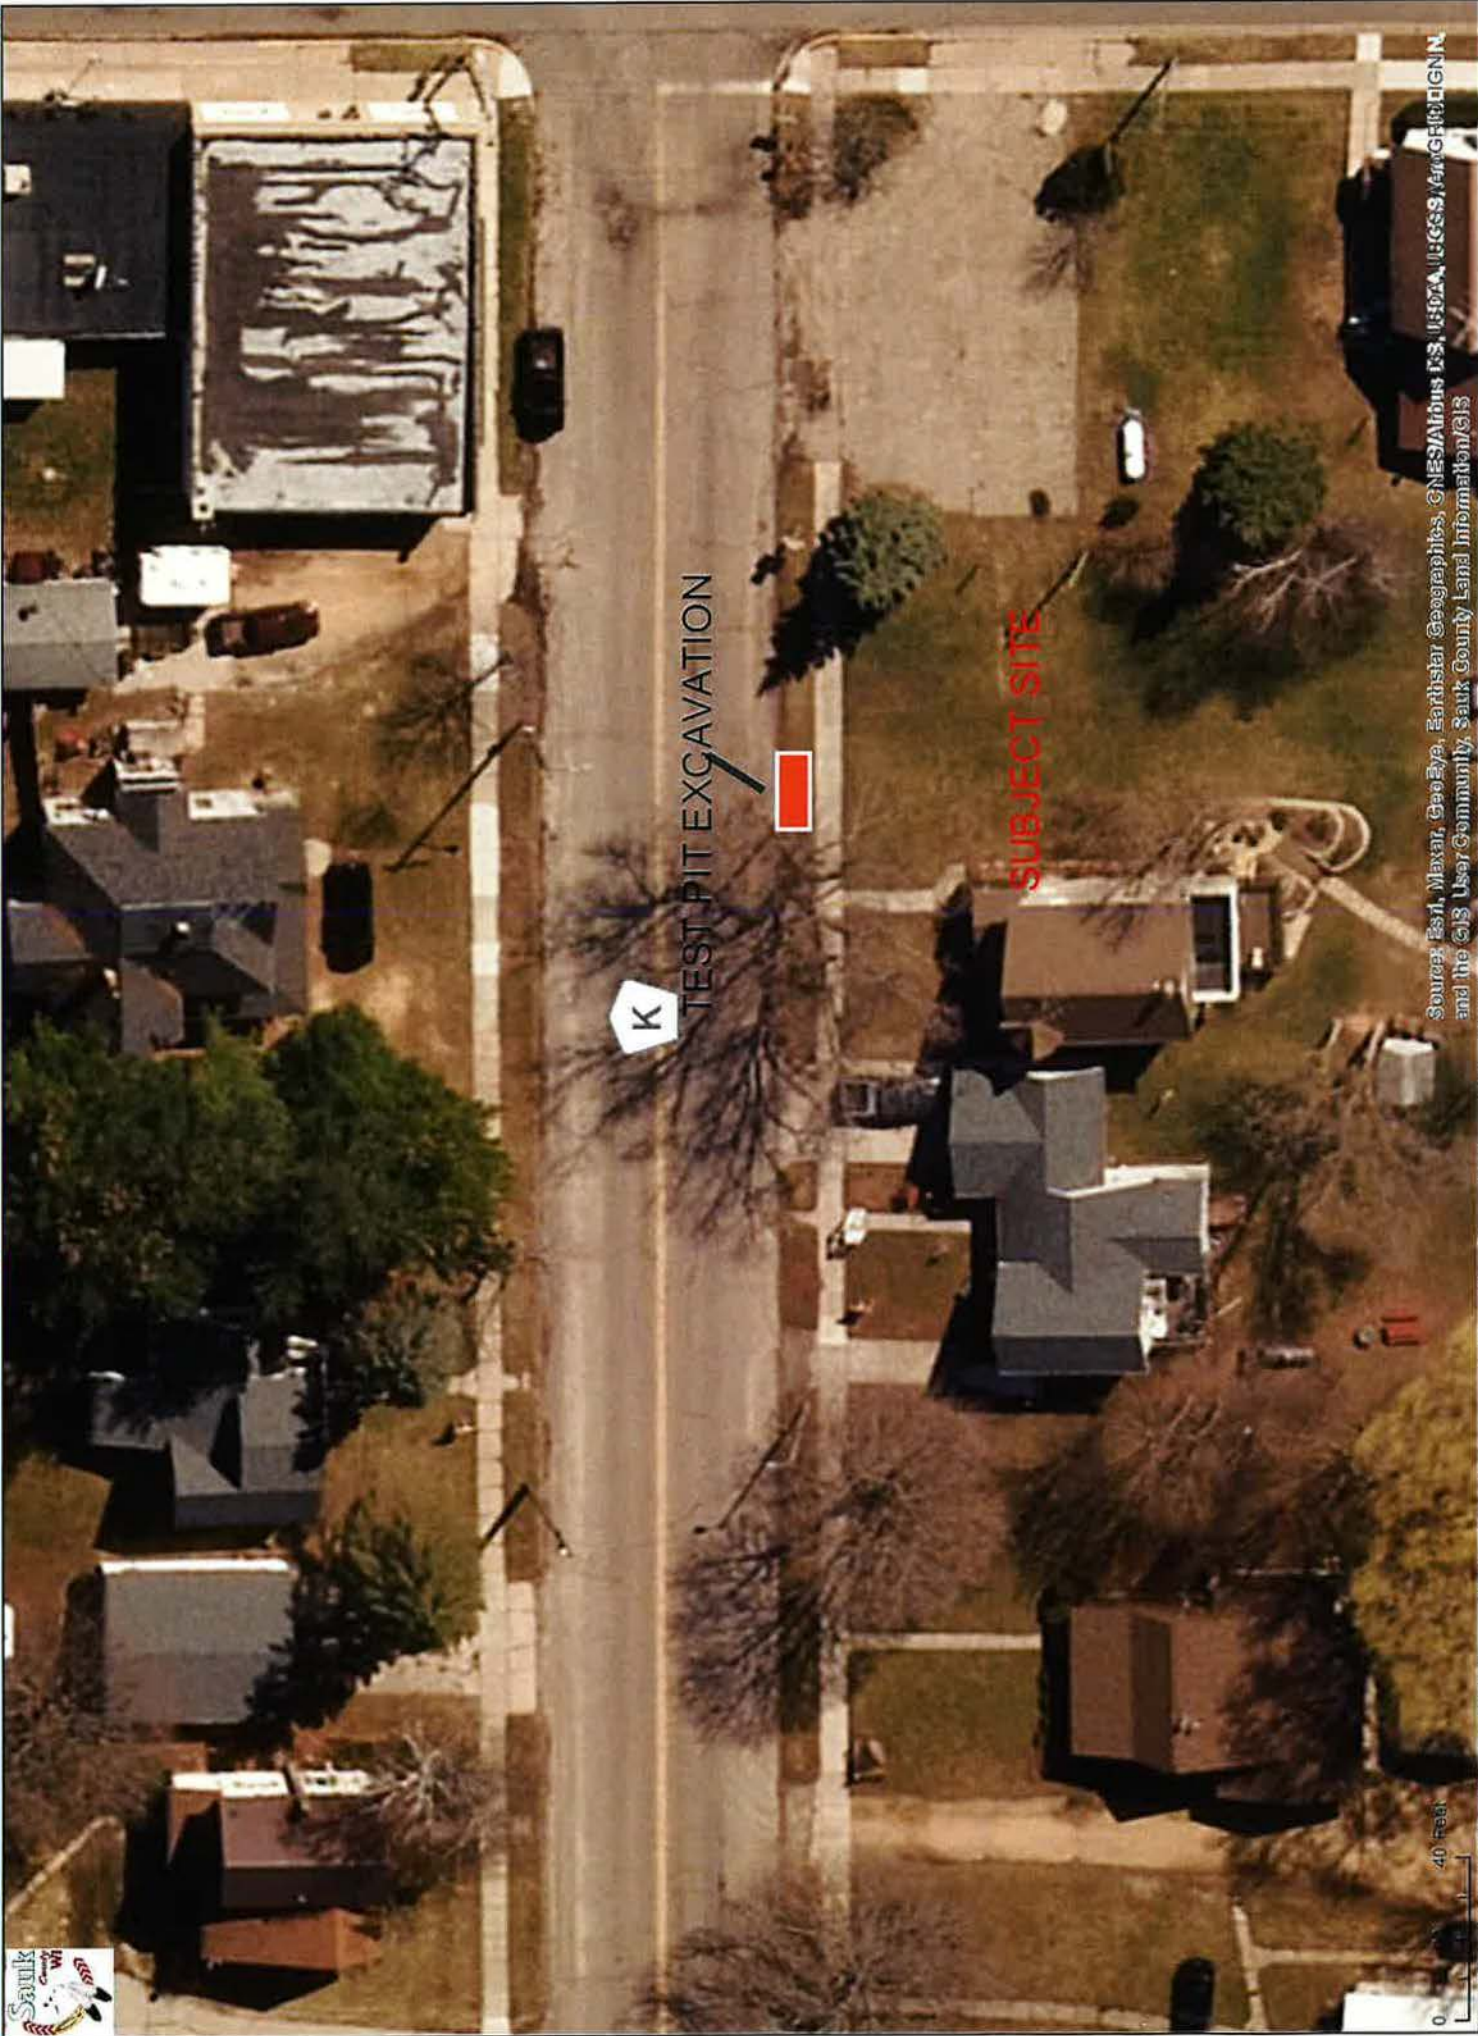
of GEC. Soil samples were collected by driving a 60-inch plastic sleeve within a metal sampling spoon into undisturbed soils. The soil probes were advanced to depths of up to 15 feet below ground surface (bgs). The soil probes and temporary monitoring well locations are shown of Figure 2, Appendix A.
