May 24, 2017

SUBJECT: Final Case Closure with Continuing Obligations
Appleby's Auto Salvage, W2578 Holland Lima Rd, Oostburg, WI
DNR BRRTS Activity #: 03-60-305128

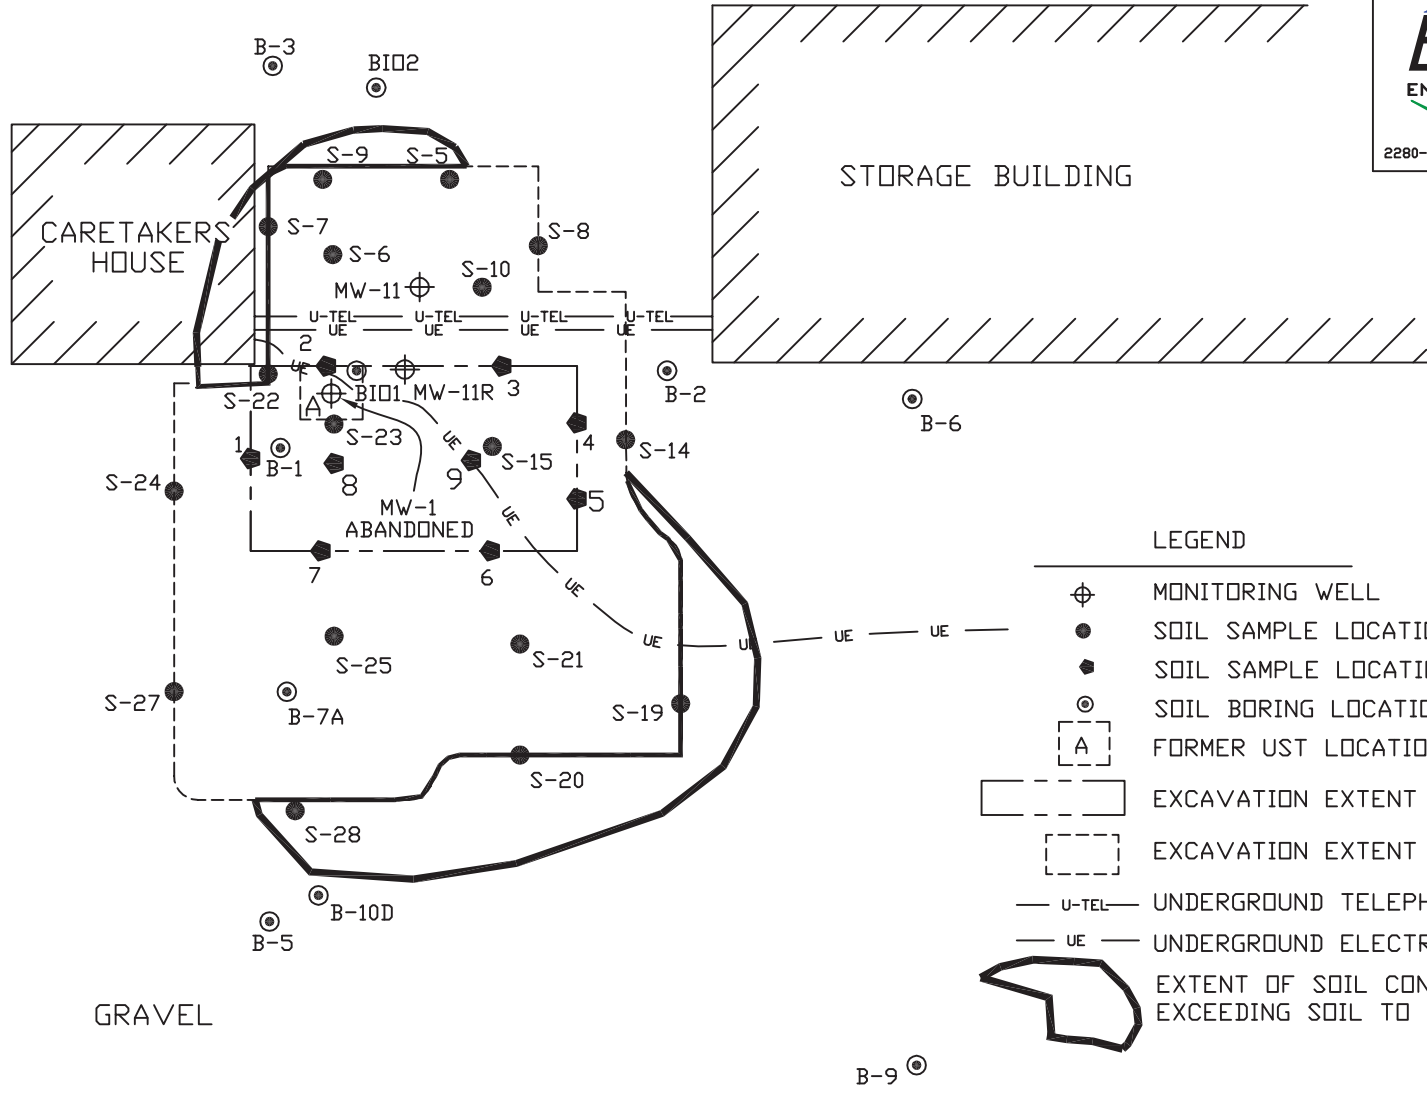
SCALE	SHEET NO.	DWG NO.	DATE	SIZE	DRWN BY	FILE	REVISED	APP'D
1' = 30'	1 OF 1	P07770.45.B.3.b.	1/30/17	A	SVD	221	5/12/17	SV

Future Concern: Petroleum contamination remains in both soil and groundwater, as shown on the attached maps, *Groundwater Isoconcentration*, Figure B.3.b, January 30, 2017 and *Residual Soil Contamination*, Figure B.2.b, January 30, 2017, at levels that may be of concern for vapor intrusion in the future, depending on construction and occupancy of a building. At the present time, there is an unoccupied dwelling on the property referred to as the Caretakers House. Therefore, before a building is constructed or the existing building is modified, the property owner must notify the DNR at least 45 days before the change. Vapor control technologies are required for construction of occupied buildings unless the property owner assesses the vapor pathway and DNR agrees that vapor control technologies are not needed.

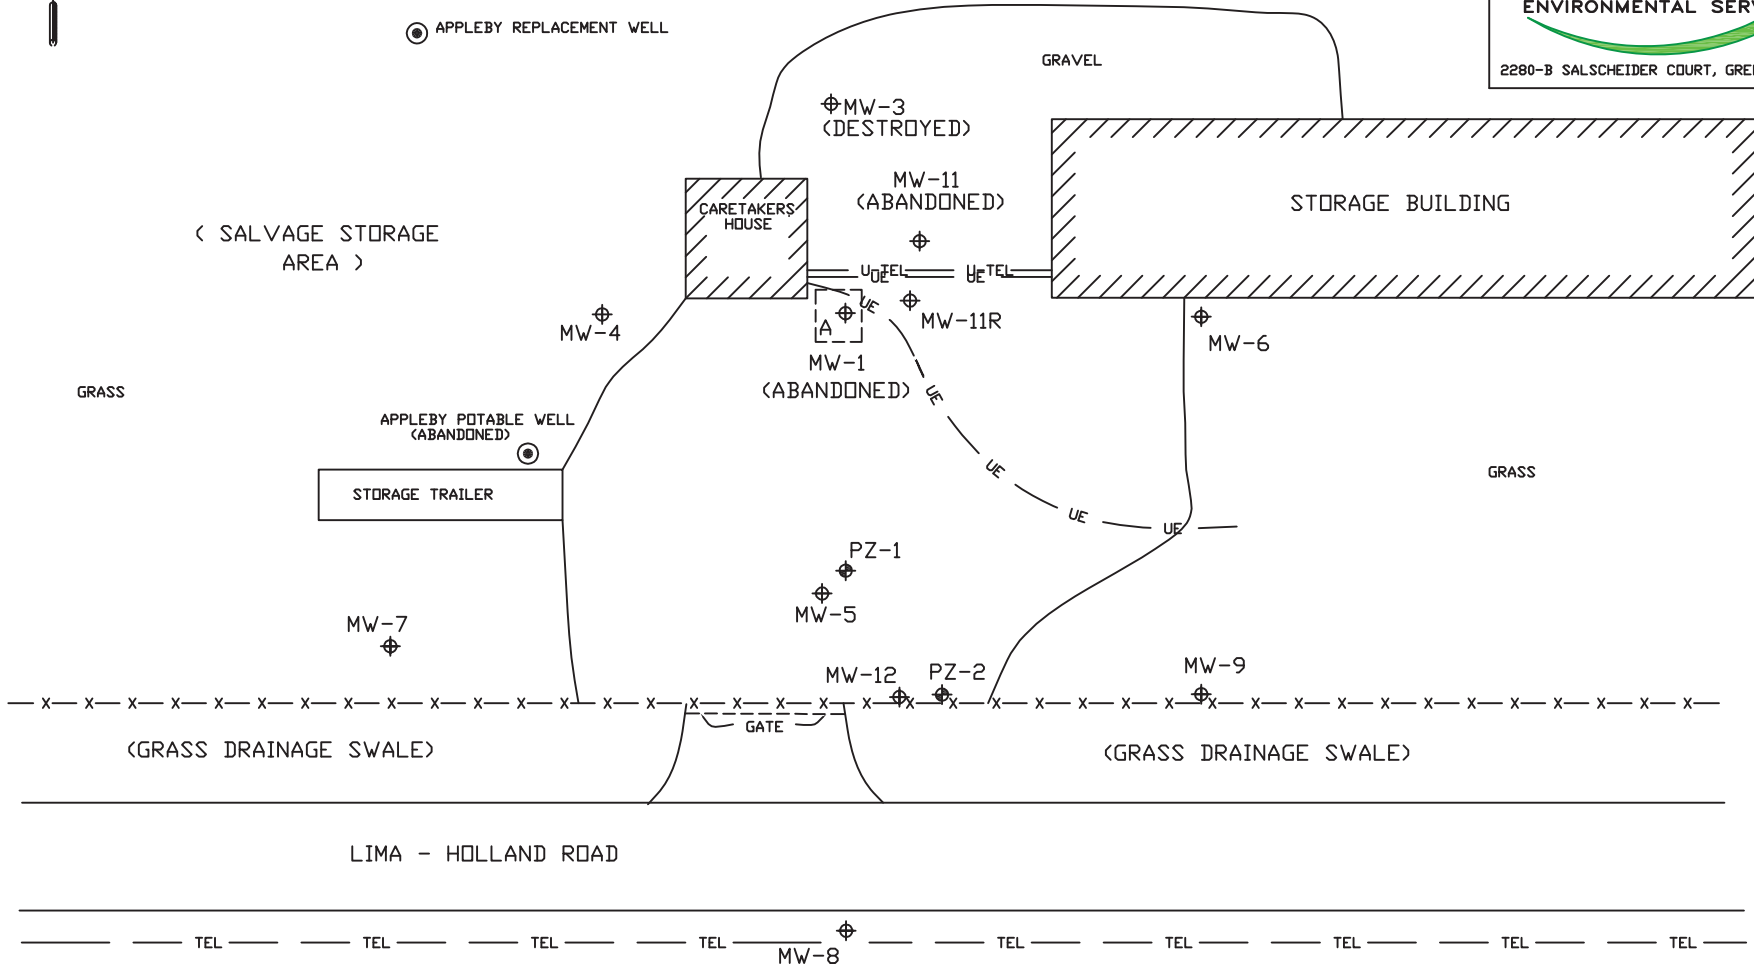
SCALE	SHEET NO.	DWG NO.	DATE	SIZE	DRWN BY	FILE	REVISED	APP'D
1' = 30'	1 OF 1	P07770.45.B.1.b.1	1/30/17	A	SVD	221

Monitoring well MW-3, located on the source property, W2578 Holland Lima Road, shown on the attached map *Detailed Site Map*, Figure B.1.b.1, January 30, 2017, could not be properly filled and sealed because it was missing due to normal scrap yard activities. Your consultant made a reasonable effort to locate the well and to determine whether it was properly filled and sealed, but was unsuccessful. You may be held liable for any problems associated with the monitoring wells if they create a conduit for contaminants to enter groundwater. If the groundwater monitoring well is found, the then current owner of the property on which the well is located is required to notify the DNR, to properly fill and seal the wells and to submit the required documentation to the DNR.

The monitoring wells at the site must be properly abandoned in accordance with ch. NR 141, Wis. Adm. Code. Documentation of well abandonment for all wells must be submitted to Tom Verstegen, 625 E. Cty Rd Y, Suite 700, Oshkosh, WI 54901-9731, on Form 3300-005, found at <http://dnr.wi.gov/topic/groundwater/forms.html>.

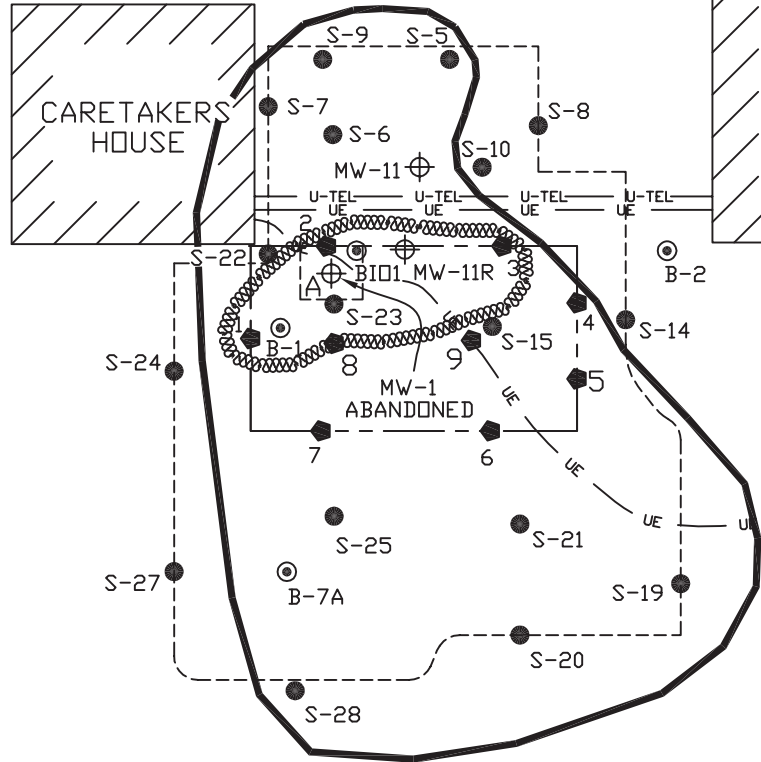
SCALE	SHEET NO.	DWG NO.	DATE	SIZE	DRWN BY	FILE	REVISED	APP'D
1' = 20'	1 OF 1	P07770.45.B.2.a.	1/30/17	A	SVD	221

- ii. Describe the concentration(s) and types of soil contaminants found in the upper four feet of the soil column.
As a result of the site remedial excavation, direct contact soils were removed and no soil concentrations in excess of the direct contact RCLs remain in the upper four feet of the soil column.

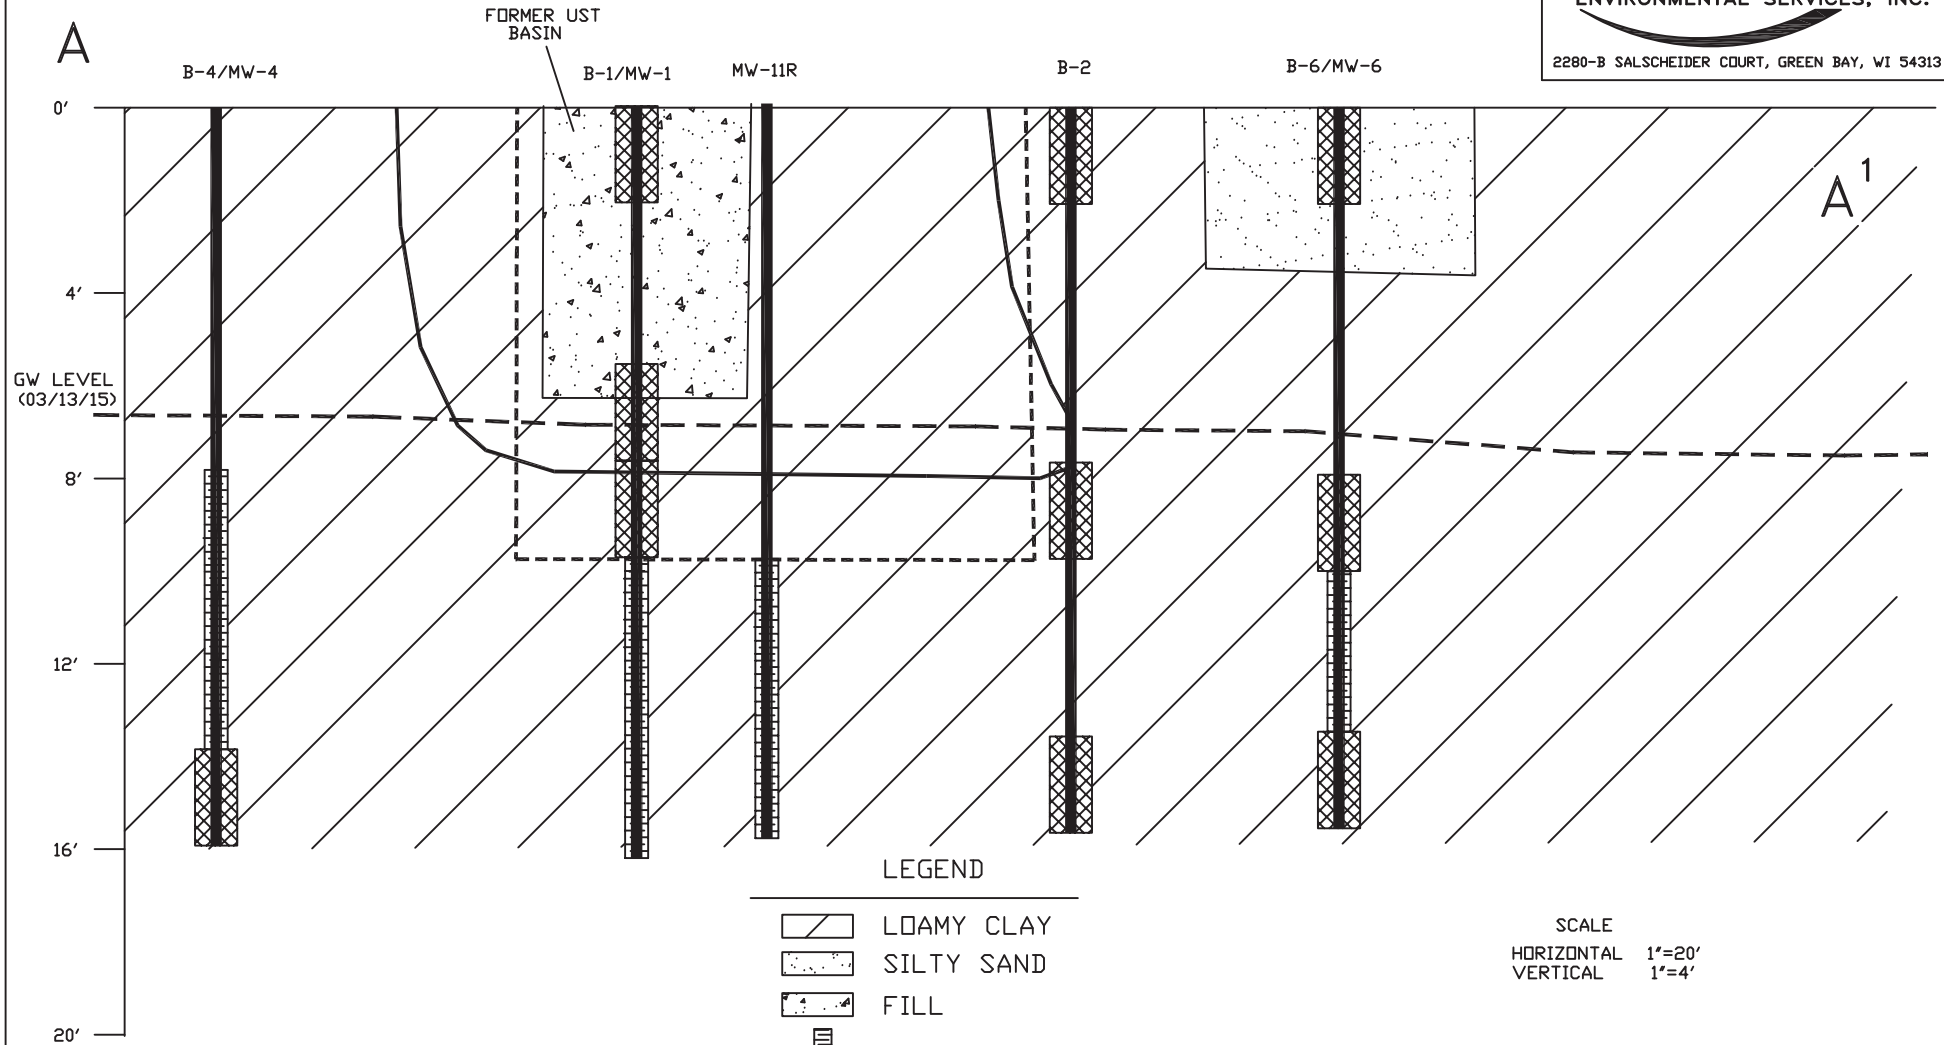
FIGURE B.3.a.
GEOLOGIC CROSS-SECTION A-A¹
APPLEBY'S AUTO SALVAGE
OOSTBURG, WISCONSIN

- i. Discuss depth to groundwater and piezometric elevations. Describe and explain depth variations, including high and low water table elevation and whether free product affects measurement of water table elevation. Describe the stratigraphic unit(s) where water table was found or which were measured for piezometric levels.
Depth to shallow groundwater ranges from 1.09 feet bgs (MW-5 12/21/09) to 10.16 feet bgs (PZ-1 09/28/2009) within the silty clay soils. Depth to shallow water variations across the site appear to be the result of seasonal precipitation. No free product has ever been measured at the site. Review of local potable well construction reports indicates depth to potable water was measured between approximately 60 and 100 feet bgs.
