## Supplemental Remedial Action Plan

**Bishop's Creek Community Development Corporation  
4759 North 32<sup>nd</sup> Street  
Milwaukee, Wisconsin**

**October 29, 2010  
(Revised November 30, 2010)  
Project No. 1E-0912014**

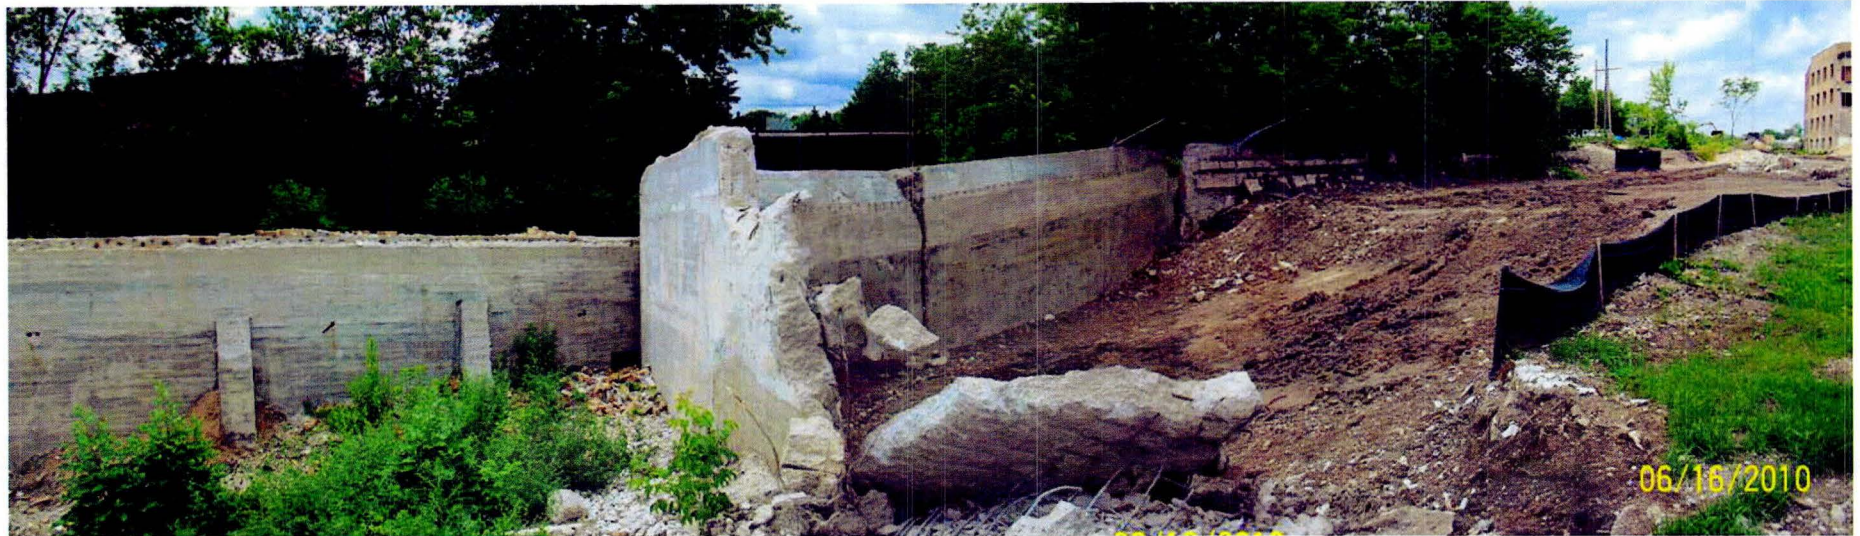
**PHOTOGRAPH 01**

View of bank area looking west with of the former building footing walls before they were cut down.

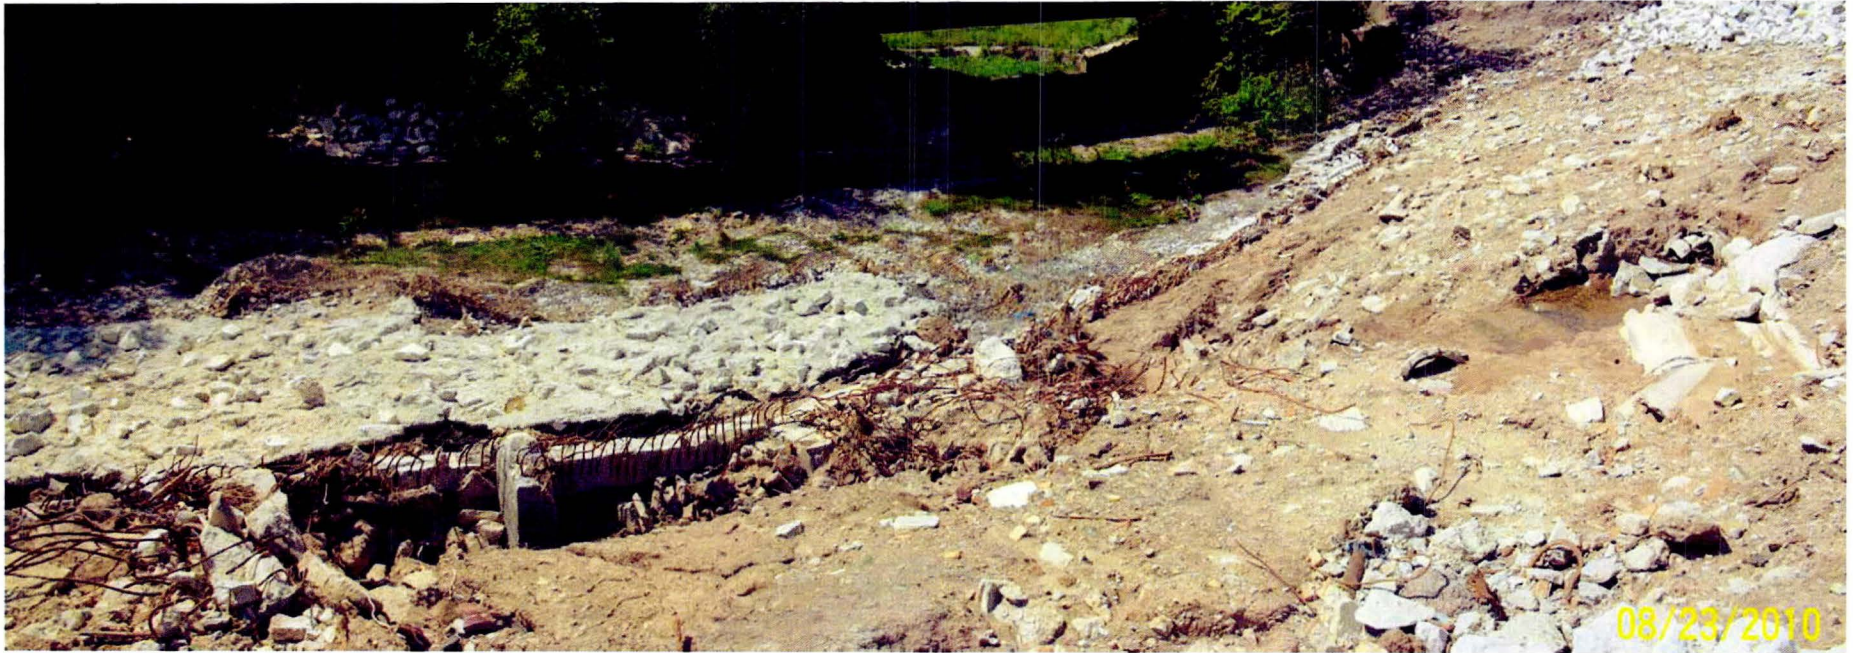
**PHOTOGRAPH 02**

View of bank area looking west after flood damage and with former building footing walls cut down.

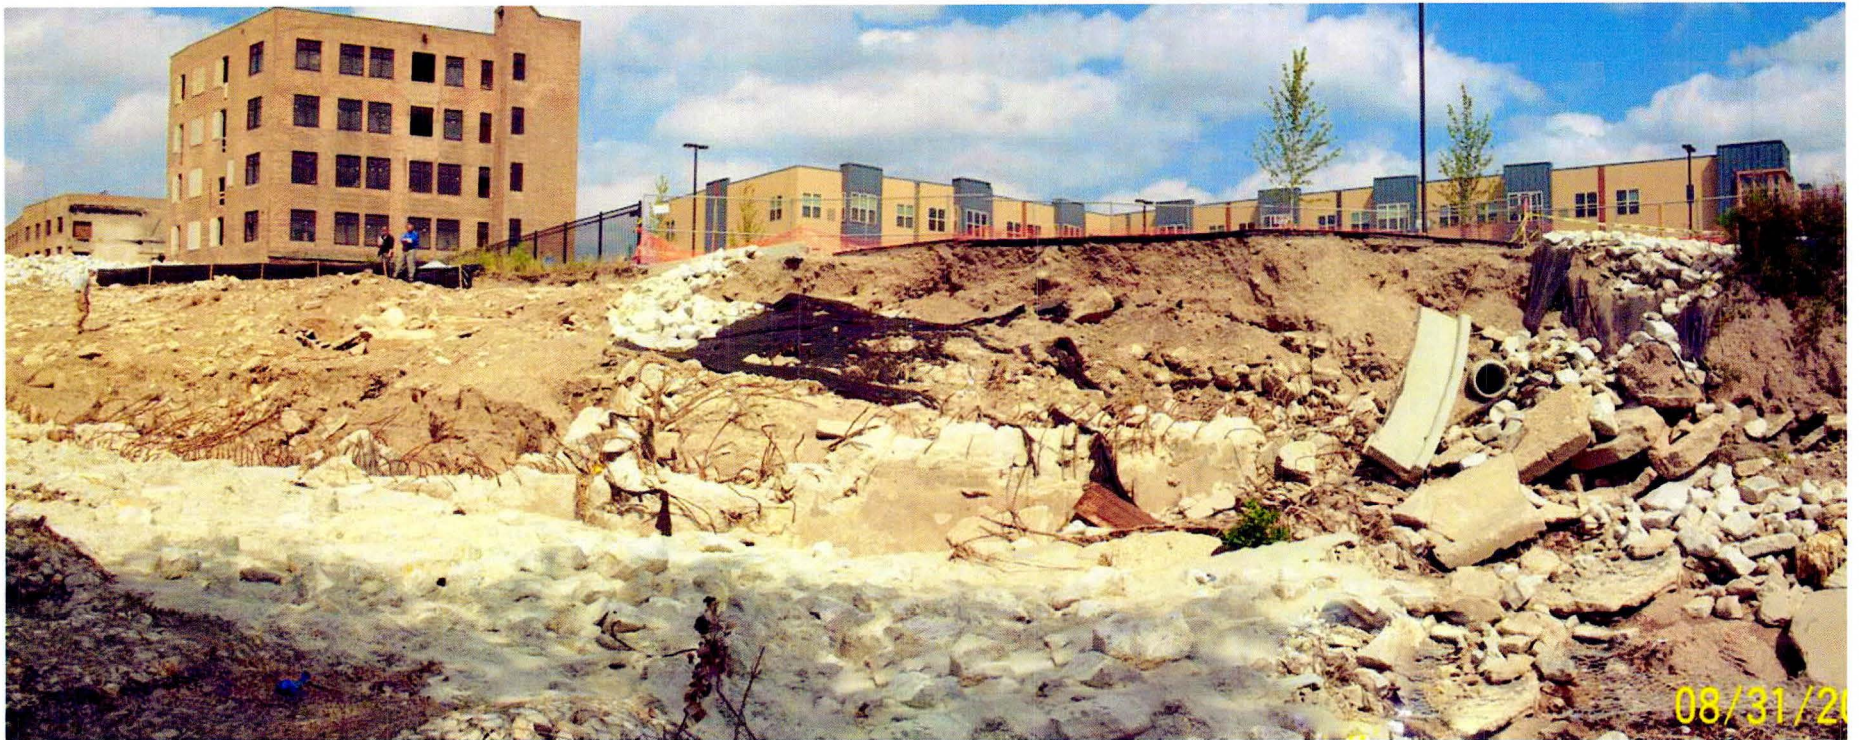
**PHOTOGRAPH 03**

View of bank area flood damage looking north.

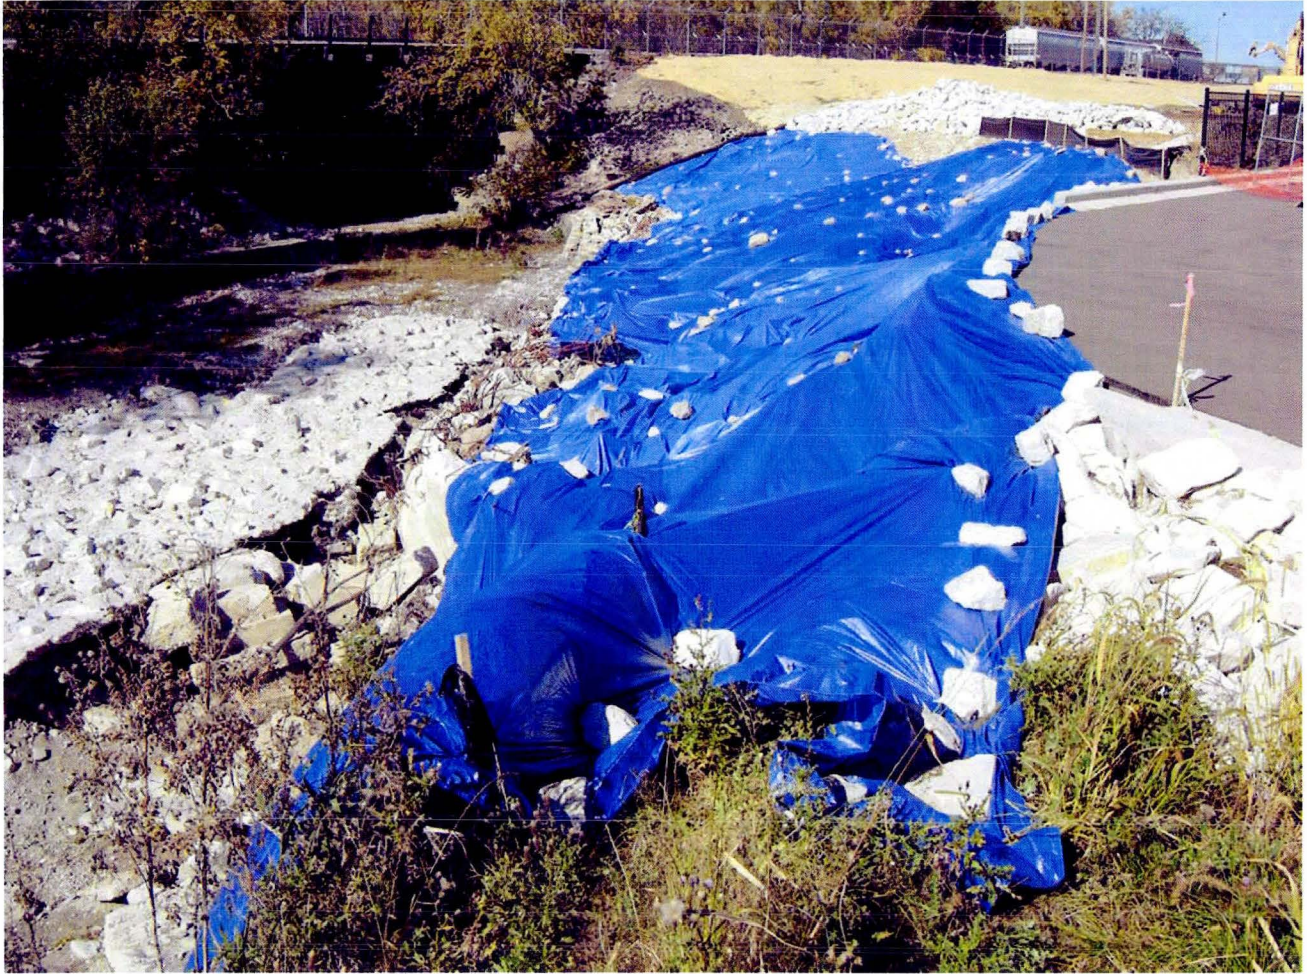
**PHOTOGRAPH 04**  
October 22, 2010

View of bank area looking west with temporary tarps placed to limit erosion and runoff.

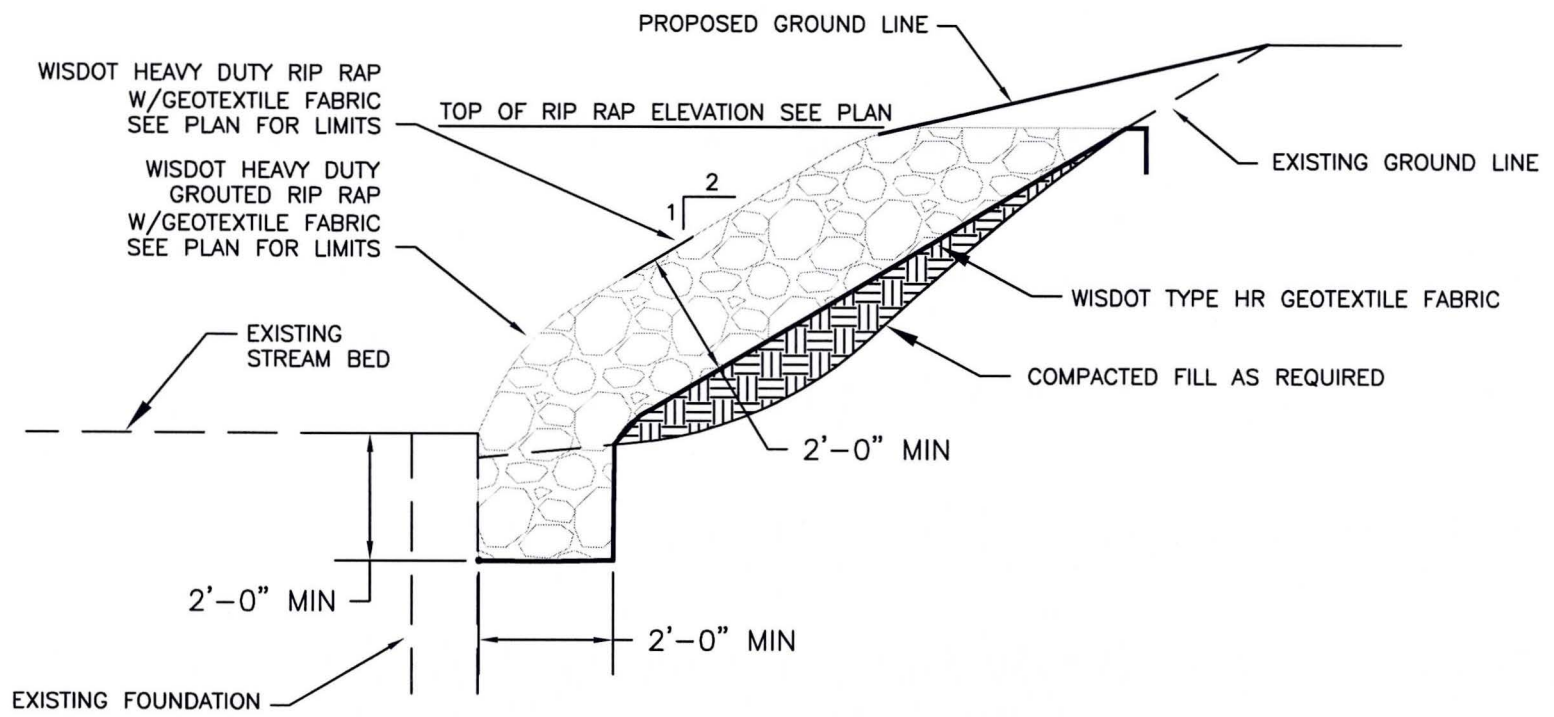
SECTION A-A

WISDOT HEAVY DUTY  
RIPRAP W/ TYPE HR  
GEOTEXTILE FABRIC

WISDOT GROUDED  
HEAVY DUTY RIPRAP  
W/ TYPE HR  
GEOTEXTILE FABRIC

EXISTING RETAINING  
WALL FOUNDATION

The first activity of this task will be the removal, backfilling, and reshaping of the temporary access road. Next the bank will be filled and graded to sub-grade and the protruding rebar rods of the remaining foundation along the by-pass will be cut and removed. The sub-grade fill will be graded and compacted, followed by the installation of a geotextile filter fabric and the placement of heavy rip rap (6 1/2-inch to 20-inch Stone) over the fabric. The rip rap will be grouted with cement seven to eight feet up the slope of the bank to provide additional stabilization. Copies of the proposed plans and specifications showing details regarding geotextile fabric and rip rap placement and grading are included in Appendix D.
