**Re: Basement Survey – 3200 Block South Side of 60th Street:
Suggar Property
3301 – 60th St.
Kenosha, WI 53144
PECFA# 53144-4143-05
BRRTS# 03-30-004964
FID# 230156410**

FIGURE 1
BASEMENT CONFIGURATION
3200 BLOCK – SOUTH SIDE OF
60TH STREET KENOSHA, WI

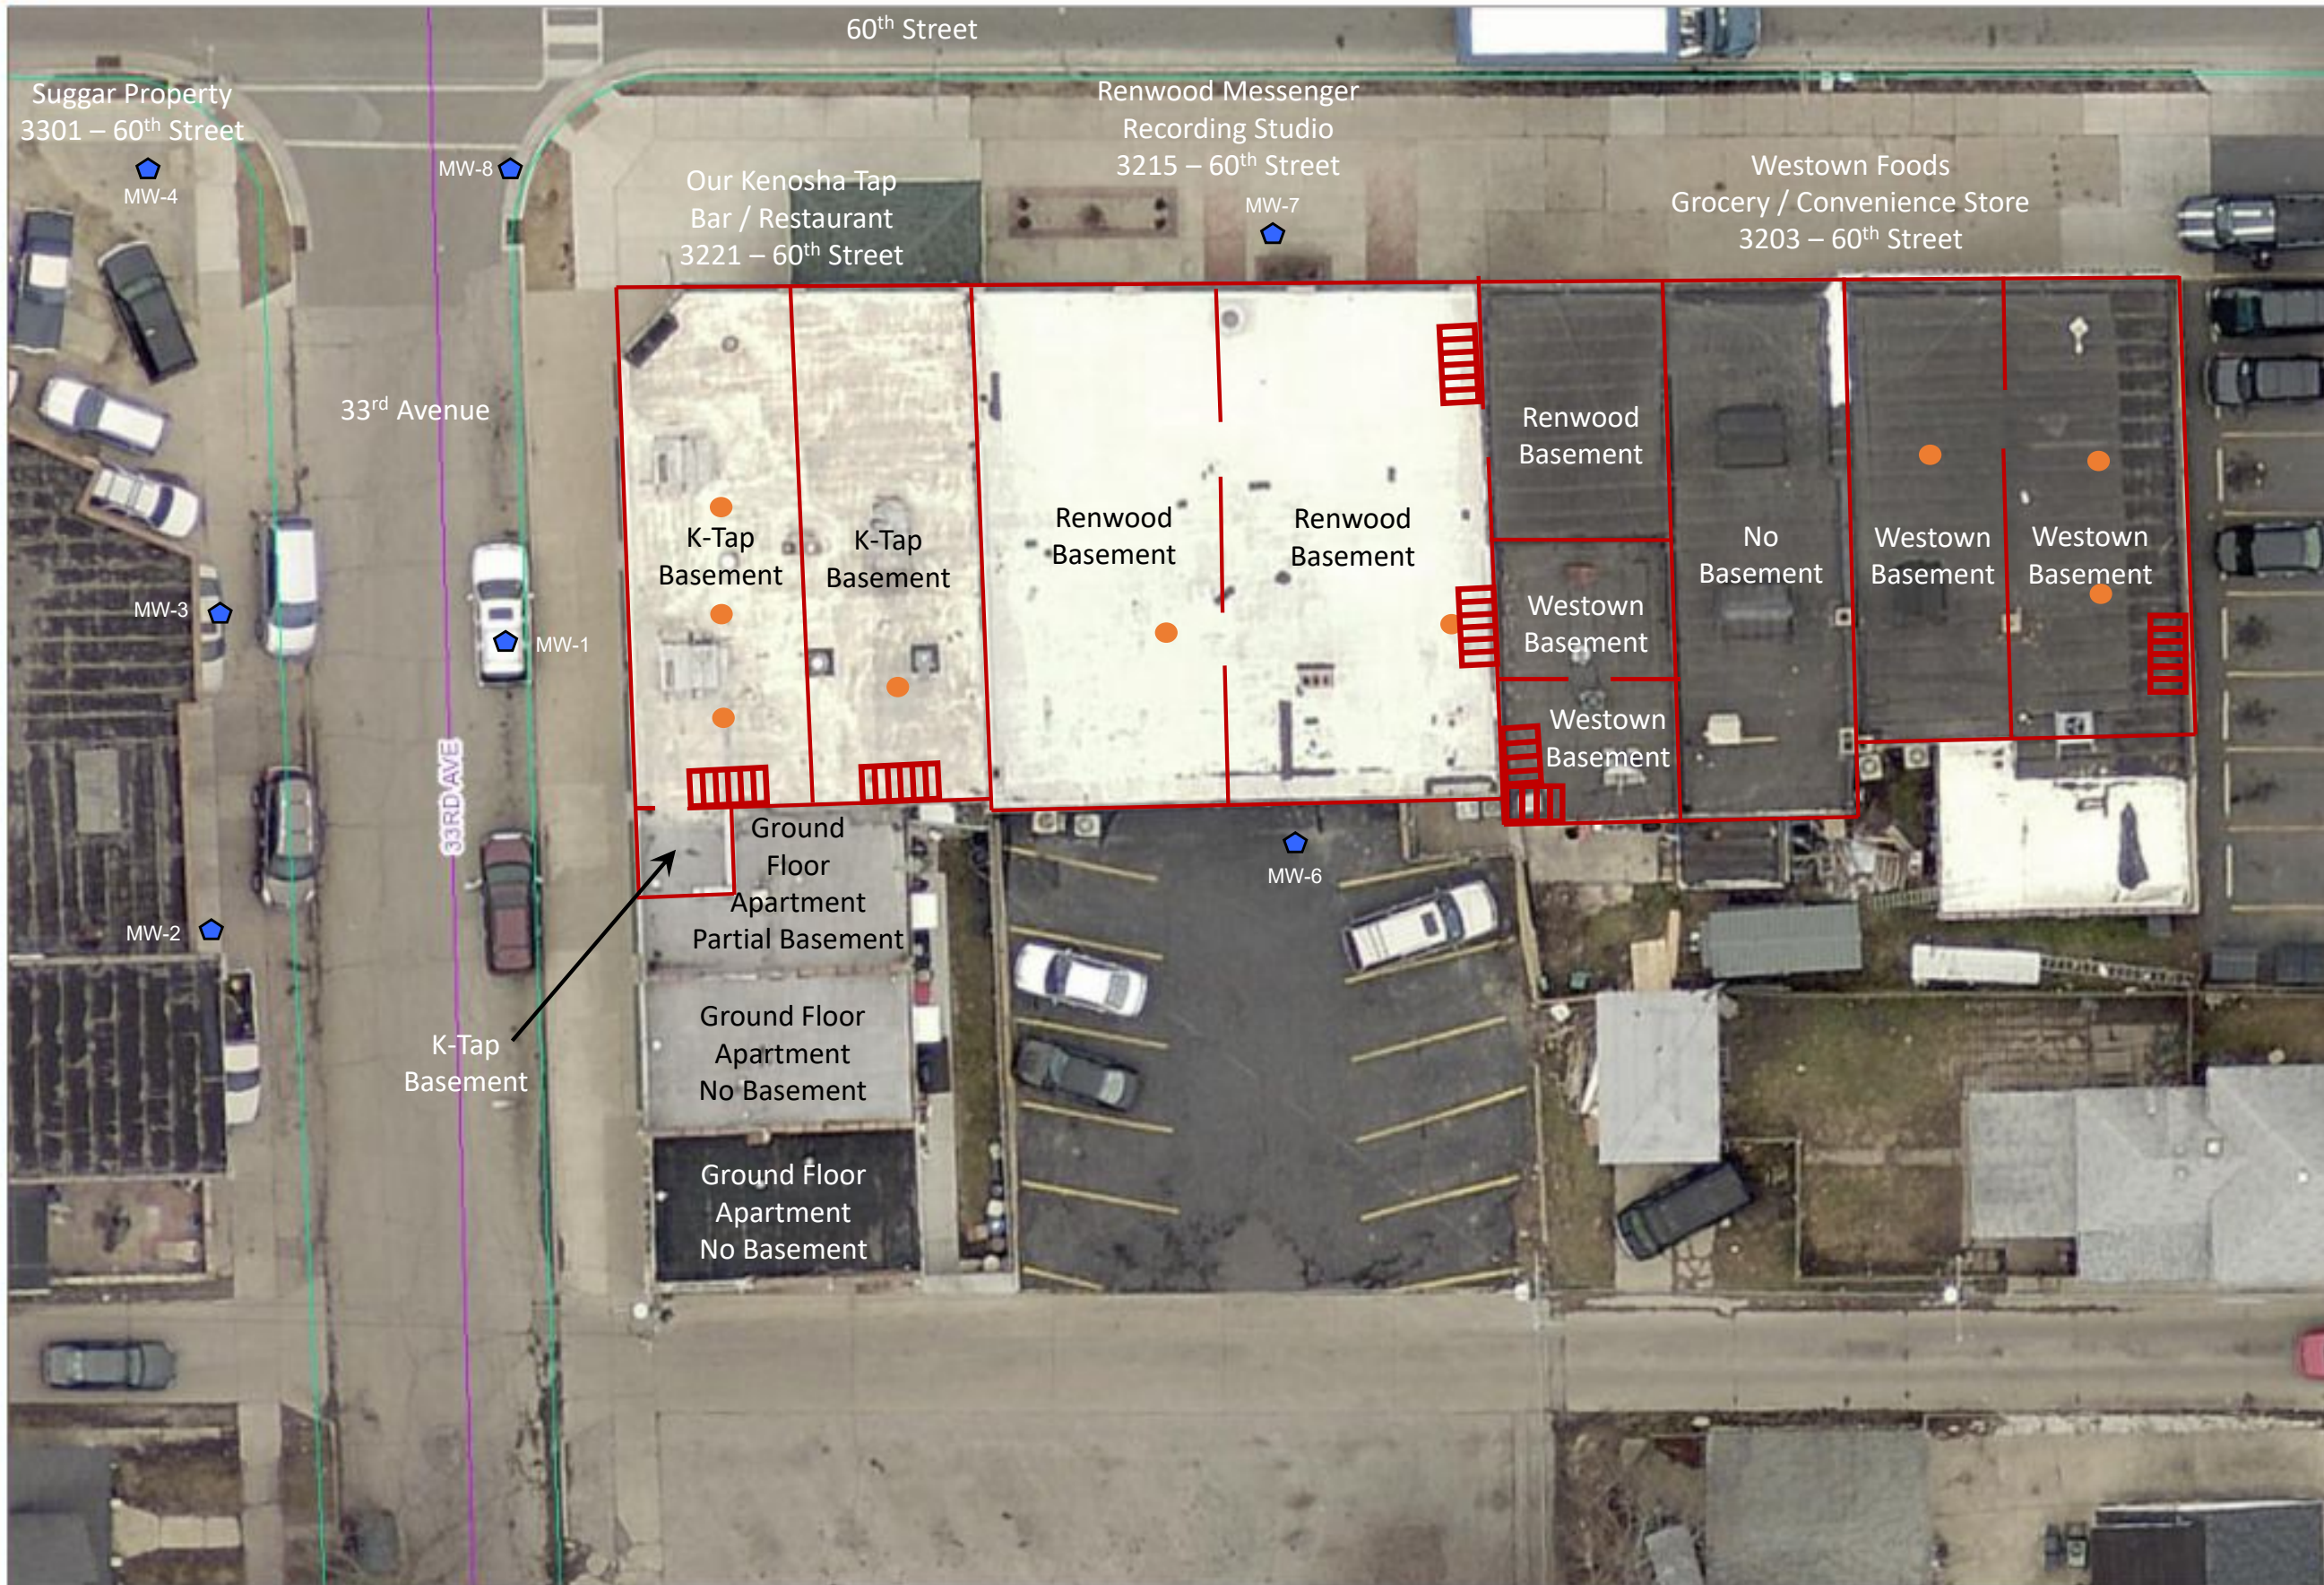
The basement survey was to be conducted prior to planned sub-slab vapor sampling of the basement onsite at the Suggar Property so that if additional sub-slab vapor sampling is warranted, such sampling can be conducted during one field mobilization. The layout of the basements is illustrated on Figure 1.

The building has two separate basement areas, east and west, both of which extend to approximately eight feet below land surface. Both sections have exterior walls of poured concrete with concrete block and brick walls in the interior portions and poured concrete floors. A small section of the western basement extends beneath a ground floor apartment attached to the south end of the bar/restaurant building. Two remaining attached ground floor apartments are of concrete slab-on-grade construction with no basement beneath. The basements are used for storage with a small office located in the western basement. The building is served by natural gas forced air heat.

The building has a full basement and an additional basement room that extends beneath the northwest corner of the building adjacent to the east. The basement extends to approximately eight feet below land surface. The exterior walls are poured concrete with concrete block, brick and wood-frame walls in the interior portions and a poured concrete floor. A small section of the concrete floor in the southern portion of the basement has deteriorated exposing sand beneath. The basement is used for music recording and rehearsal. The building is served by natural gas forced air heat.

The building has a basement in the southwest corner and a basement room occupied by Renwood Messenger to the west that extends beneath the northwest corner of the building. An additional basement area is located on the east end of the building. According to the building owner there is no basement beneath the central portion of the building. The basements extend to approximately eight feet below land surface. The exterior walls are poured concrete with concrete block and brick walls in the interior portions and poured concrete floors. The basements are used for storage. The building is served by natural gas forced air heat.
