SUBJECT: Final Case Closure with Continuing Obligations
Milwaukee County Zoo/Bliffert Lumber Site, 10733 W. Bluemound Rd., Milwaukee
DNR BRRTS # 02-41-000655 and # 03-41-005150 PECFA # 53226-4282-33-A
FID #: 241494110

Attachments: Groundwater Isoconcentration, Figure B.3.b.1., dated July 3, 2013
Residual Soil Contamination, Figure B.2.b., dated July 3, 2013
Monitoring Well, Figure E.1.1., dated July 3, 2013

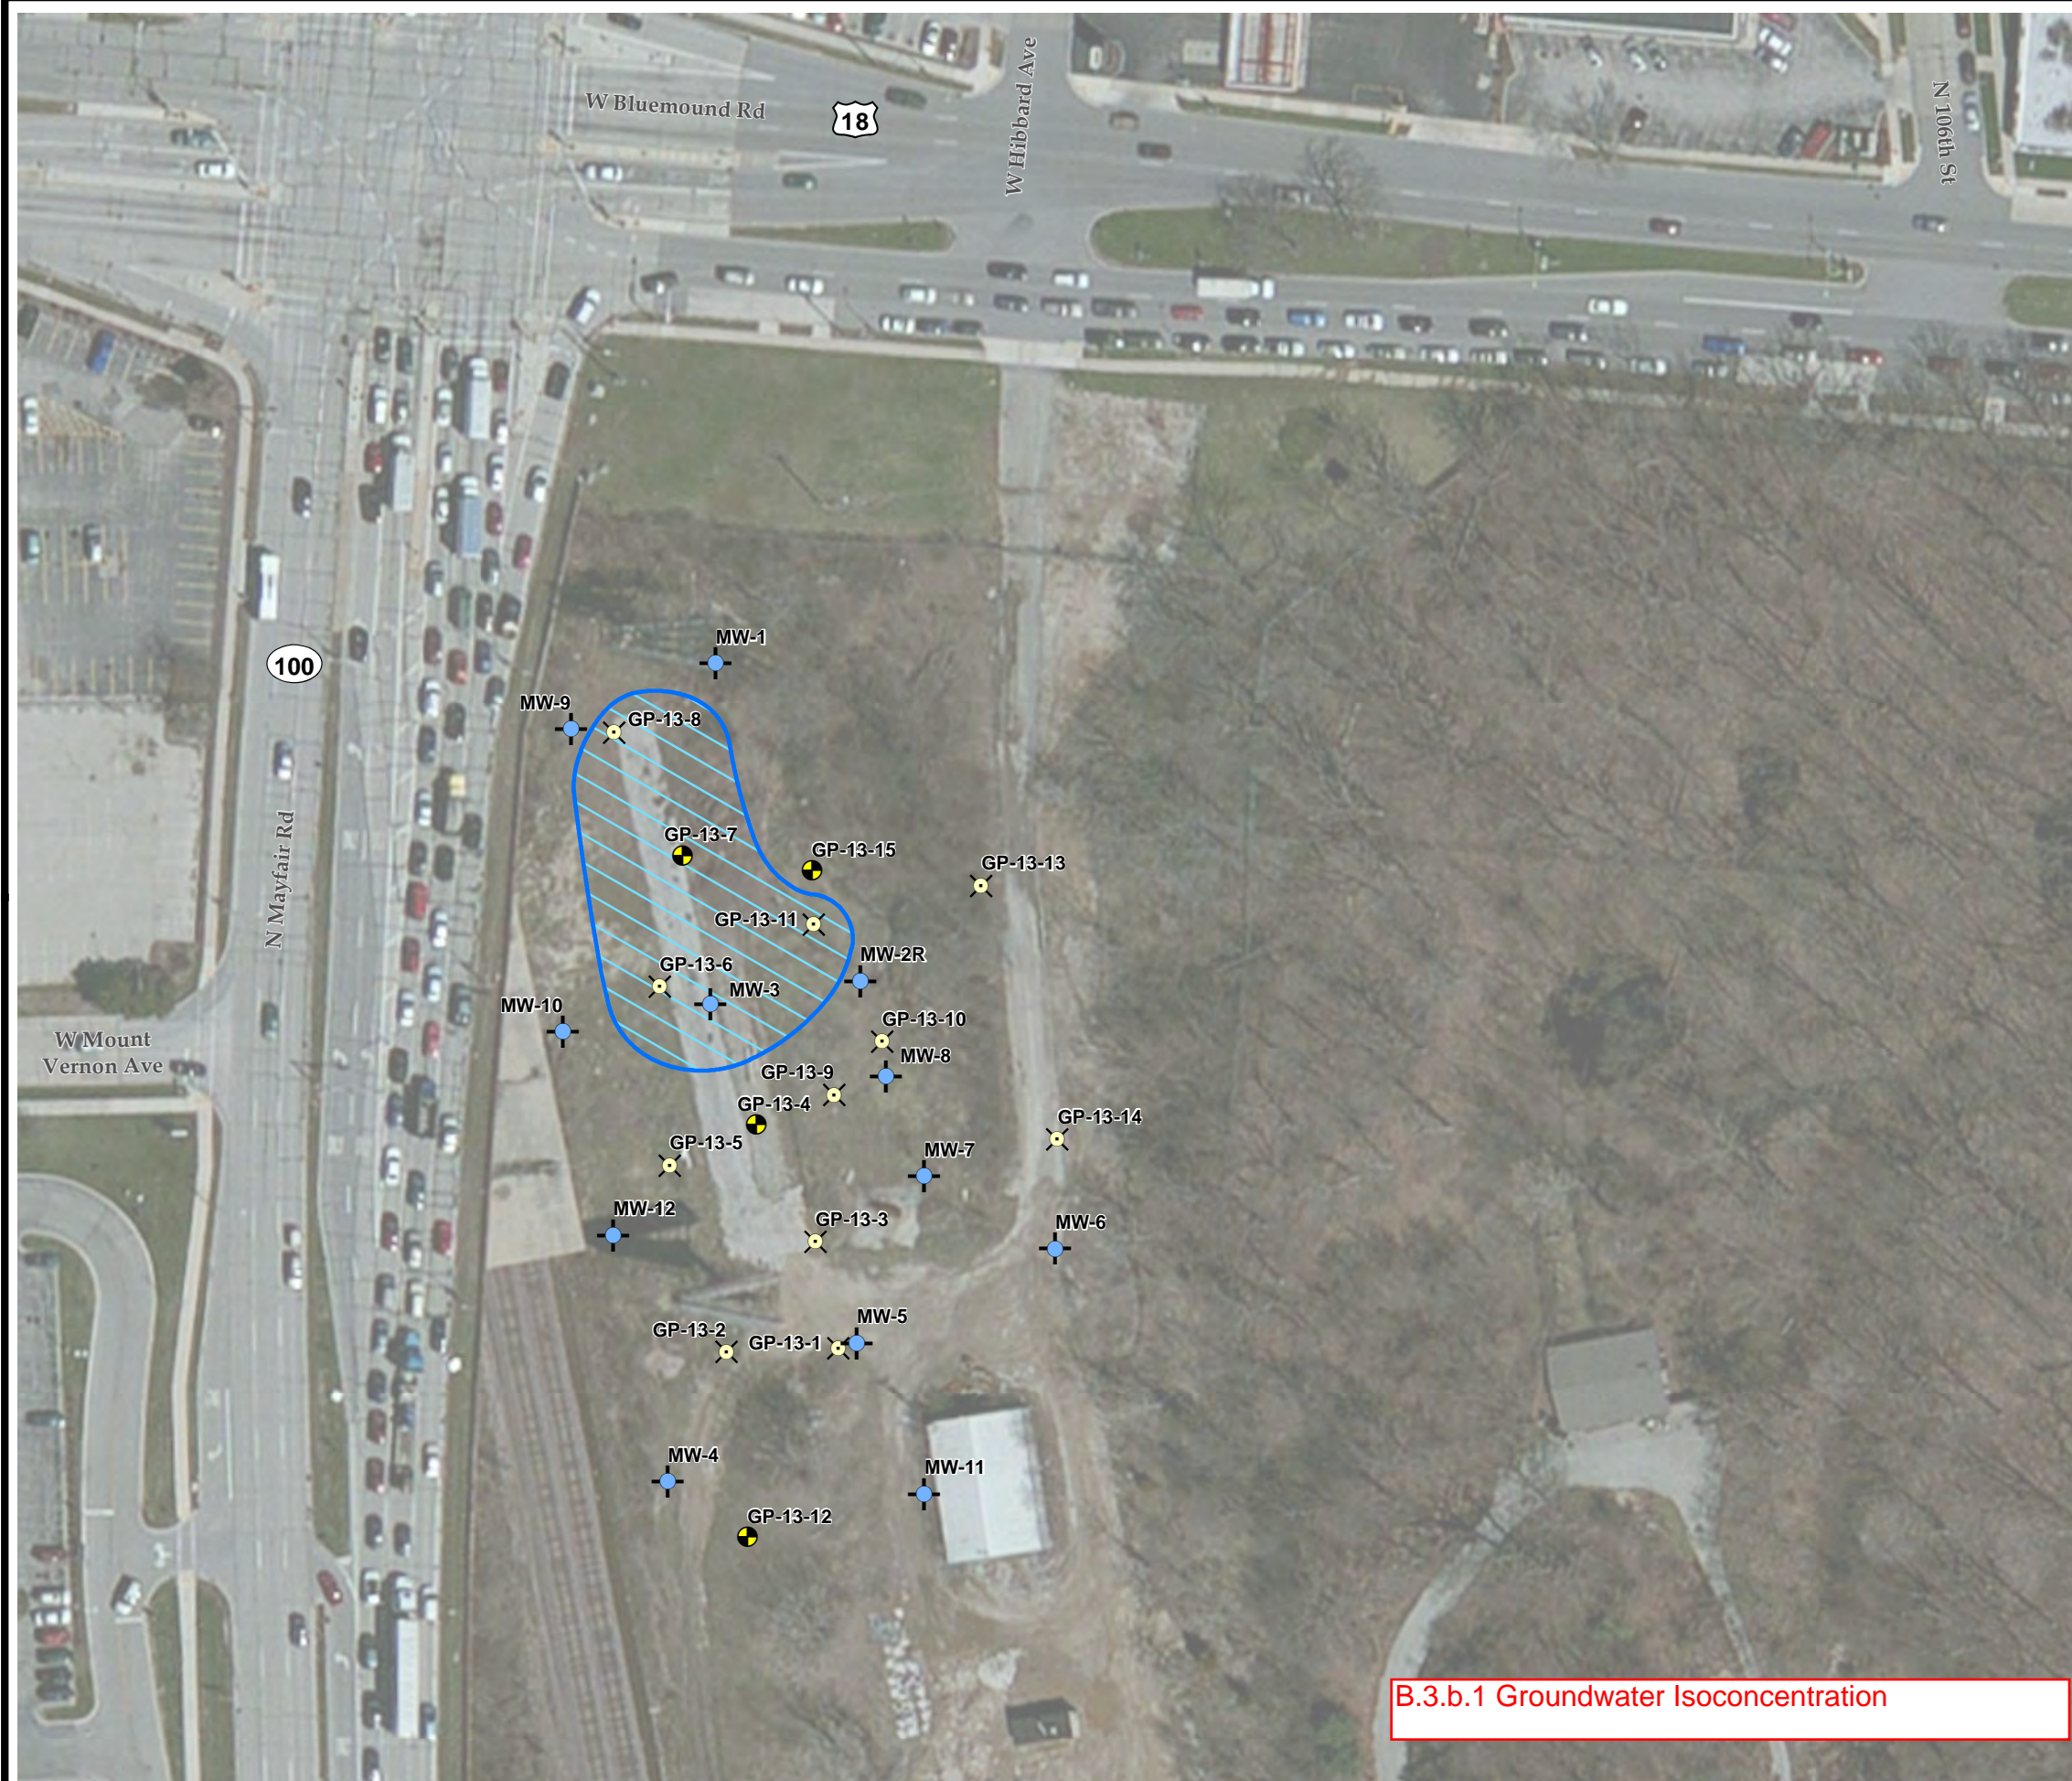
B.3.b.1 Groundwater Isoconcentration

PROJECT: MILWAUKEE COUNTY - BLIFFERT SITE		
WDNR BRRTS NO. 02-41-000655		
PECFA NO. 53226-4282-33-A		
SHEET TITLE: GROUNDWATER CONTAMINANT DISTRIBUTION MAP		
JUNE 2013		
DRAWN BY: PAPEZ J	SCALE: 1:960	PROJ. NO. 202083
CHECKED BY:		FILE NO. 202083-003.mxd
APPROVED BY:	DATE PRINTED:	FIGURE 2
DATE: JULY 2013

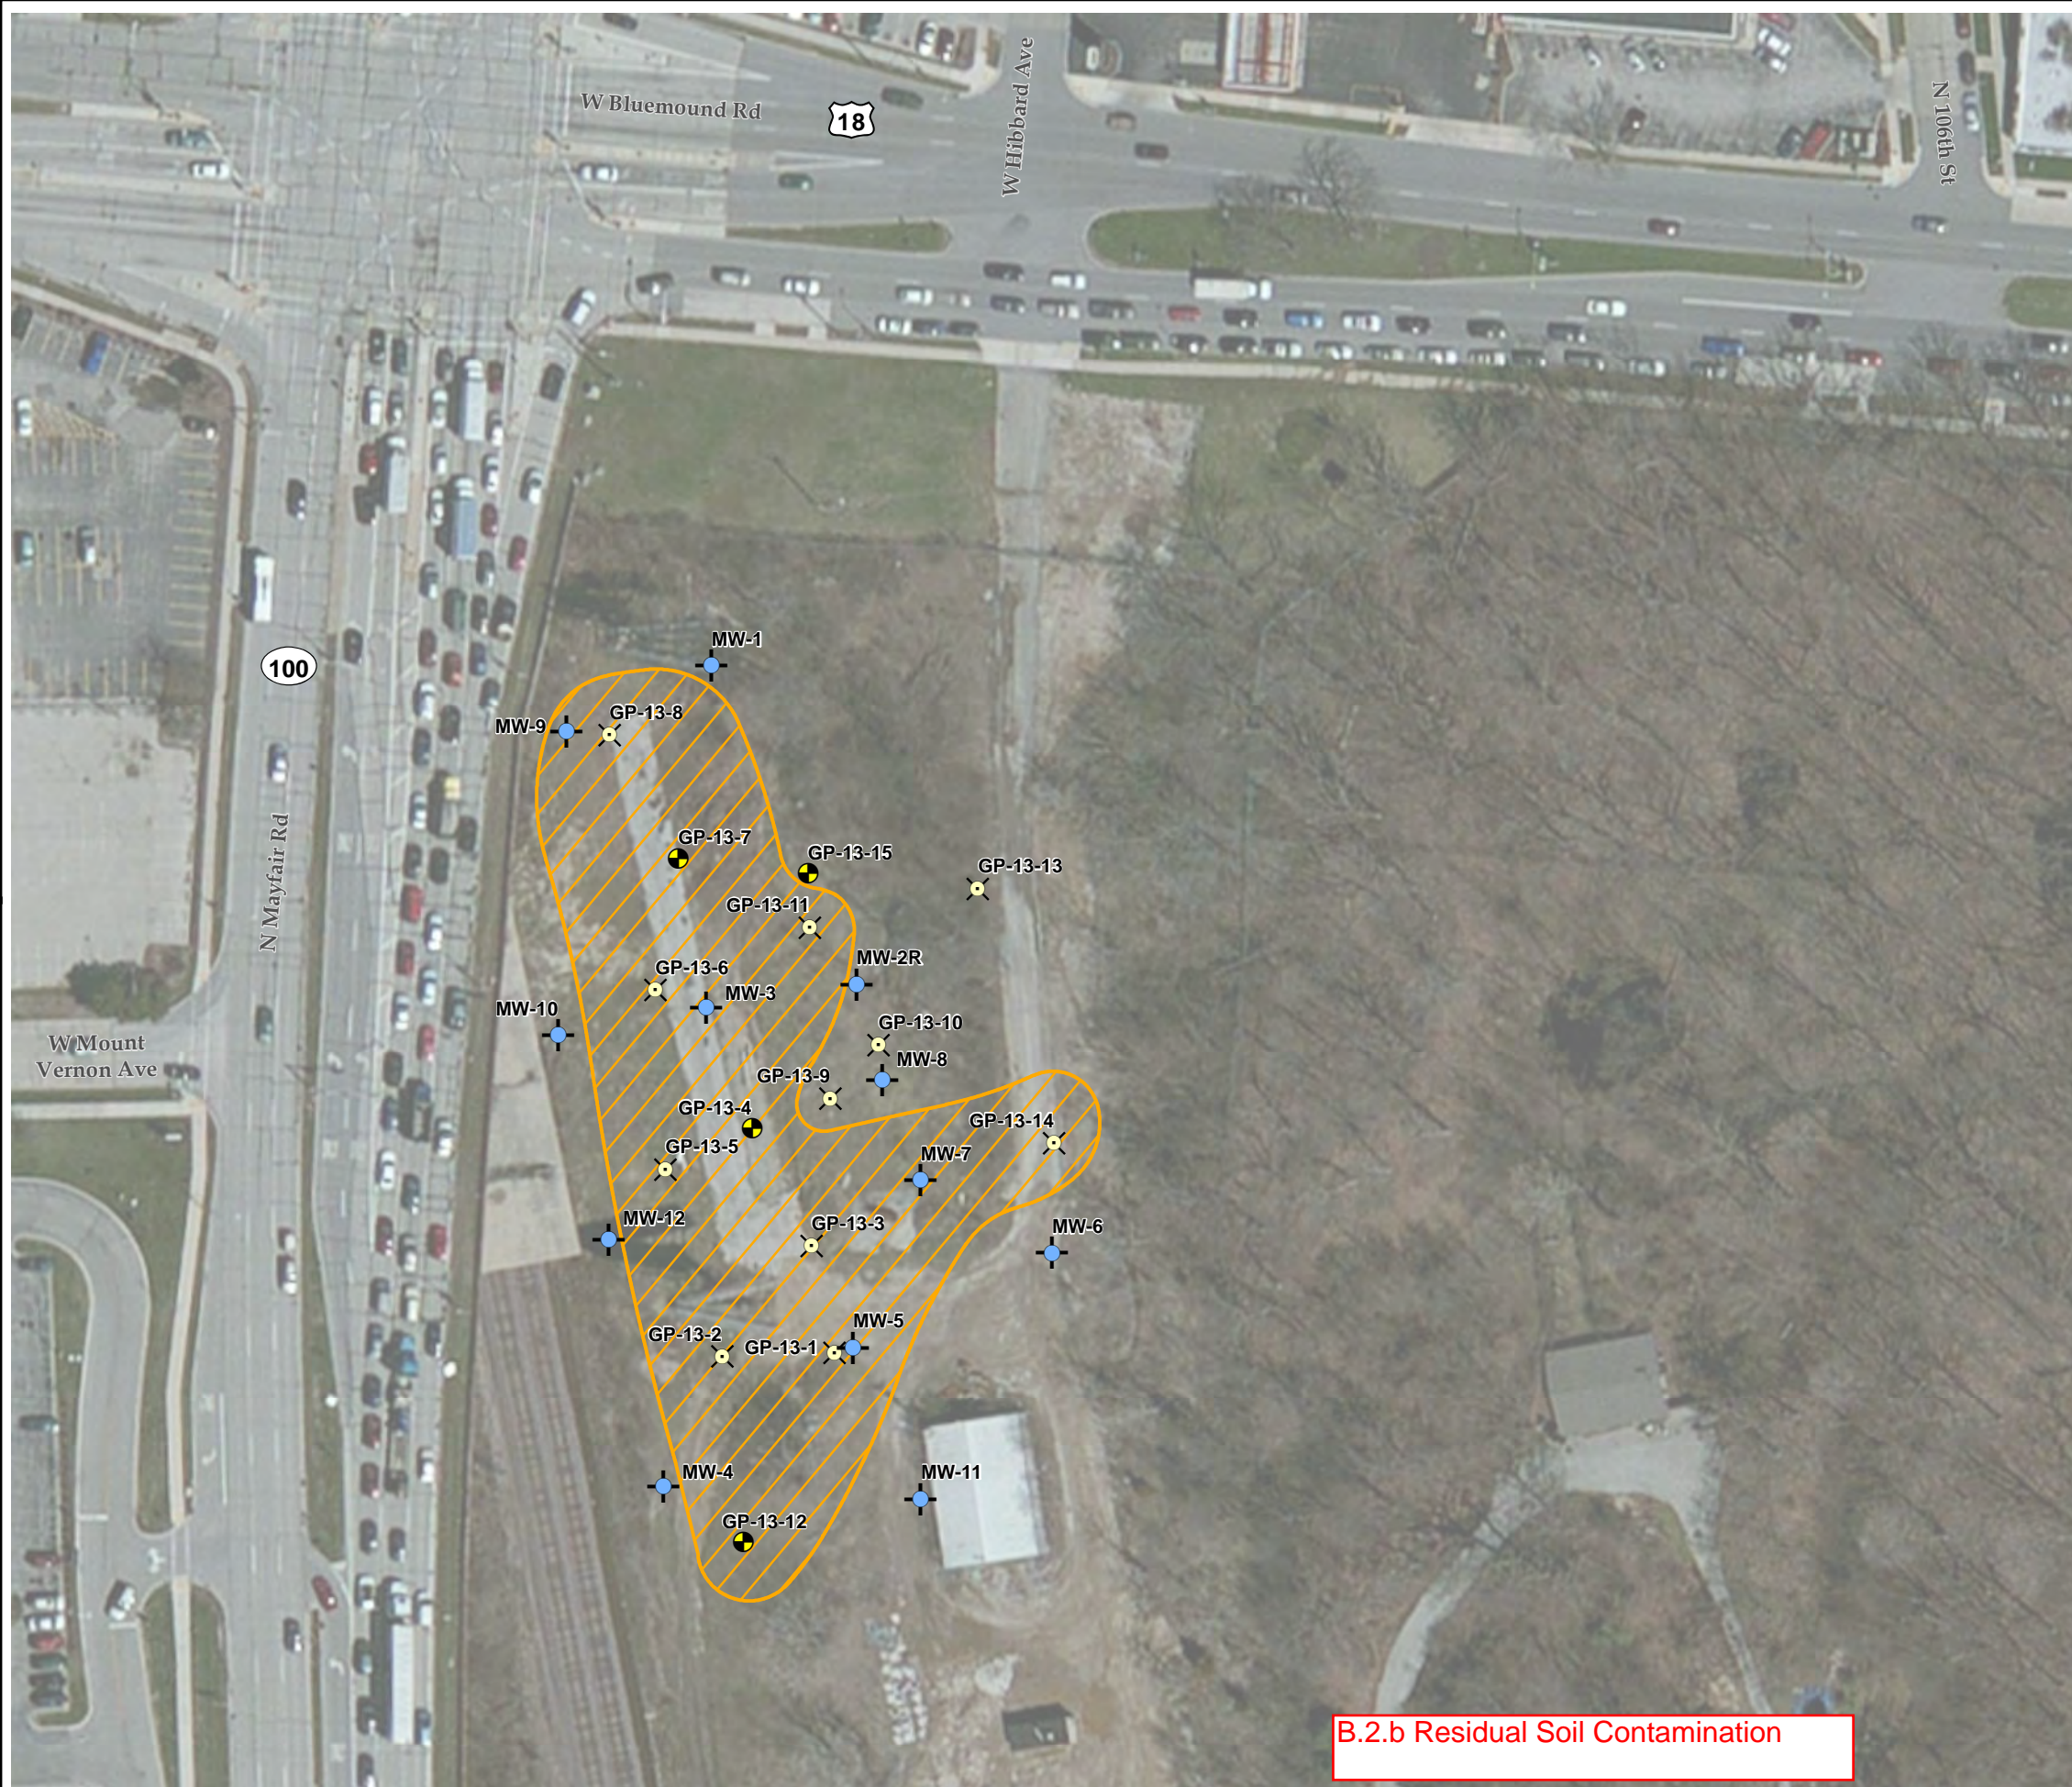
B.2.b Residual Soil Contamination

PROJECT: MILWAUKEE COUNTY - BLIFFERT SITE		
WDNR BRRTS NO. 02-41-000655		
PECFA NO. 53226-4282-33-A		
SHEET TITLE: SOIL CONTAMINANT DISTRIBUTION MAP		
MAY 2013		
DRAWN BY: PAPEZ J	SCALE: 1:960	PROJ. NO. 202083
CHECKED BY:		FILE NO. 202083-002.mxd
APPROVED BY:	DATE PRINTED:	FIGURE 1
DATE: JULY 2013

Soil contamination remains at depth across the northern portion of this parcel as indicated on the attached map, Residual Soil Contamination, Figure B.2.b., dated July 3, 2013. If soil in the specific location described above is excavated in the future, the property owner or right-of-way holder at the time of excavation must sample and analyze the excavated soil to determine if contamination remains. If sampling confirms that contamination is present, the property owner or right-of-way holder at the time of excavation will need to determine whether the material is considered solid or hazardous waste and ensure that any storage, treatment or disposal is in compliance with applicable standards and rules. Contaminated soil may be managed in accordance with ch. NR 718, Wis. Adm. Code, with prior DNR approval.

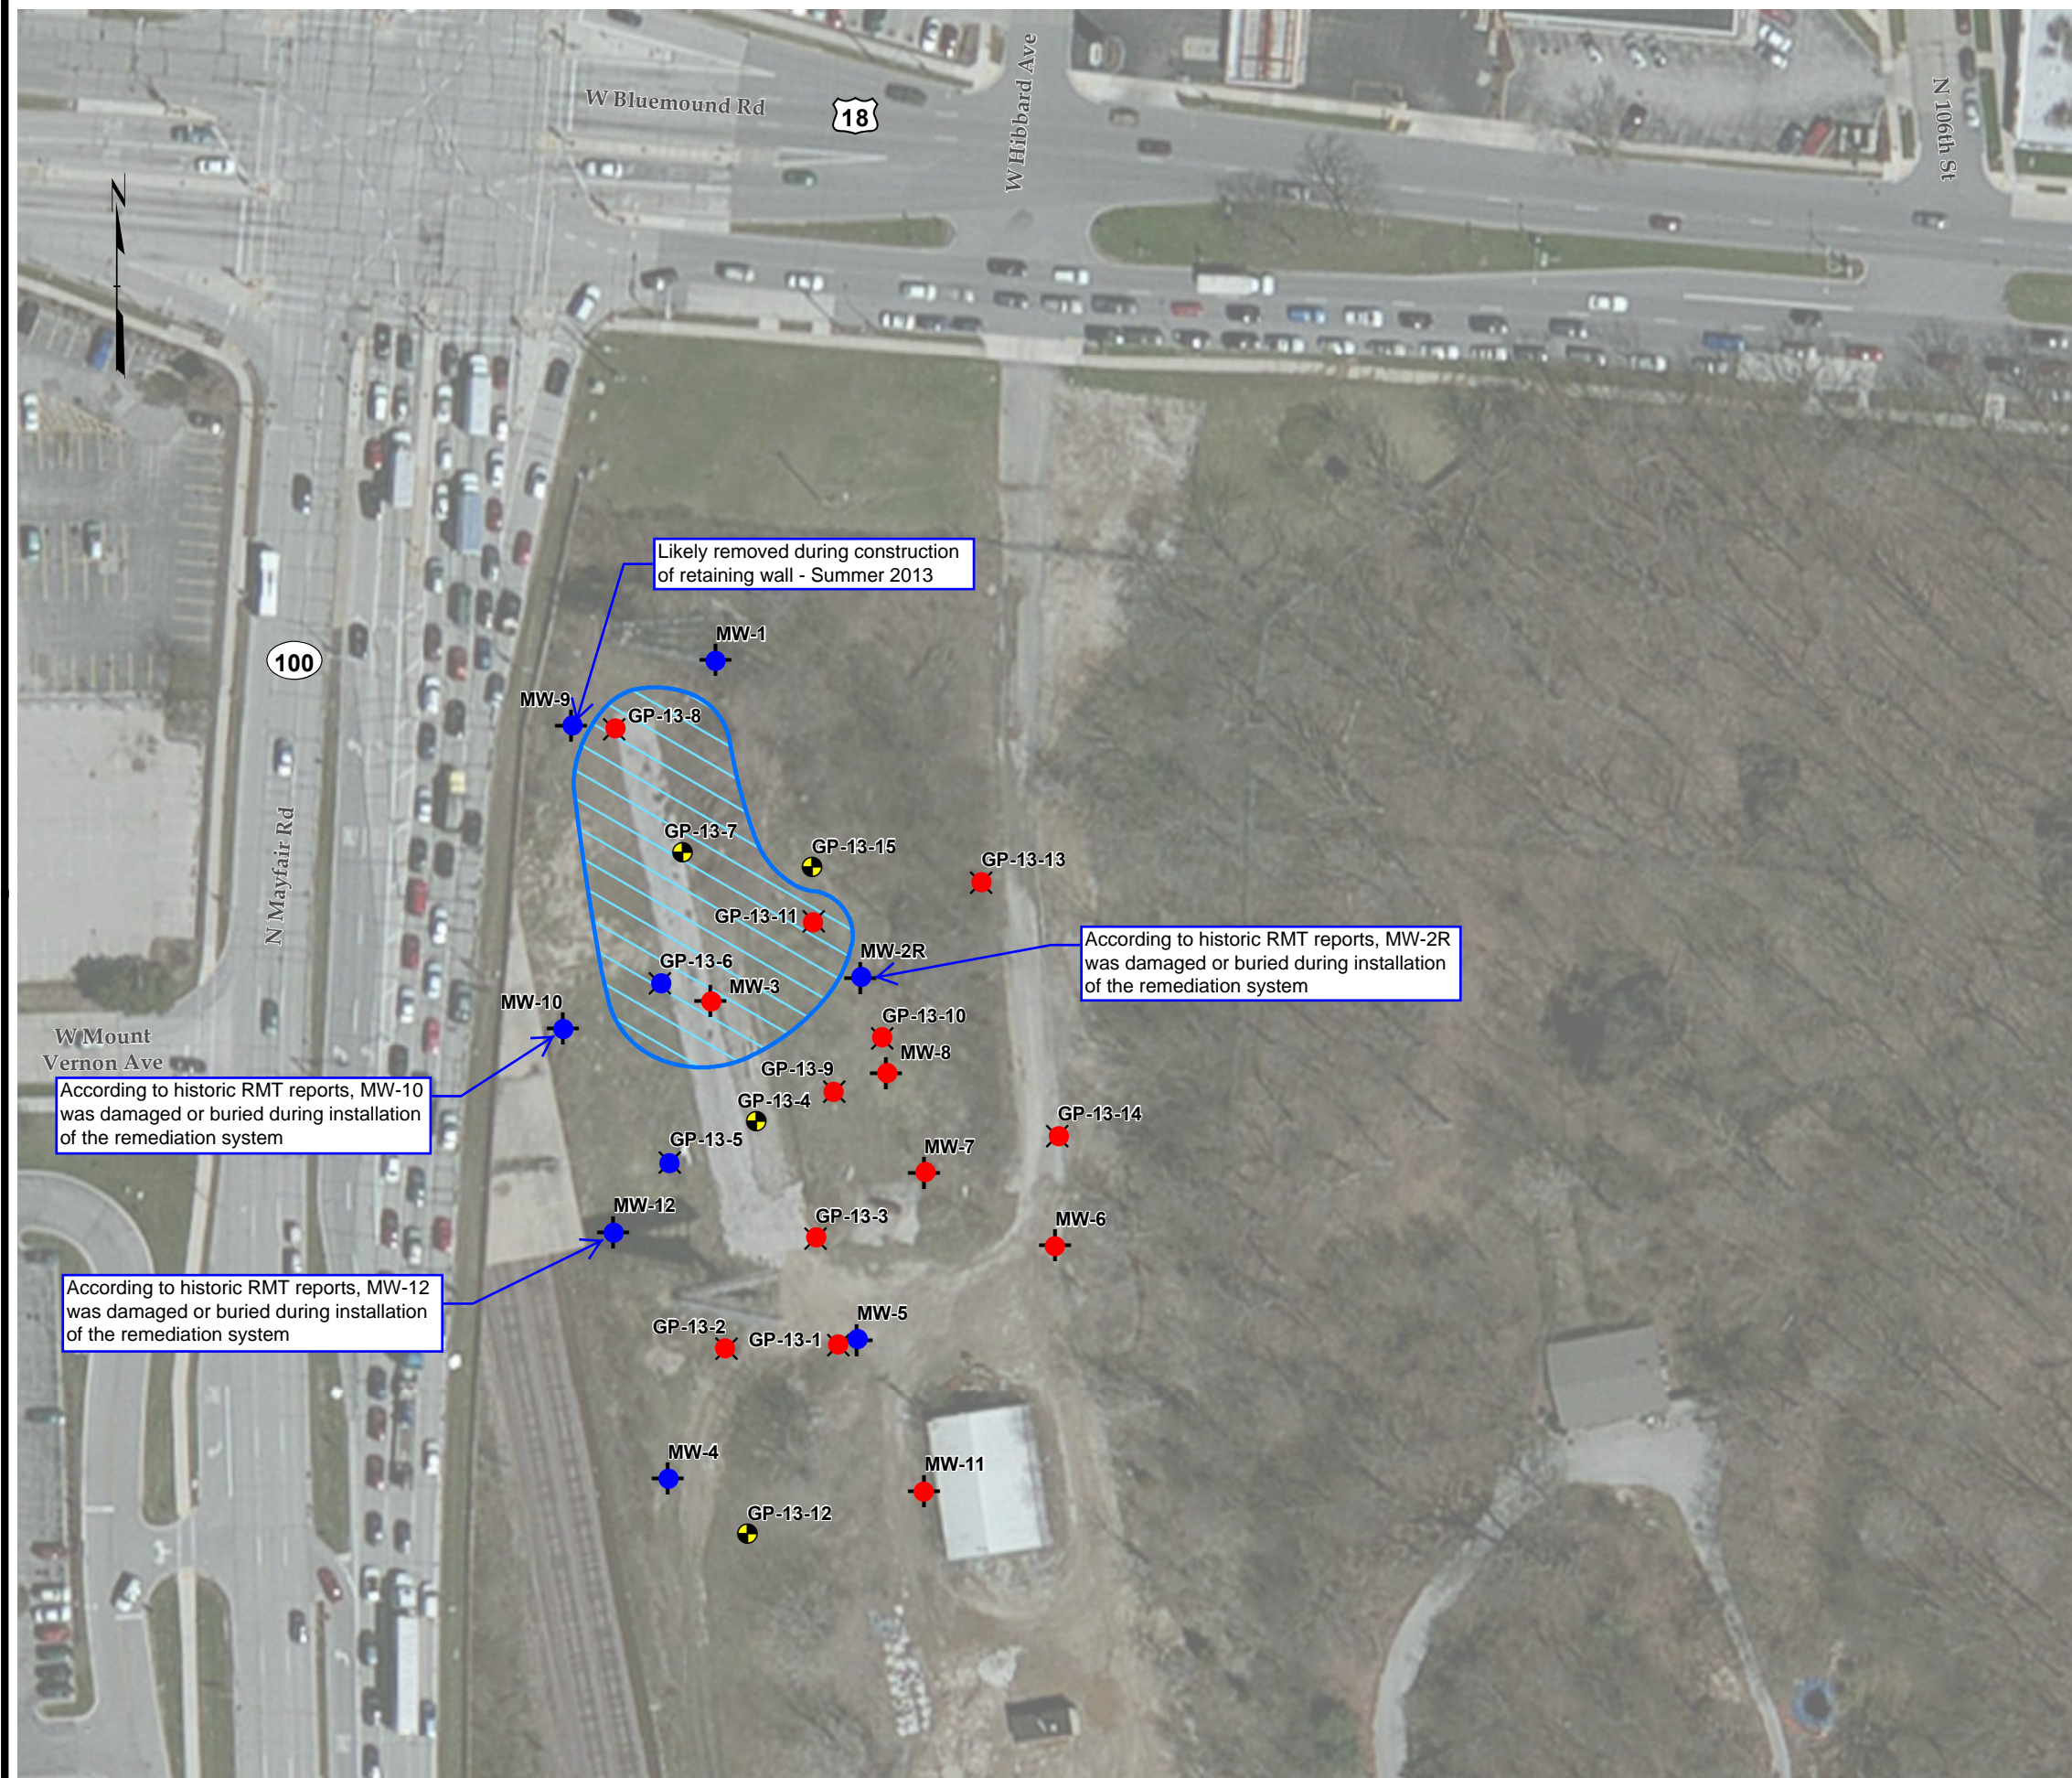
- GROUNDWATER MONITORING WELL
- SOIL PROBE BORING (5/2013)
- SOIL PROBE BORING & TEMPORARLY WELL (5/2013)
- APPROXIMATE EXTENT OF GROUNDWATER EXCEEDING NR 140 ES - JUNE 2013
- Wells that have been located and abandoned
- Wells that could not be found. If any of these wells are found in the future, they should be properly abandoned in accordance with NR 141.

- K. Identify any system hardware anticipated to be left in place after site closure, and explain the reasons why it will remain. No system hardware is to be left in place. Several monitoring wells were not found. Some may have been removed previously and not documented, or were not found.

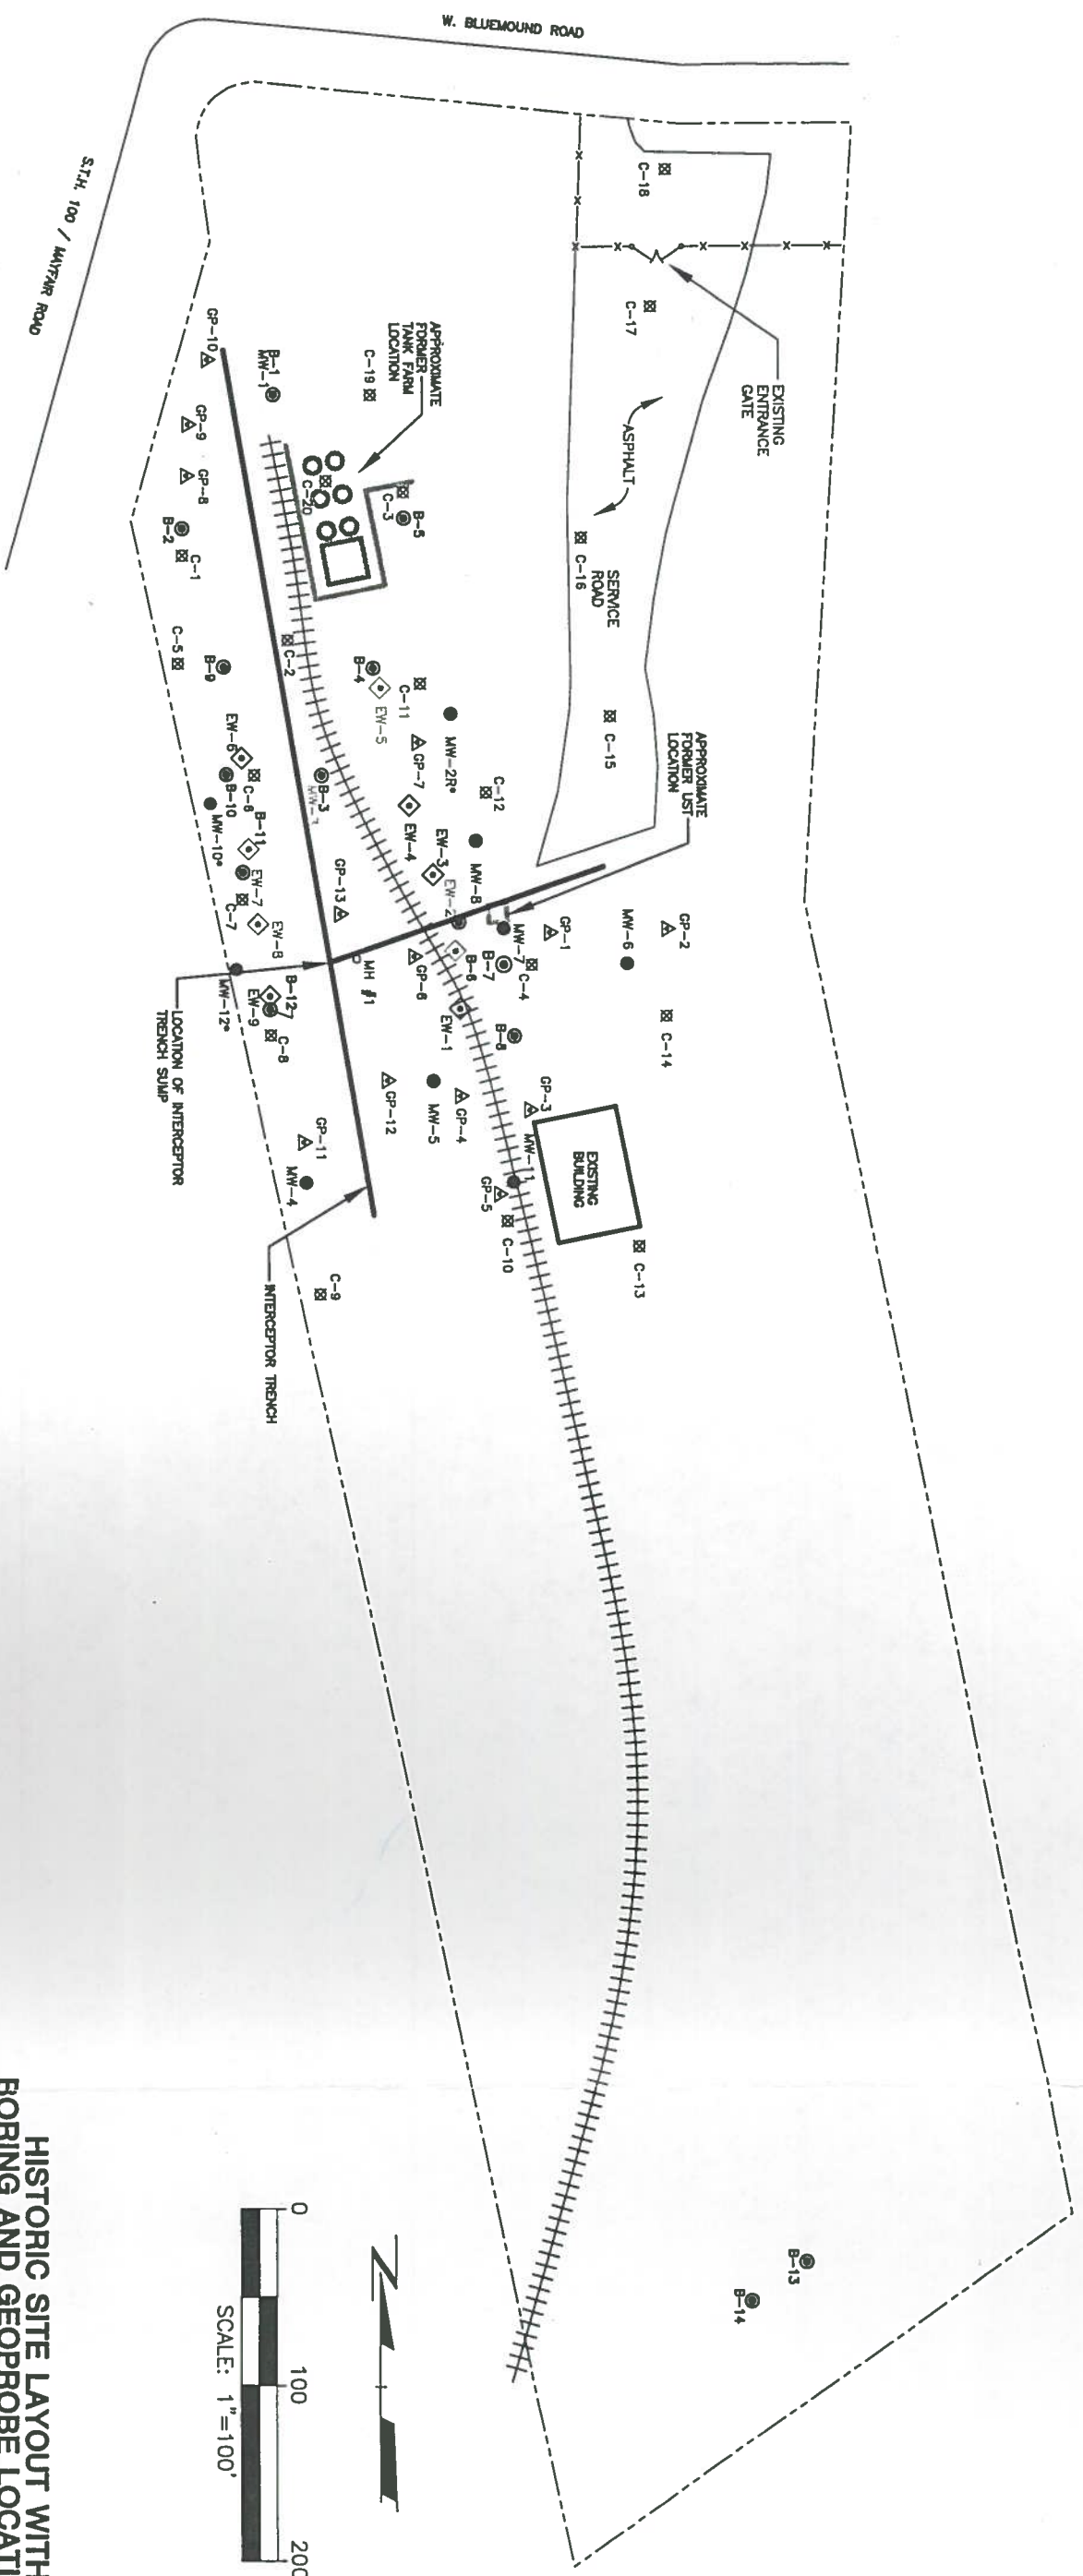
B.1.b Detailed Site Map

**HISTORIC SITE LAYOUT WITH
BORING AND GEOPROBE LOCATIONS
BLIFFERT SITE
MILWAUKEE COUNTY**

SOURCE:
LAW ENGINEERING INC.
PROJECT NO. 279-2258
FIGURE 2
DATE: 4-26-93

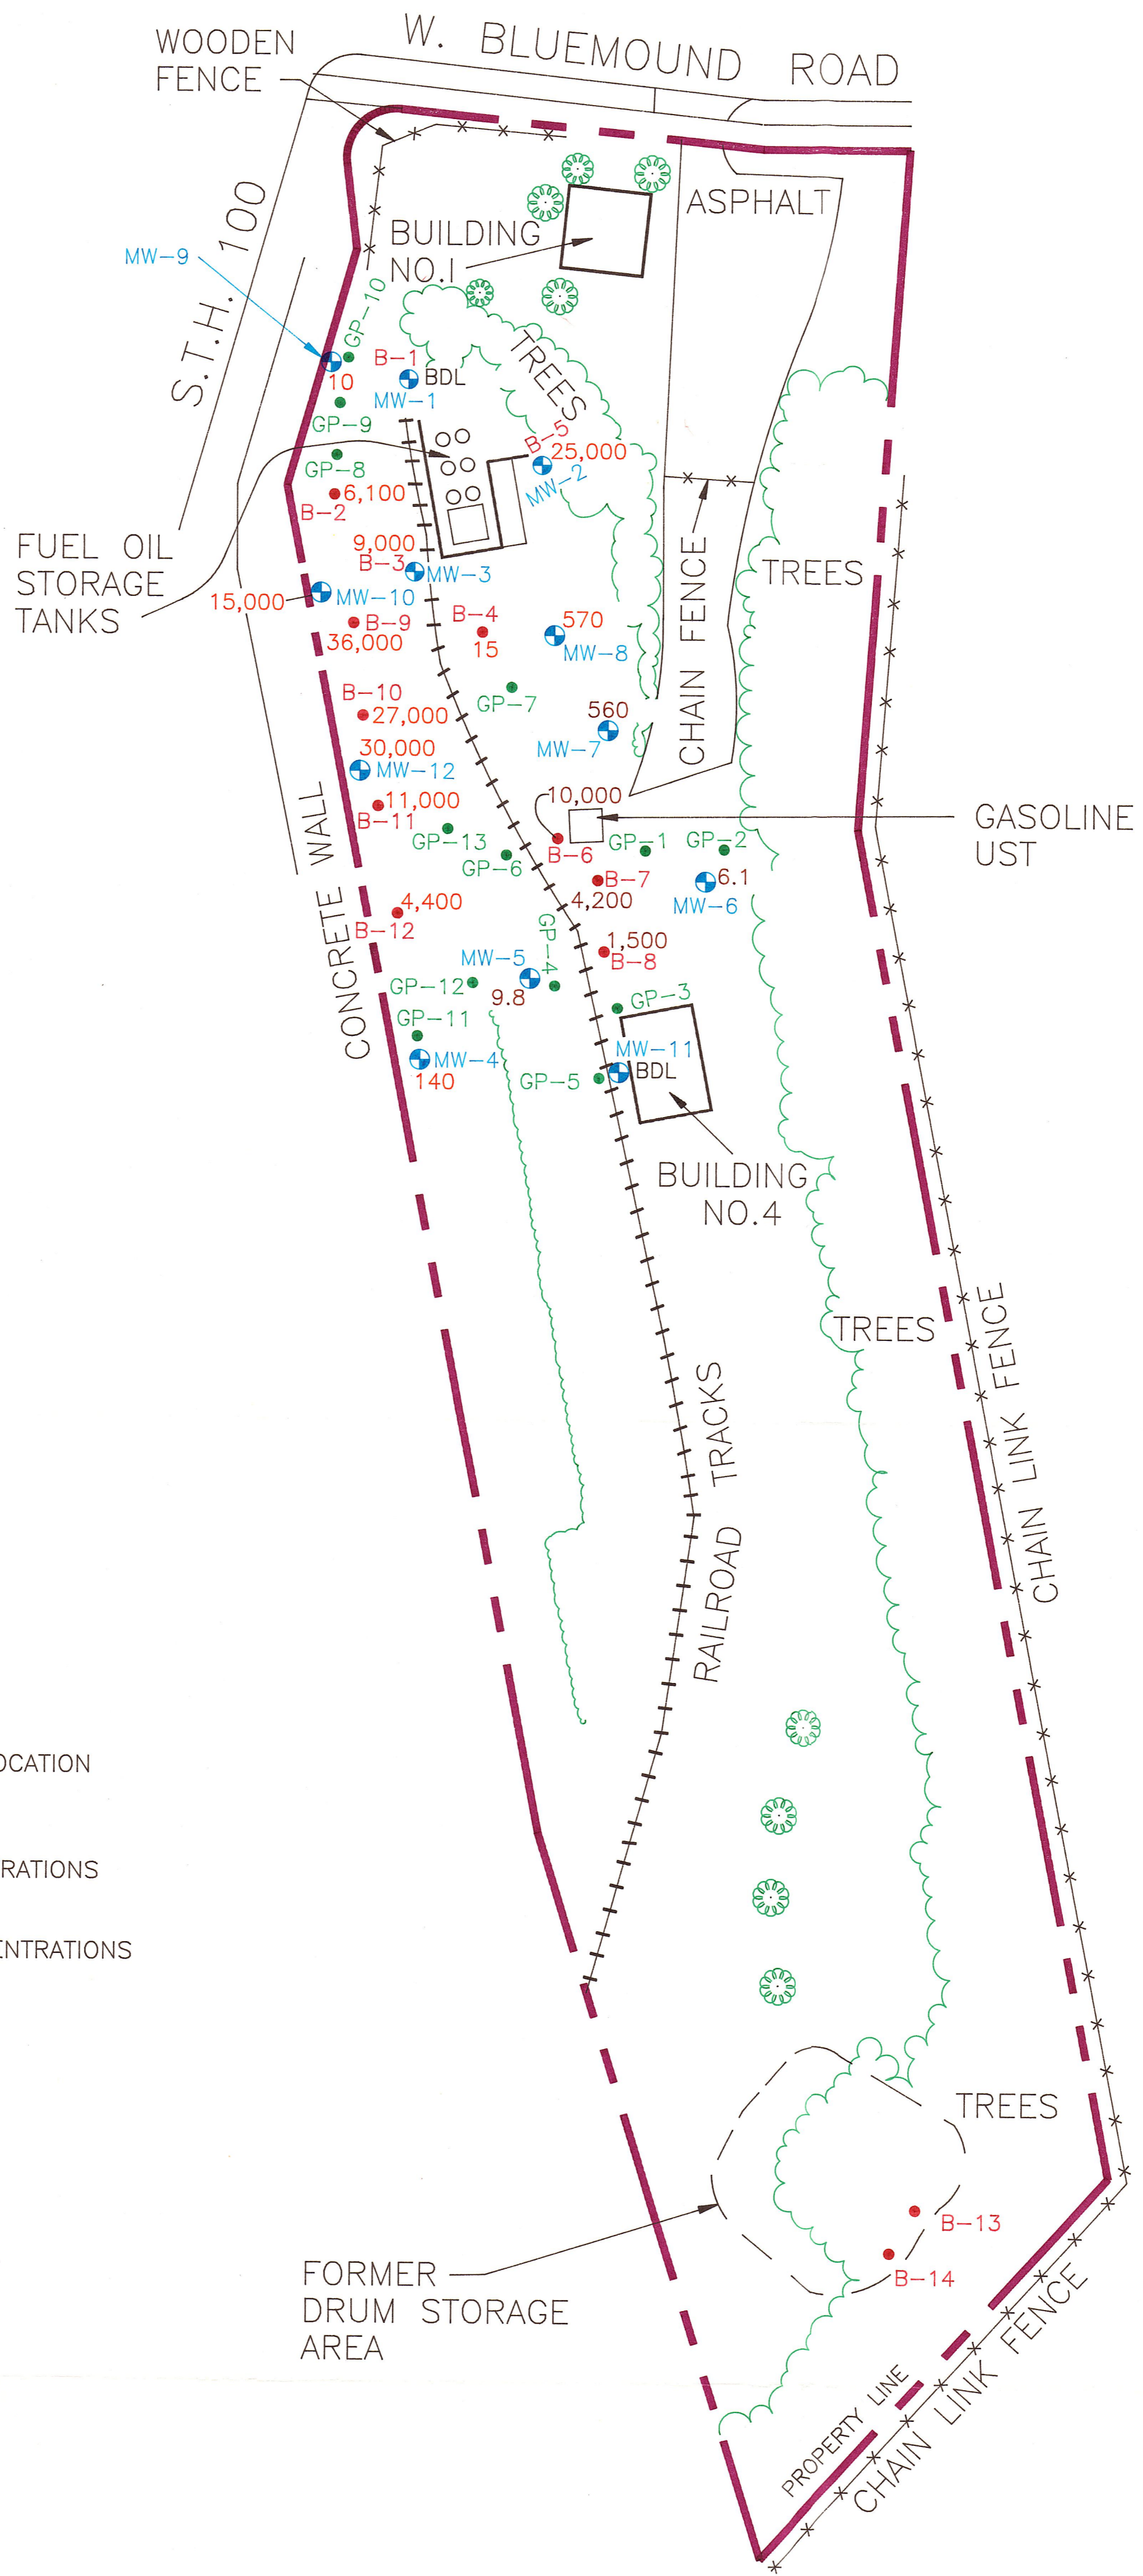
B.2.a Soil Contamination Figure

TITLE	SOIL ANALYTICAL DATA MAP (DIESEL RANGE ORGANICS & GASOLINE RANGE ORGANICS) JANUARY 1993 AND JUNE 1993
PROJECT	MILWAUKEE COUNTY ZOO BLIFFERT SITE 10733 W. BLUEMOUND ROAD WAUWATOSA, WISCONSIN

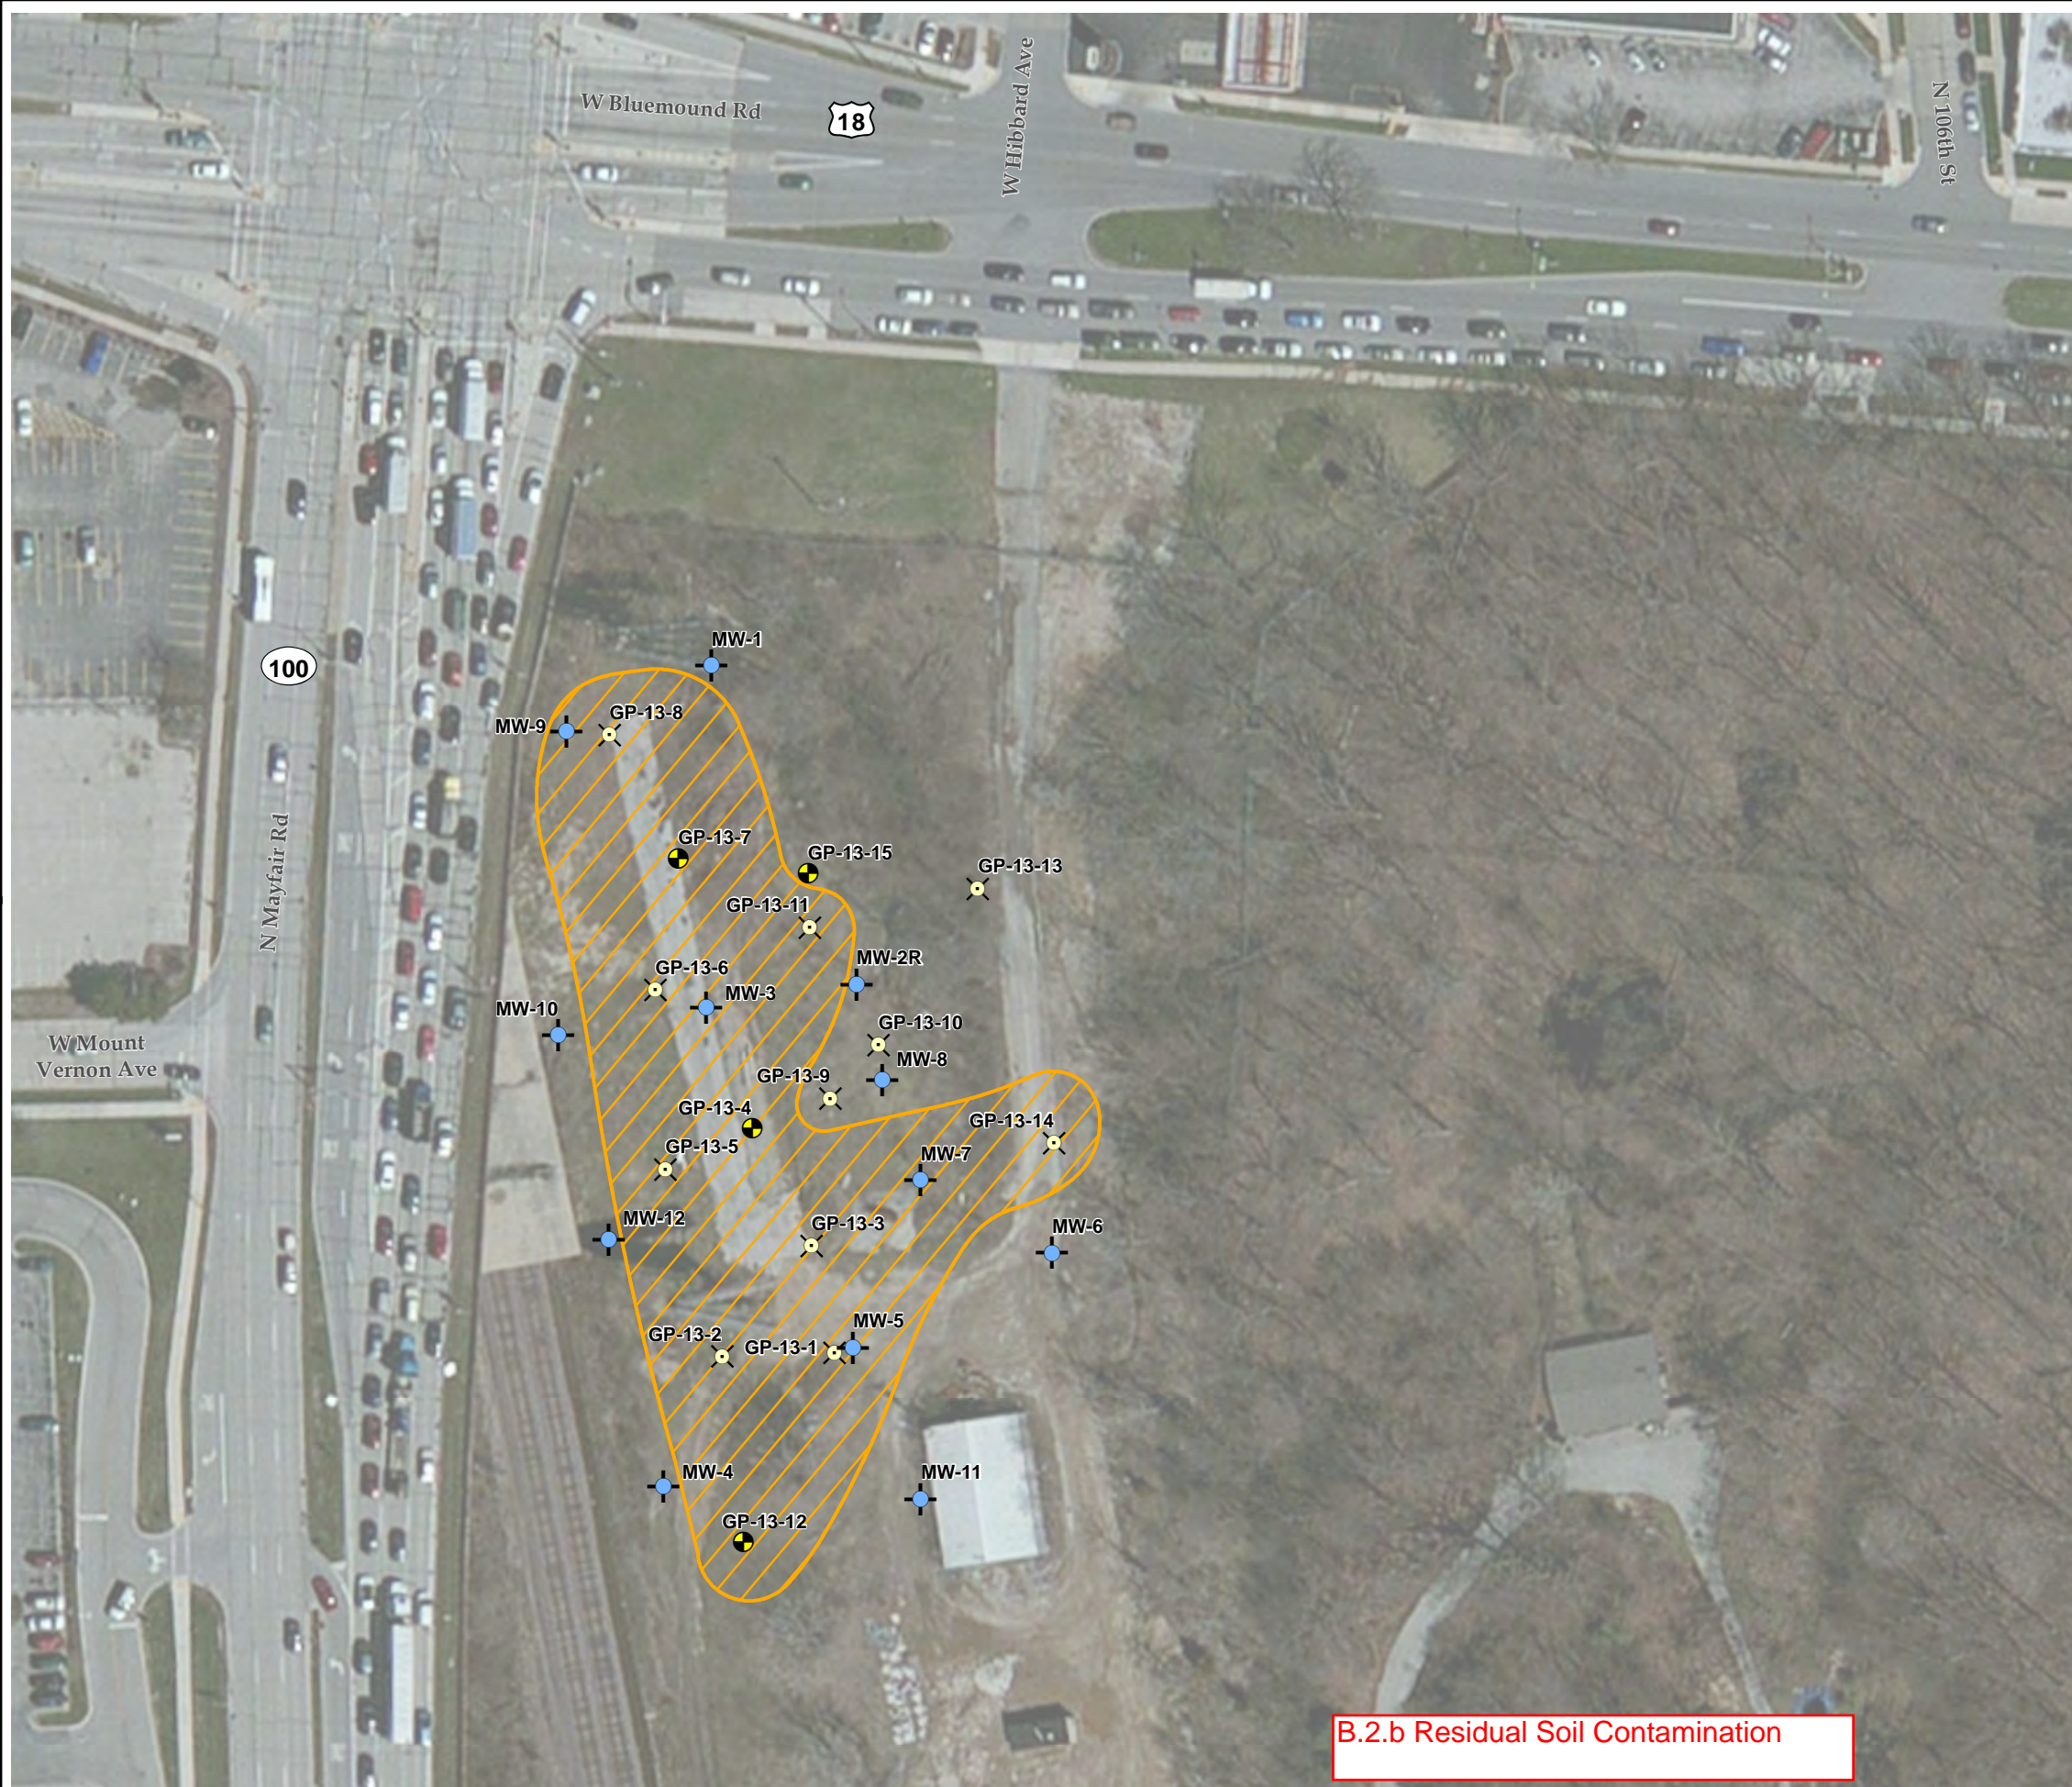
B.2.b Residual Soil Contamination

PROJECT: MILWAUKEE COUNTY - BLIFFERT SITE		
WDNR BRRTS NO. 02-41-000655		
PECFA NO. 53226-4282-33-A		
SHEET TITLE: SOIL CONTAMINANT DISTRIBUTION MAP		
MAY 2013		
DRAWN BY: PAPEZ J	SCALE: 1:960	PROJ. NO. 202083
CHECKED BY:		FILE NO. 202083-002.mxd
APPROVED BY:	DATE PRINTED:	FIGURE 1
DATE: JULY 2013
