SUBJECT: Final Case Closure with Continuing Obligations
Milwaukee County Zoo/Bliffert Lumber Site, 10733 W. Bluemound Rd., Milwaukee
DNR BRRTS # 02-41-000655 and # 03-41-005150 PECFA # 53226-4282-33-A
FID #: 241494110

Attachments: Groundwater Isoconcentration, Figure B.3.b.1., dated July 3, 2013
Residual Soil Contamination, Figure B.2.b., dated July 3, 2013
Monitoring Well, Figure E.1.1., dated July 3, 2013

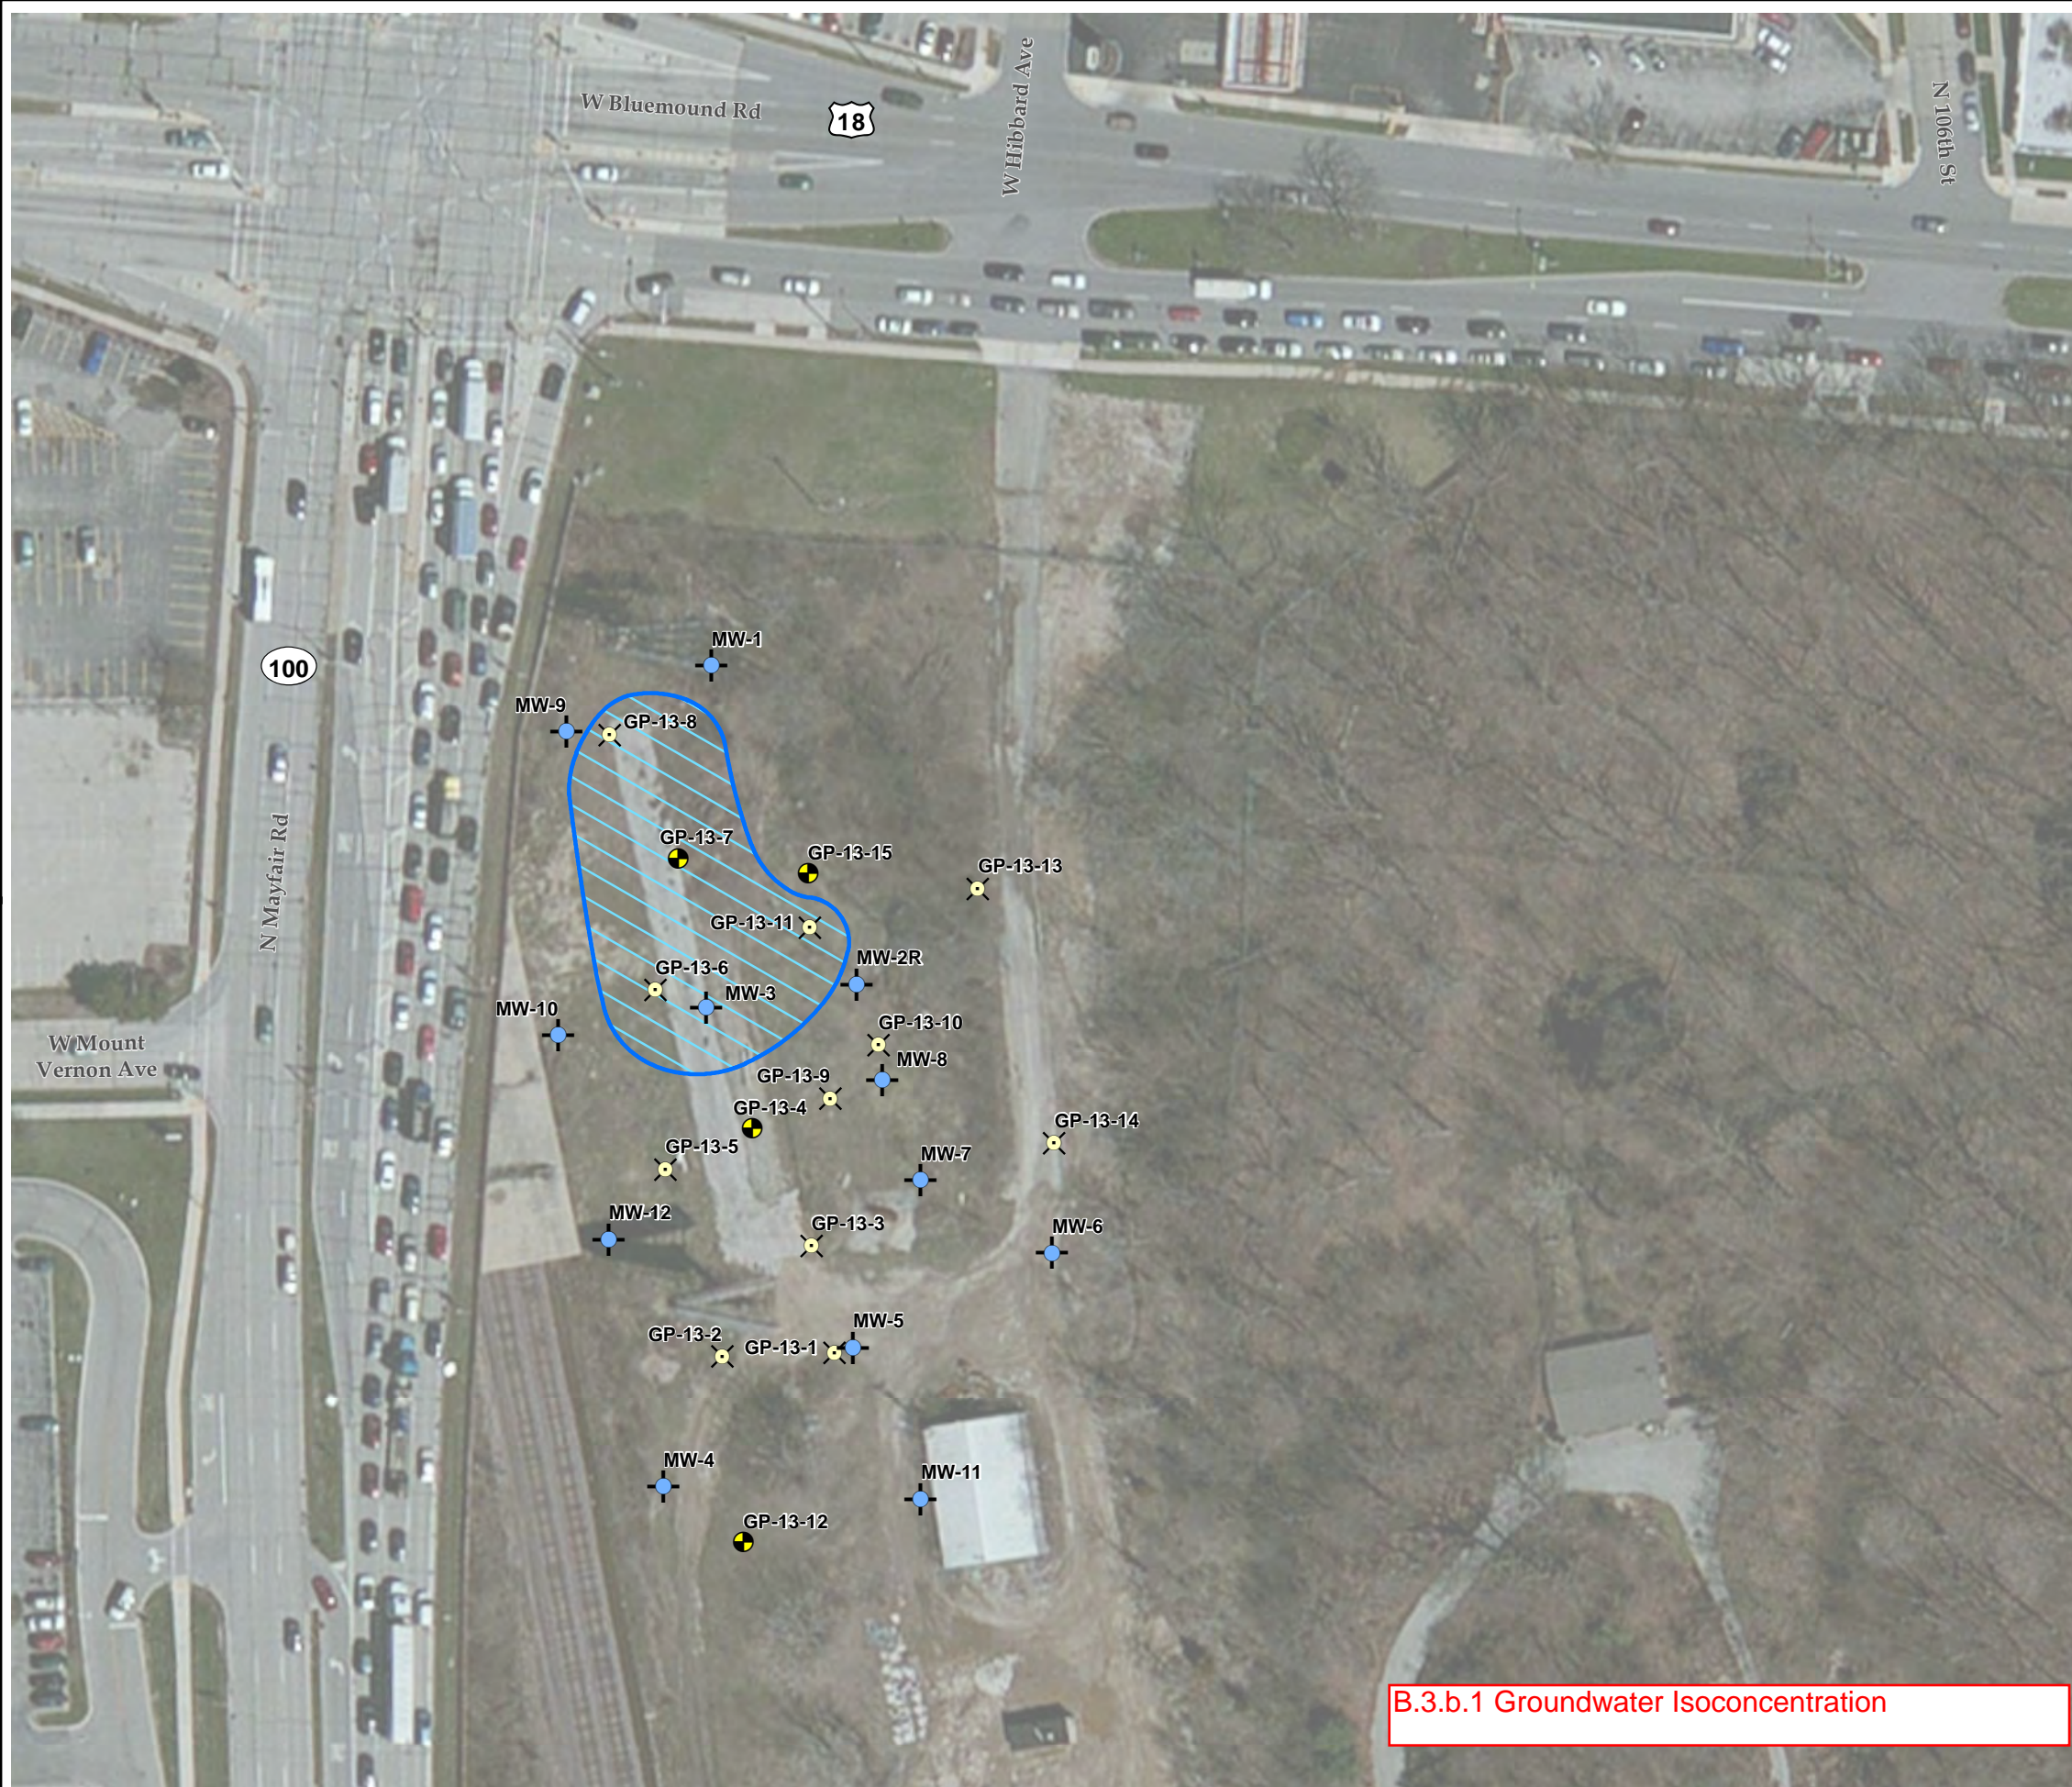
B.3.b.1 Groundwater Isoconcentration

PROJECT: MILWAUKEE COUNTY - BLIFFERT SITE		
WDNR BRRTS NO. 02-41-000655		
PECFA NO. 53226-4282-33-A		
SHEET TITLE: GROUNDWATER CONTAMINANT DISTRIBUTION MAP		
JUNE 2013		
DRAWN BY: PAPEZ J	SCALE: 1:960	PROJ. NO. 202083
CHECKED BY:		FILE NO. 202083-003.mxd
APPROVED BY:	DATE PRINTED:	FIGURE 2
DATE: JULY 2013

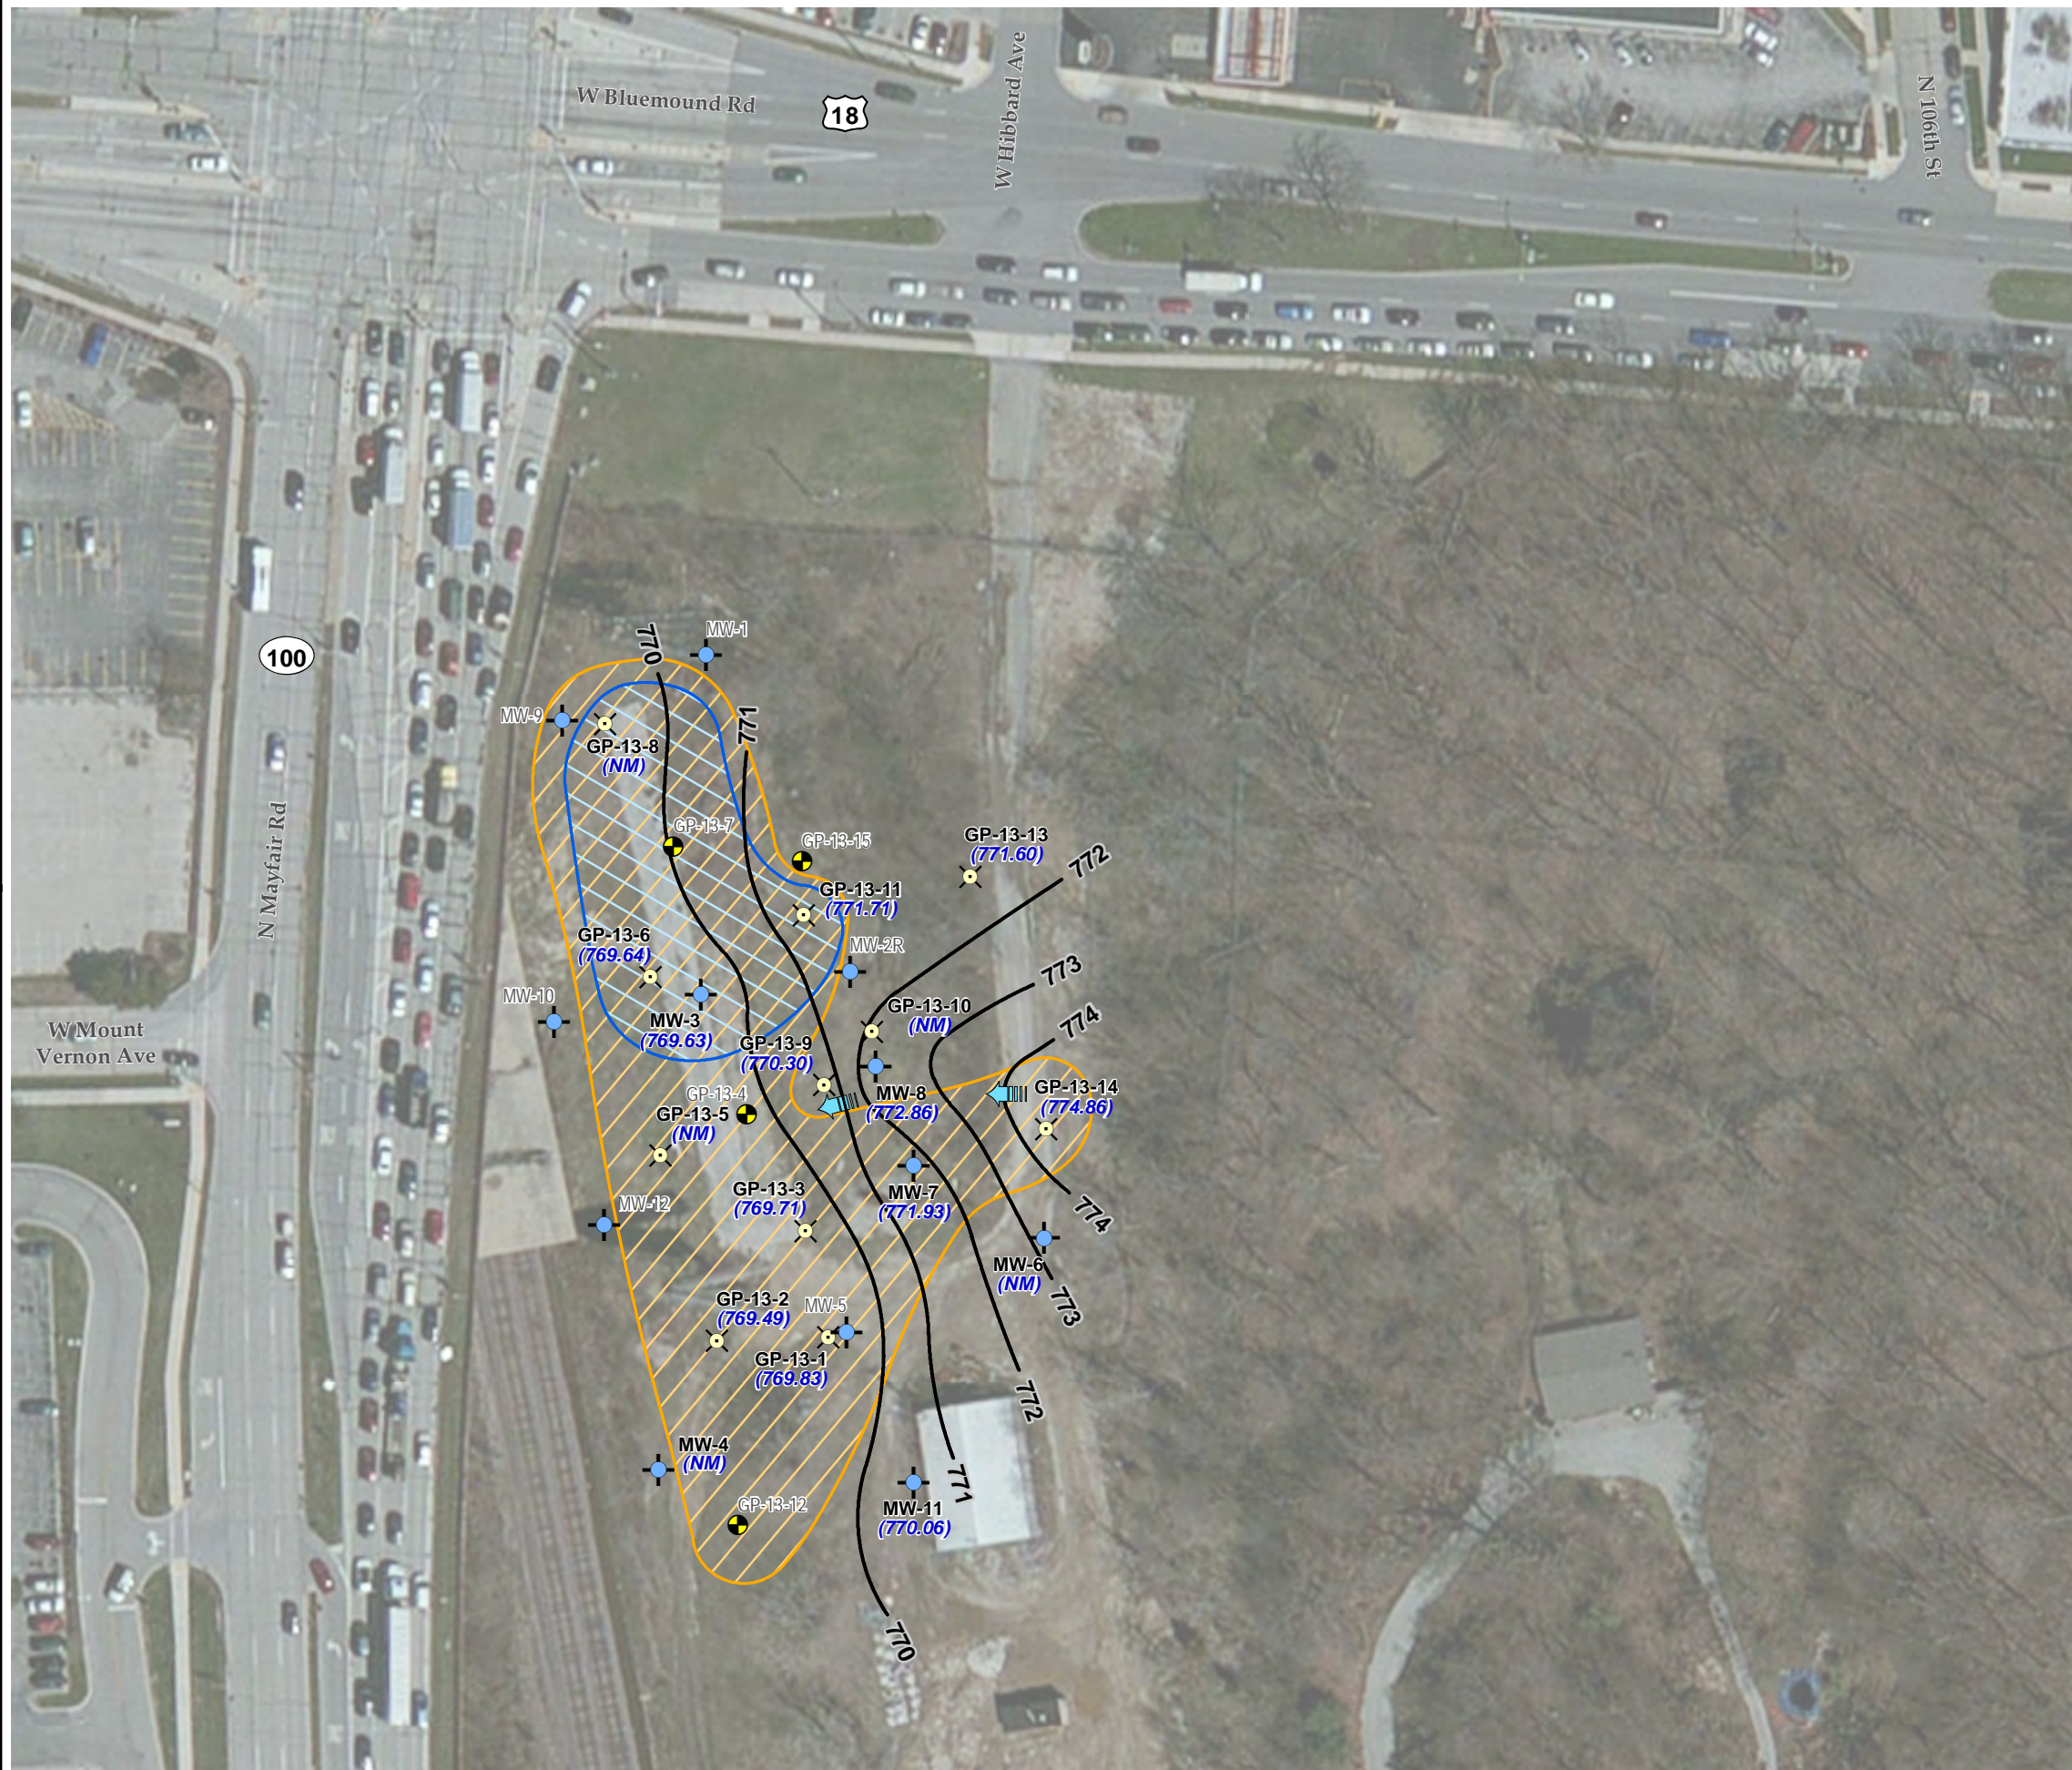
- GROUNDWATER MONITORING WELL
- SOIL PROBE BORING (5/2013)
- SOIL PROBE BORING & TEMPORARLY WELL (5/2013)
- GROUNDWATER ELEVATION CONTOUR
- (771.00)** GROUNDWATER ELEVATION (FEET, MSL)
- (NM)** NOT MEASURED
- DIRECTION OF GROUNDWATER FLOW
- APPROXIMATE EXTENT OF SOIL EXCEEDING NR 720 RCLS - MAY 2013
- APPROXIMATE EXTENT OF GROUNDWATER EXCEEDING NR 140 ES - JUNE 2013

PROJECT: MILWAUKEE COUNTY - BLIFFERT SITE		
WDNR BRRTS NO. 02-41-000655		
PECFA NO. 53226-4282-33-A		
SHEET TITLE: GROUNDWATER FLOW MAP		
JUNE 27, 2013		
DRAWN BY: PAPEZ J	SCALE: 1:960	PROJ. NO. 202083
CHECKED BY:		FILE NO. 202083-004.mxd
APPROVED BY:	DATE PRINTED:	FIGURE 3
DATE: JULY 2013

- ii. Discuss groundwater flow direction(s), shallow and deep. Describe and explain flow variations, including fracture flow if present.
Groundwater flows to the southwest through the property. The hydraulic gradients indicate that groundwater flows from the west and northeast into the foundry sand fill. Also, an apparent slight gradient exists to the south although the head measured in the clay are less reliable. However, the sand is bounded by the low permeability native clay on the south. This native clay tends to act as a barrier to off-site migration of groundwater.

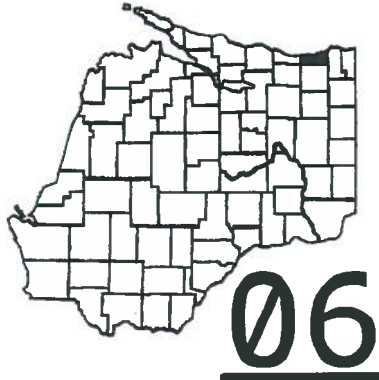
FIG. 1

PROJECT	ZOO INTERCHANGE - MAYFAIR ROAD RECONSTRUCTION
SHEET TITLE	WAWATOSA, WI - WISDOT ID 1060-33-70
PROJECT LOCATION AND LIMITS	
DRAWN BY:	J. KONIAR
CHECKED BY:	T. STAPEL
APPROVED BY:	K. YASS
DATE:	OCTOBER 2013
PROJ. NO.	199874.0000.0000
FILE NO.	199874-01.dwg
AS NOTED	DATE PRINTED:
FIGURE 1	
150 North Patrick Blvd. Suite 180 Brookfield, WI 53045 Phone: 262.879.1212

Mayfair Road is being reconstructed as part of the early stages of the overall Zoo Interchange reconstruction Mega Project (see Figure 1 for the Mayfair Road project location and limits). In preparation for this work, Forward 45 completed a Phase 1 Hazardous Materials Assessment in 2011, and TRC completed Phase 2.5 investigations in 2012. Summary information (i.e. tabulated data and site figures showing areas of contamination) from this work is included in Attachment 1. TRC prepared the hazardous materials special provisions, a copy is included in Attachment 1. The hazardous materials special provisions were submitted to the WDNR. The WDNR responded by issuing the concurrence letters included at the end of Attachment 1. Note that the WDNR concurred that the CVOC contamination at one of the sites was non-hazardous (see WDNR letter dated May 29, 2012 for Site 33 in Attachment 1). An overview of the areas where contamination has been identified by the Phase 2.5 investigation within the project limits is presented as Figure 2.

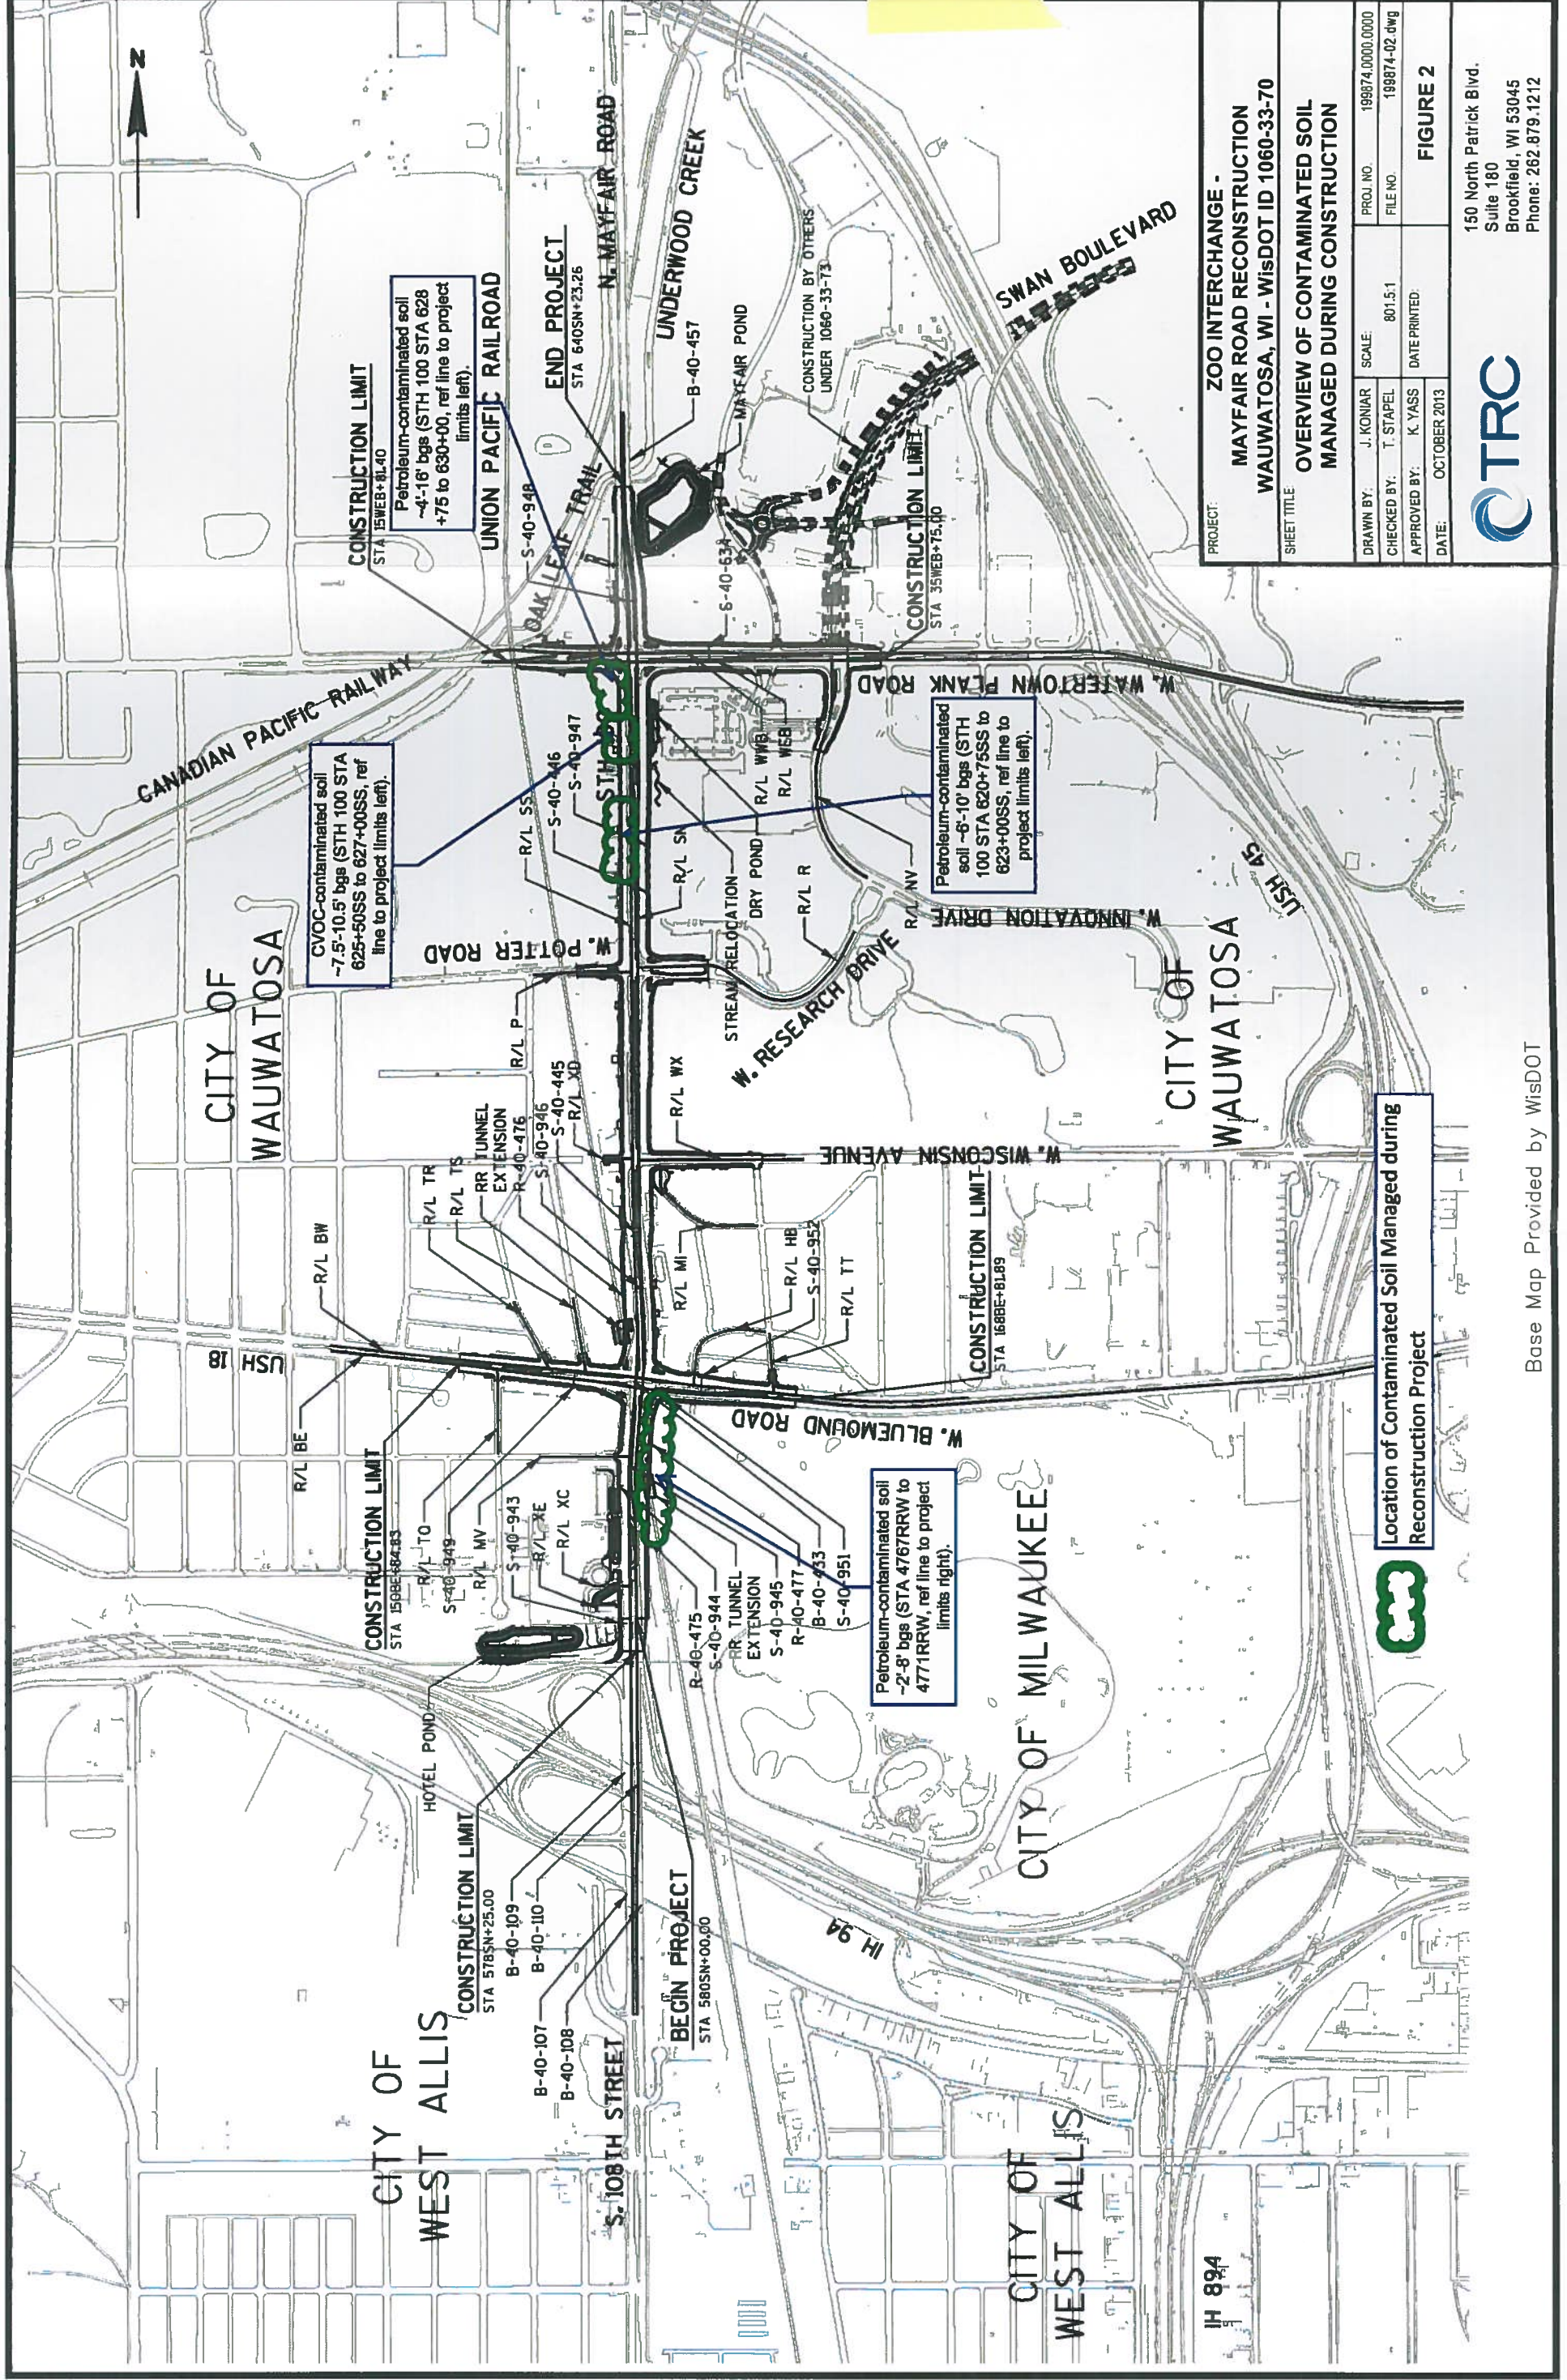
C. 6. 5. Other

Location of Contaminated Soil Managed during Reconstruction Project

Off site structural impediments exist to the west of the Bliffert property. Union Pacific railroad tracks, a railroad tunnel under State Highway 100, prohibit investigation there, but also serve as performance standard barrier for direct contact and the groundwater pathway. As noted above, the DOT's contractor excavated materials adjacent to the railroad tunnel to enable the tunnels expansion.

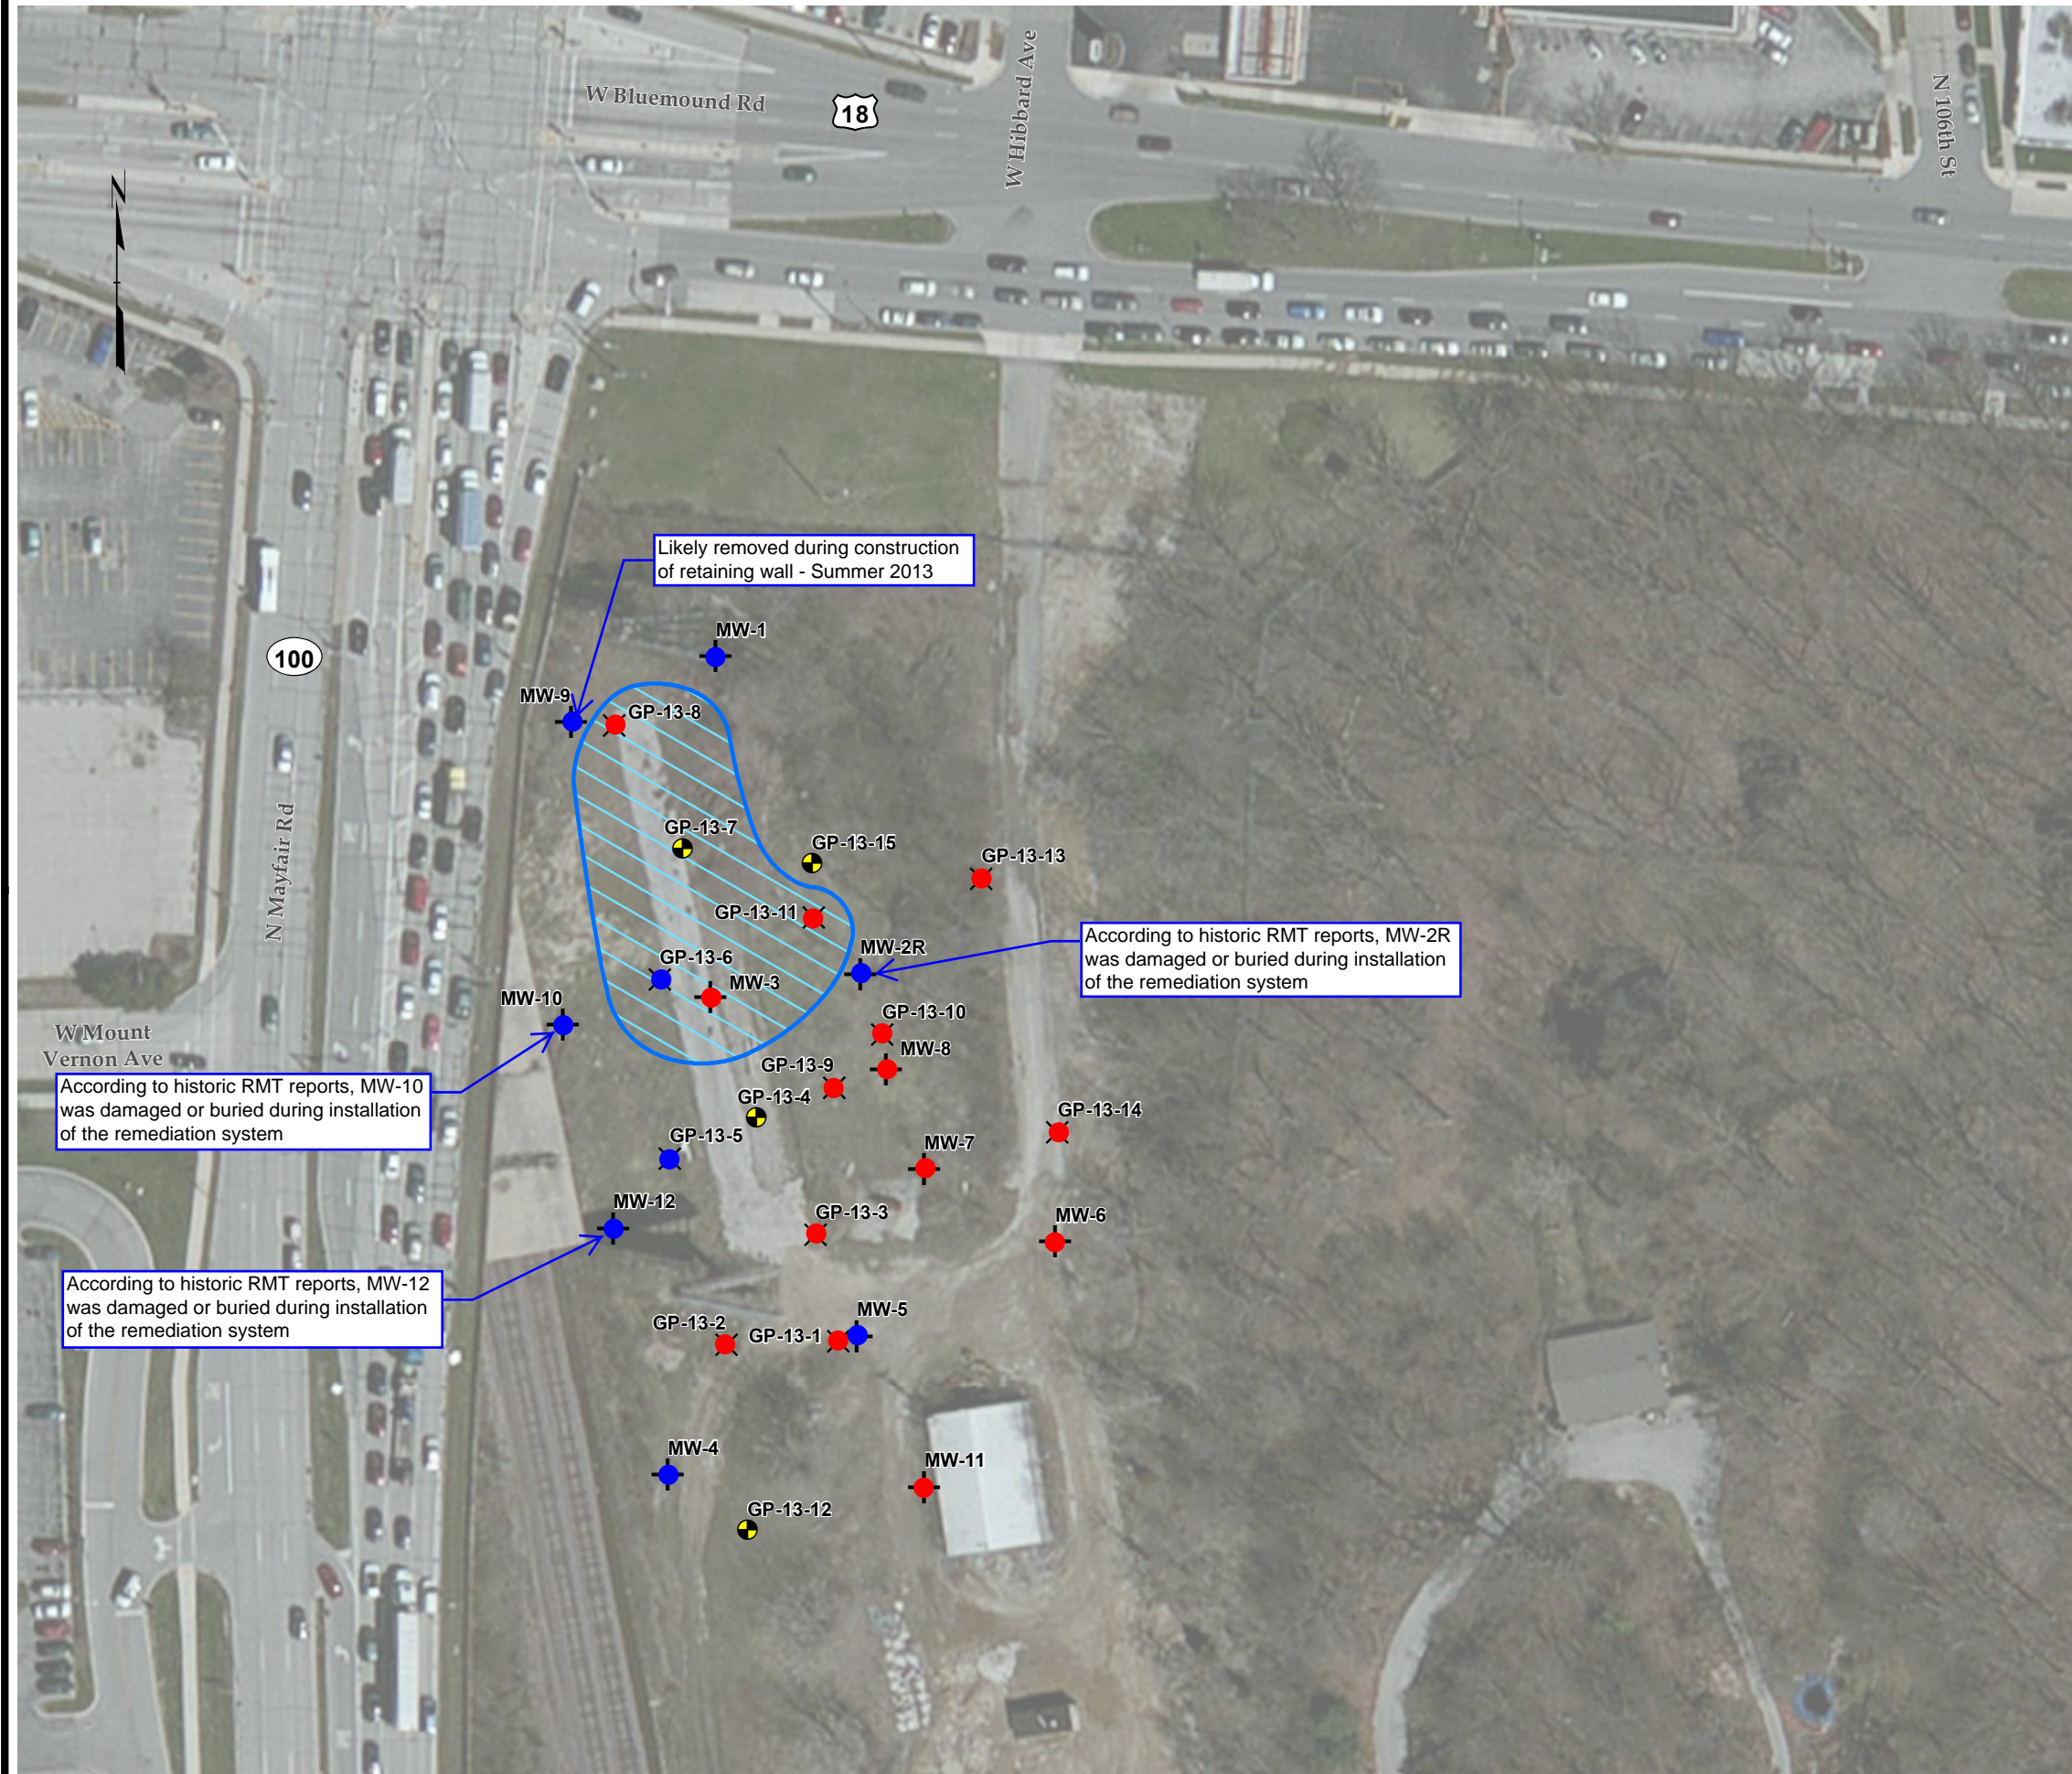
E. 1. 1. Monitoring Well Information- Figure from TRC 2013

- GROUNDWATER MONITORING WELL
- SOIL PROBE BORING (5/2013)
- SOIL PROBE BORING & TEMPORARLY WELL (5/2013)
- APPROXIMATE EXTENT OF GROUNDWATER EXCEEDING NR 140 ES - JUNE 2013
- Wells that have been located and abandoned
- Wells that could not be found. If any of these wells are found in the future, they should be properly abandoned in accordance with NR 141.
