Annual Operation, Maintenance, and Monitoring Report

January 2020 through December 2020

Former Holtz Krause Landfill
Wausau, Wisconsin

City of Wausau

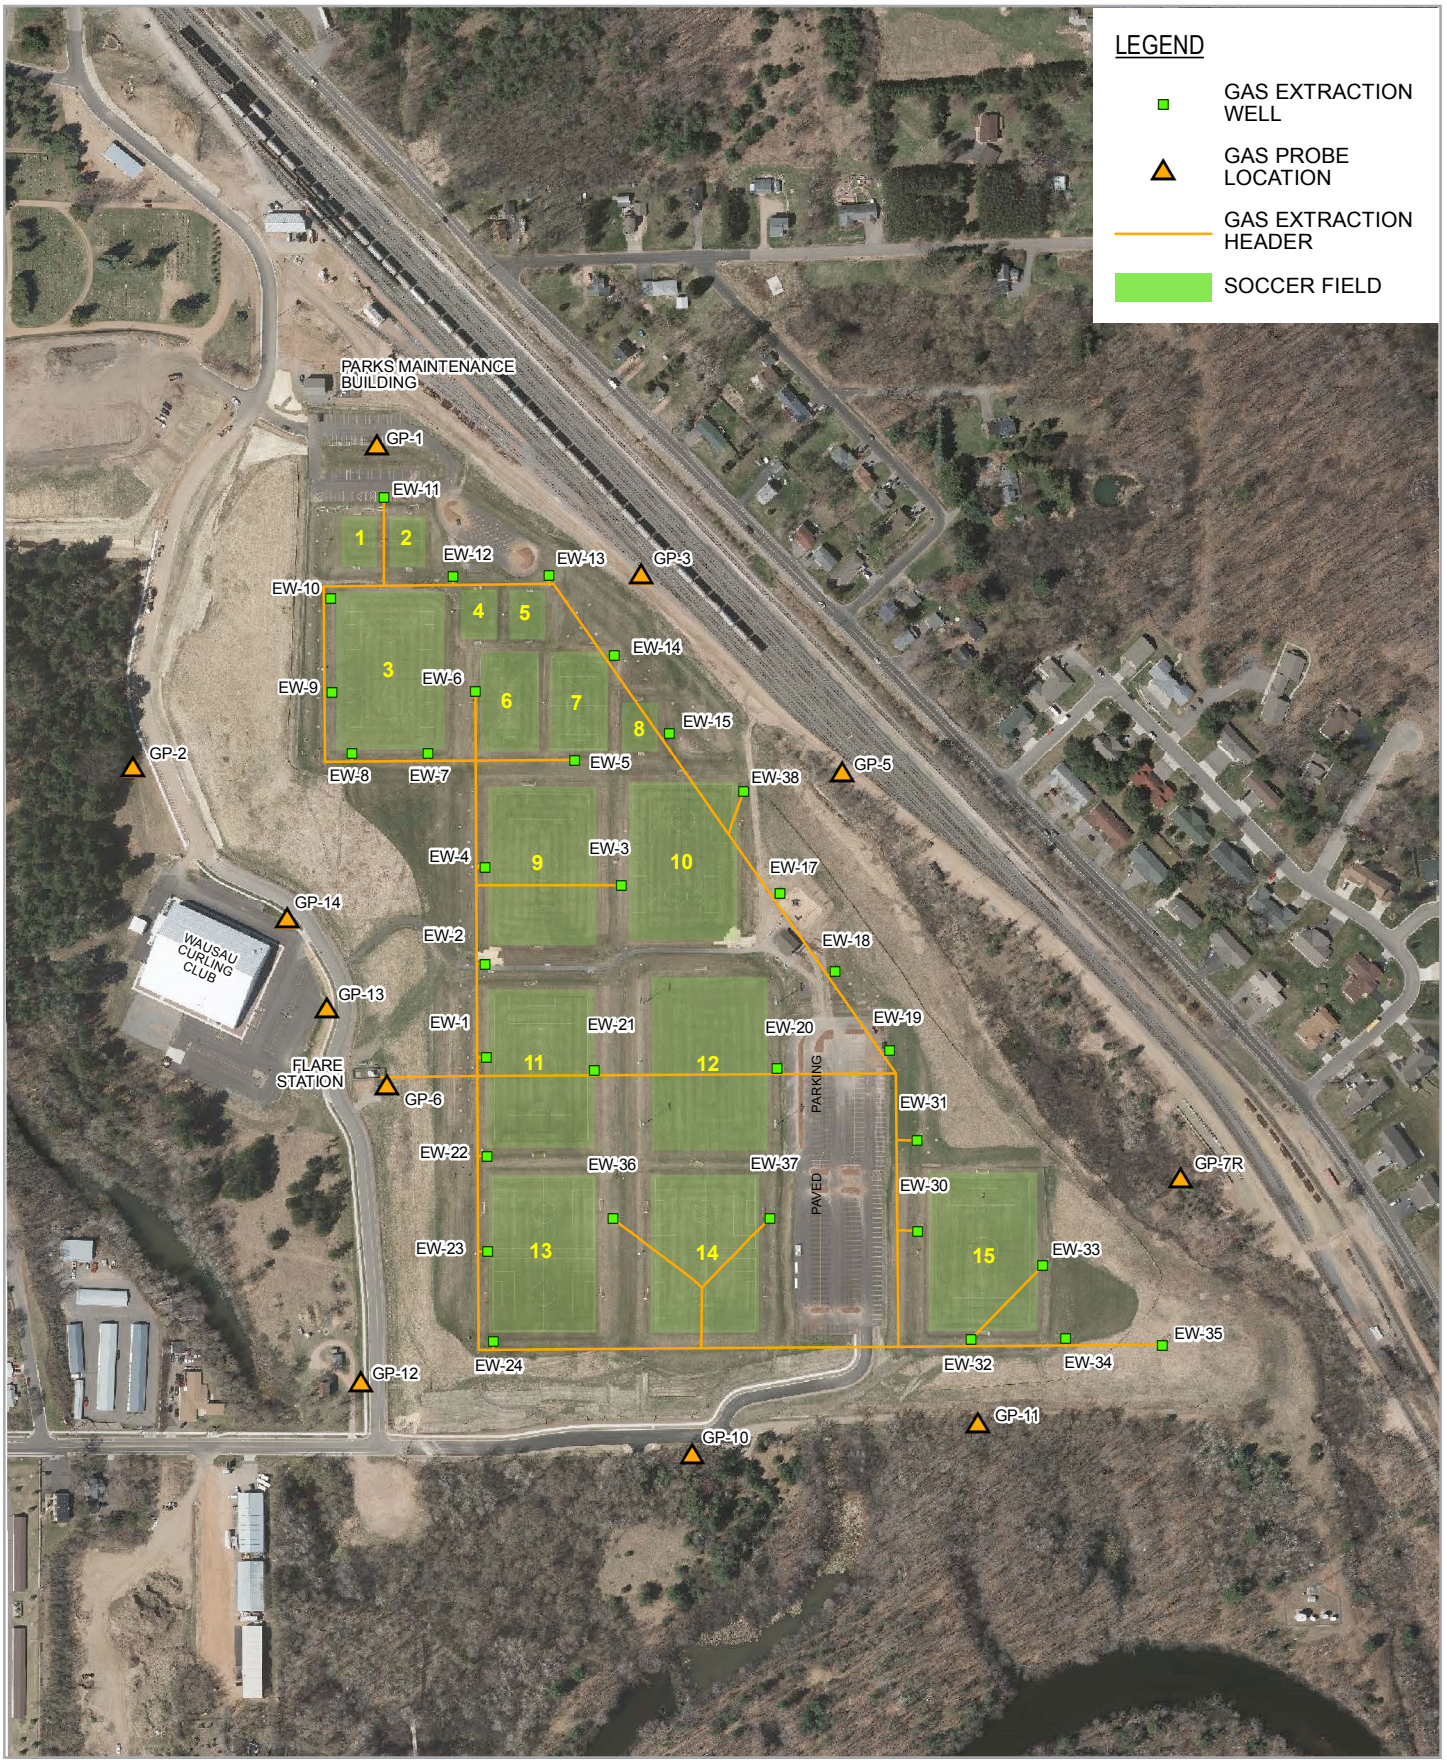
FIGURE 1.1

The components of the gas extraction system are shown on Figure 1.1.

GAS EXTRACTION WELL
-

GAS PROBE LOCATION
-

GAS EXTRACTION HEADER
-

SITE PLAN
