SUBJECT: Case Closure with Continuing Obligations  
Appleton Wire (Former), 908 N. Lawe Street, Appleton, WI 54911  
BRRTS #: 02-45-000015, FID #: 445035910

### GROUNDWATER ISOCONCENTRATION - METALS

**EXTENT OF RESIDUAL HEXAVALENT CHROMIUM CONTAMINATION IN SOIL ON 908 NORTH LAWE STREET**

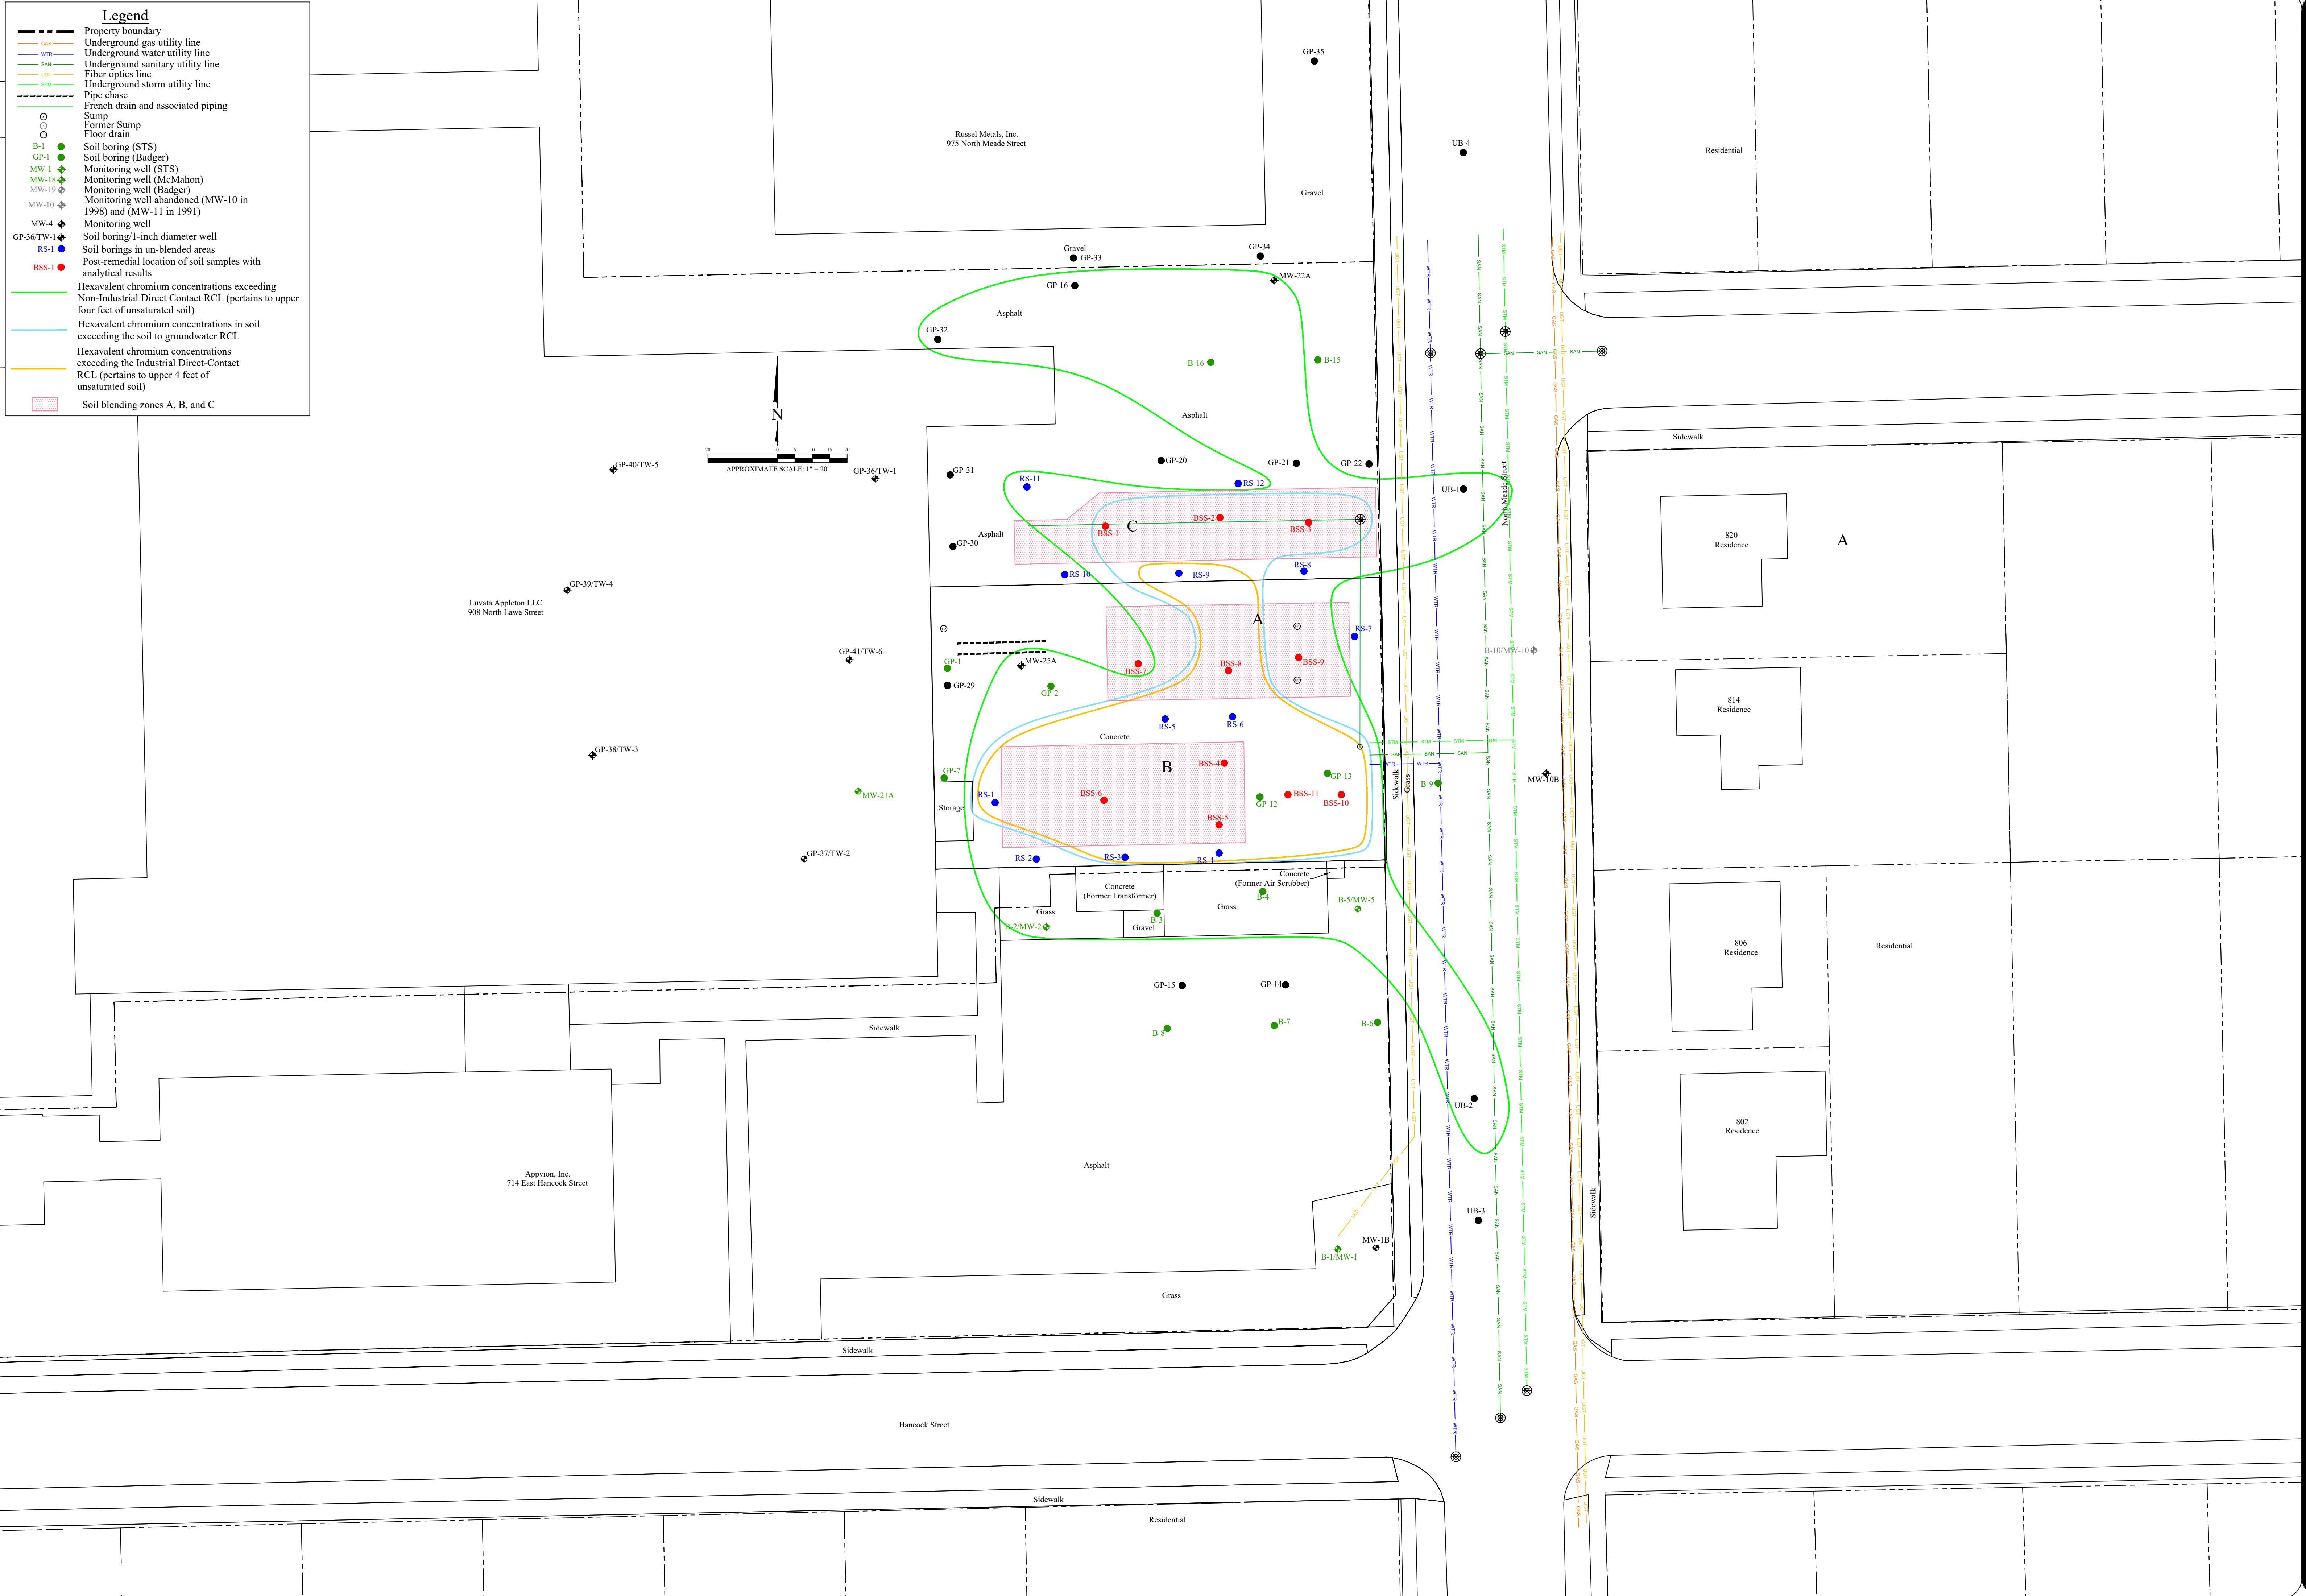
- Hexavalent chromium concentrations exceeding the Industrial Direct Contact RCL (pertains to upper 4 feet of unsaturated soil)
- Soil blending zones A, B, and C

No.	1	Date	7/3/18	Revision	Updates	Approved	WF
Date	4/5/19	Designed:	EB	Drawn:	EB	Checked:	BK
Figure	RESIDUAL SOIL CONTAMINATION - HEXAVALENT CHROMIUM						
Project	Former Appleton Wire 908 North Lawe Street Appleton, Wisconsin						
Figure	B.2.b.2						
Project	6486						
825 North Capital Avenue • Indianapolis, IN 46204 EnviroForensics.com							
DWG file: 6486-2681

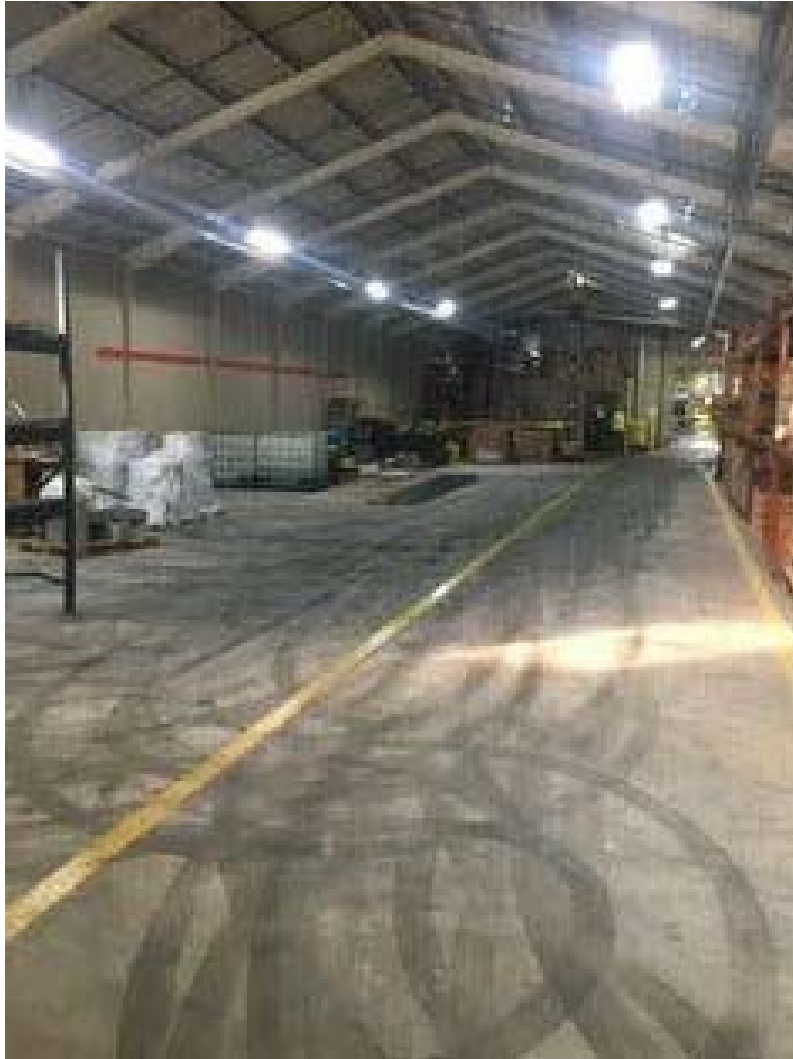
View of concrete floor on south side of warehouse, facing west.

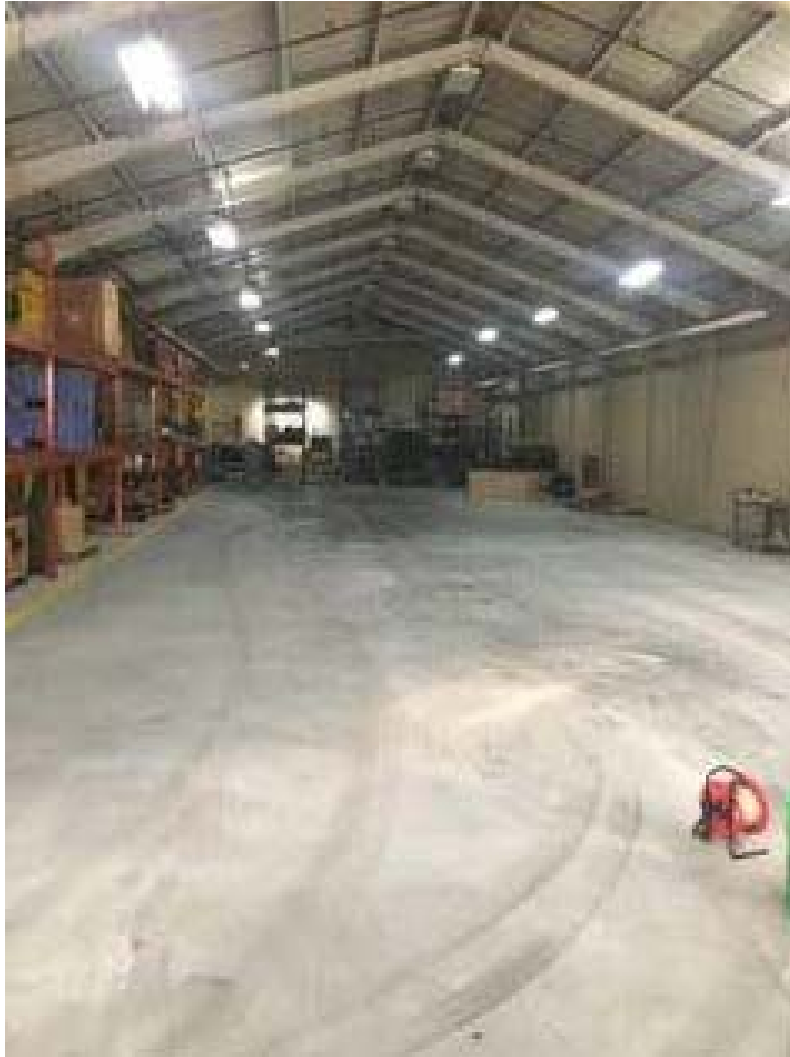
View of concrete floor on north side of warehouse, facing west.

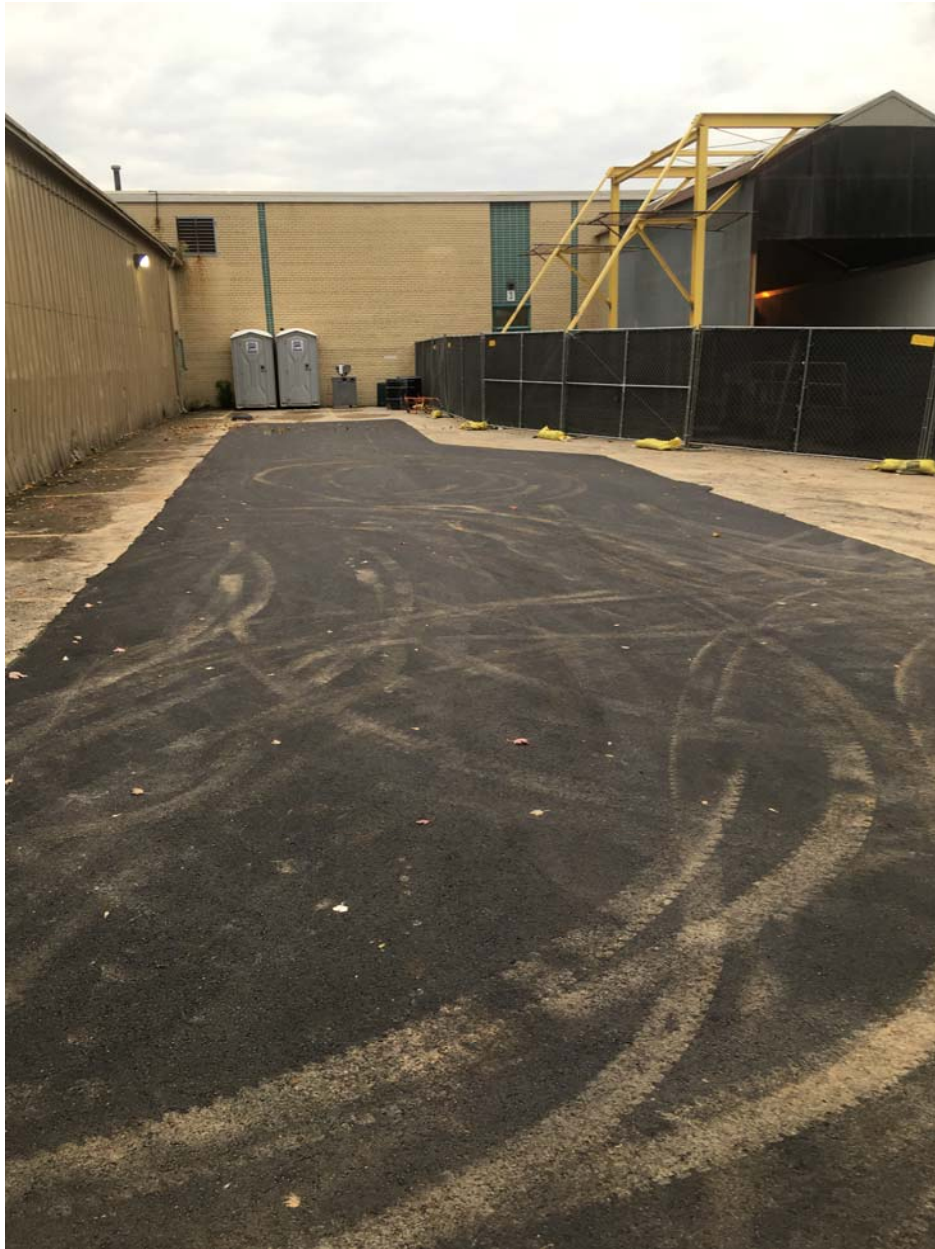
View of the asphalt parking area on north side of warehouse, facing west.

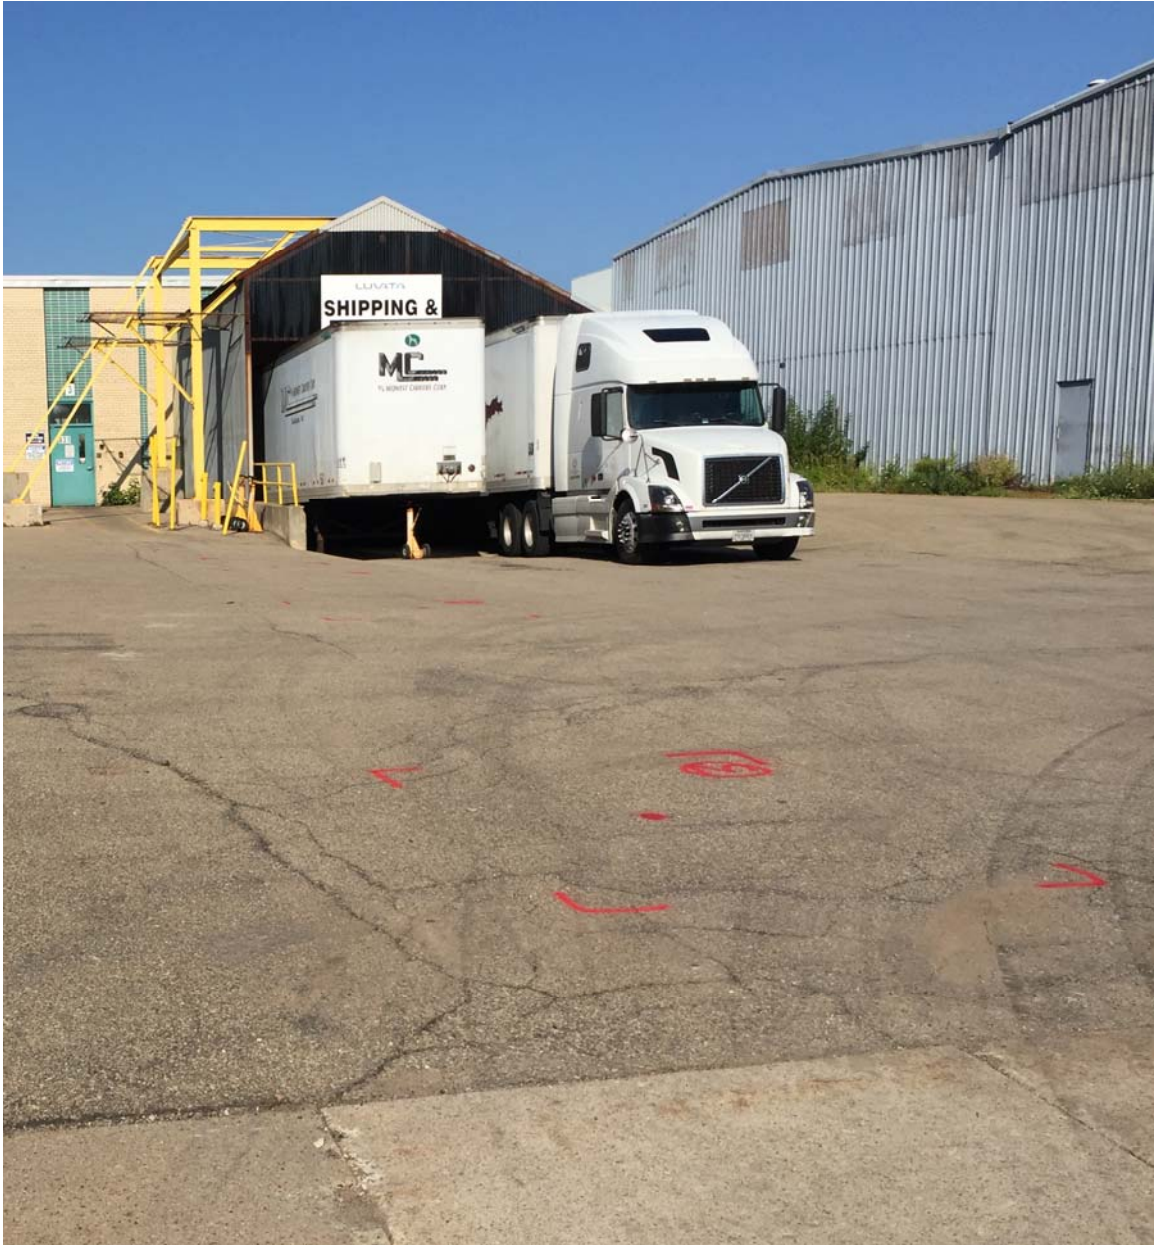
View of the asphalt driveway area north of the warehouse, facing northwest.

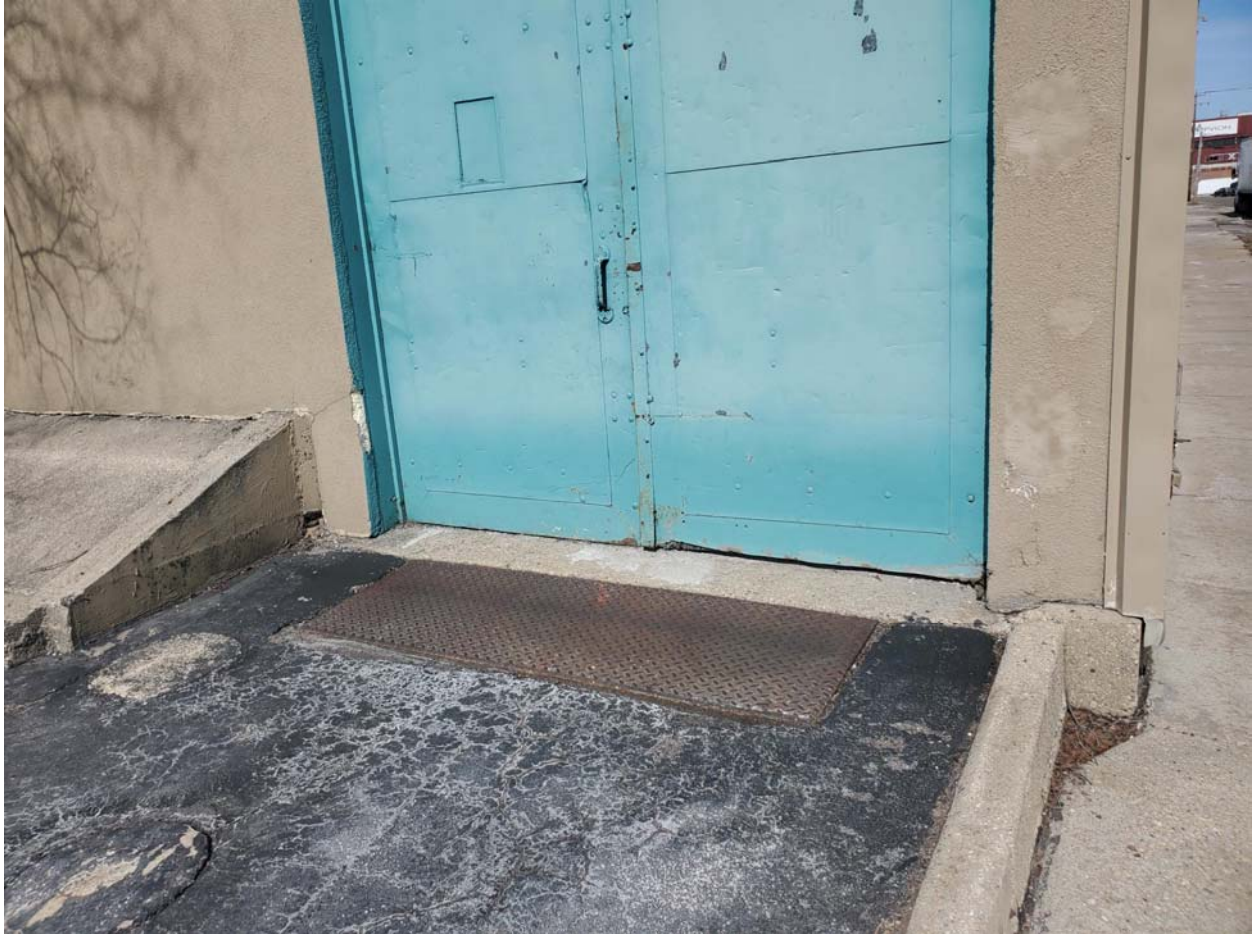
View of the asphalt driveway area outside the southeast corner of the warehouse,  
facing north.

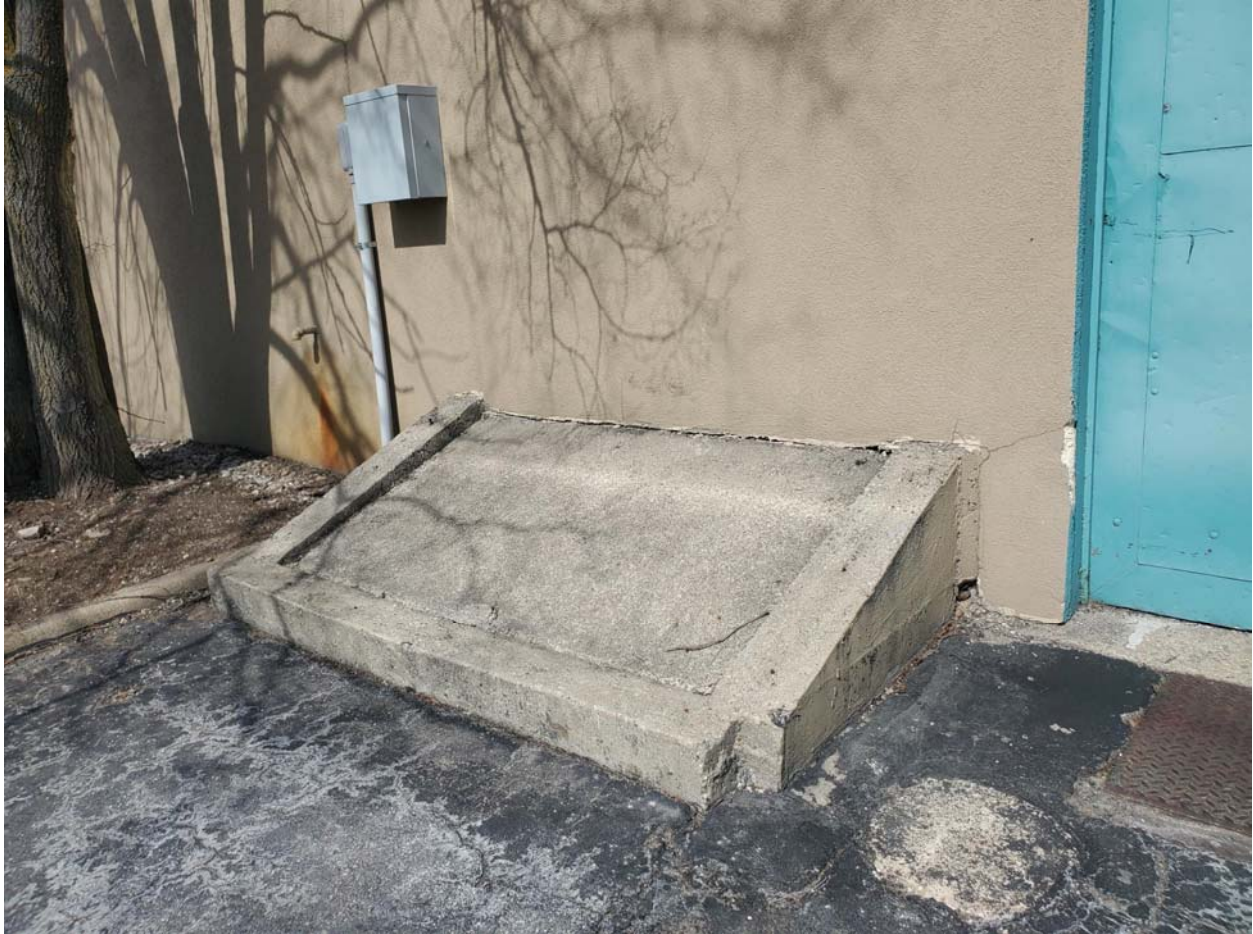
View of a concrete surface feature near the southeast corner of the warehouse,  
facing northwest.

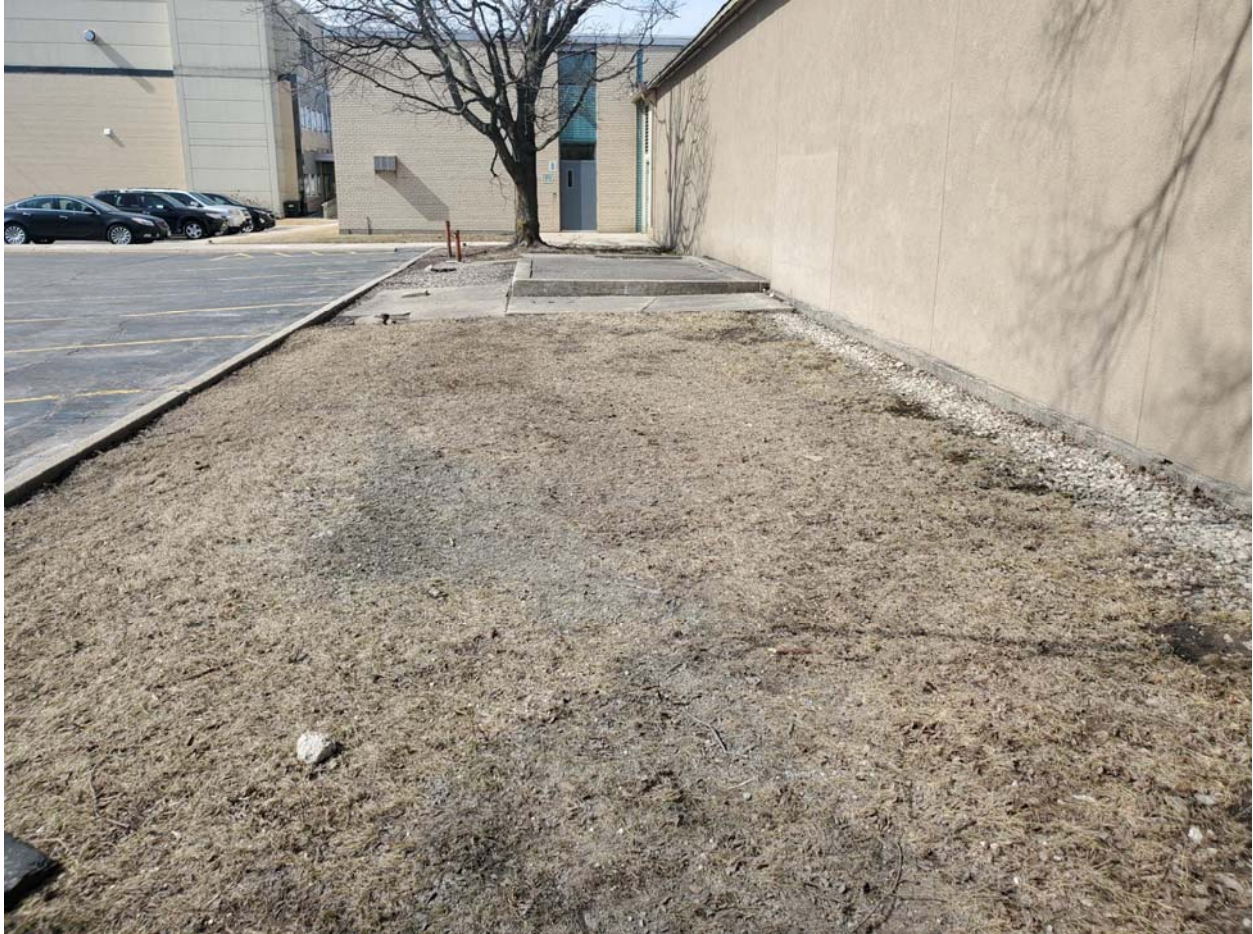
View of the grass, gravel, and concrete-covered area along the south wall of the warehouse, facing west. The boundary with the 714 Hancock Street parcel is approximately 3 feet south of warehouse building wall.

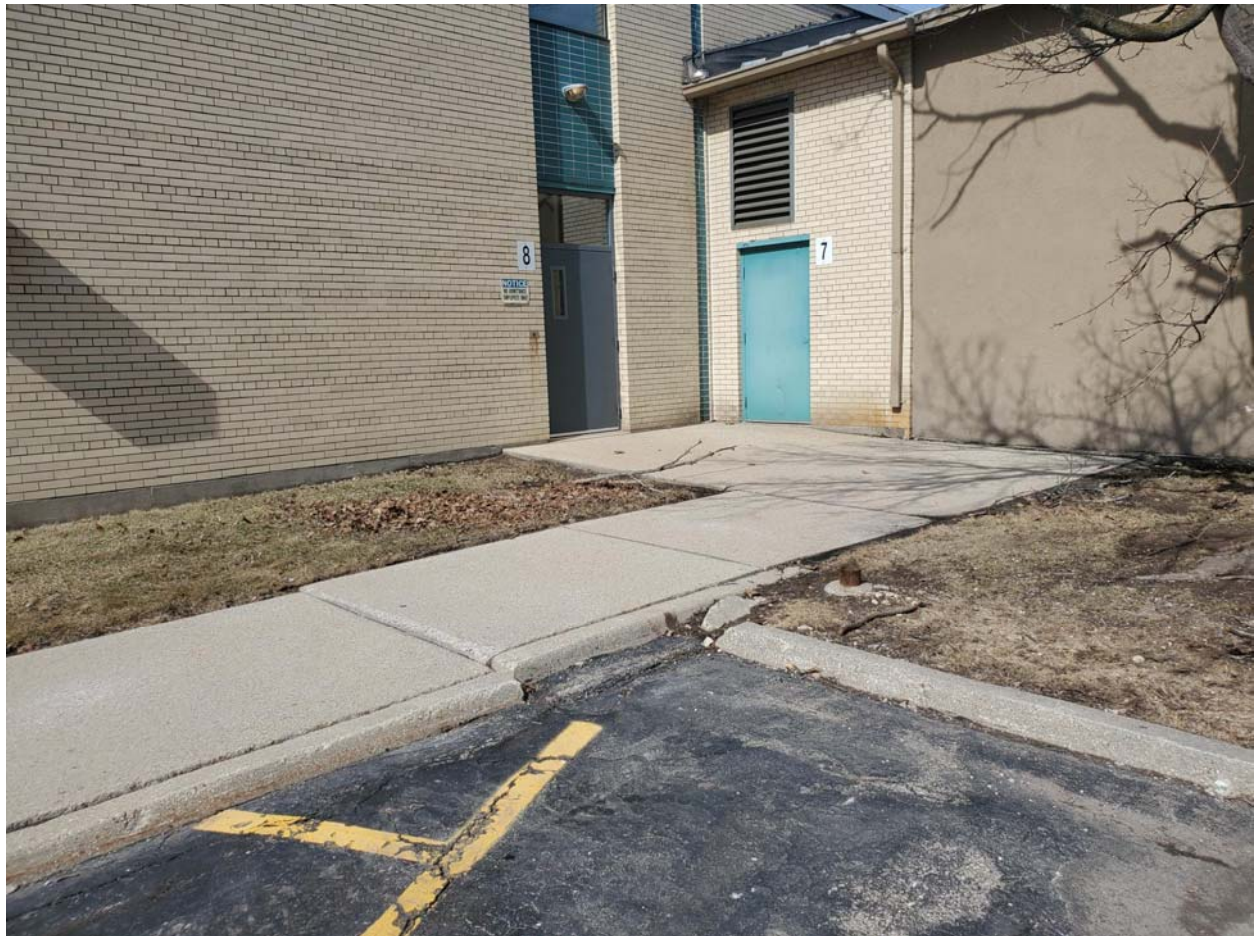
View of grass and concrete portions of the cap outside the southwest corner of the warehouse, facing northwest. The asphalt in the photo is on the 714 Hancock Street parcel.

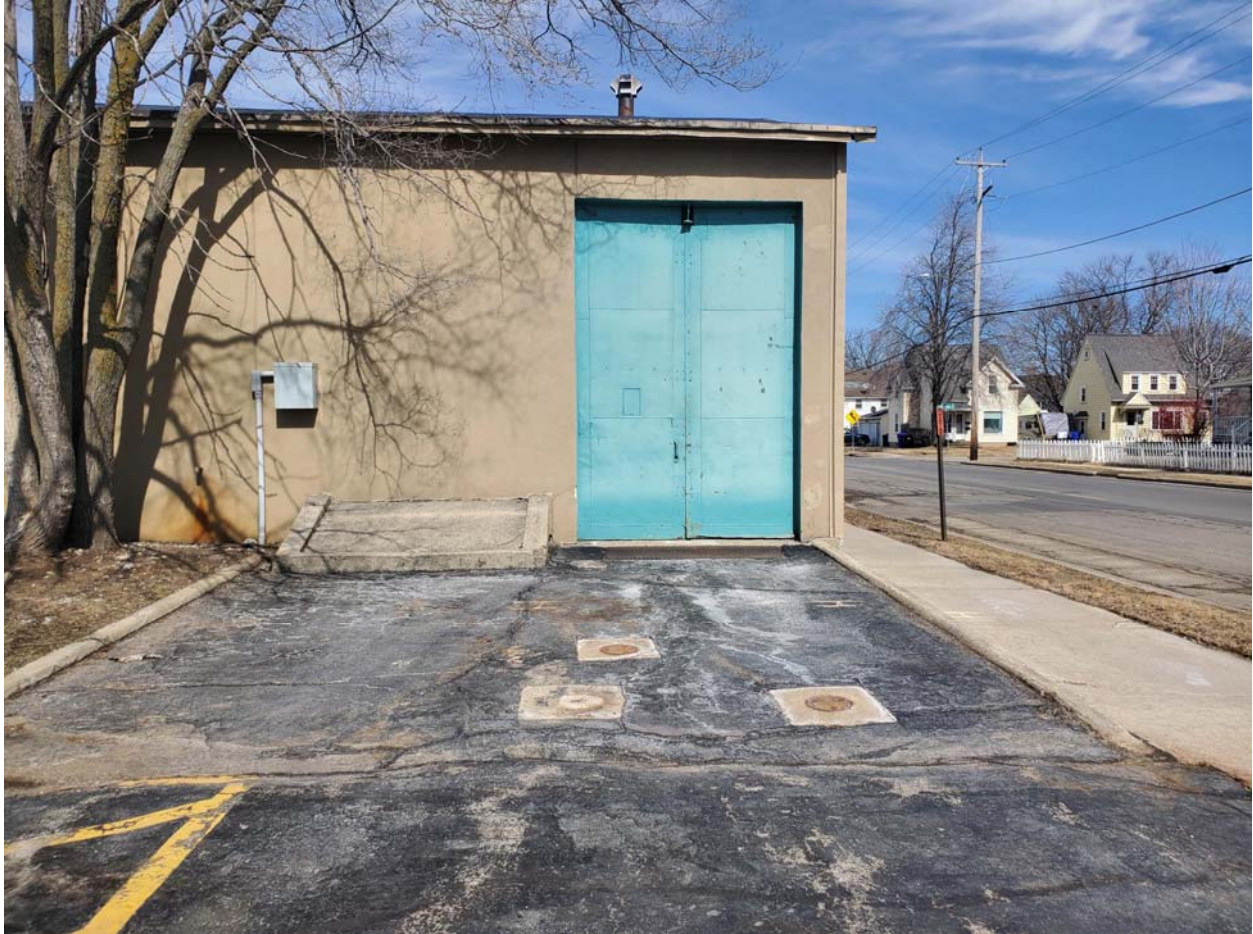
View of the asphalt portion of the cap, facing north.

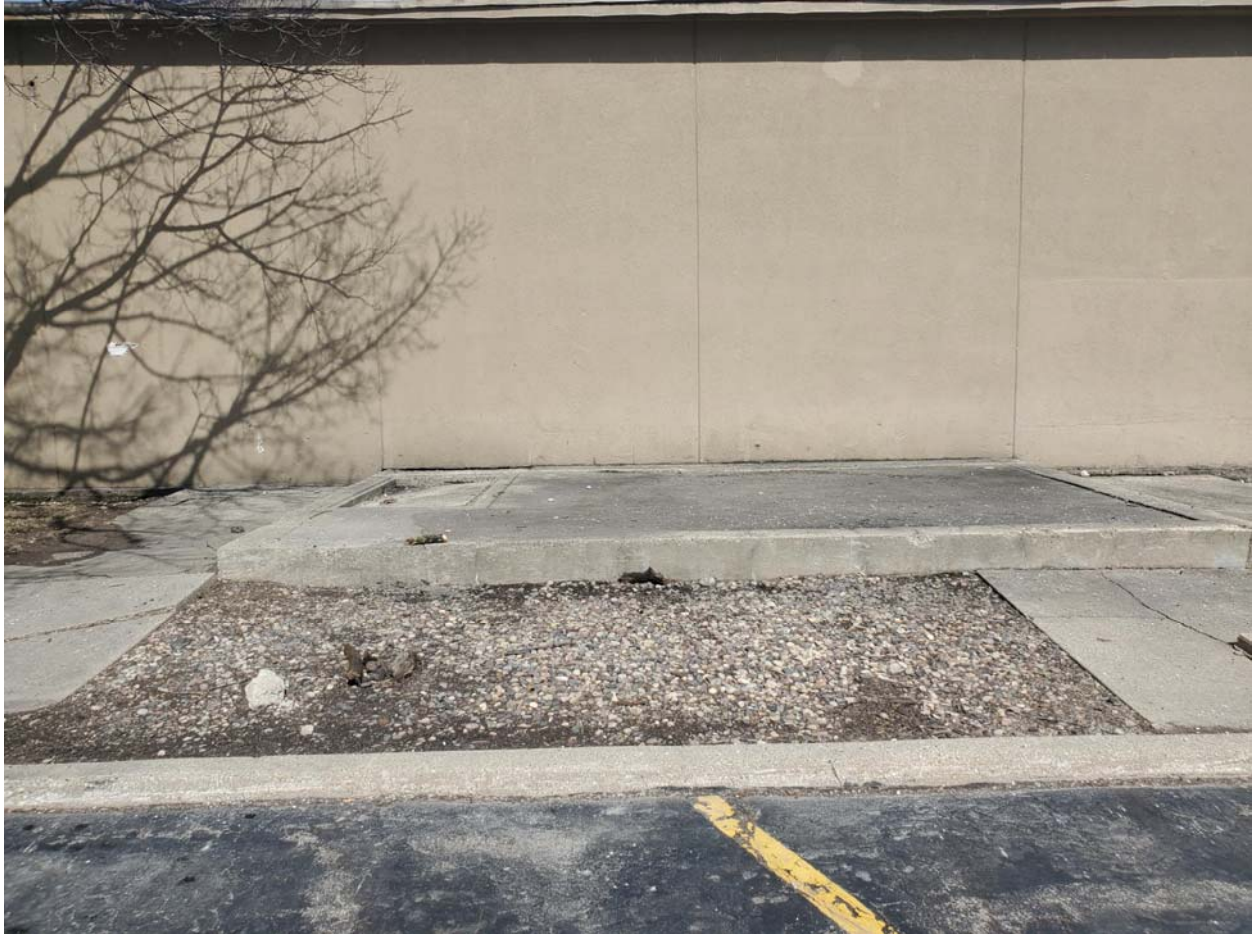
View of gravel and concrete portions of the cap, facing north.

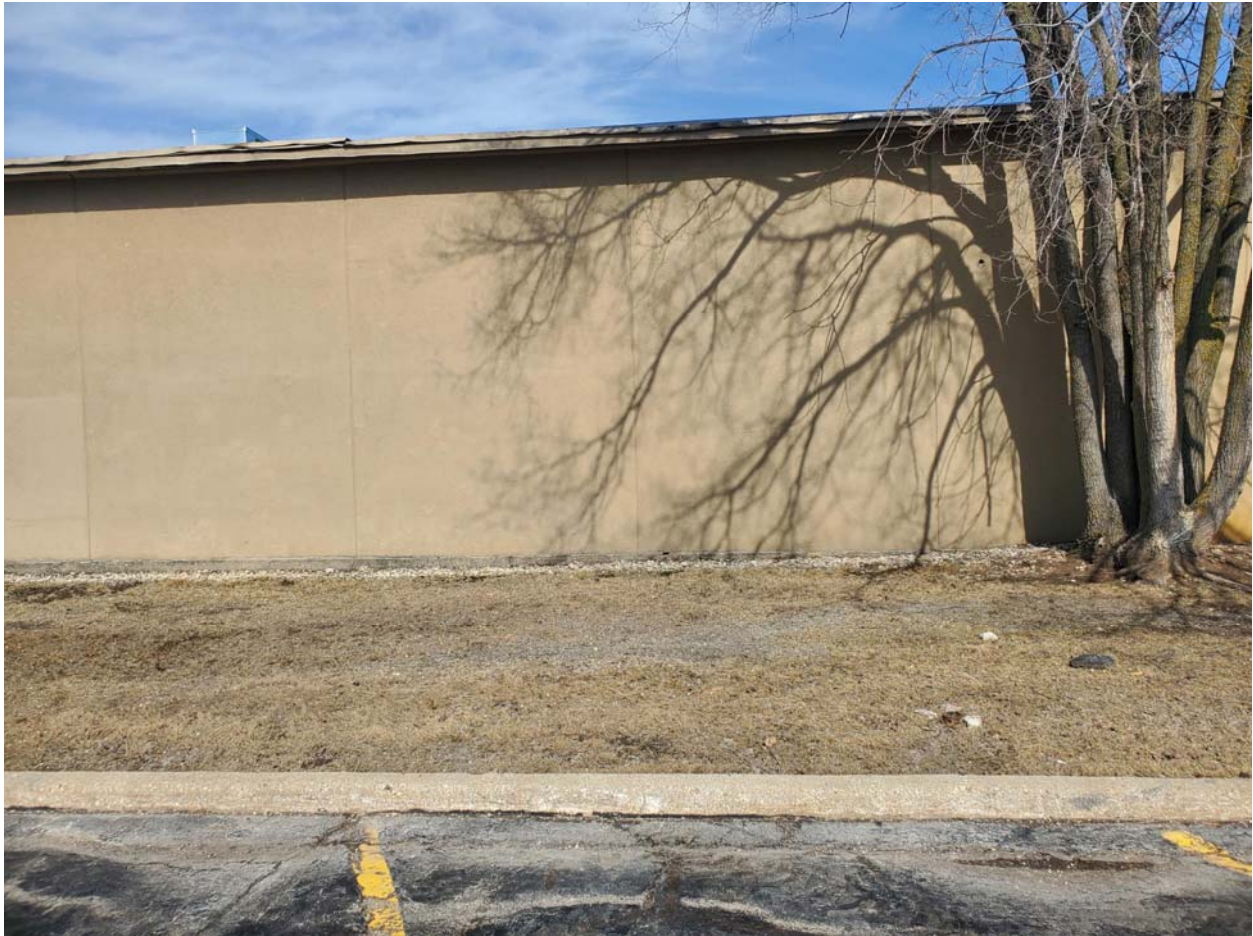
View of the grass-covered portion of the cap, facing north.

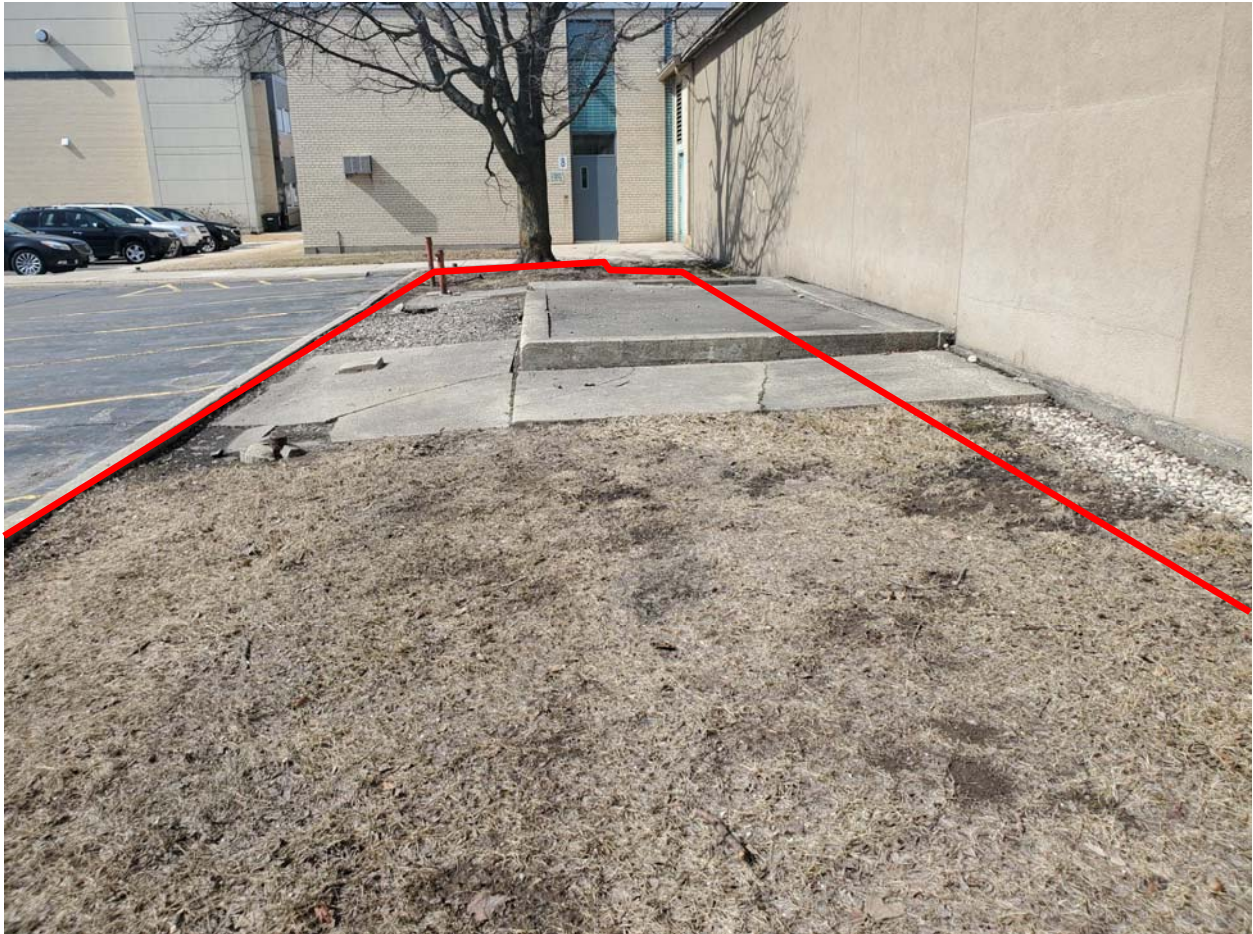
Overview of the cap, facing west. The north-south extent of the cap is from the curb on the left side of the photograph to the boundary with the 908 N. Lawe Street parcel, which is approximately 3 feet off the building wall on the right side of the photograph.
