# **Optimization Review Report Remedial Process Optimization Study**

**Better Brite Plating Co. Chrome and Zinc  
Shops Superfund Site  
City of De Pere, Brown County, Wisconsin  
EPA Region 5**

**BETTER BRITE PLATING CO. CHROME AND ZINC SHOPS  
SUPERFUND SITE**

FINAL REPORT  
May 2020

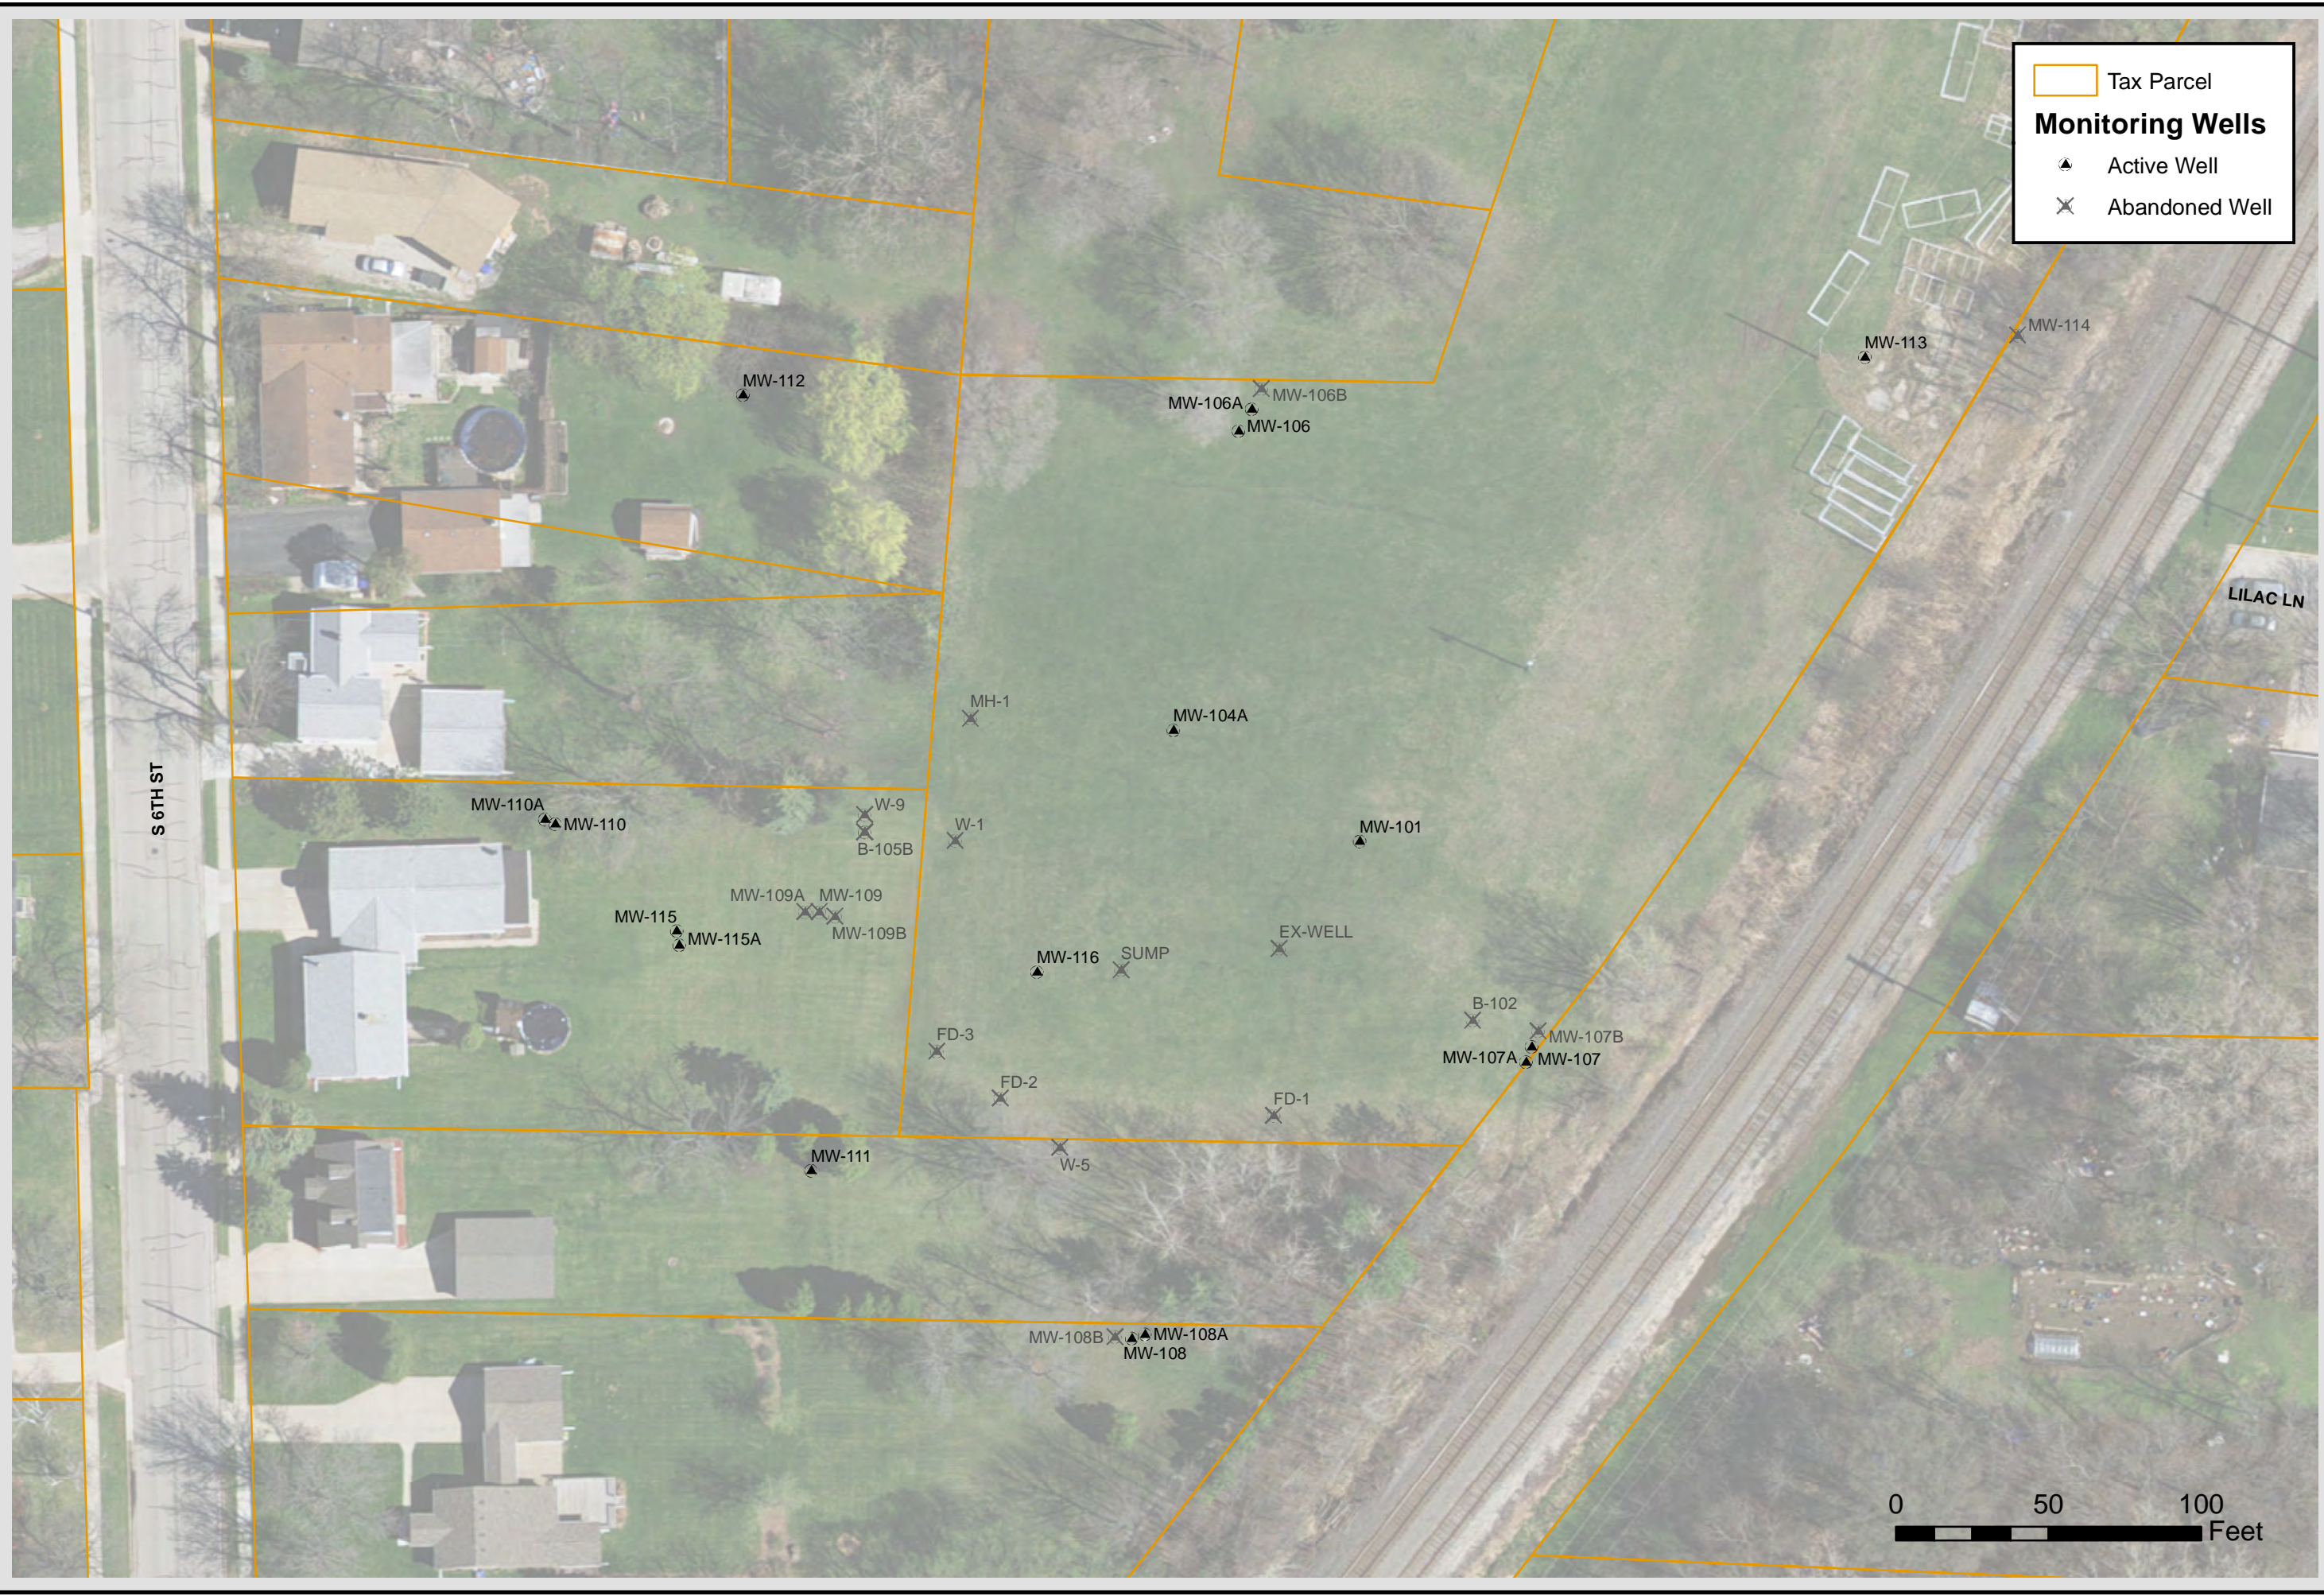
Tax Parcel  
**Monitoring Wells**  
 Active Well  
 Abandoned Well

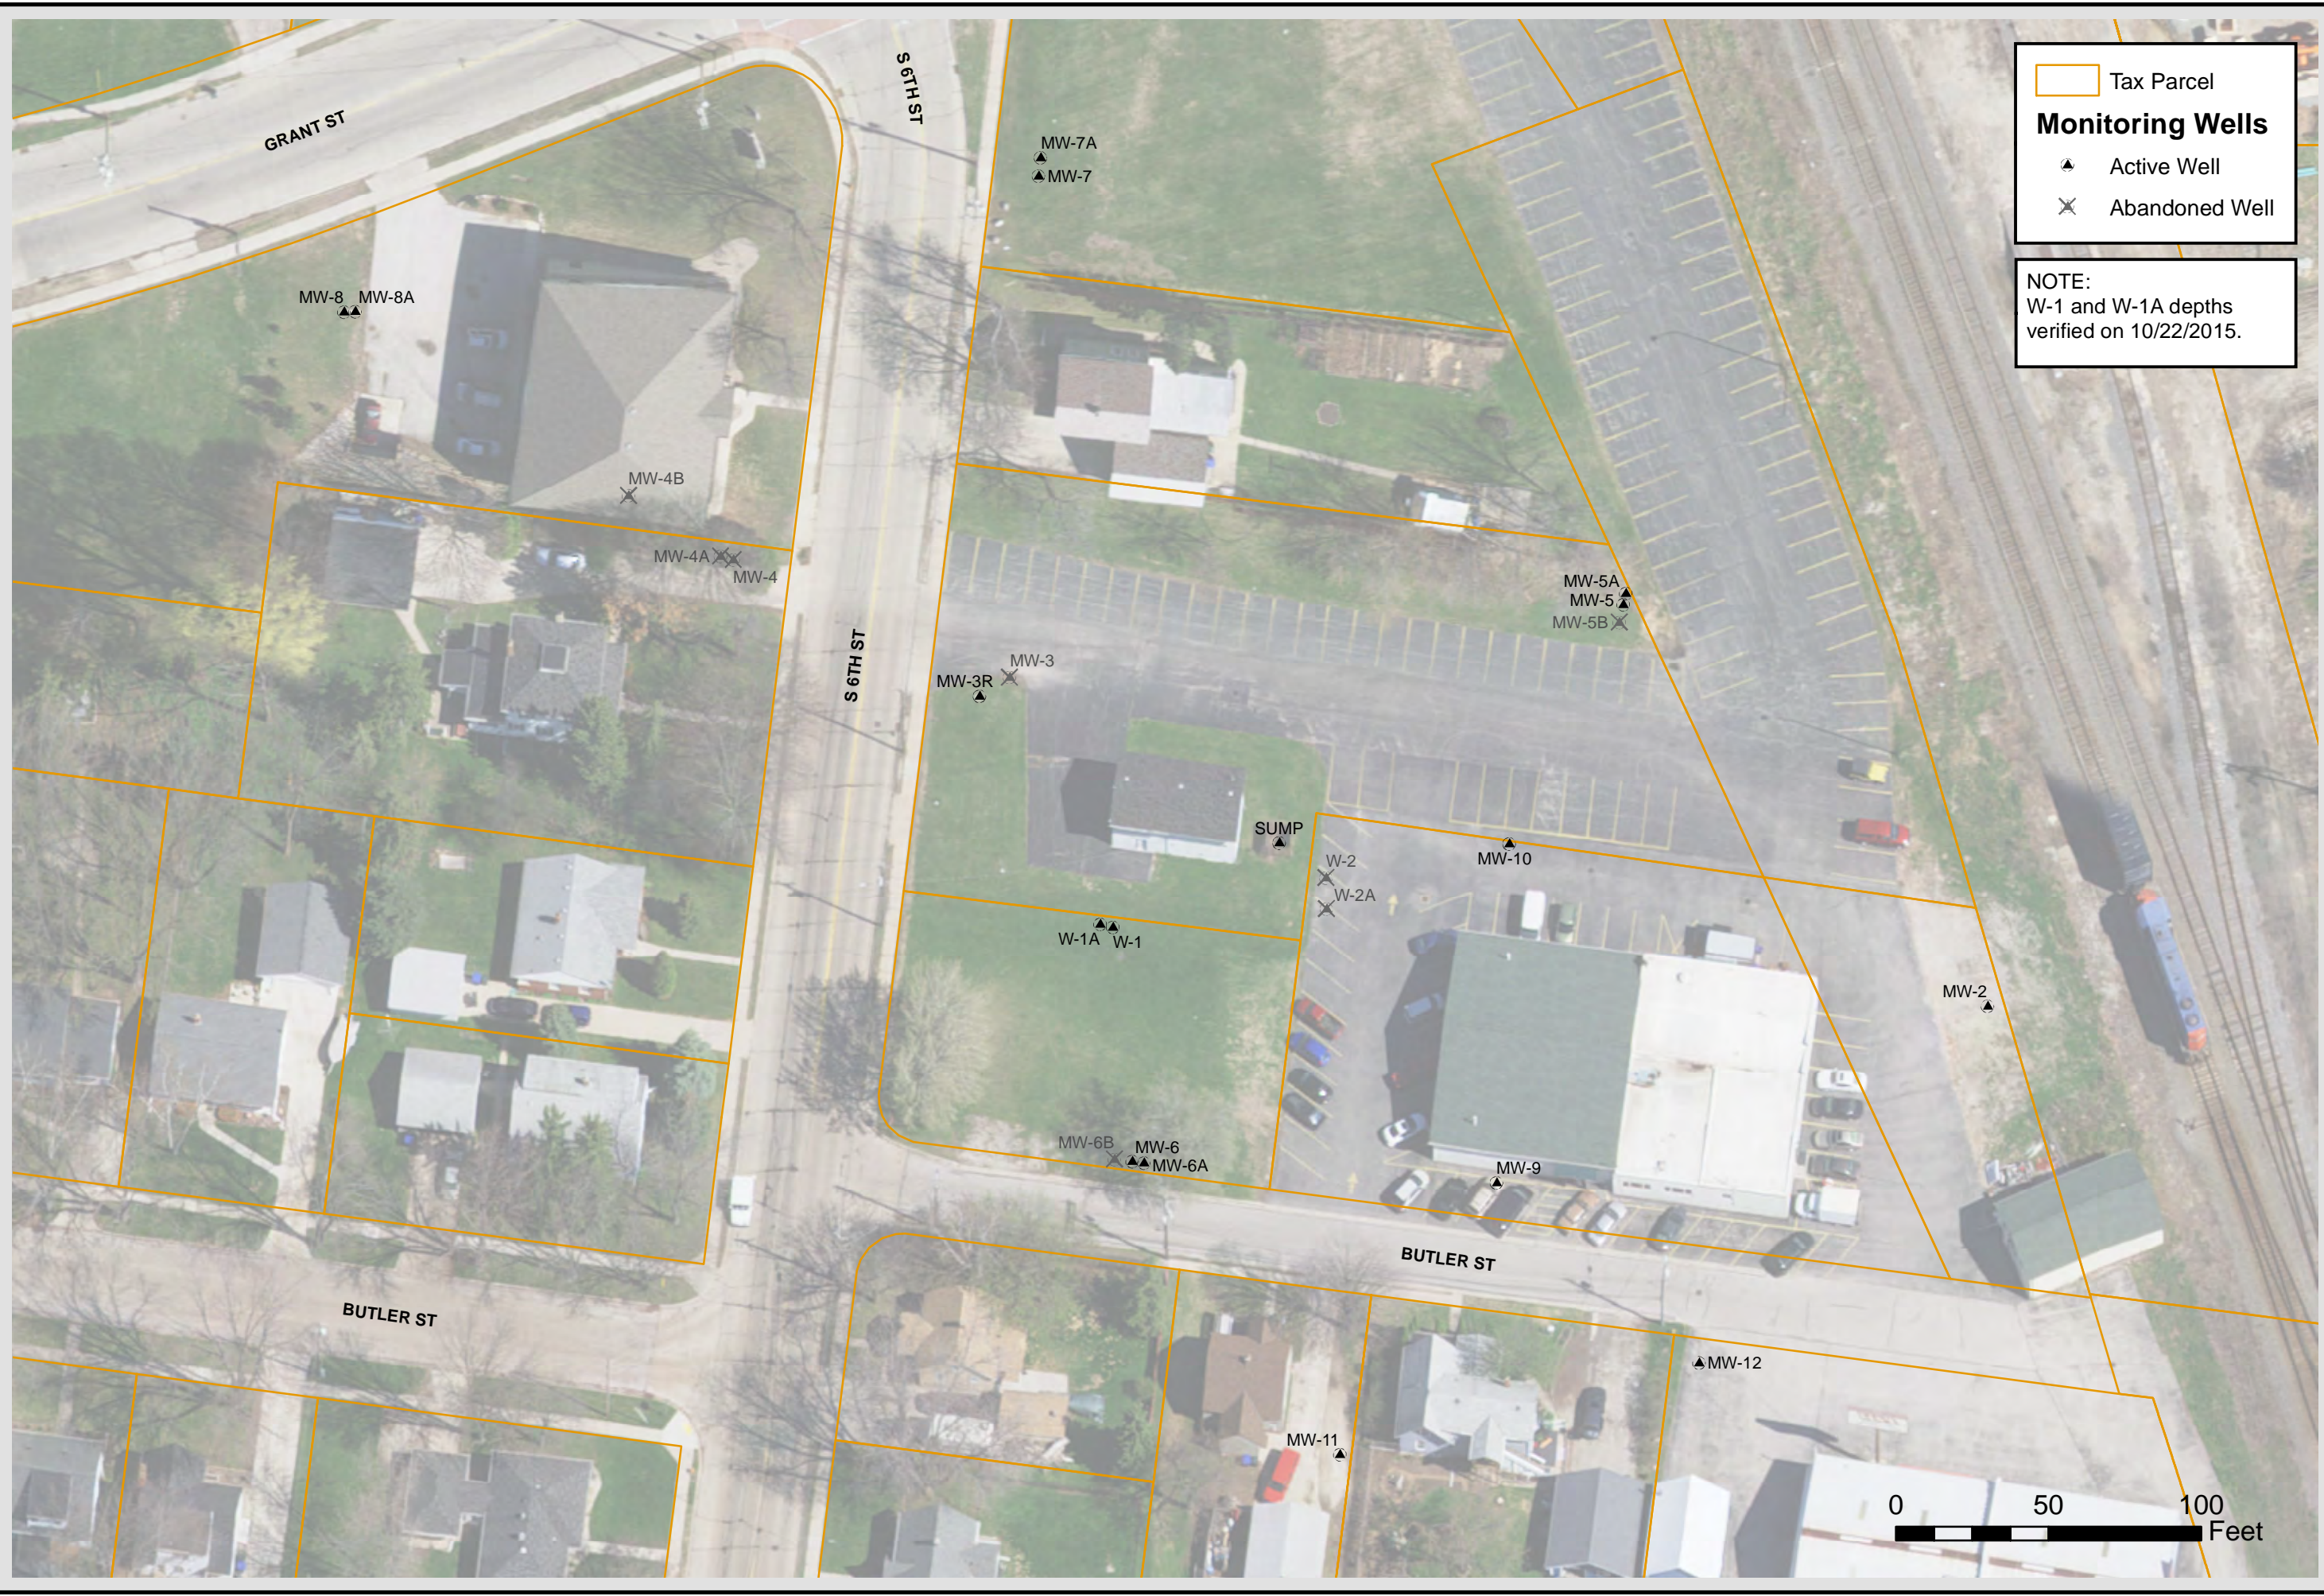
Tax Parcel  
**Monitoring Wells**  
 Active Well  
 Abandoned Well

**NOTE:**  
 W-1 and W-1A depths  
 verified on 10/22/2015.
