Date: December 2, 2014
To: Frank Dombrowski, We Energies
From: Chris Robb and Brian Hennings
Subject: Assessment of Fox River Canal Dewatering and Potential for DNAPL Mobilization
We Energies Appleton Former MGP Site

Assessment of MGP Residual and DNAPL Mobility

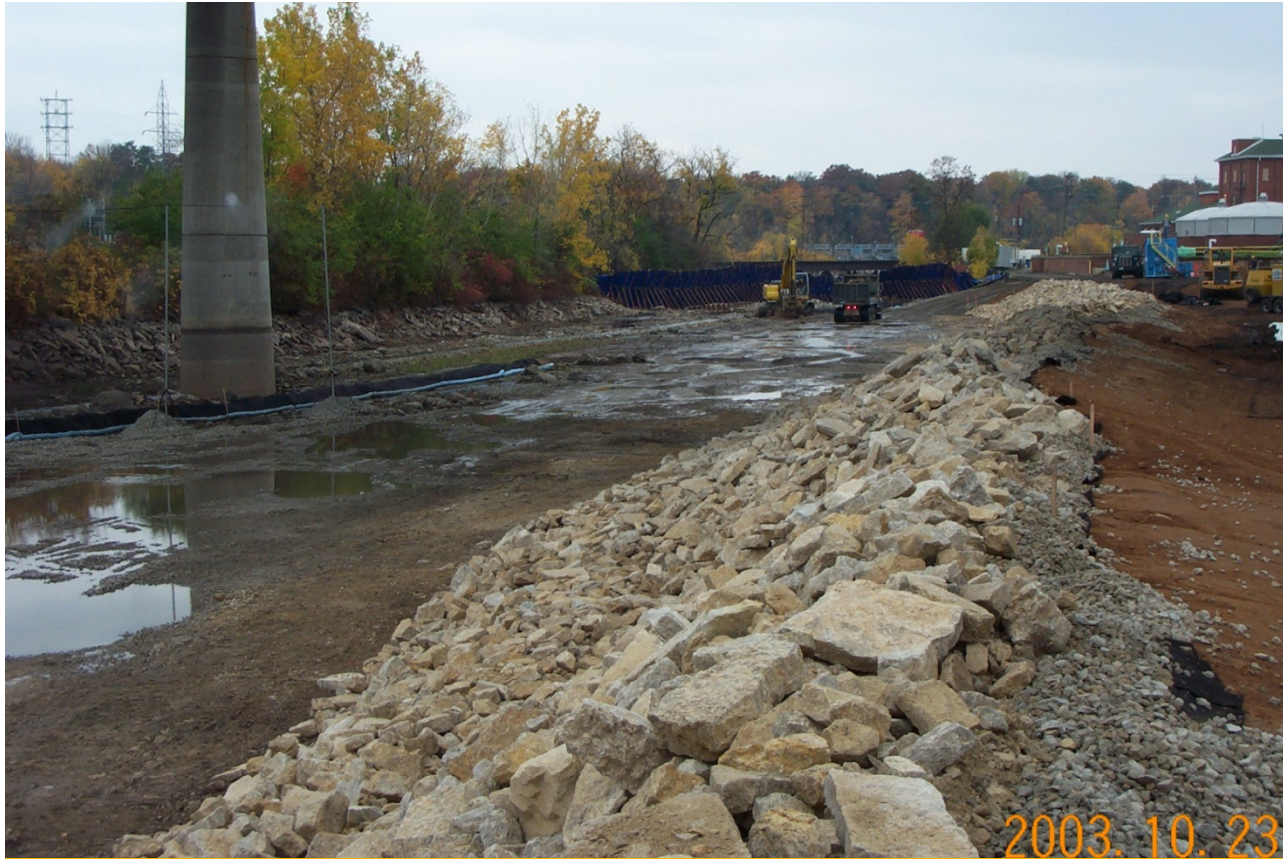
Photo Number: 3

Description: Restoration of Fox River Canal; near completion of stone placement along canal bottom

- The excavated canal substrate was replaced with 3-inch crushed, washed stone to the original canal bottom grades (Photo 3, Attachment A).
- Prior to 2002 and since completion of the Fox River Canal remedial action in 2003, We Energies has not observed sheen, ebullition mobilizing MGP residuals, or free phase residuals appearing on the water surface within the canal.

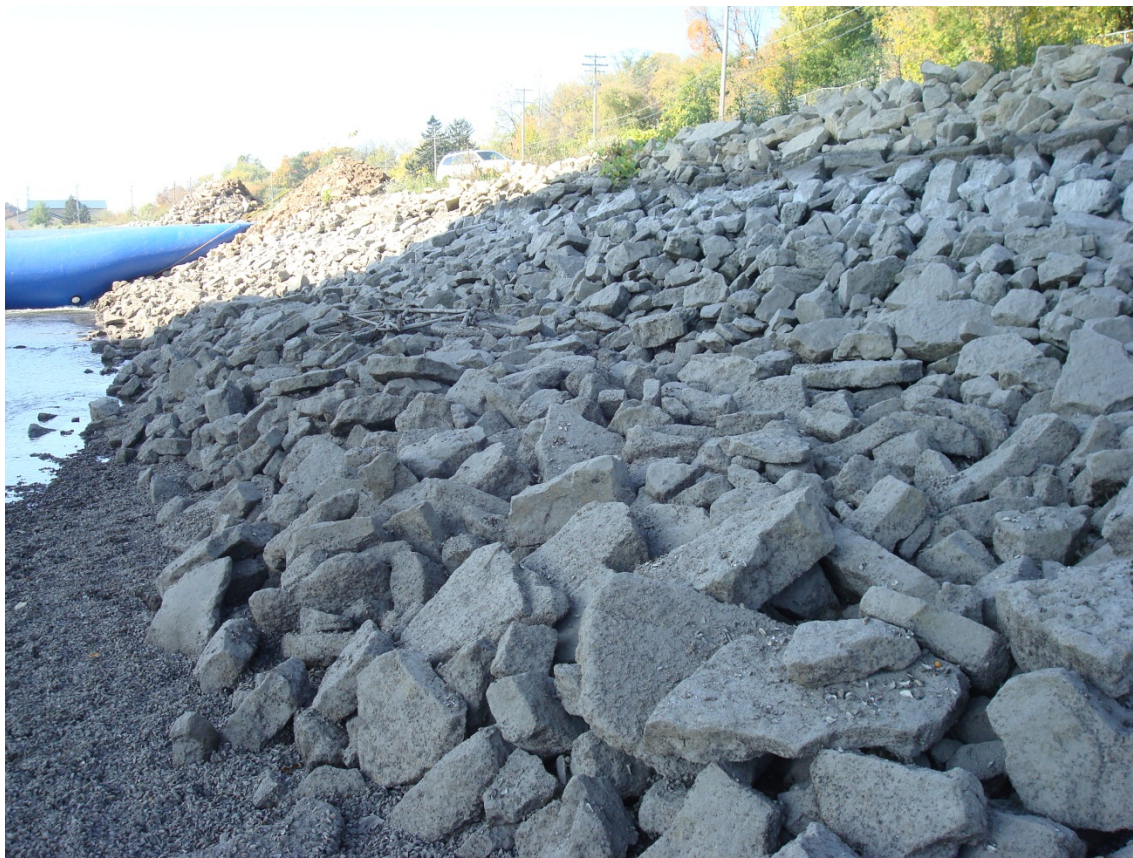
Photo Number: 6

Description: Riverbank inspection adjacent to former Appleton MGP site

- The riverbank adjacent to the Site is in excellent condition. No evidence of scour, rip rap displacement, rip rap degradation, or river bank failure was observed during the inspection (Photo 6, Attachment A).

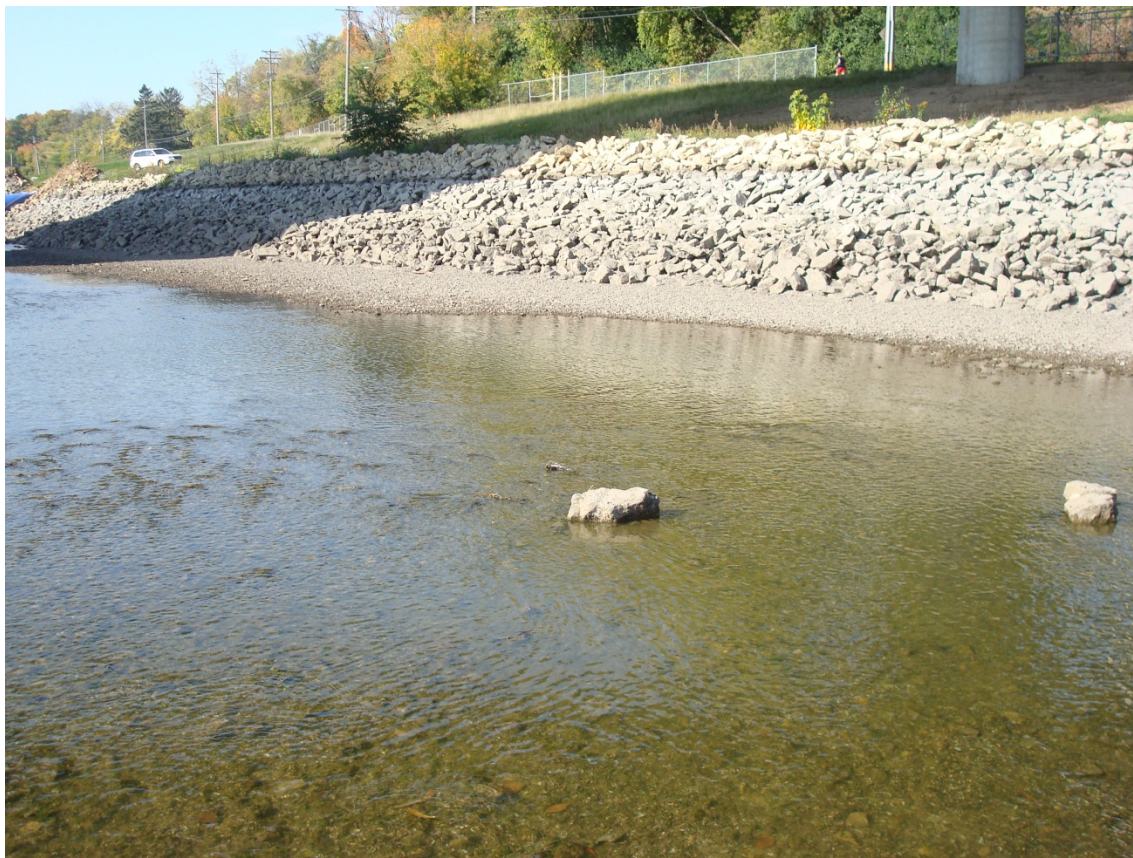
Photo Number: 7

Description: Dewatered canal inspection adjacent to former Appleton MGP site

- No evidence of sheen or MGP residuals was observed along or at the toe of the riverbank.
- Leakage around the temporary dam resulted in water flowing along the canal bottom from 1 to 6 inches in depth (Photo 7, Attachment A).

- No evidence of sheen or MGP residuals were observed on the water surface in the dewatered canal (Photo 7, Attachment A) or upstream of the temporary dam.

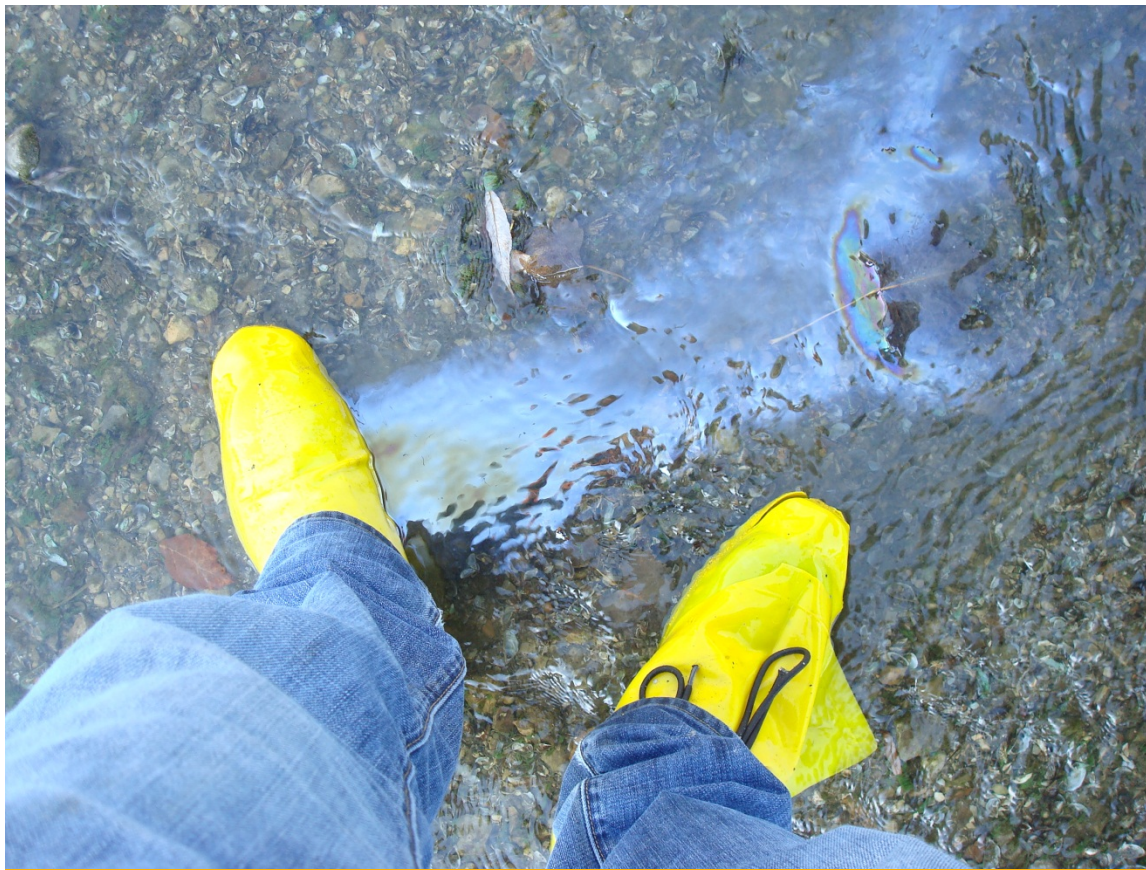
Photo Number: 8

Description: Dewatered canal inspection adjacent to former Appleton MGP site. Sheen observed when canal bottom disturbed.

- Some areas of the dewatered canal bottom exhibited sheen when disturbed or agitated (Photo 8, Attachment A). These areas were adjacent to the riverbank along the former MGP site near MW-21. No free phase MGP residuals were observed.

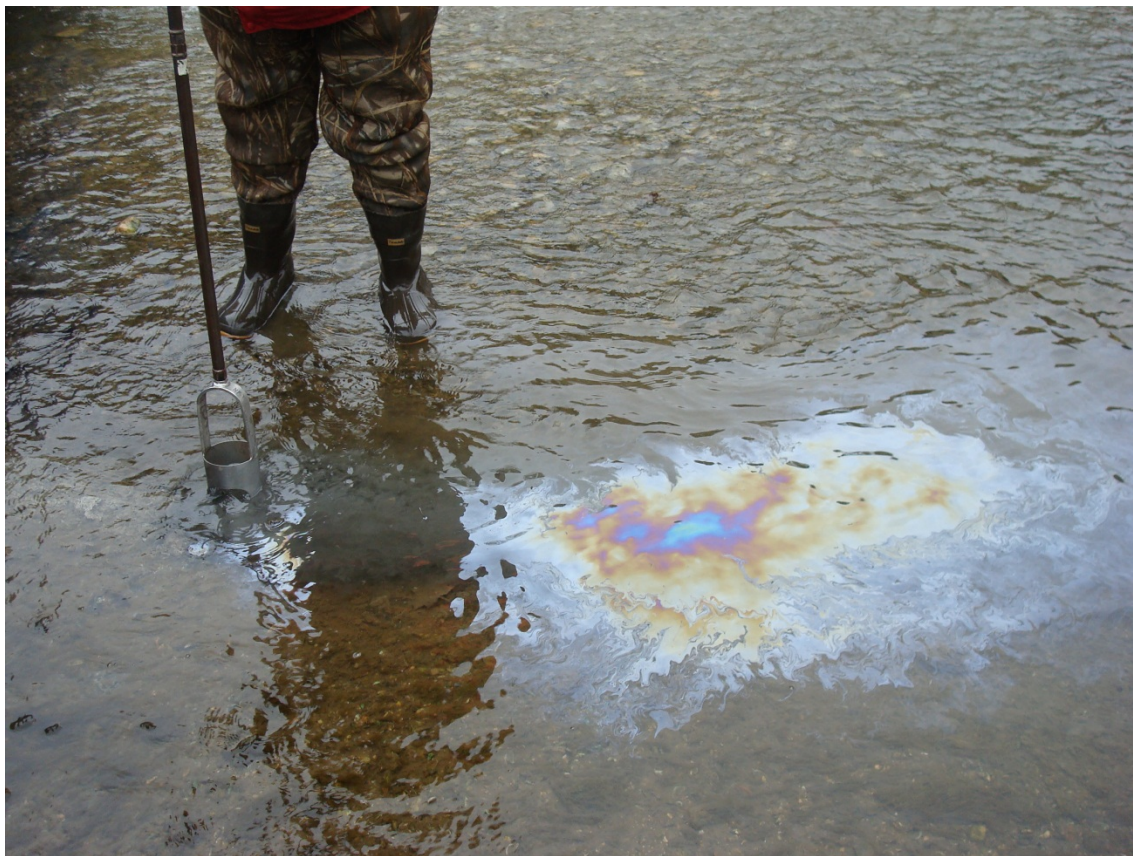
Photo Number: 9

Description: Poling/disturbing canal bottom. Sheen observed when canal bottom disturbed.

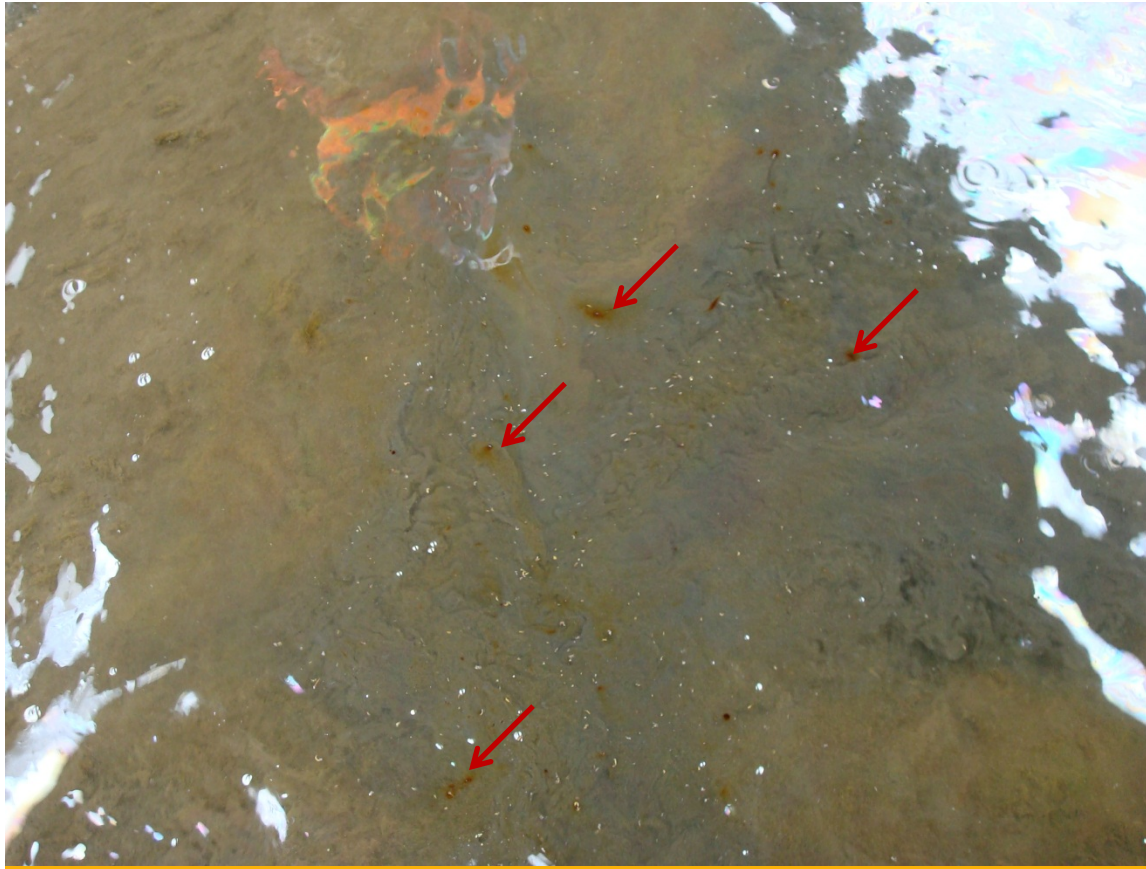
Photo Number: 11

Description: Poling/disturbing canal bottom. Red arrows indicate free phase droplets.

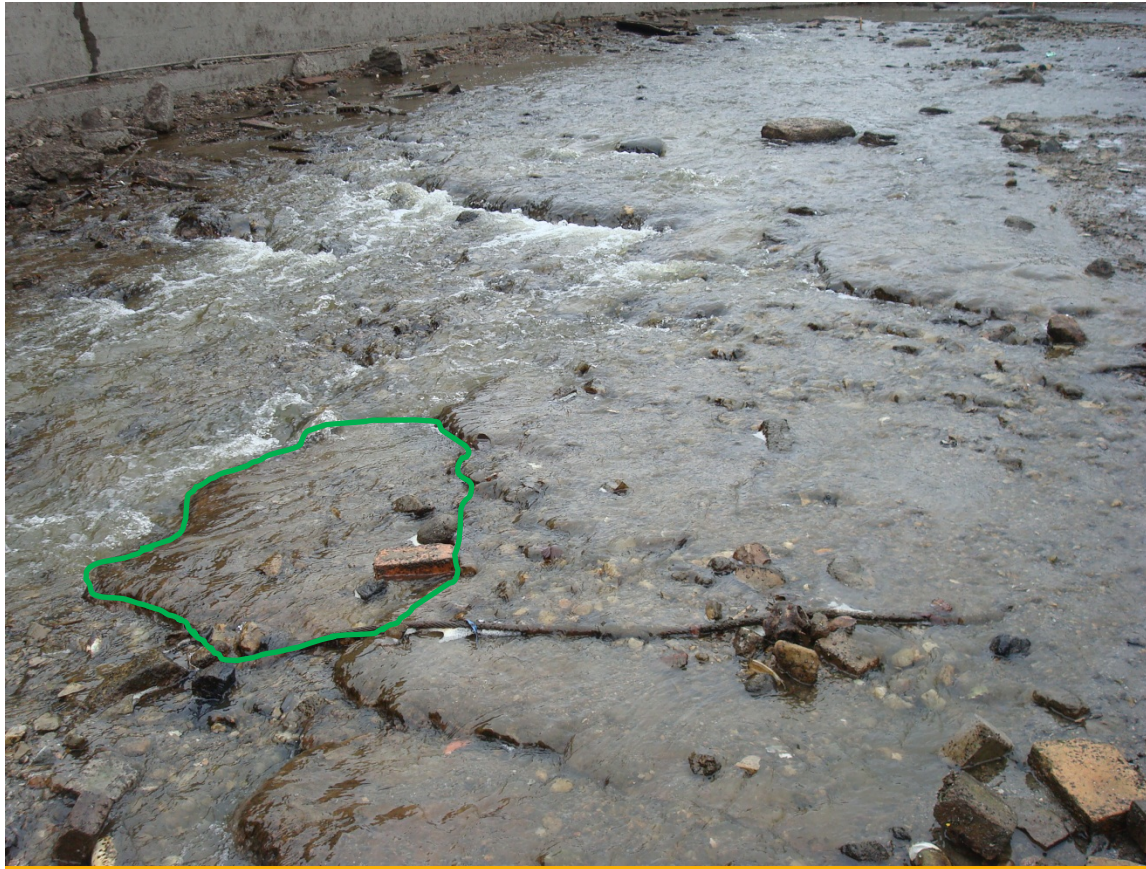
Photo Number: 12

Description: Evidence of upper weathered bedrock ("lower till") at bottom of Fox River Canal. Green line outlines flat plane of upper weathered bedrock. Additional planes of upper weathered bedrock can be observed in photo.

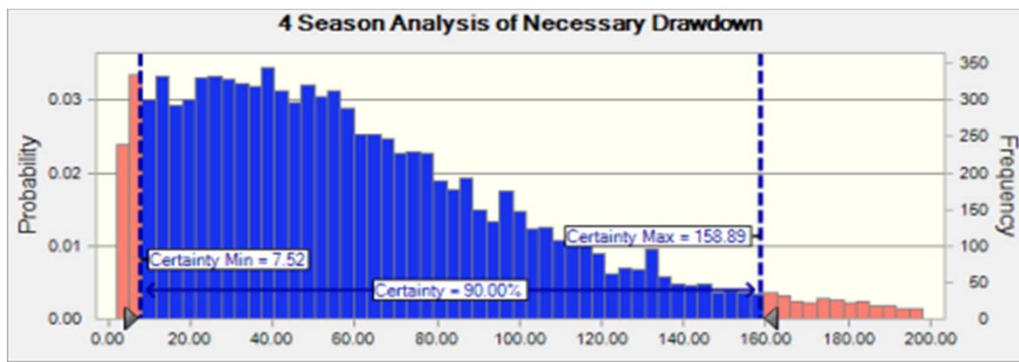
- Certainty level is 90.00%
- Certainty range is from 7.52 to 158.89
- Entire range is from 1.86 to 353.66
- Base case is 2.29
- After 10,000 trials, the std. error of the mean is 0.48

Statistics:	Forecast values
Trials	10,000
Base Case	2.29
Mean	63.66
Median	53.21
Mode	---
Standard Deviation	48.07
Variance	2310.59
Skewness	1.35
Kurtosis	5.29
Coeff. of Variability	0.7551
Minimum	1.86
Maximum	353.66
Range Width	351.80
Mean Std. Error	0.48

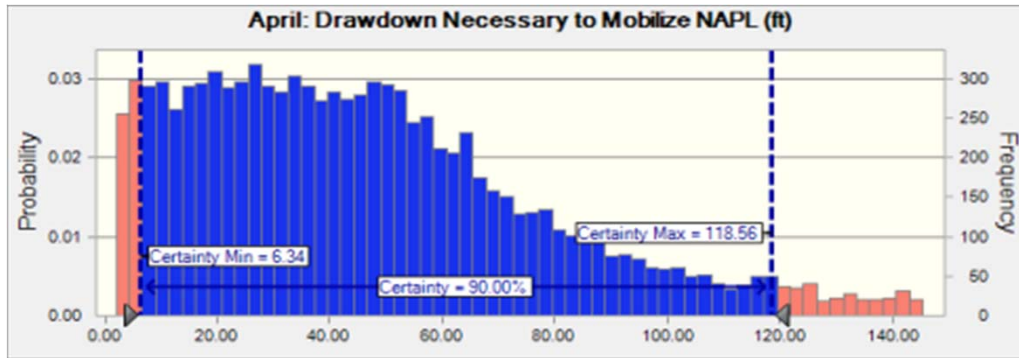
Certainty level is 90.00%
 Certainty range is from 6.34 to 118.56
 Entire range is from 2.04 to 233.79
 Base case is 2.70
 After 10,000 trials, the std. error of the mean is 0.35

Statistics:	Forecast values
Trials	10,000
Base Case	2.70
Mean	48.73
Median	42.57
Mode	---
Standard Deviation	34.56
Variance	1194.47
Skewness	1.15
Kurtosis	4.43
Coeff. of Variability	0.7092
Minimum	2.04
Maximum	233.79
Range Width	231.74
Mean Std. Error	0.35
