TECHNICAL MEMORANDUM

Date: May 31, 2016
To: Frank Dombrowski
From: Brian Hennings and Nate Keller
Subject: May 2016 Technical Memorandum
Results of High Purge Volume Vapor Sampling and Site Reconnaissance

MAY 2016 TECHNICAL MEMORANDUM
FORMER APPLETON MANUFACTURED GAS PLANT (MGP) FACILITY
WE ENERGIES
APPLETON, WISCONSIN

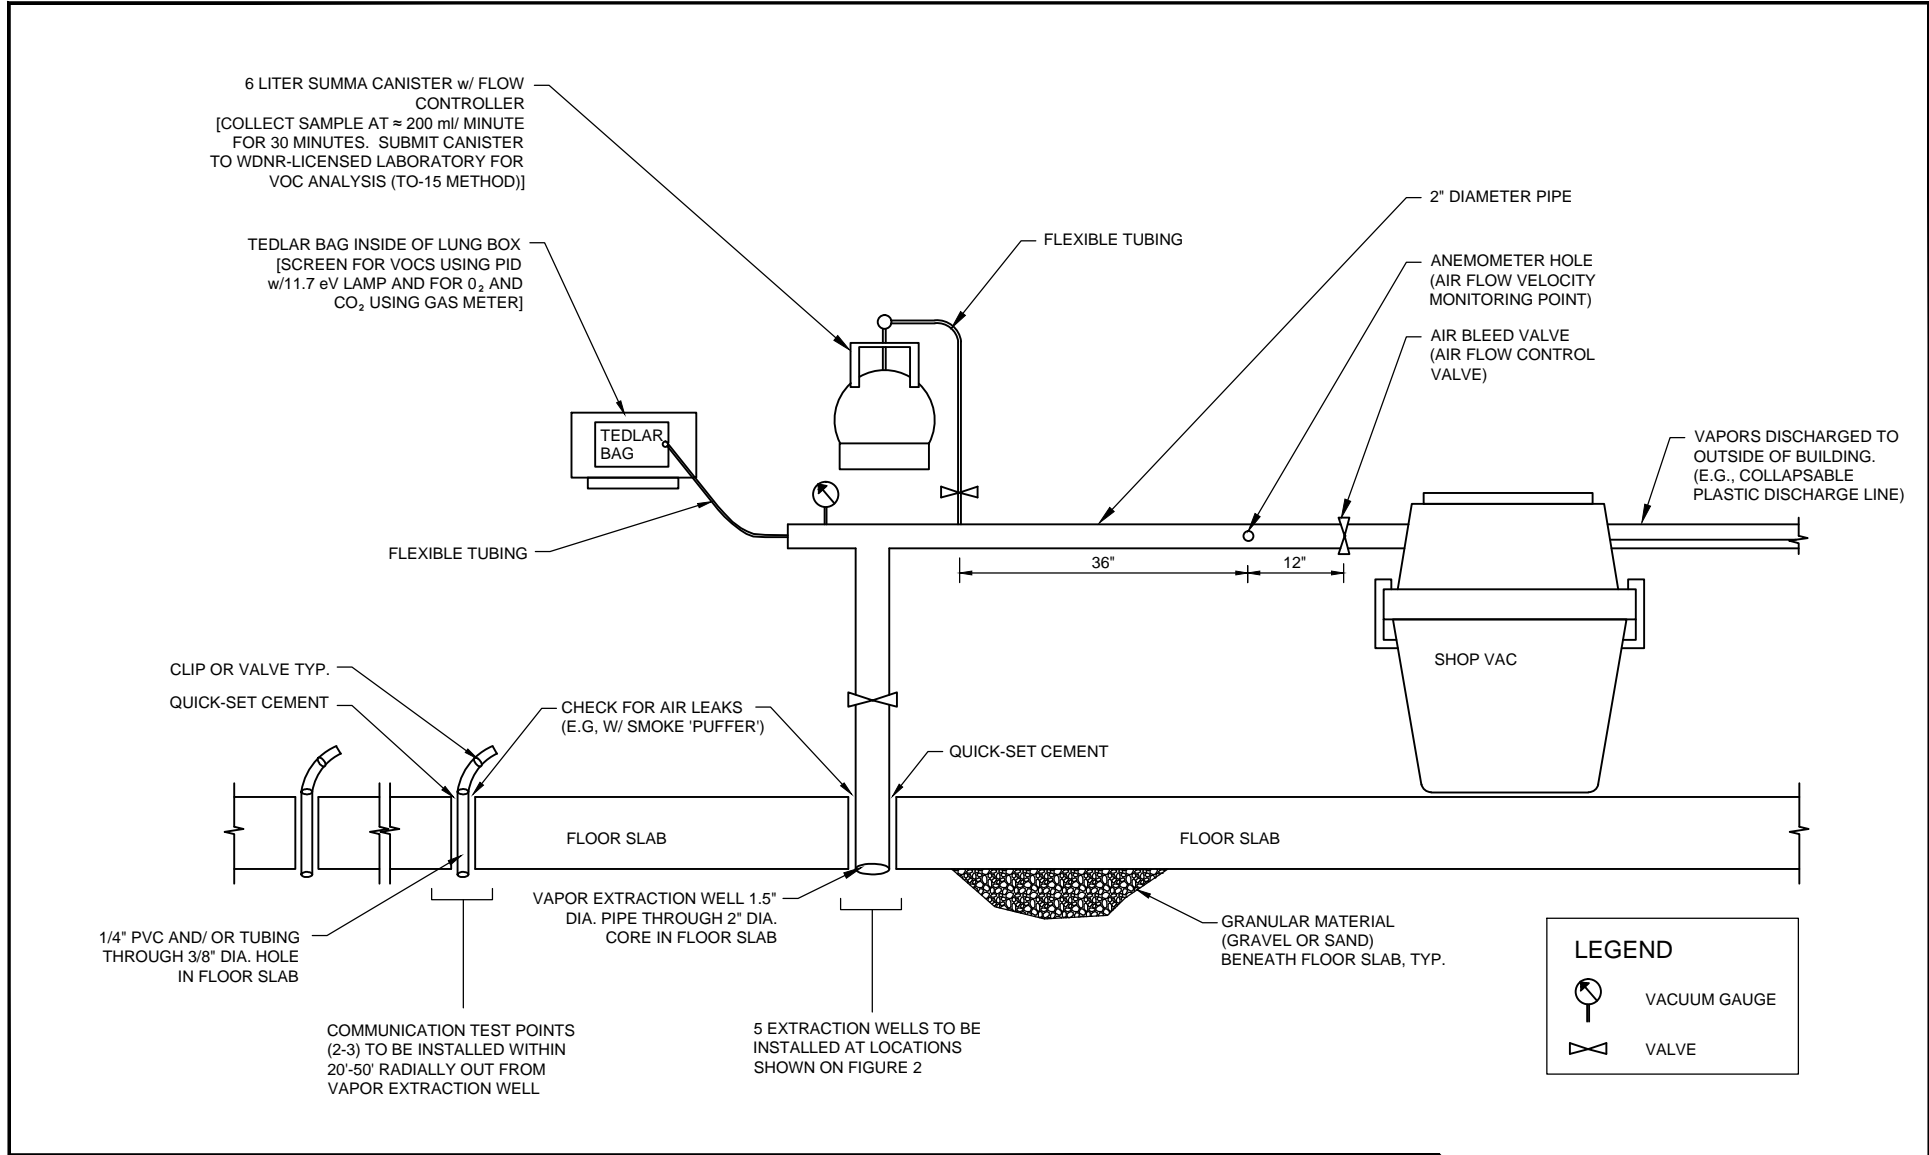
FIGURE NO.
 Figure 2

High purge sampling was completed at location SS-1 and SS-5 to evaluate sub-slab soil gas beneath the parking garage and adjacent occupied spaces (Figure 1). A schematic of the equipment set up for high purge volume sampling is included in Figure 2. Samples were collected using the procedures proposed in the December 2015 Technical Memorandum as follows:

HIGH PURGE VOLUME SUB-SLAB VAPOR SAMPLING SCHEMATIC

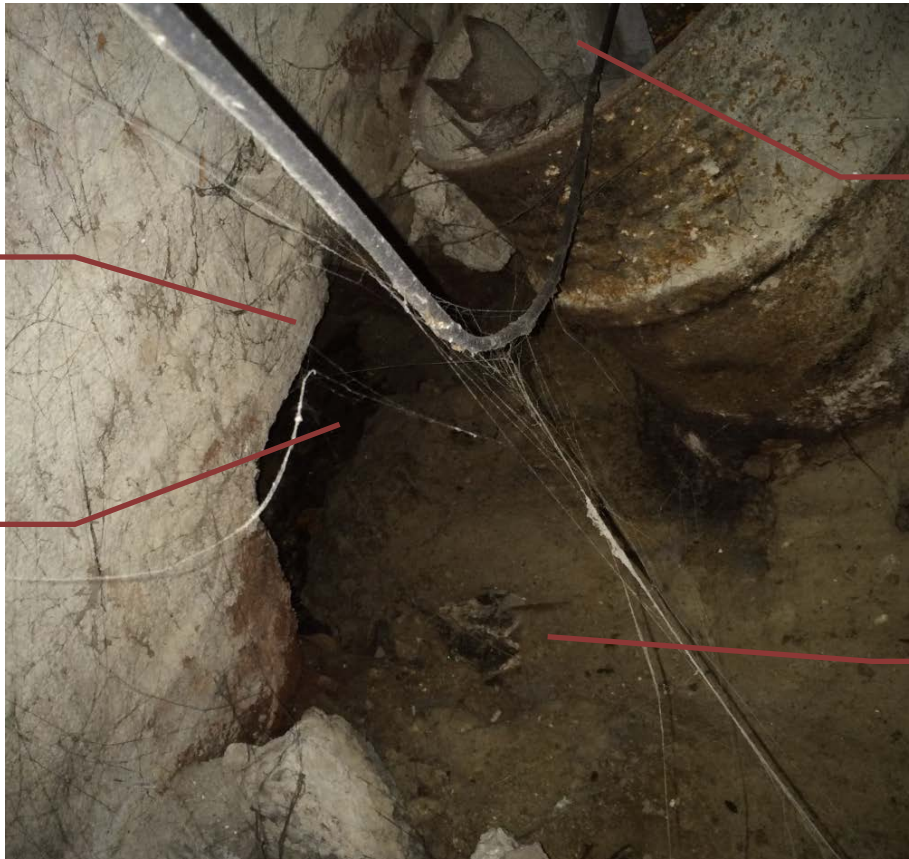
Photo Number: 1

- The archway through the east wall of the boiler room encountered during the September 2015 site visit (Photo Log, Photo 1) was visually inspected and it was determined that a large crawlspace was located on the other side of the wall. The crawlspace extends to the north and east below the occupied space east of the boiler room (Photo Log, Photo 2). The crawlspace construction was very similar to the crawlspace present beneath the boiler room and garage floor (Photo Log, Photo 3). The PID meter did not indicate any measureable concentrations of VOCs from the crawlspace and there was movement of air from the crawlspace beneath the occupied areas toward the boiler room crawlspace. The limits of the crawlspace below the occupied space could not be measured, but it appeared to be present below most of the footprint of the occupied space (Figure 1). Oxygen levels recorded by the four-gas meter were safely and consistently above 19%.

Archway with opening to the east

Water moving to the east is not visible in photo

Open drum containing debris

Ground is covered in debris but dry

Description: Photo of archway through the east wall of the boiler room, originally provided as Photo 7 of the December 2015 VI Tech Memo

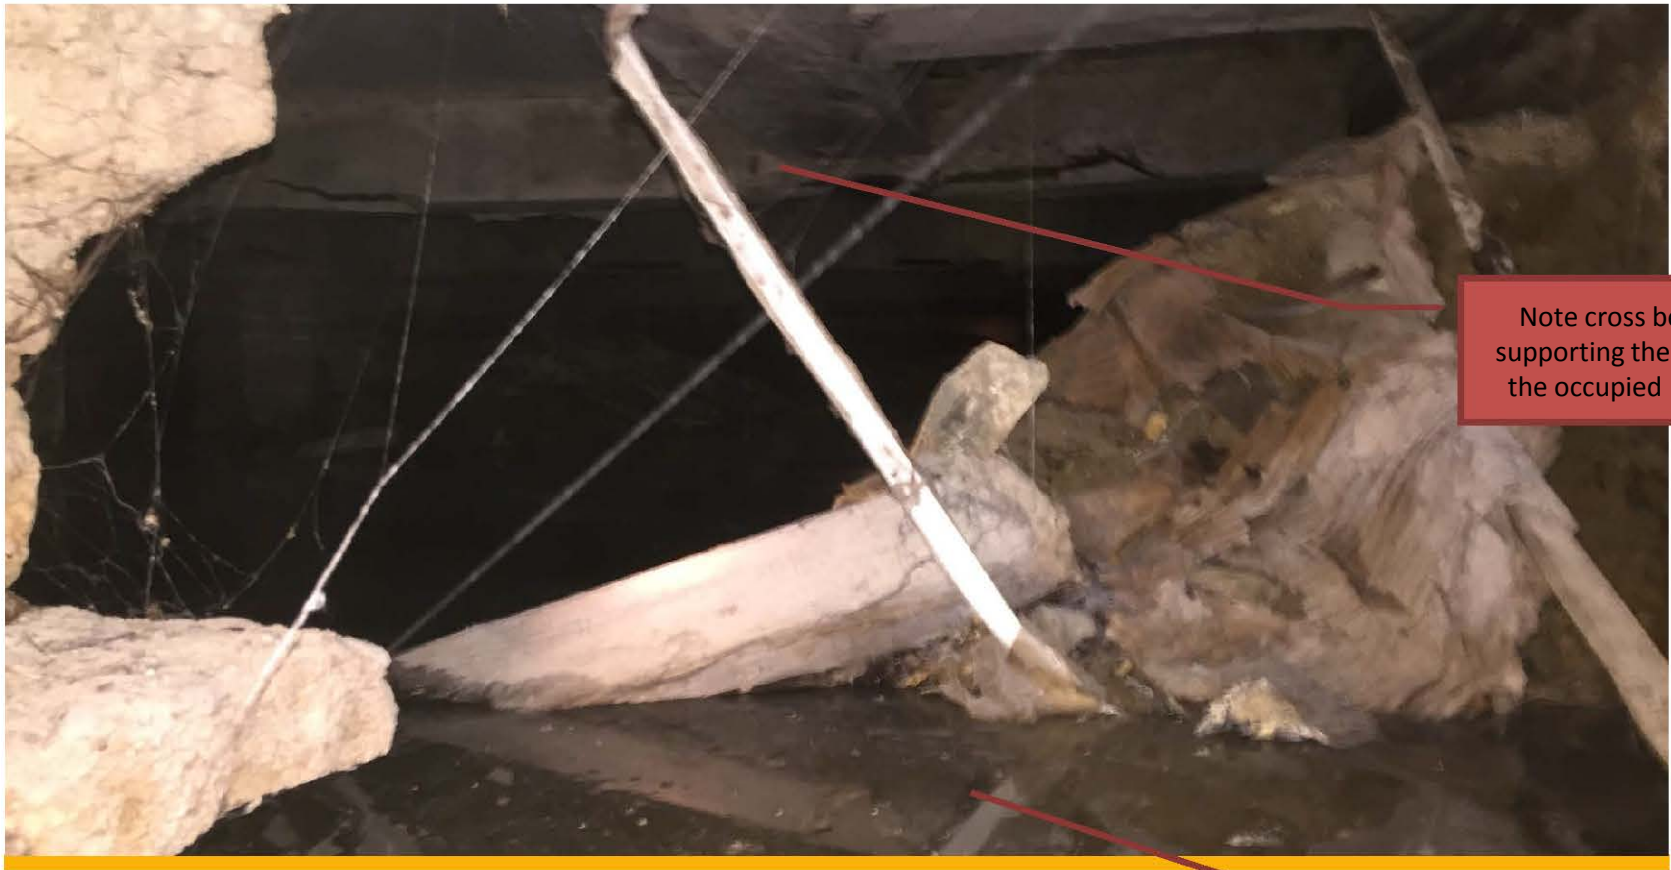
- The water level in the crawlspace was notably higher than the water level observed during the previous inspection conducted in September, 2015. The depth to water from the bottom of the garage floor had decreased from 4-feet to 3.15-feet (water level rose approximately 0.8-feet). Surface water elevations above the hydroelectric unit measured at SG-3 also rose 0.7-feet between site visits increasing from 720.94 to 721.64 feet. Surface water elevations downstream of the hydroelectric unit measured at SG-4 rose 2.77 feet from 709.06 to 711.83 feet. These observations are consistent with those presented in the December 2015 tech memo that indicated the building is constructed with drains that route groundwater upstream of the hydroelectric unit beneath the garage floor and discharges it in the tail water of the hydroelectric unit.

Note cross beams supporting the slab of the occupied space

Note standing water rather than a trickle

Photo Number: 2
Date of Photo: March 2016
Description: Photo looking east through the archway (Photo 1) below occupied units east of the boiler room
Creator: BGH

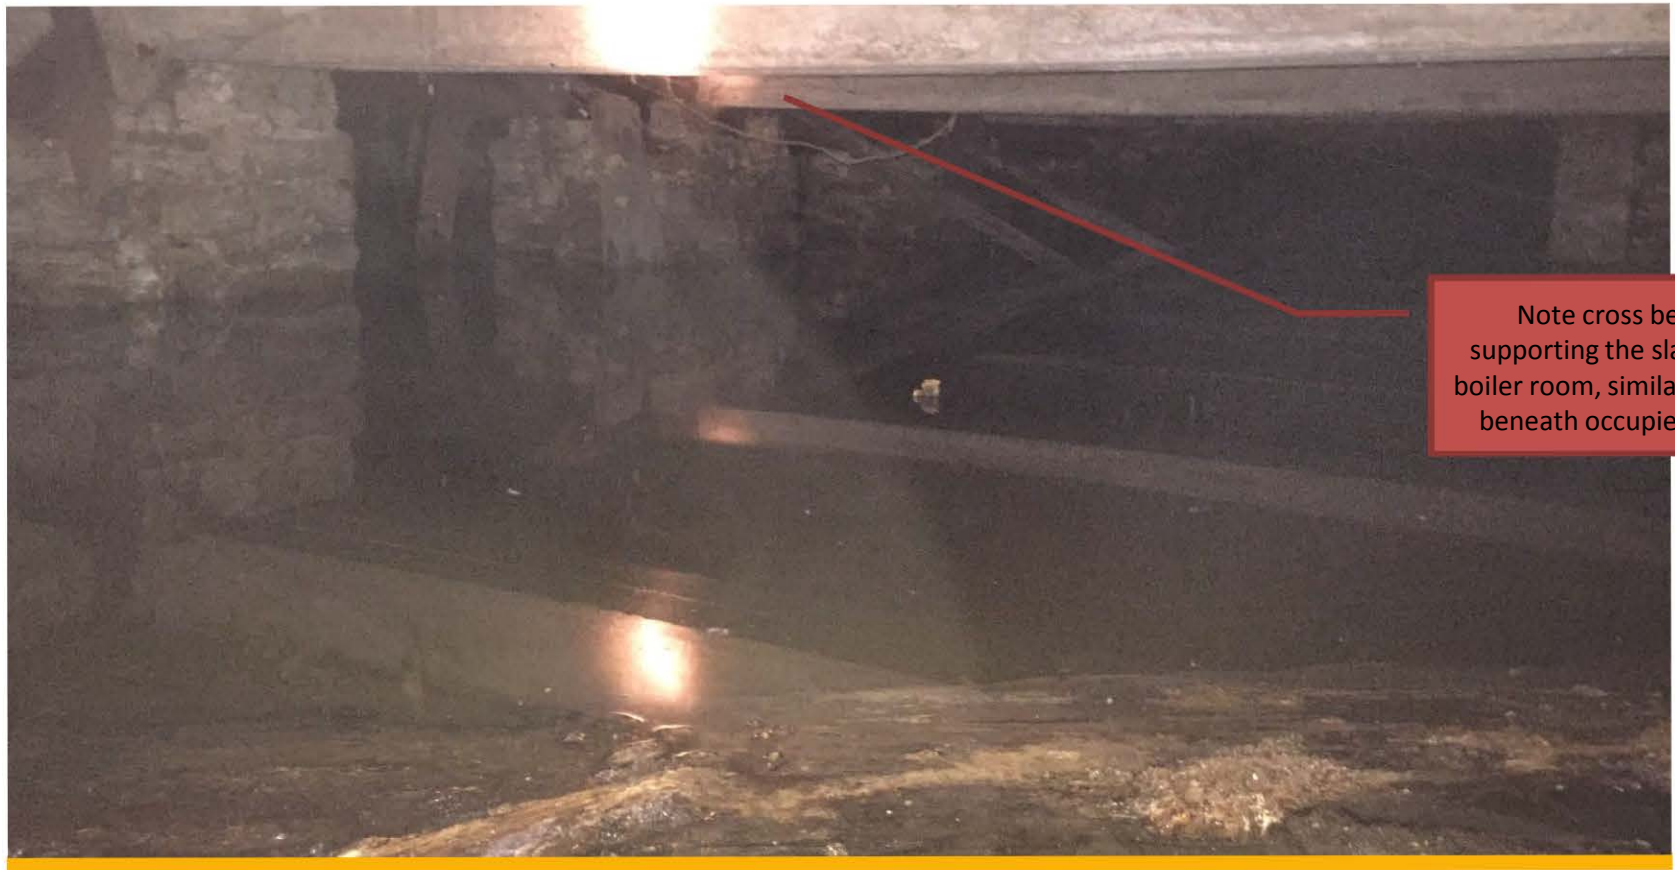
Photo Number: 3

Based on site reconnaissance completed in September 2015 and March 2016, the lowest level of the building is constructed with both floating slabs above air filled crawlspace and slabs over granular backfill. Based on field measurements, the air in the crawlspaces and granular fill contains ample oxygen for degradation of VOCs. In addition, it appears that the air in the crawlspaces is connected with, and mixing with air in the garage and boiler room.

Note cross beams supporting the slab of the boiler room, similar to those beneath occupied space

Description: Photo looking north beneath the boiler room slab and garage floor
