SUBJECT: Request for closure of a 4,000 gallon diesel fuel underground storage tank, former NIKE Battery M-86 Launch area, N84 W220060 Menomonee Avenue, Menomonee Falls, Wisconsin. BRR-ERP FID#268328940.

Reference: Underground Storage Tank Site Assessment/Closure Report
Former NIKE Battery M-86 Launch Area
N84 W22060 Menomonee Avenue
Menomonee Falls, Wisconsin 53051

UST SITE ASSESSMENT/CLOSURE REPORT
 FORMER NIKE BATTERY M-86 LAUNCH AREA
 N84 W22060 MEMONONEE AVENUE
 MEMONONEE FALLS, WISCONSIN

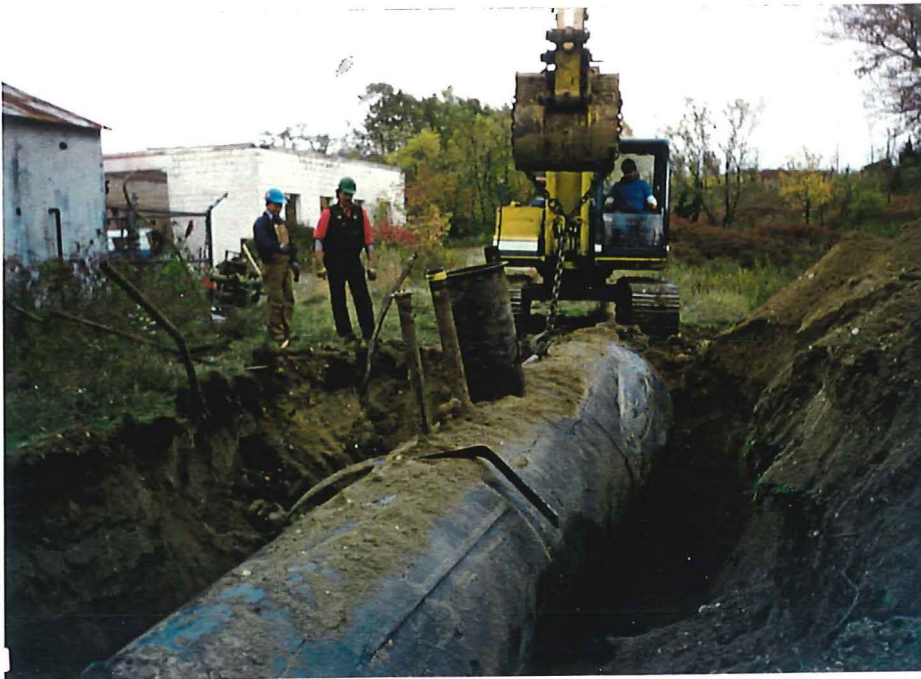
PHOTOGRAPH 1:

Removal of 4,000 gallon diesel fuel UST. Viewing south.

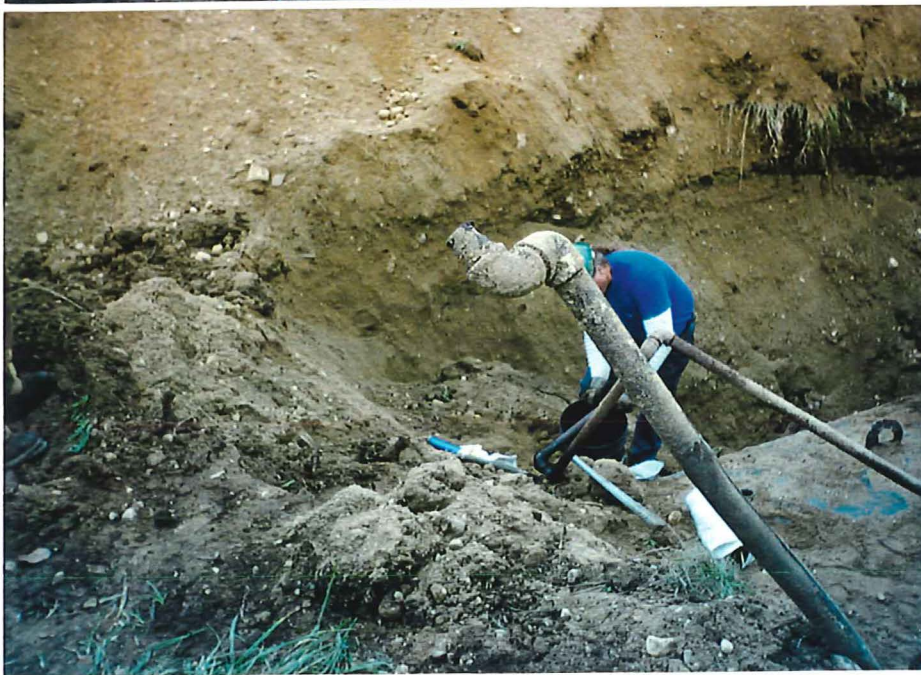
PHOTOGRAPH 2:

Removal of UST pipe line. Viewing northwest.

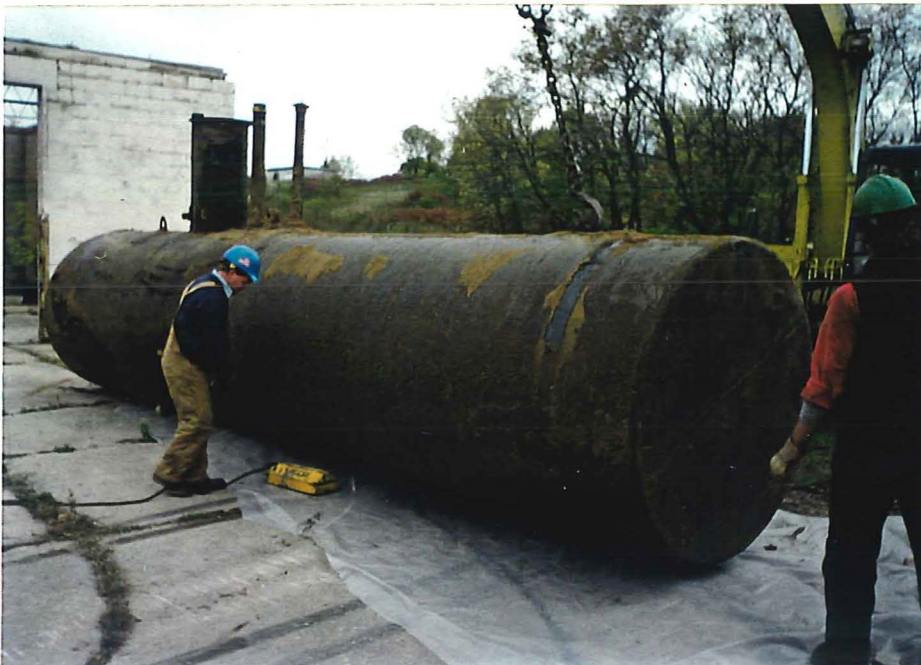
PHOTOGRAPH 3:

A circular hole was cut in the side of the UST for cleaning purposes. The UST was constructed of coated steel with a capacity of 4,000-gallons and contained diesel fuel. The 4,000-gallon UST was 5-feet 3-inches in diameter and 24-feet 4-inches long. No holes or cracks were observed in the UST. After the UST cleaning, the UST was transported to Waukesha Iron & Metal Inc. by EETCO for disposal. Following removal of the UST, the cavity was backfilled with clean backfill material and graded to its previous elevation.

Cleaned 4,000 gallon diesel fuel UST ready for disposal.
