C.M. CHRISTIANSEN CO. INC.
c/o Registered Agent Solutions Inc
PO Box 266
Eaton Rapids, MI 48827
Ground Cover Maintenance Plan

"POLEYARD"
County E
Phelps, WI 54554

DNR BRRTS Case #02-64-000068
FID #76436230

**CM CHRISTIANSEN CO., INC. - Cover Maintenance Plan
Map Showing Deed Restrictions**

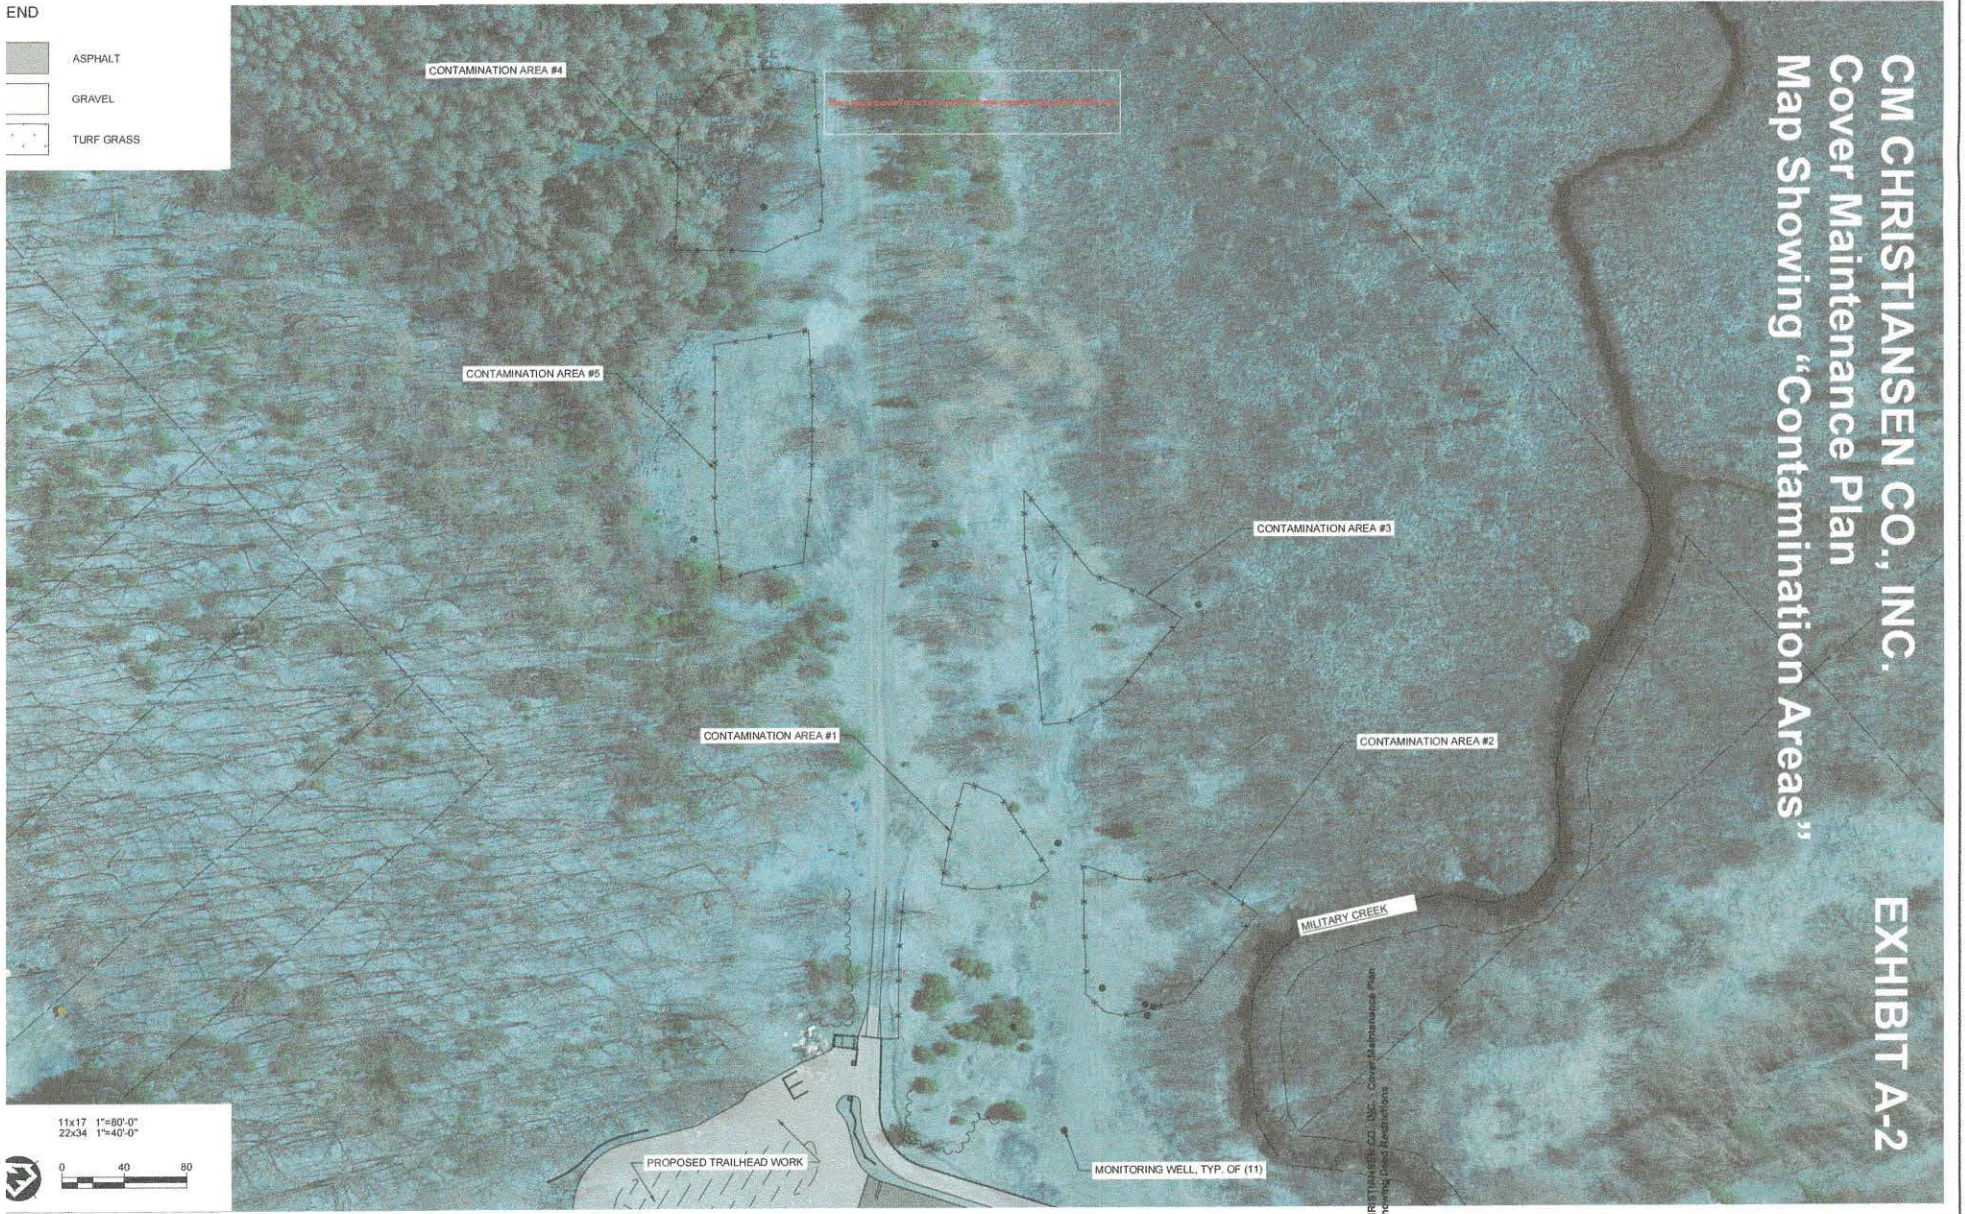
EXHIBIT A-2

CM CHRISTIANSEN CO., INC.
Cover Maintenance Plan
Map Showing "Contamination Areas"

Soil contaminated by #2 fuel oil blended with approximately 5% pentachlorophenol was located in the areas subject to deed restrictions (EXHIBIT A-1), also described as "Contamination Areas" (EXHIBIT A-2), attached to this Plan.

The groundcover barrier consists of a minimum of 6 inches of clean sand and gravel with respect to all areas except "Contamination Area #2" (referring to EXHIBIT A-2), where the groundcover barrier is 6 inches of topsoil beneath a non-woven geo-textile, covered with an additional 6-inch layer of two-inch stone riprap (above the fabric). SEE EXHIBIT B, an excerpt from the Remedial Action Documentation Report for the Former Pole Treatment Facility, dated January 21, 2000 (pages 2-16 and 2-17). In addition, the property owner has fenced the respective "contamination areas" with chain-link fence.

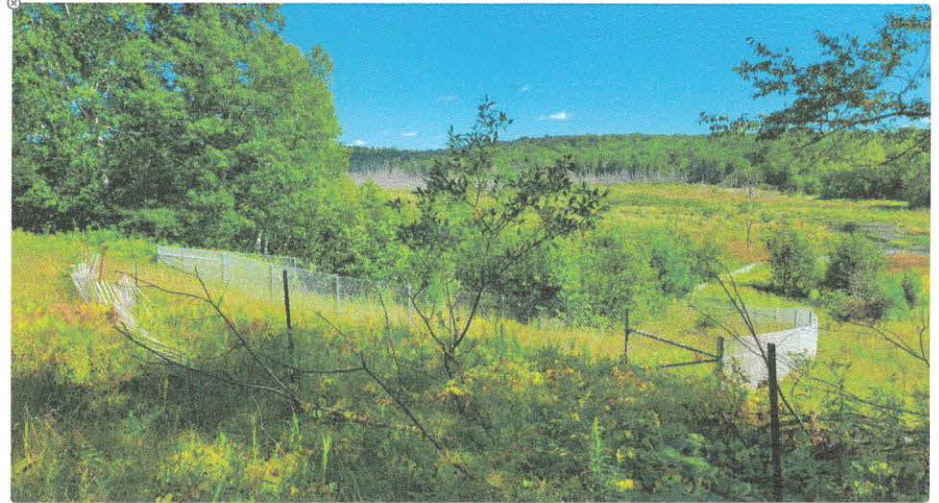
View looking downhill [S] from RR Grade (Snowmobile Trail) towards Creek/Wetland showing Largest Containment Area

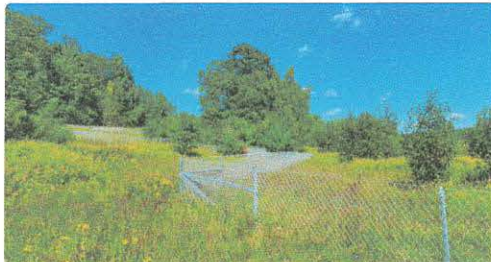
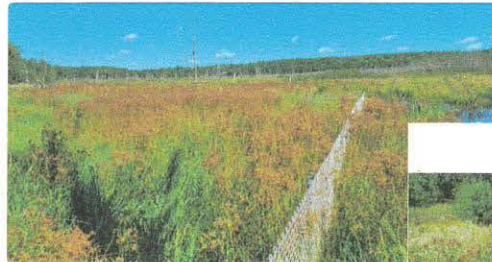
Largest Containment Area, from RR Grade (Snowmobile Trail) at left; Creek on Right (looking E and S). Fence corner is in wetland based on current water level.

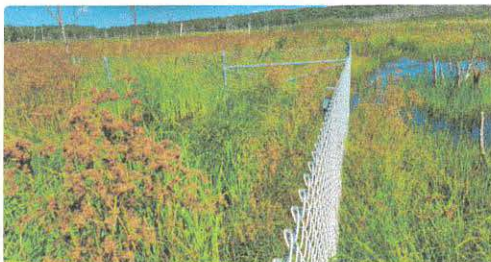
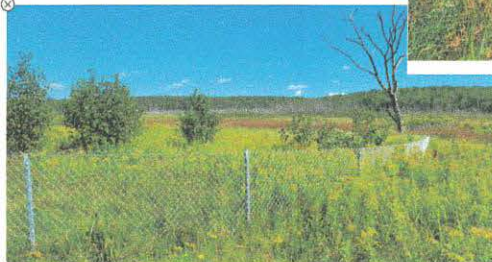
Largest Containment Area looking up towards from RR Grade (Snowmobile Trail) [N]

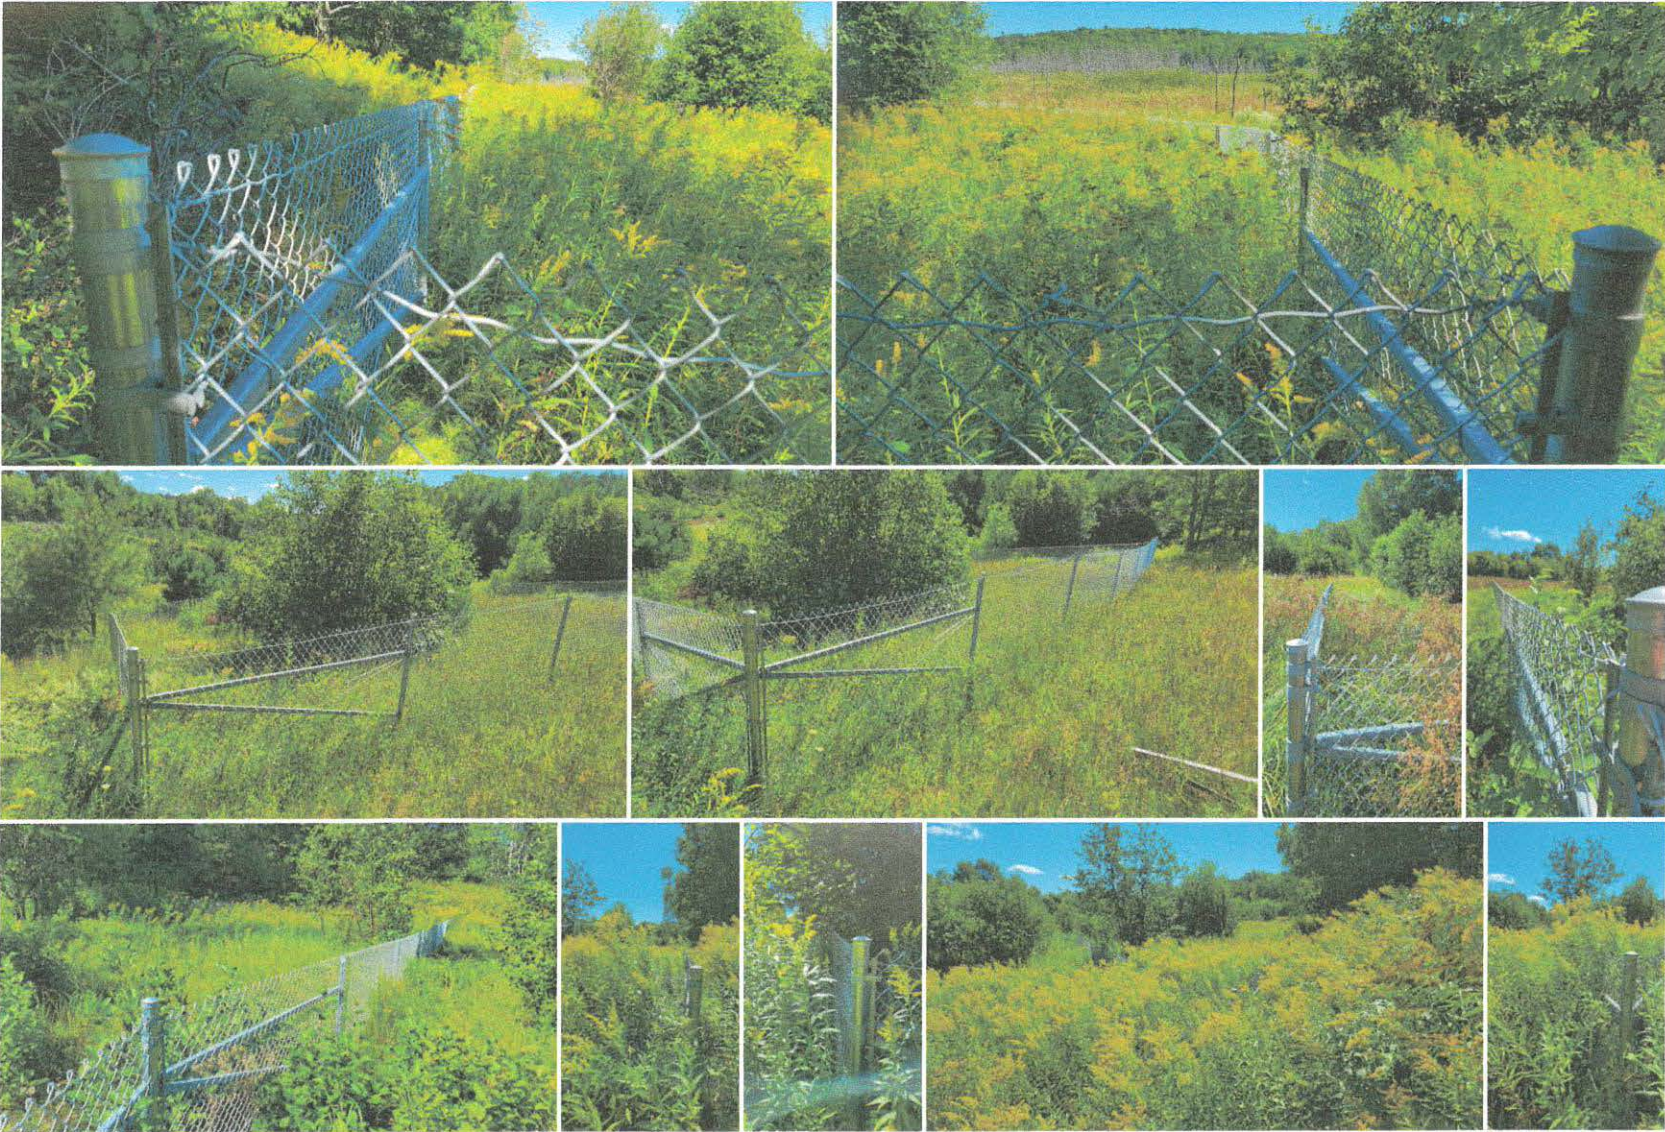
Perimeter of Containment Area to the East of Largest Containment Area
