Source Property Information

CLOSURE DATE: 06/18/2015

J & J CLEANERS - WAUPACA WELL #4

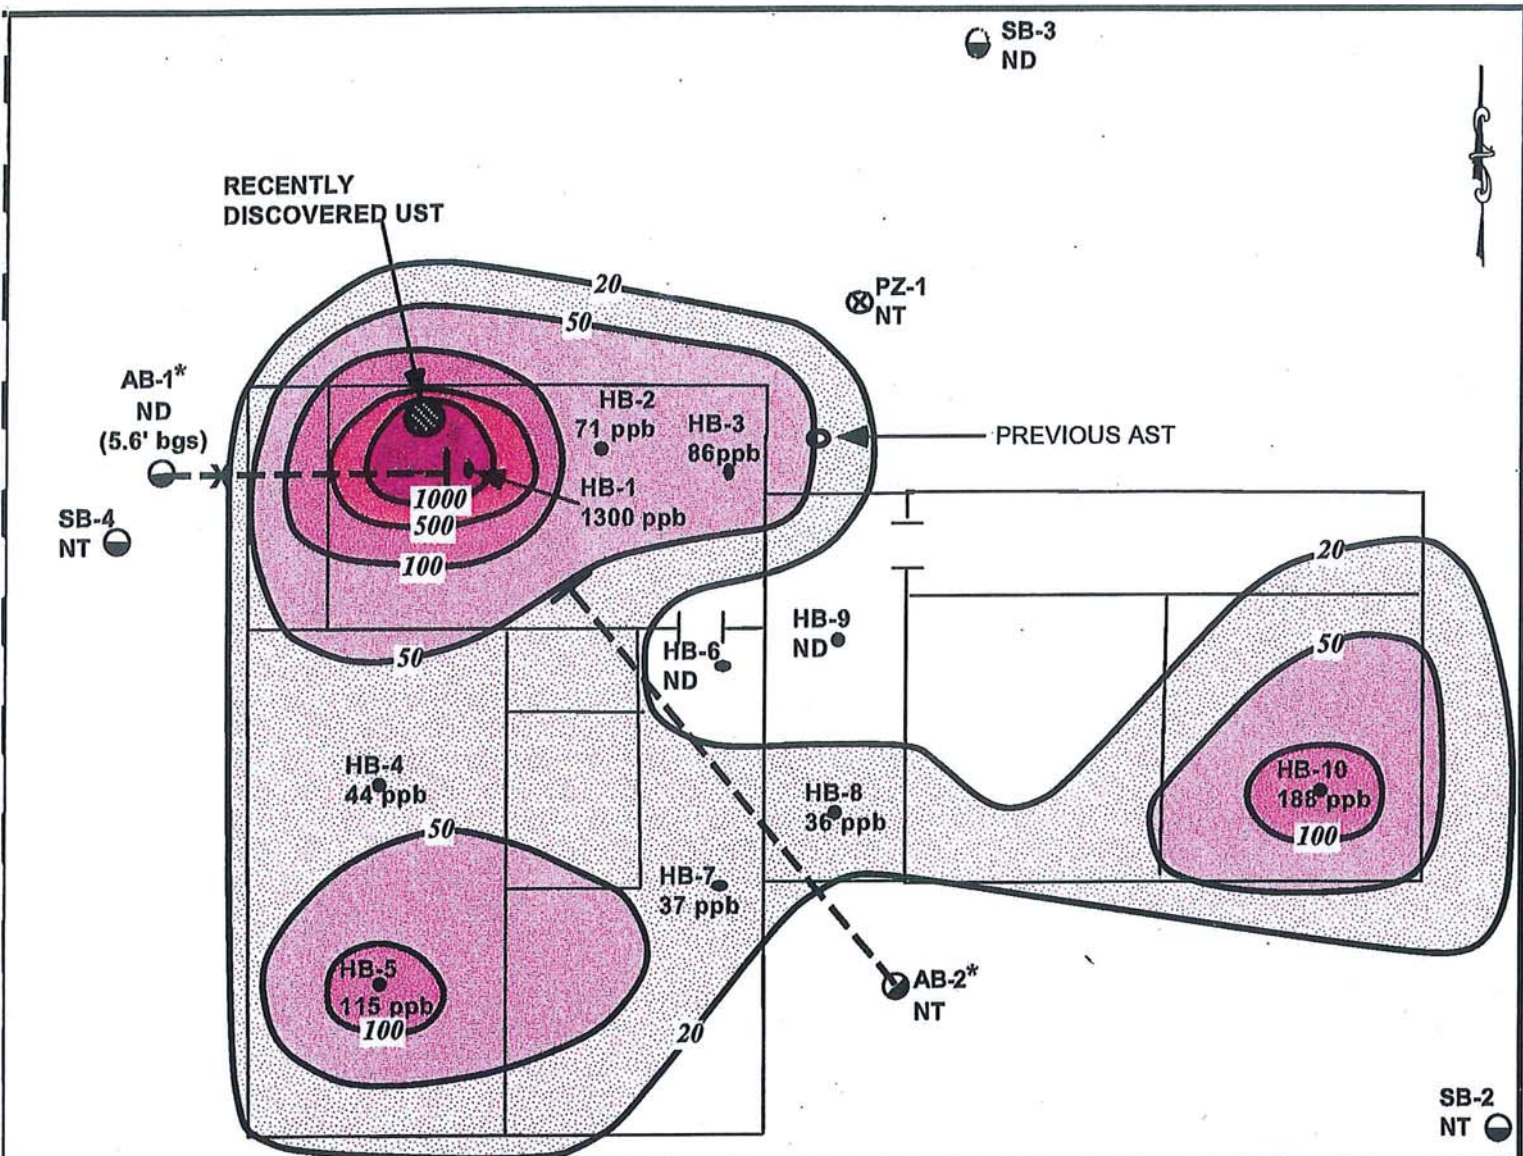
KEY	20	PCE CONTAMINATION CONTOUR (concentrations in parts per billion)	PIEZOMETER
		VERTICAL SOIL BORING	
		ANGLED SOIL BORING SHOWING LOCATION OF END OF BORING ("X" indicates lateral sample location at the depth interval indicated in parenthesis)	NT NOT TESTED
			ND NOT DETECTED
			ppb PARTS PER BILLION
		*NOTE: AB-1 Drilled at 30 degrees from vertical	bgs BELOW GROUND SURFACE
		AB-2 Drilled at 45 degrees from vertical

**PCE CONTAMINATION CONTOURS
AT 3 TO 5 FEET
BELOW GROUND SURFACE**

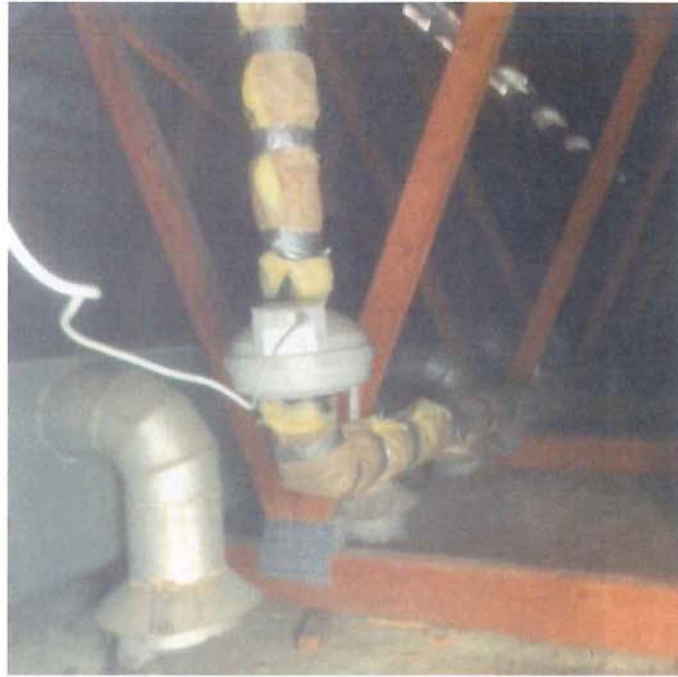
Photo 1: Prowler fan and connecting piping in attic space. System #1, main building.

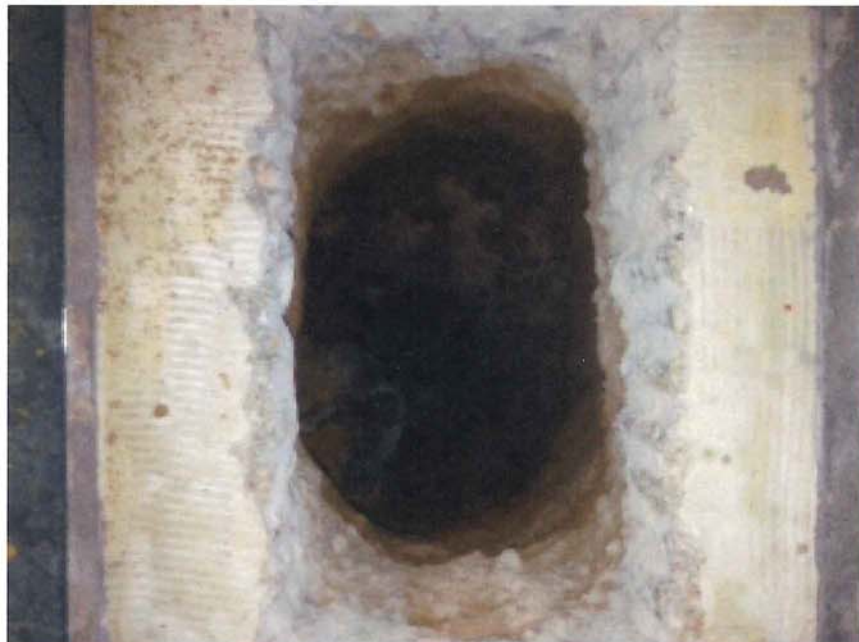
Photo 2: Pickup point #2 in storage unit 1 of main building – boulders at bottom.

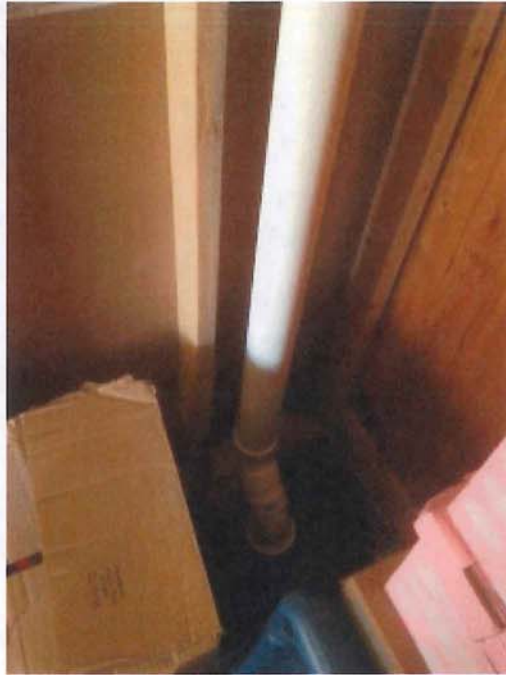
Photo 3: Pickup point #2 in storage unit 1 of main building – boulders at bottom.

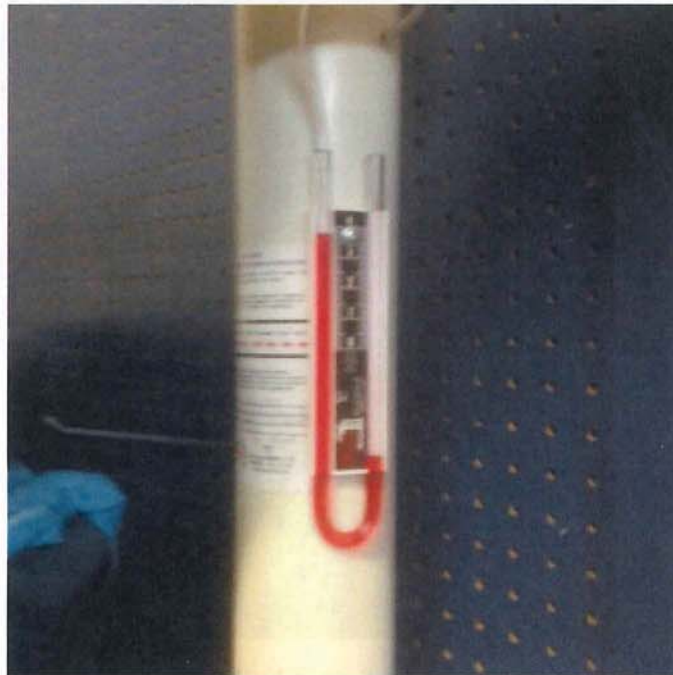
Photo 4: Manometer on system #2, garage.

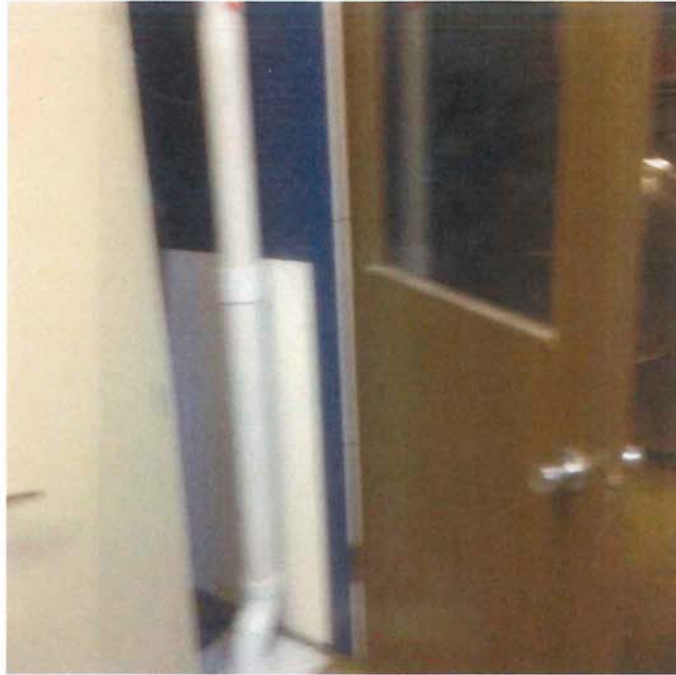
Photo 5: Pickup location in garage – system #2. CT 11/21/14

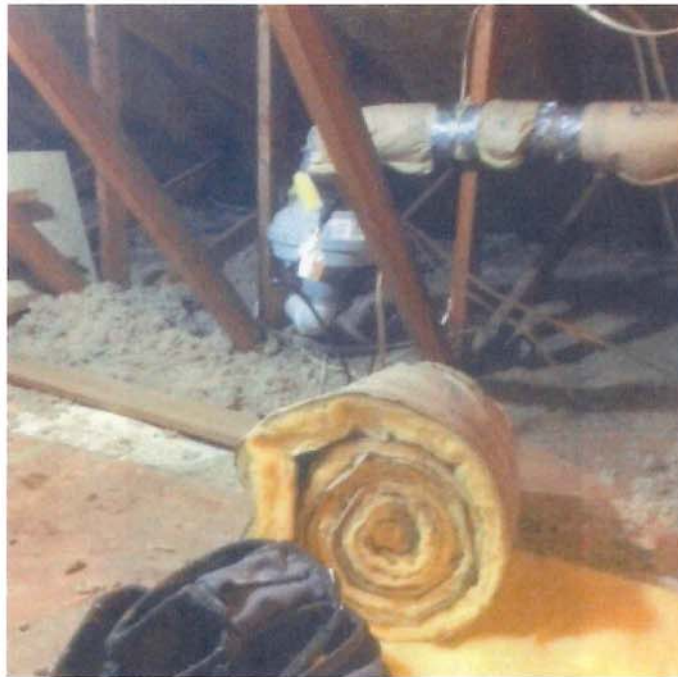
Photo 6: Eagle fan in attic above garage – system #2.

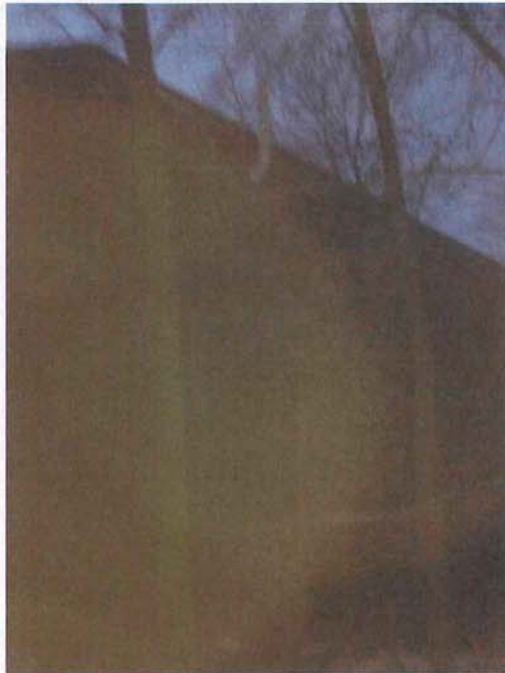
Photo 7: Discharge piping – system #2.

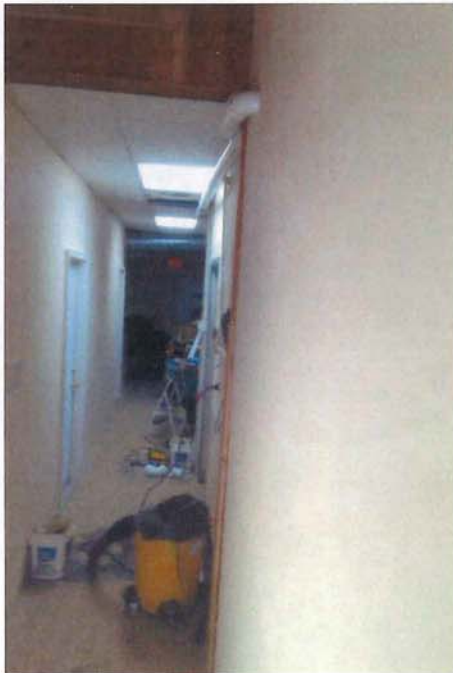
Photo 8: Piping connecting pickup points #2 and #3 in main building.

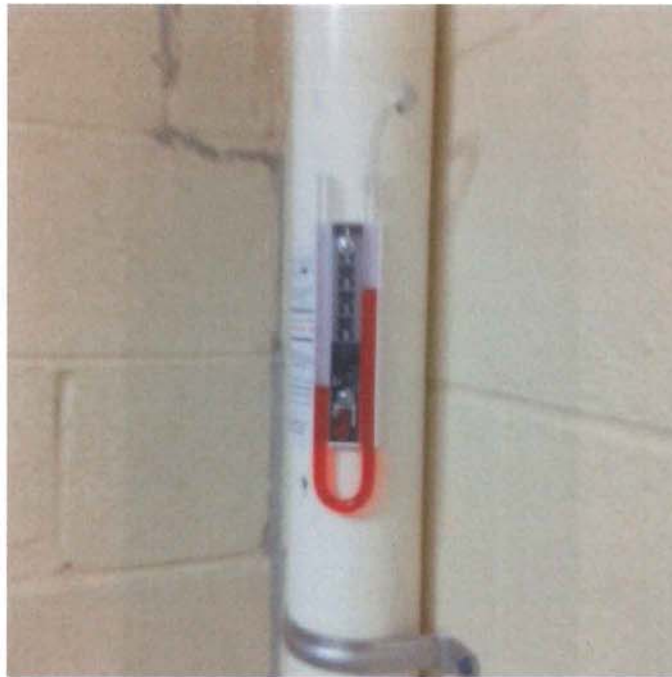
Photo 9: Manometer installed on pickup point #3 in main building. Note caulking on crack to the left of the pipe. Smoke detected leaks in the crack.

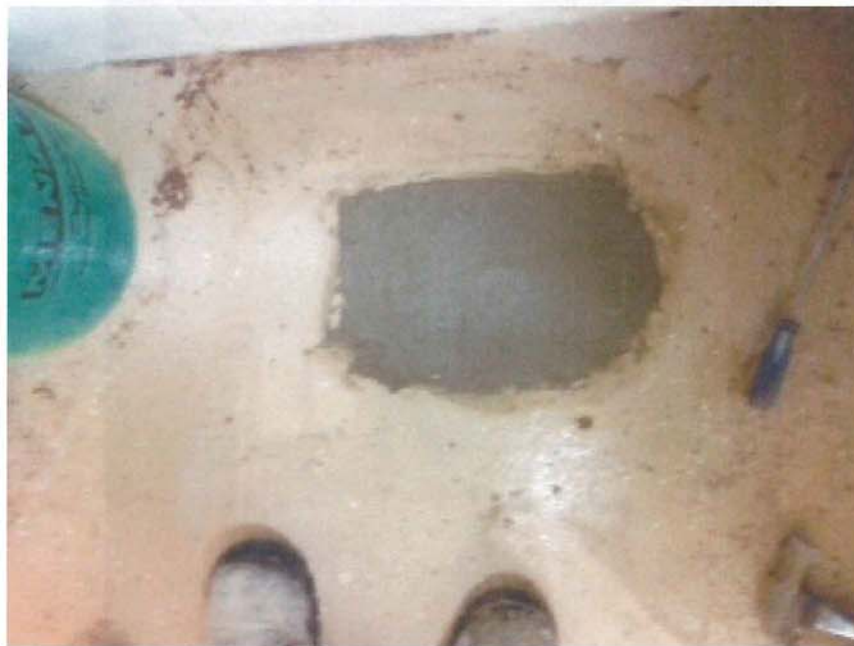
Photo 10: Failed pickup point #3; concrete tank underneath. Resealed with concrete (hole #3 moved).

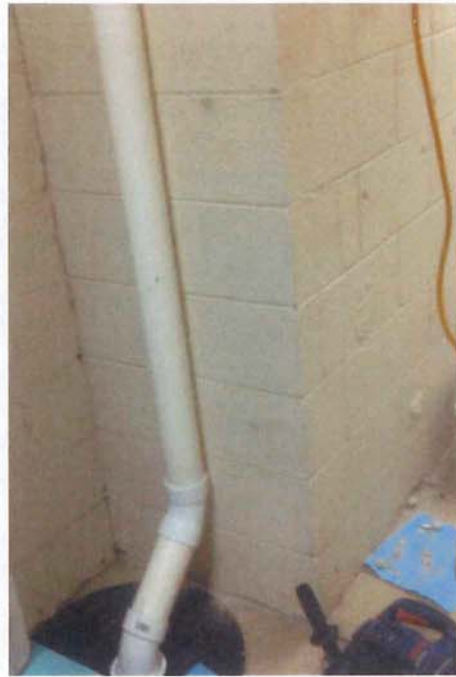
Photo 11: Hole/pickup point #3 in hall of storage area of main building (beside crack/joint).

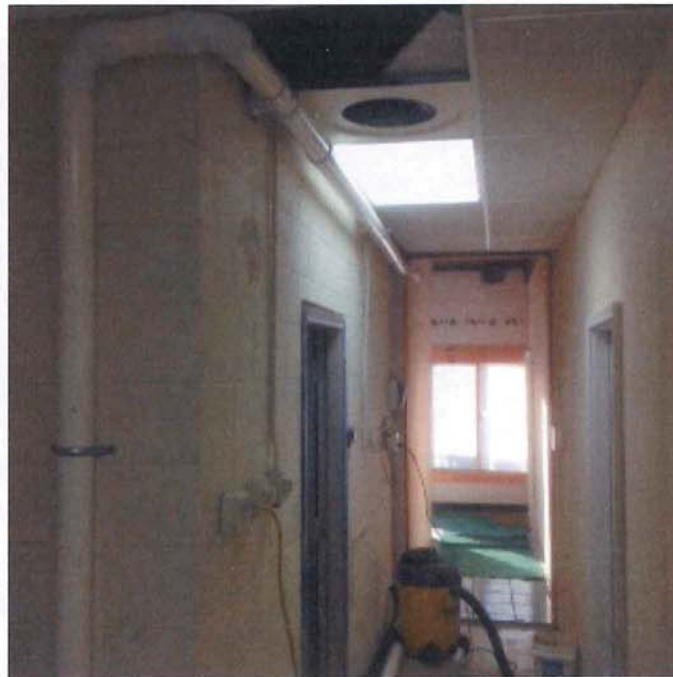
Photo 12: Piping connecting pickup points #2 and #3 in main building.

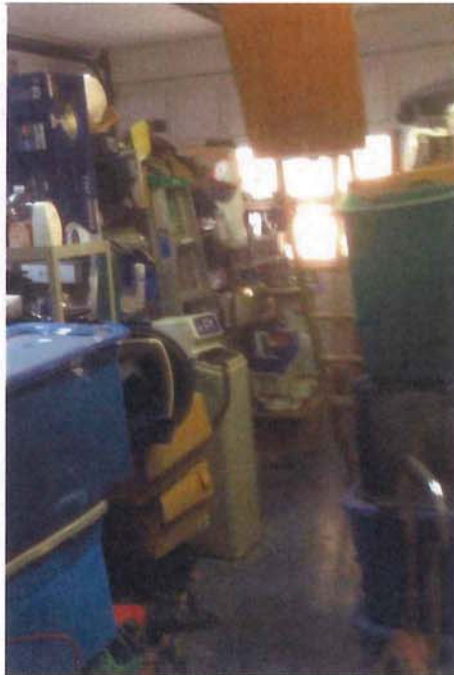
Photo 14: Garage where mitigation system #2 installed.

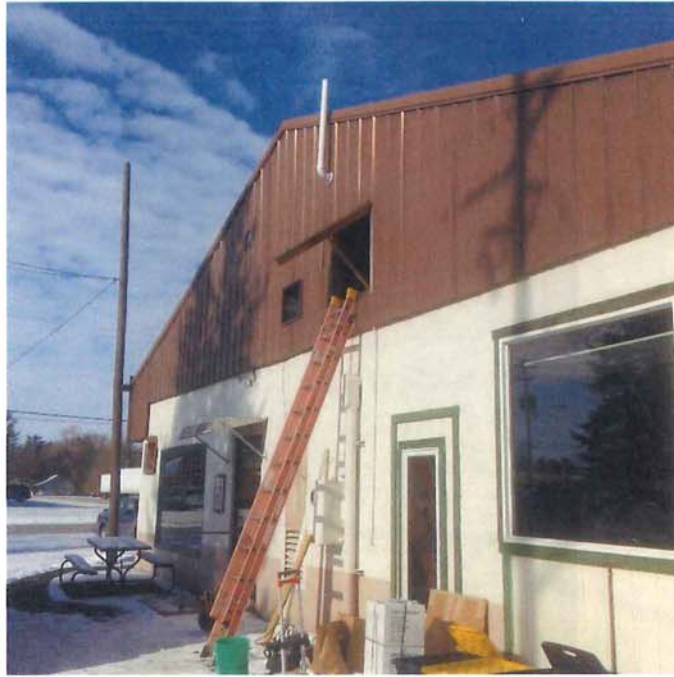
Photo 15: Attic access and discharge piping on main building.

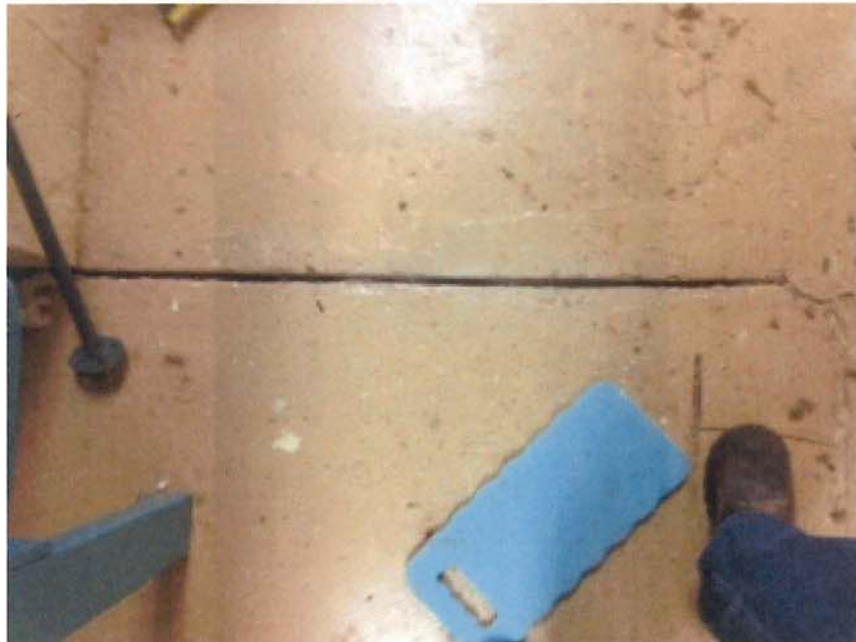
Photo 16: One-half-inch crack/joint in locker/storage area of main building. Crack later sealed where exposed.

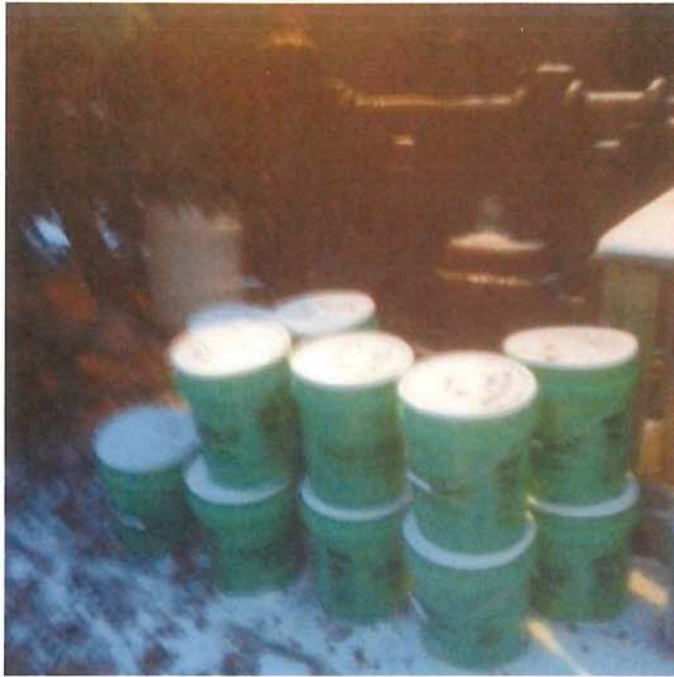
Photo 17: Sub-slab cuttings from pickup points.

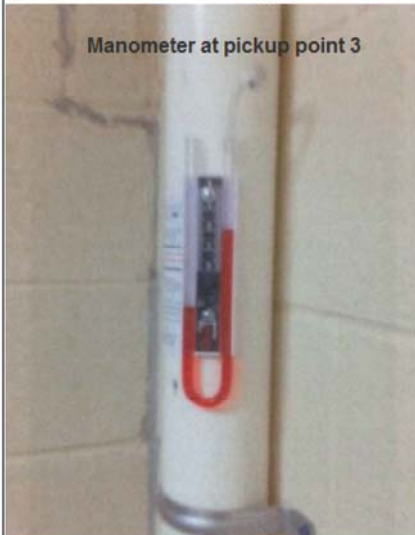
Title: Manometer at pickup point #3
