FIFTH FIVE-YEAR REVIEW REPORT FOR LEMBERGER LANDFILL, INC. AND LEMBERGER TRANSPORT & RECYCLING SUPERFUND SITES MANITOWOC COUNTY, WISCONSIN

U.S. Environmental Protection Agency Region 5 CHICAGO, ILLINOIS

7/20/2020

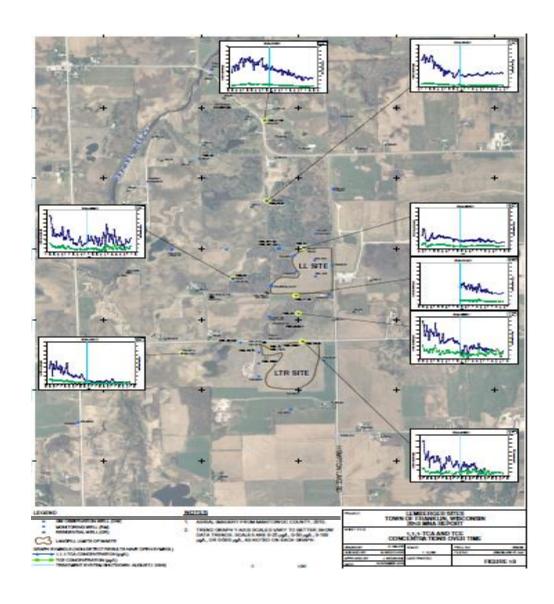
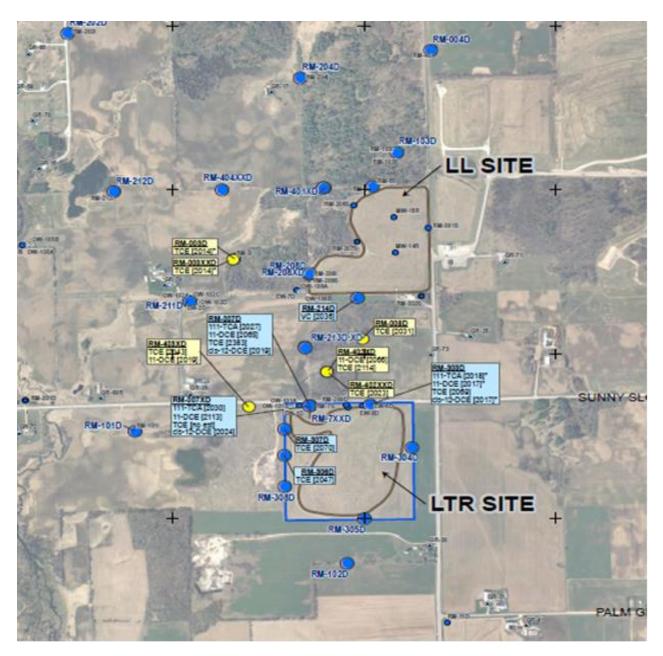
FIGURE 5 – VOC TRENDS OVER TIME

- The overall size of the VOC groundwater plume has diminished significantly since the remediation activities commenced and concentrations of VOCs within the impacted area continue to decrease.
- VOCs in the groundwater near the identified LTR source have degraded through anaerobic
 microbial reductive dechlorination to form primary breakdown products (such as 1,1dichloroethene). Aerobic conditions downgradient of the LTR inhibited production of alternate
 degradation compounds (e.g., vinyl chloride and 1,1-dichloroethene). VOCs continue to be
 degraded via abiotic processes.
- Statistical analysis of the historical groundwater data indicates that the concentrations of most VOC parameters above the ES at most locations in the groundwater contaminant plume will reach the ES in approximately 50 years.

- Blue dots represent no ES exceedance and downward trend
- Yellow dots represent ES exceedance and stable or downward trend

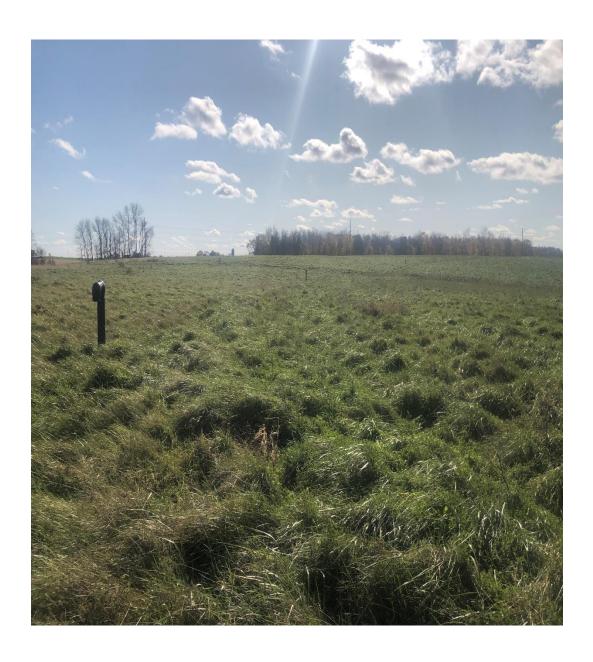
During the inspection of the Sites it was noted that all appropriate fencing was in place to prevent trespassers from accessing either landfill. Both landfill caps were inspected and looked completely intact with vegetation growing across the surface. All drainage areas looked well covered with rock where needed. All monitoring wells were intact and accessible as needed. The remediation building is still standing and holds all of the remaining equipment associated with the currently-idle groundwater pump-and-treat system. All access roads were drivable and there were no erosional areas noticed. No Site uses that are inconsistent with the implemented ICs or the remedy IC objectives were noted during the inspection. The Site Inspection Checklist and photos taken during the inspection are included as Appendix C.

Photo from top of LTR landfill showing thick cover that is well maintained and mowed properly.

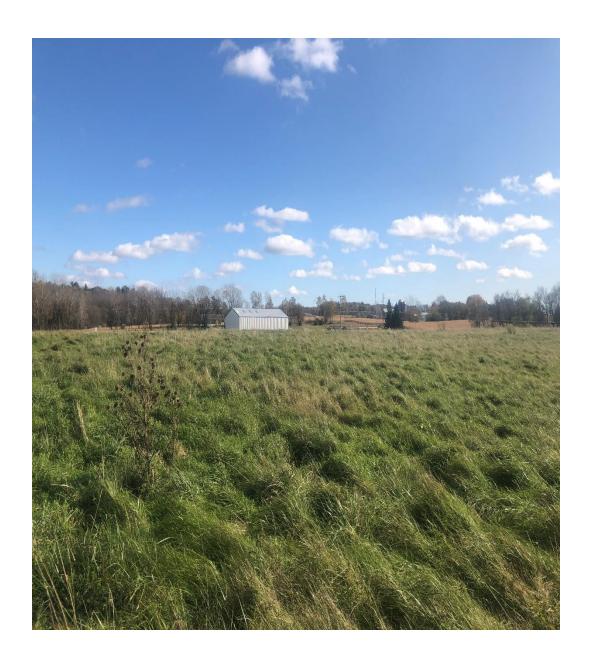
Photo showing remediation building where the out-of-service groundwater treatment machinery is housed and where the leachate from the LL was stored.

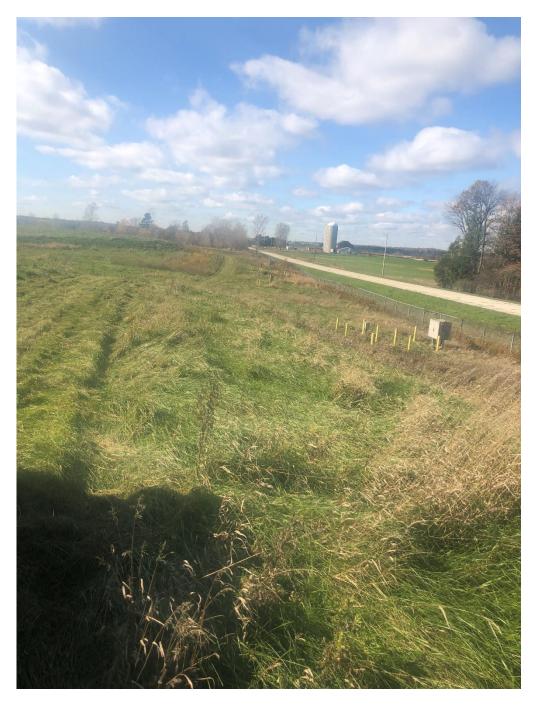
Photo along Sunny Slope Road showing an extraction well and the fence surrounding the landfill.
