Five-Year Review Report
Third Five-Year Review Report
for
N. W. Mauthe Superfund Site
Appleton
Outagamie County, Wisconsin
April 2011

Wisconsin Department of Natural Resources
Jennifer Borski, Hydrogeologist
625 E Cty Rd Y, STE 700
Oshkosh, Wisconsin 54901-9731

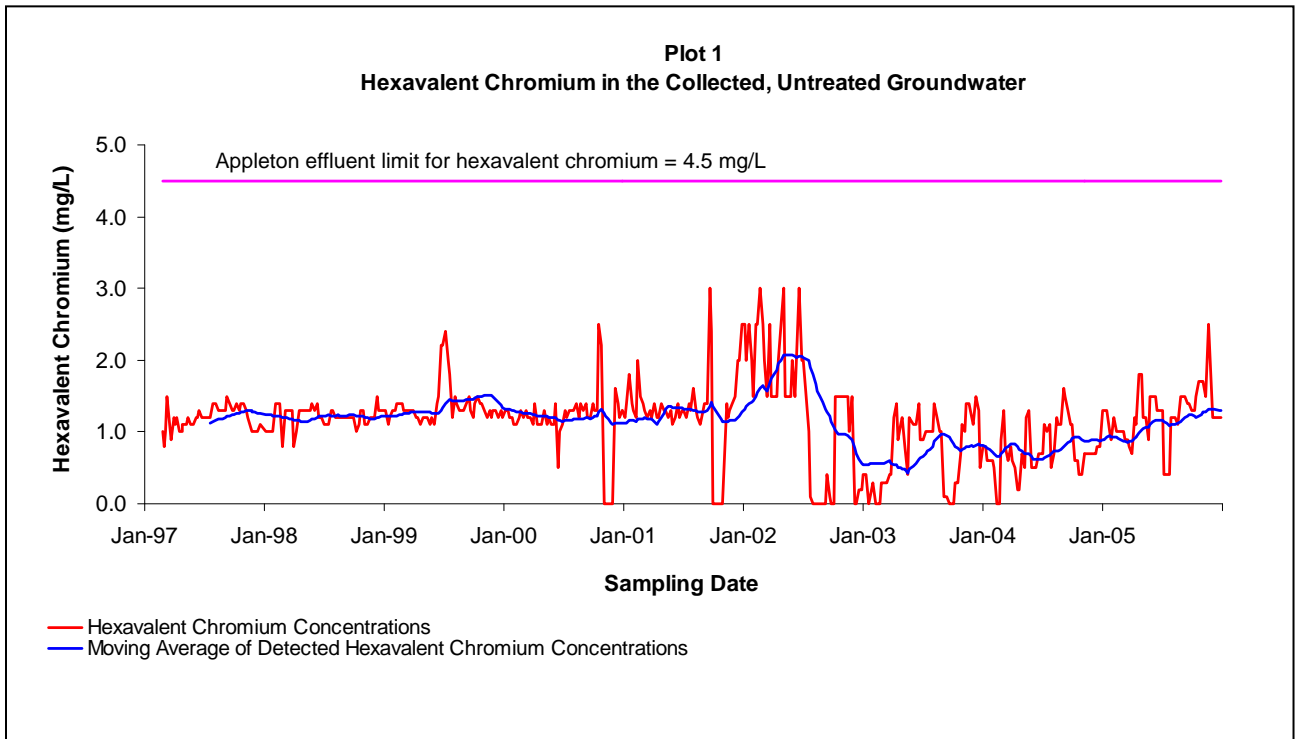
Plot 1 shows the hexavalent chromium concentrations found in groundwater collected at the site prior to the groundwater being treated by the on-site treatment system. The highest concentration found over that time period was 3.0 mg/L, which is less than the City of Appleton pretreatment standard. – Additional Site Investigation Report, OMNNI Associates, April 24, 2007
