**BRRTS ID No. 02-16-000144**

Review Date: 05/04/2022

Site Name: Clothes Basket/Jack's Place

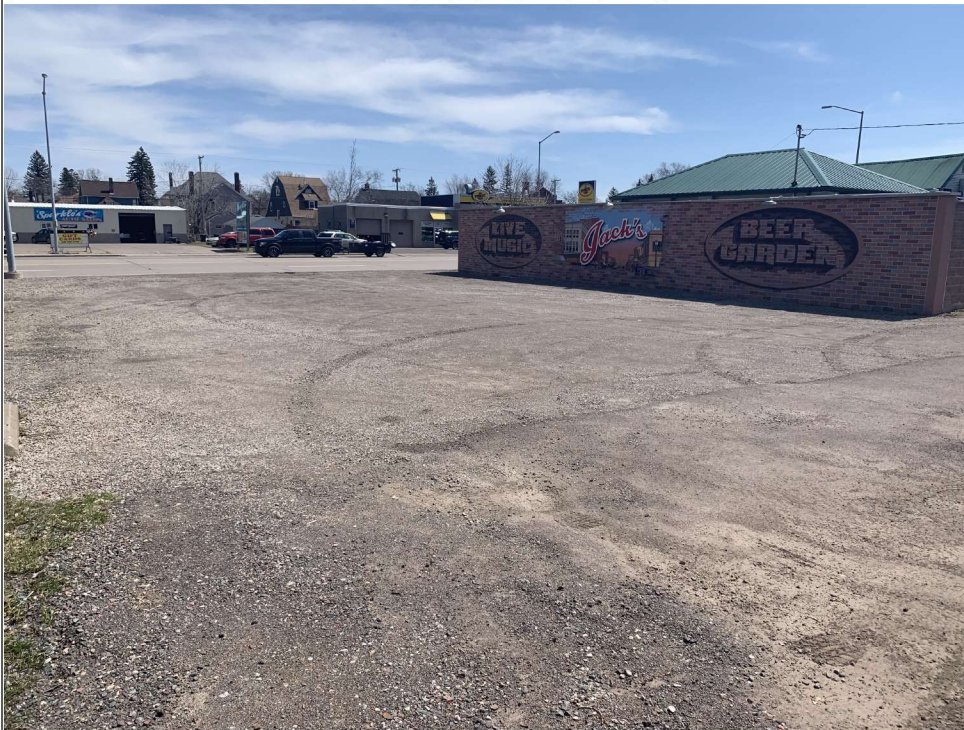
Date added: 05/11/2022

Title: Location of former Clothes Basket building (structural impediment) that is now gravel parking area; view to the southeast toward Tower Ave. and Jack's Bar beer garden.

- No
- Yes – Summarize the actions needed to return the site to compliance and identify who is responsible:  
RP should hire consultant to conduct investigation to determine if soil contamination exists in footprint of former building and whether it poses threat to human health or environment; submittal of sampling documentation and post-closure modification request & fee.

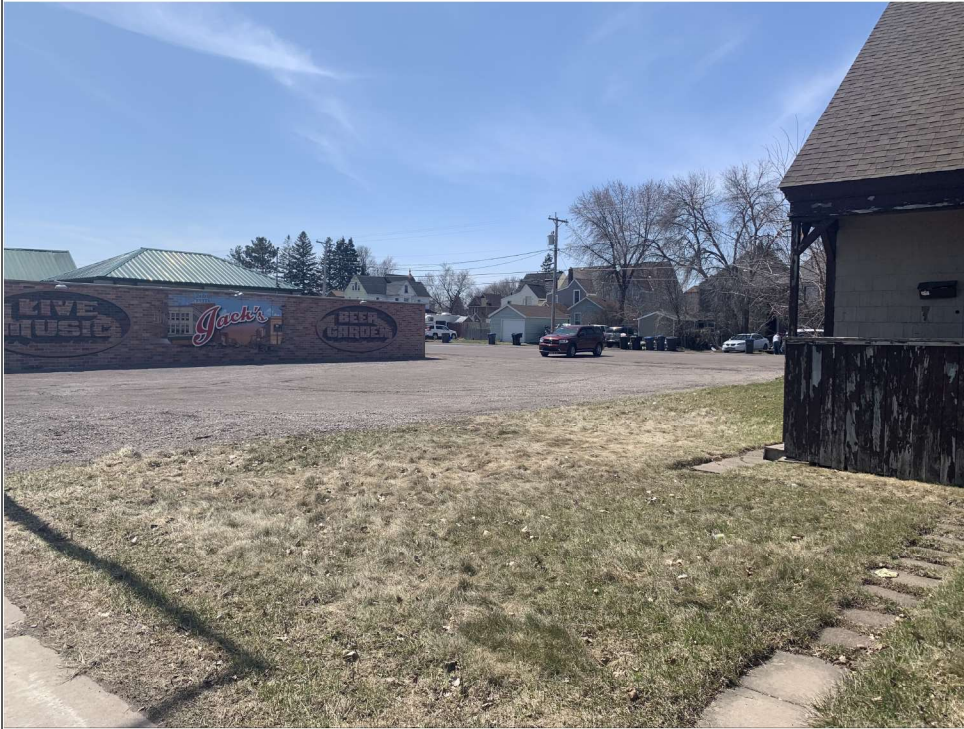
Date added: 05/11/2022

Title: Location of former Clothes Basket building (structural impediment) that is now gravel parking area; view to the southwest toward alley and Jack's Bar beer garden; adjacent residence in foreground on right.

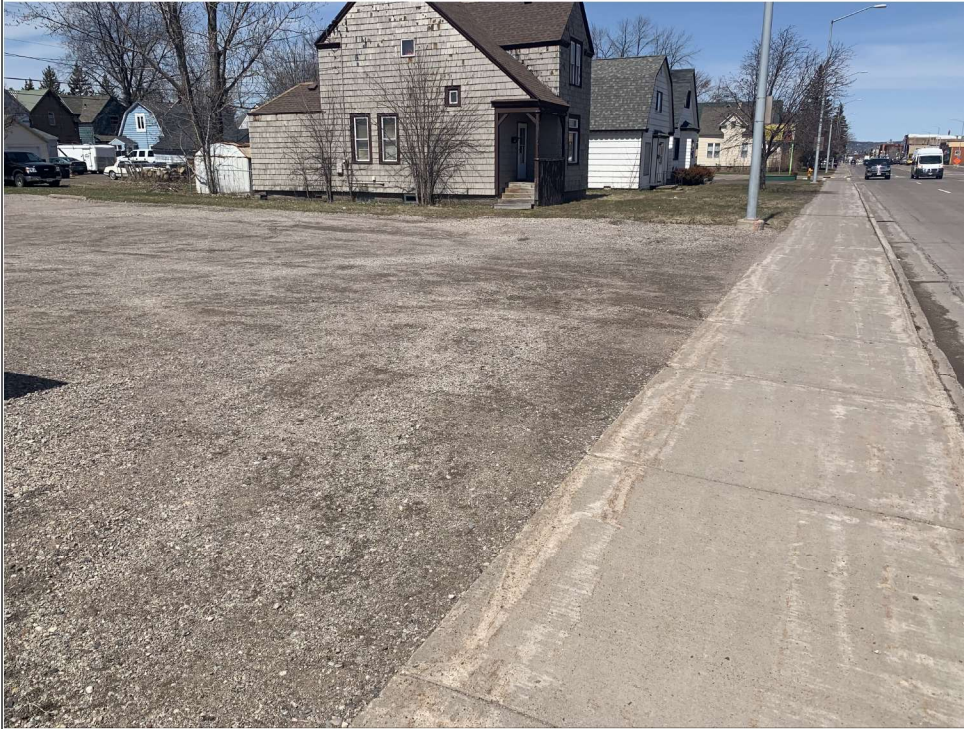
Date added: 05/11/2022

Title: Location of former Clothes Basket building (structural impediment) that is now gravel parking area; view to the north along Tower Ave and sidewalk.
