WISCONSIN DEPARTMENT OF NATURAL RESOURCES
REPORT OF AN INVESTIGATION OF THE
E.I. DUPONT DENEMOURS COMPANY'S EXPLOSIVES PLANT
AT BARKSDALE, BAYFIELD COUNTY, WISCONSIN

SPOONER, WISCONSIN
JANUARY 1982

By: Barry D. O'Flanagan
Hazardous Waste Specialist
Wisconsin DNR

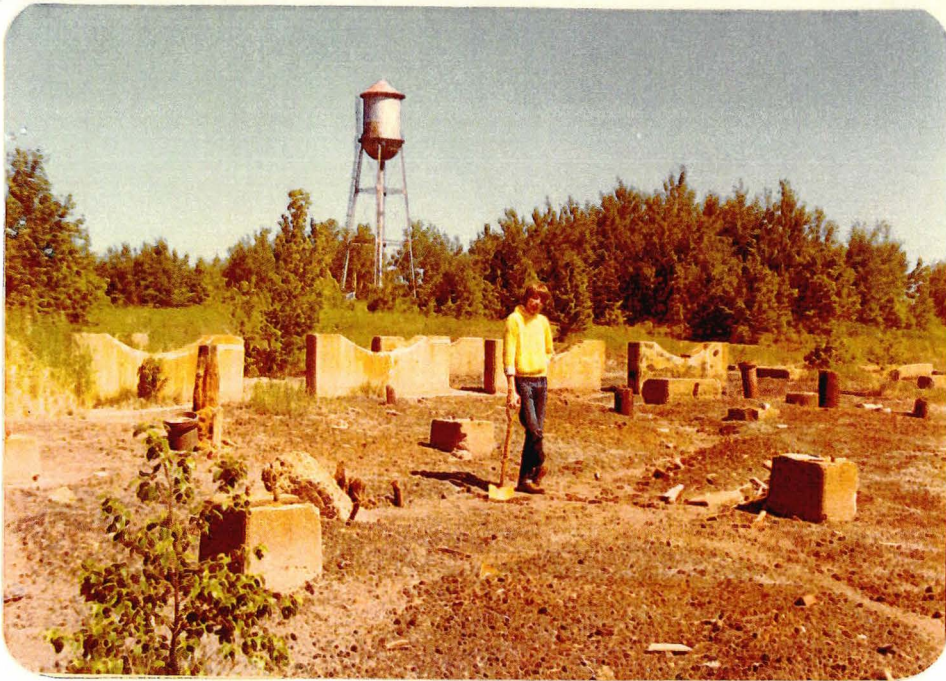
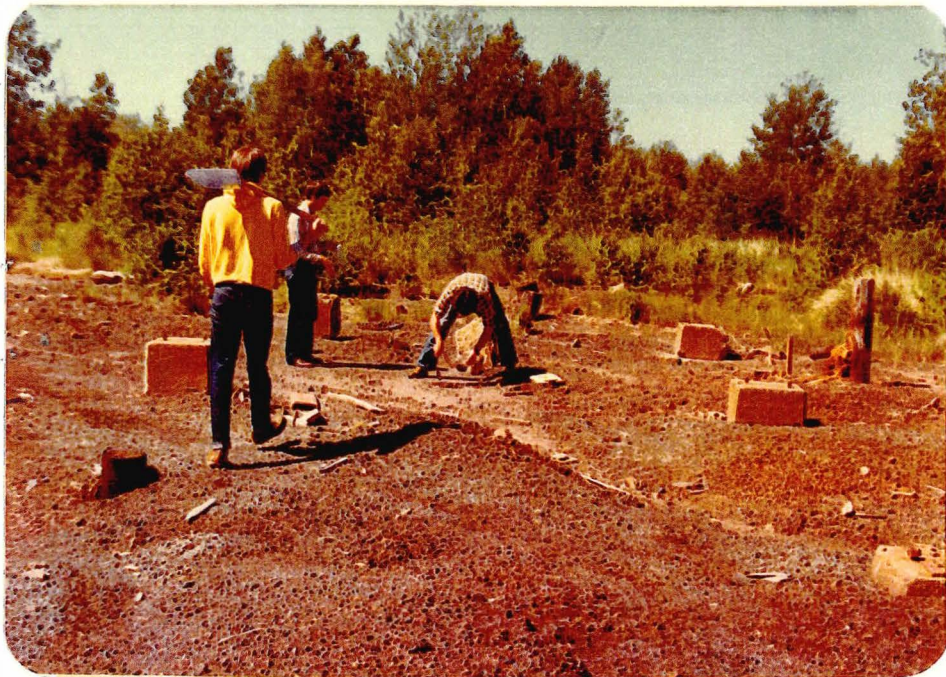
1) Soil sample in non-vegetated area southeast of water tower	7/1/81		3.5		8.5		5.0								This was the nitric acid production area sample taken from top 4-6" of soil.

Samples numbered 1 through 6 were taken in areas where Mr. Thannum had expressed concern. Number 1 is a soil sample from a former nitric acid production area. There was very little vegetation growing in this area and no vegetation in the immediate area of the soil sample. The pH of this soil is 3.5. Sample 2 is from an underground pipe system. It appears this liquid is a combination of surface and groundwaters draining the nitric and sulfuric acid production areas. This liquid has a high conductivity, low pH and showed a very high sulfate (SO_4) concentration. Sample 3 was a water sample from a ditch draining the sulfur storage and sulfuric acid production areas. Relatively low pH--4.3, and a high sulfate concentration--120 mg/l were found. Samples 4, 5 and 6 are from Boyd Creek and the creek bed at the base of the Barrel Dump. Samples 4 and 5 are from Boyd Creek. Values of all parameters measured for these samples are within expected ranges. Sample 6 is a soil sample from the base of the dump. Heavy metals analysis was performed on this sample. For the analyses run, no unusual values were found.

Nitric Acid Production
Area - Sample
Location 1 (7/1/81)

The area around sample 1 (HNO_3 production) has a soil pH which very probably inhibits revegetation. It is recommended this area be treated with a neutralizing agent to raise the near-surface (3-5 inches) soil pH to approximately 7.0. This should be done such that the neutralizing

agent is mixed with and incorporated into the soil. Following neutralization, the area should be seeded with suitable grasses.

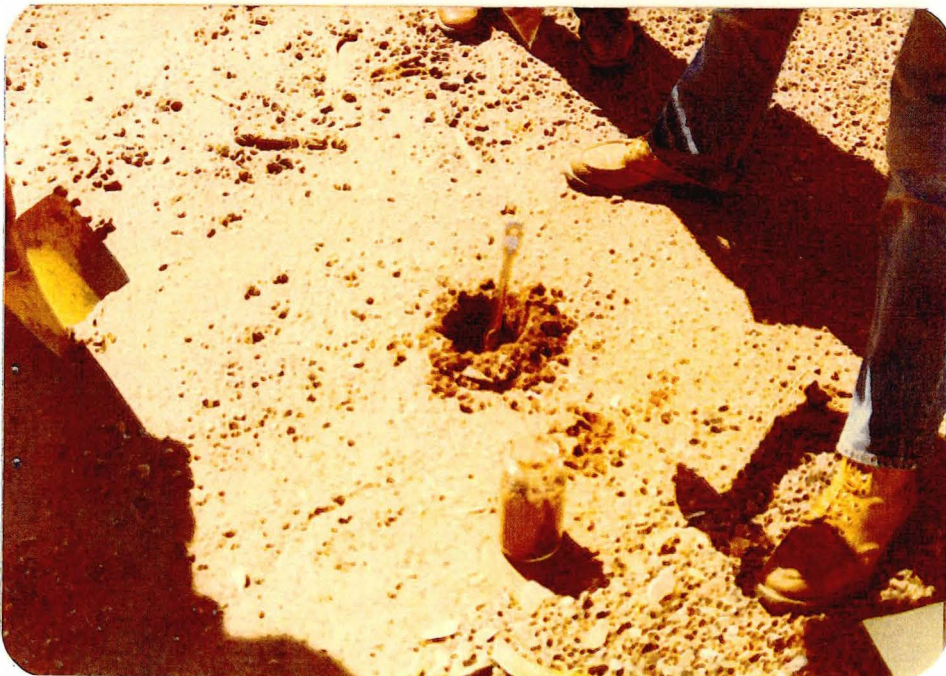
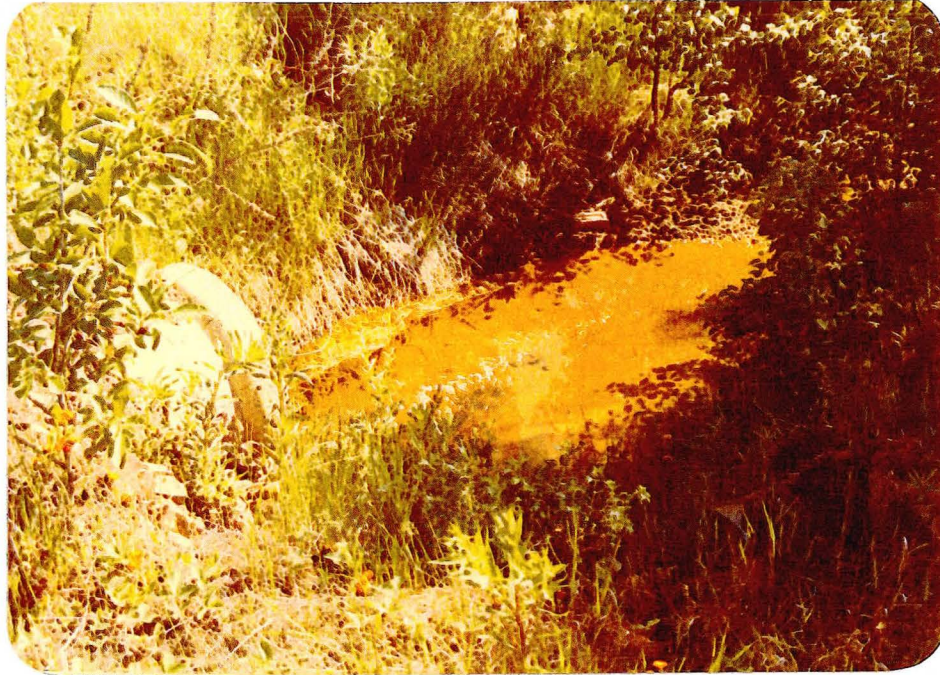
2) Pipe effluent in drainage ditch	7/1/81	1850	3.5	15.4			36		1100						Orange precipitate.
3) Drainage water in ditch near sulfur storage area	7/1/81		4.3	22			.02		120						H ₂ SO ₄ production and sulfur storage areas are drained by this ditch.

Drainage pipe with yellow precipitate
sample location 2 (7/1/81)

Sample 2 shows low pH, and high conductivity, sulfates and nitrates. The low pH enhances dissolution and probably contributes to the other parameters being high. It is recommended the pipe be removed, the ditch filled in and the area graded to prevent future erosion. This will allow for infiltration and cleansing of this drainage water.

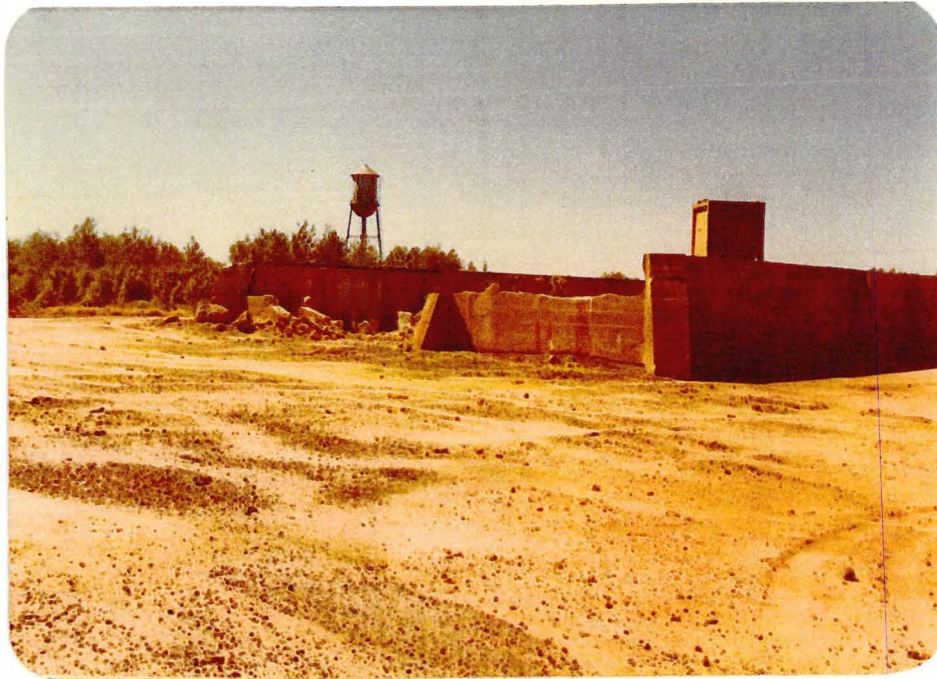
Sulfur Storage Bunker

The sulfur deposits were located near a concrete foundation. There were a number of small sulfur "nuggets" laying on the ground in the immediate area. This was, according to Mr. Bye, a sulfur storage area. There was no vegetation growing in the immediate vicinity. Apparently, this was also a heavily travelled area with some cinder roadbeds present. We found no lead deposits.

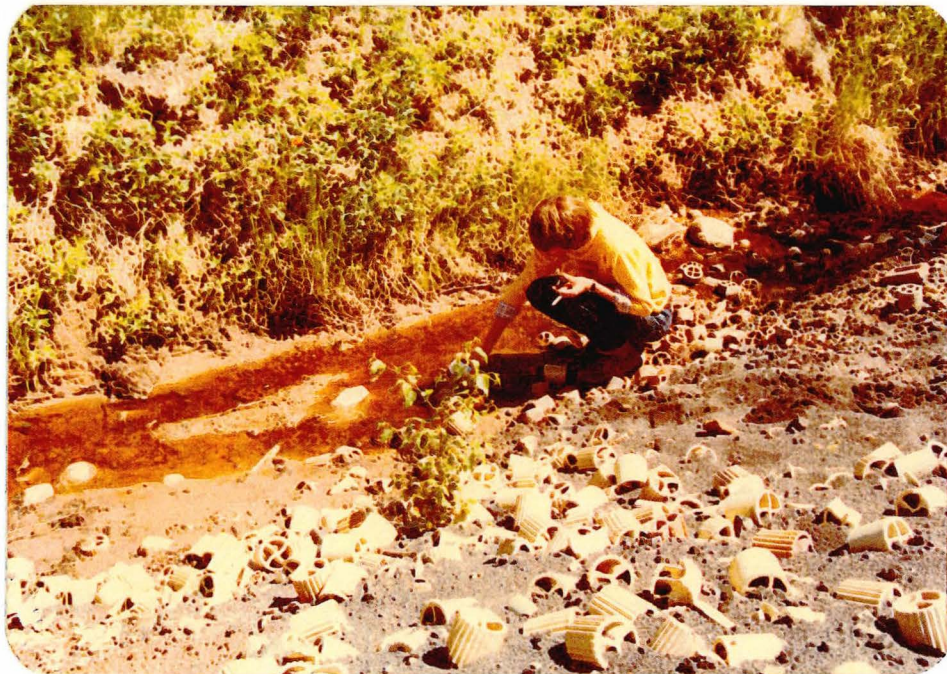
Stream draining sulfuric acid production area
Sample Location 3 (7/1/81)

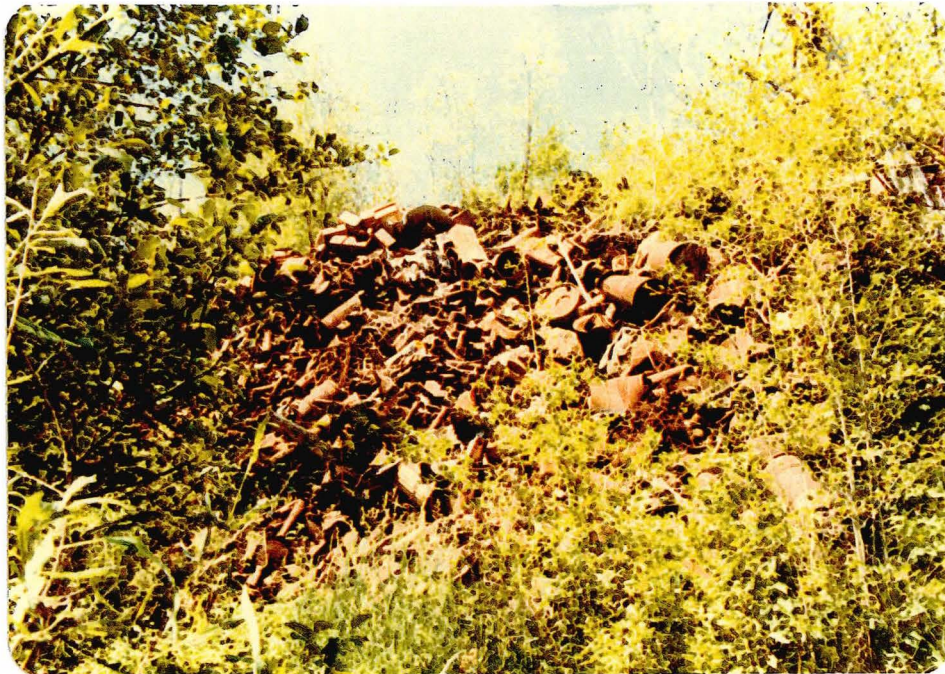
4) Boyd Creek above Barrel Dump	7/1/81	110	6.7	18	2	39	.05		12						
5) Boyd Creek below Barrel Dump	7/1/81	120	7.0	18	2	41	.05		11						
6) Soil sample from base of Barrel Dump	7/1/81		7.2		1.5										Heavy metals analyses run- Pb - 10 ppm Cd - 1 ppm Cr - 5 ppm

Metal (barrel) dump adjacent to Boyd Creek
Sample sites 4, 5 and 6 located here (7/1/81)

Dump sites for metal containers were located along a portion of the creek bed and flood plain during the investigation. The one immediately adjacent to the creek was looked at more closely. There were many types and sizes of containers. All visible containers were rusted and appeared empty with either the containers being punctured on the top or the bung removed. Some of the containers, including barrels, had washed downstream a distance. Gary LaRoy indicated to Bruce Lawrence that it would be necessary to clean the dump site up as it was, at the least, an aesthetic nuisance. The extent of the dump sites was impossible to determine because of the snow cover and frozen ground.

There were no problems identified with samples 4, 5 or 6. However, the barrel dump and surrounding areas should be cleaned up. The drums and other debris lying along the stream bed must be collected and buried. All dump sites adjacent to flowing water, particularly along Boyd Creek, must be cleaned up and the material landfilled. At the dump site where samples 4, 5 and 6 were taken, the rubbish must be pulled up and away from the creek and buried. The bank should be graded, then covered and seeded to minimize soil erosion. This area should be checked periodically and maintained until it is stabilized.

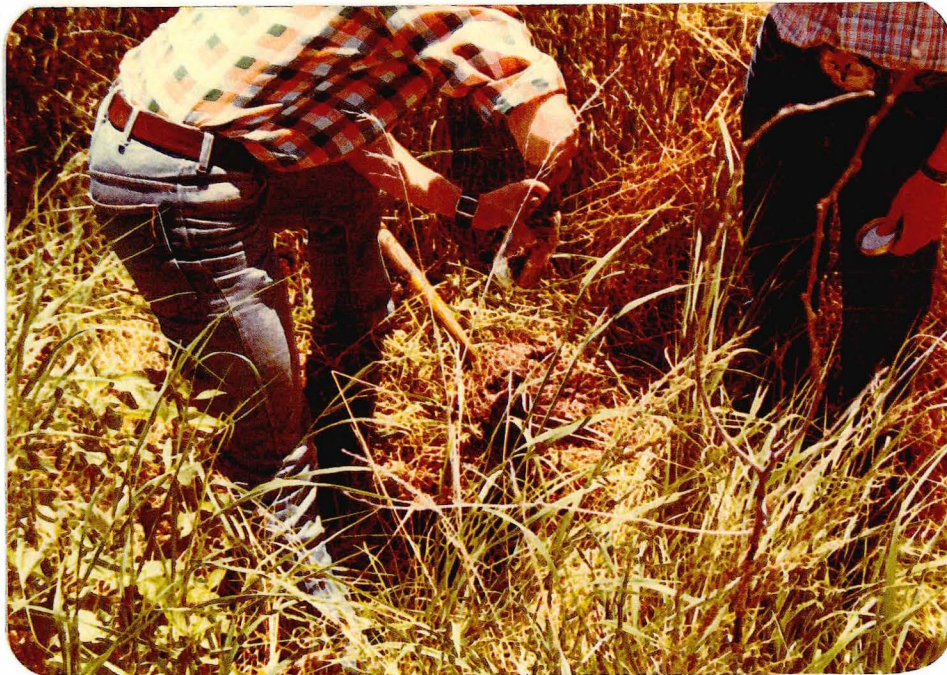
8) Soil sample from wetland south of the bermed area	7/1/81		4.1		10.0			2.5							This area appeared to be an old dump.
9) Soil sample from ridge and furrow area	7/1/81		7.0		7.0			.5	4.68	4.62	4.90	4.88	4.70	2.48	This is the ridge and furrow system used for treating the red water.

was a soil sample from a small wetland just south of the TNX area. This was sampled as it appeared the area had at one time been used as a dump. The pH of the sample is a bit low, but apparently not low enough to have any affect on vegetative growth. Sample 9 was from the ridge and furrow area used for "treating" the TNT red water waste. TNT and breakdown products were found. However, there were no extremely high concentrations noted. Samples 10 and 11 were groundwater samples. Sample 10 was from a well near the front gate and 11 was from an old well near the power house. The wells were not bailed prior to sampling so it is not known how representative the results are of the surrounding groundwater. The conductivities were somewhat higher than those of the creek, but not excessively high. Sample 12 was from a lightly vegetated sand and gravel fill in the Nitramex area. Nothing unusual was found in this sample. Sample 13 was from the burning area. This is where plant refuse and waste explosives were burned. The area was covered with cinders. Again, nothing unusual is noted in these results.

Marsh dump site south of TNX production area
Sample location 8 7/1/81)

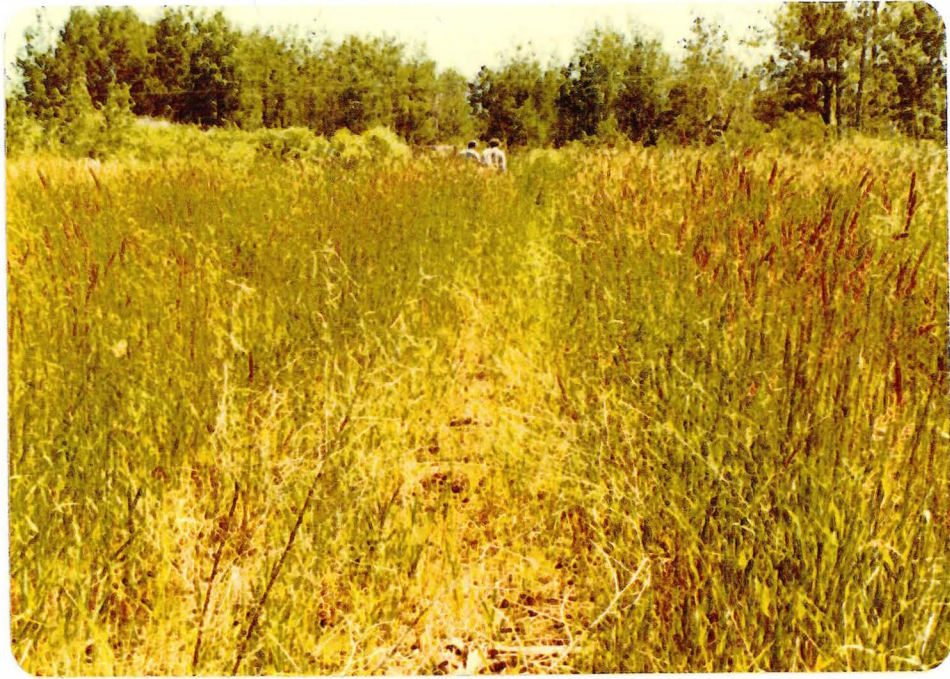
Ridge and furrows area for red water treatment
Sample location 9 (7/1/81)

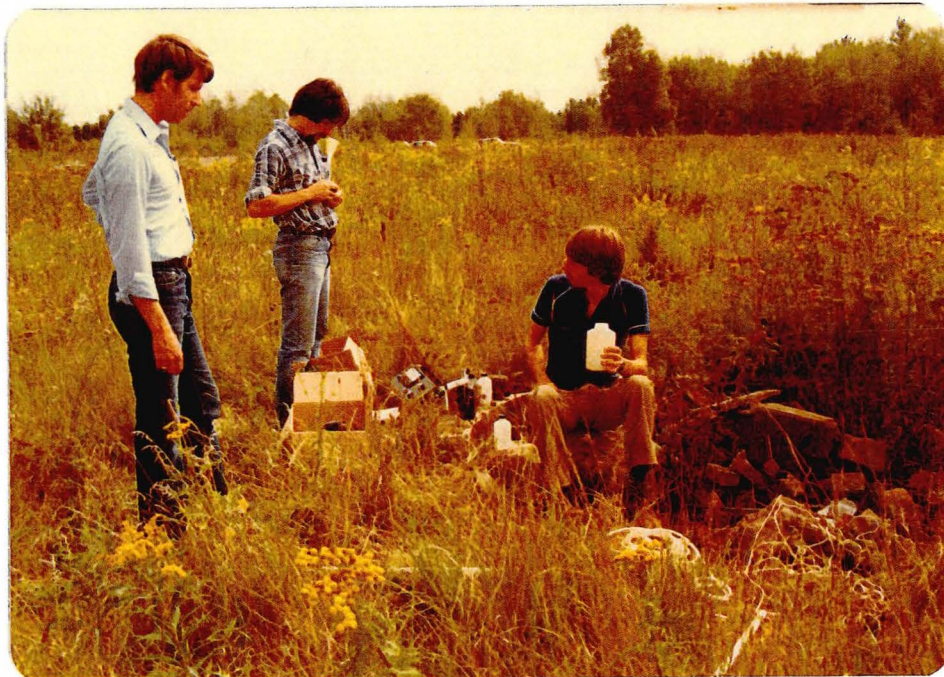
10) Well sample at front gate	9/3/81	365	6.5	9.5			.02		6						Well located at front gate-well was not bailed prior to sampling.
11) Power plant well sample	9/3/81	460	7.5				.02		2						Well is broken off improperly abandoned. Well was not bailed. Water level - 34'.

Power plant well site
Sample location 11 (9/3/81)

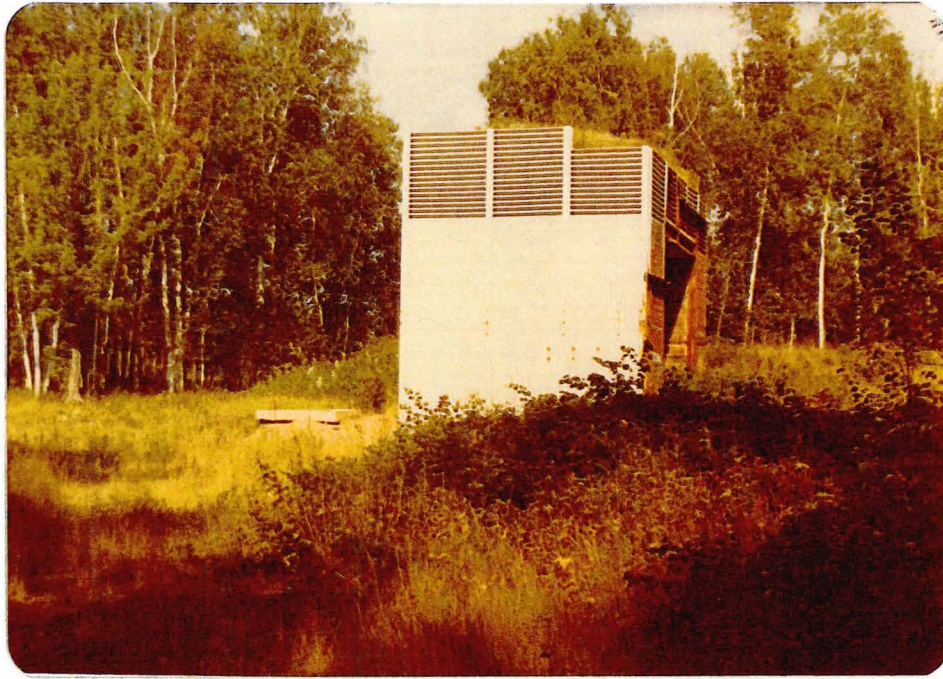
12) Soil sample from sandy soil in old nitramex area	9/3/81		5.6		.5			7.0							Sandy-gravelly area with little vegetation.
13) Soil sample from old burning area	9/3/81		6.5		.5			26.0							Burn area used for refuse and waste explosives disposal.

Views of a portion of the Nitramex area
Sample location 12 (9/3/81)

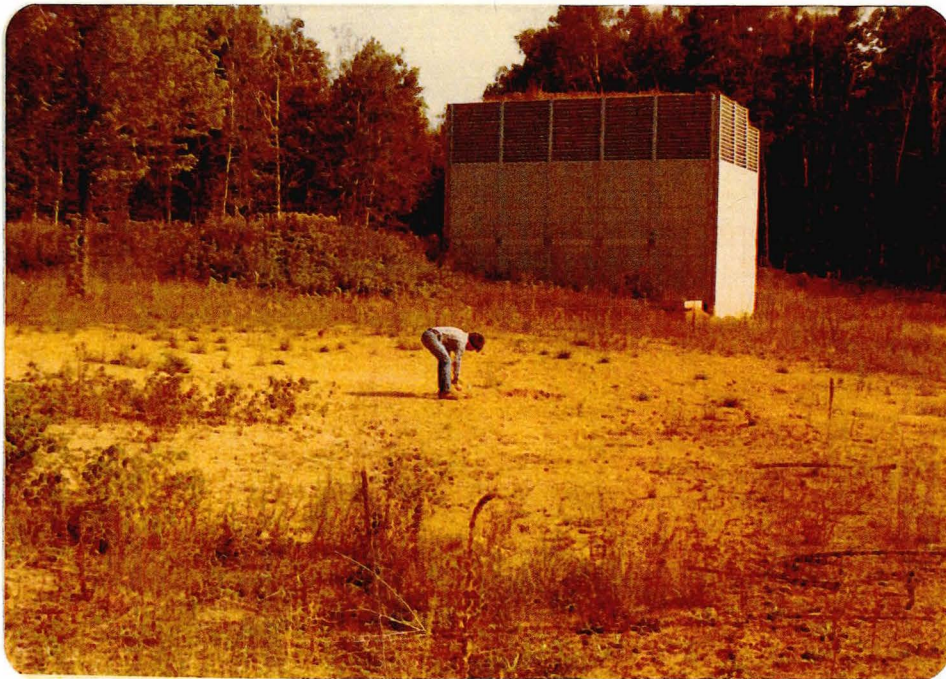
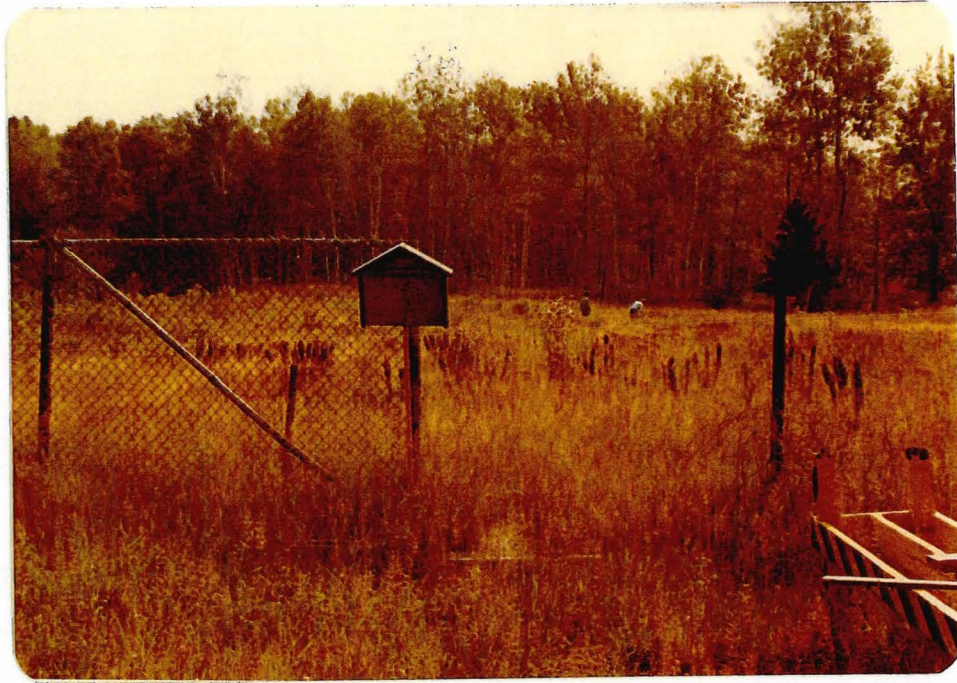
Views of burning area
Sample location 13 (9/3/81)
